**OHIO DEPARTMENT OF TRANSPORTATION
2014 PHYSICAL CONDITION REPORT**

**I-71 NB OVER SR 176 NB
BRIDGE NO. CUY-71-1791R**

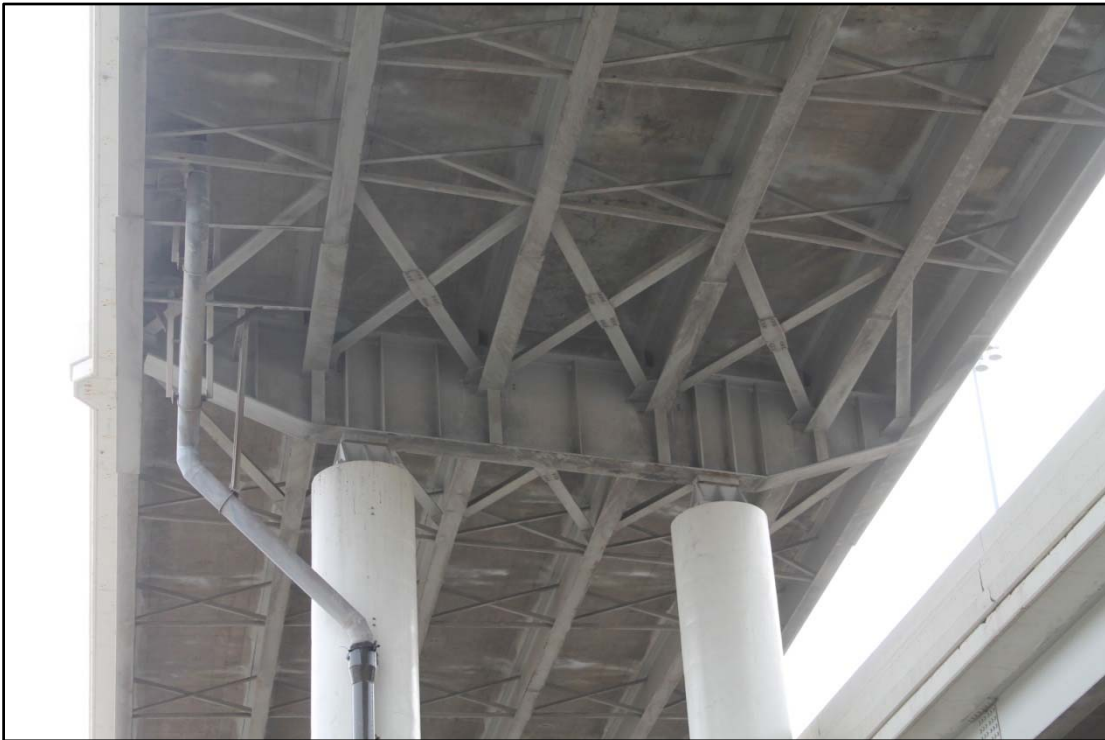
Photo 2- Fracture Critical Steel Pier Cap, Pier 20AE.

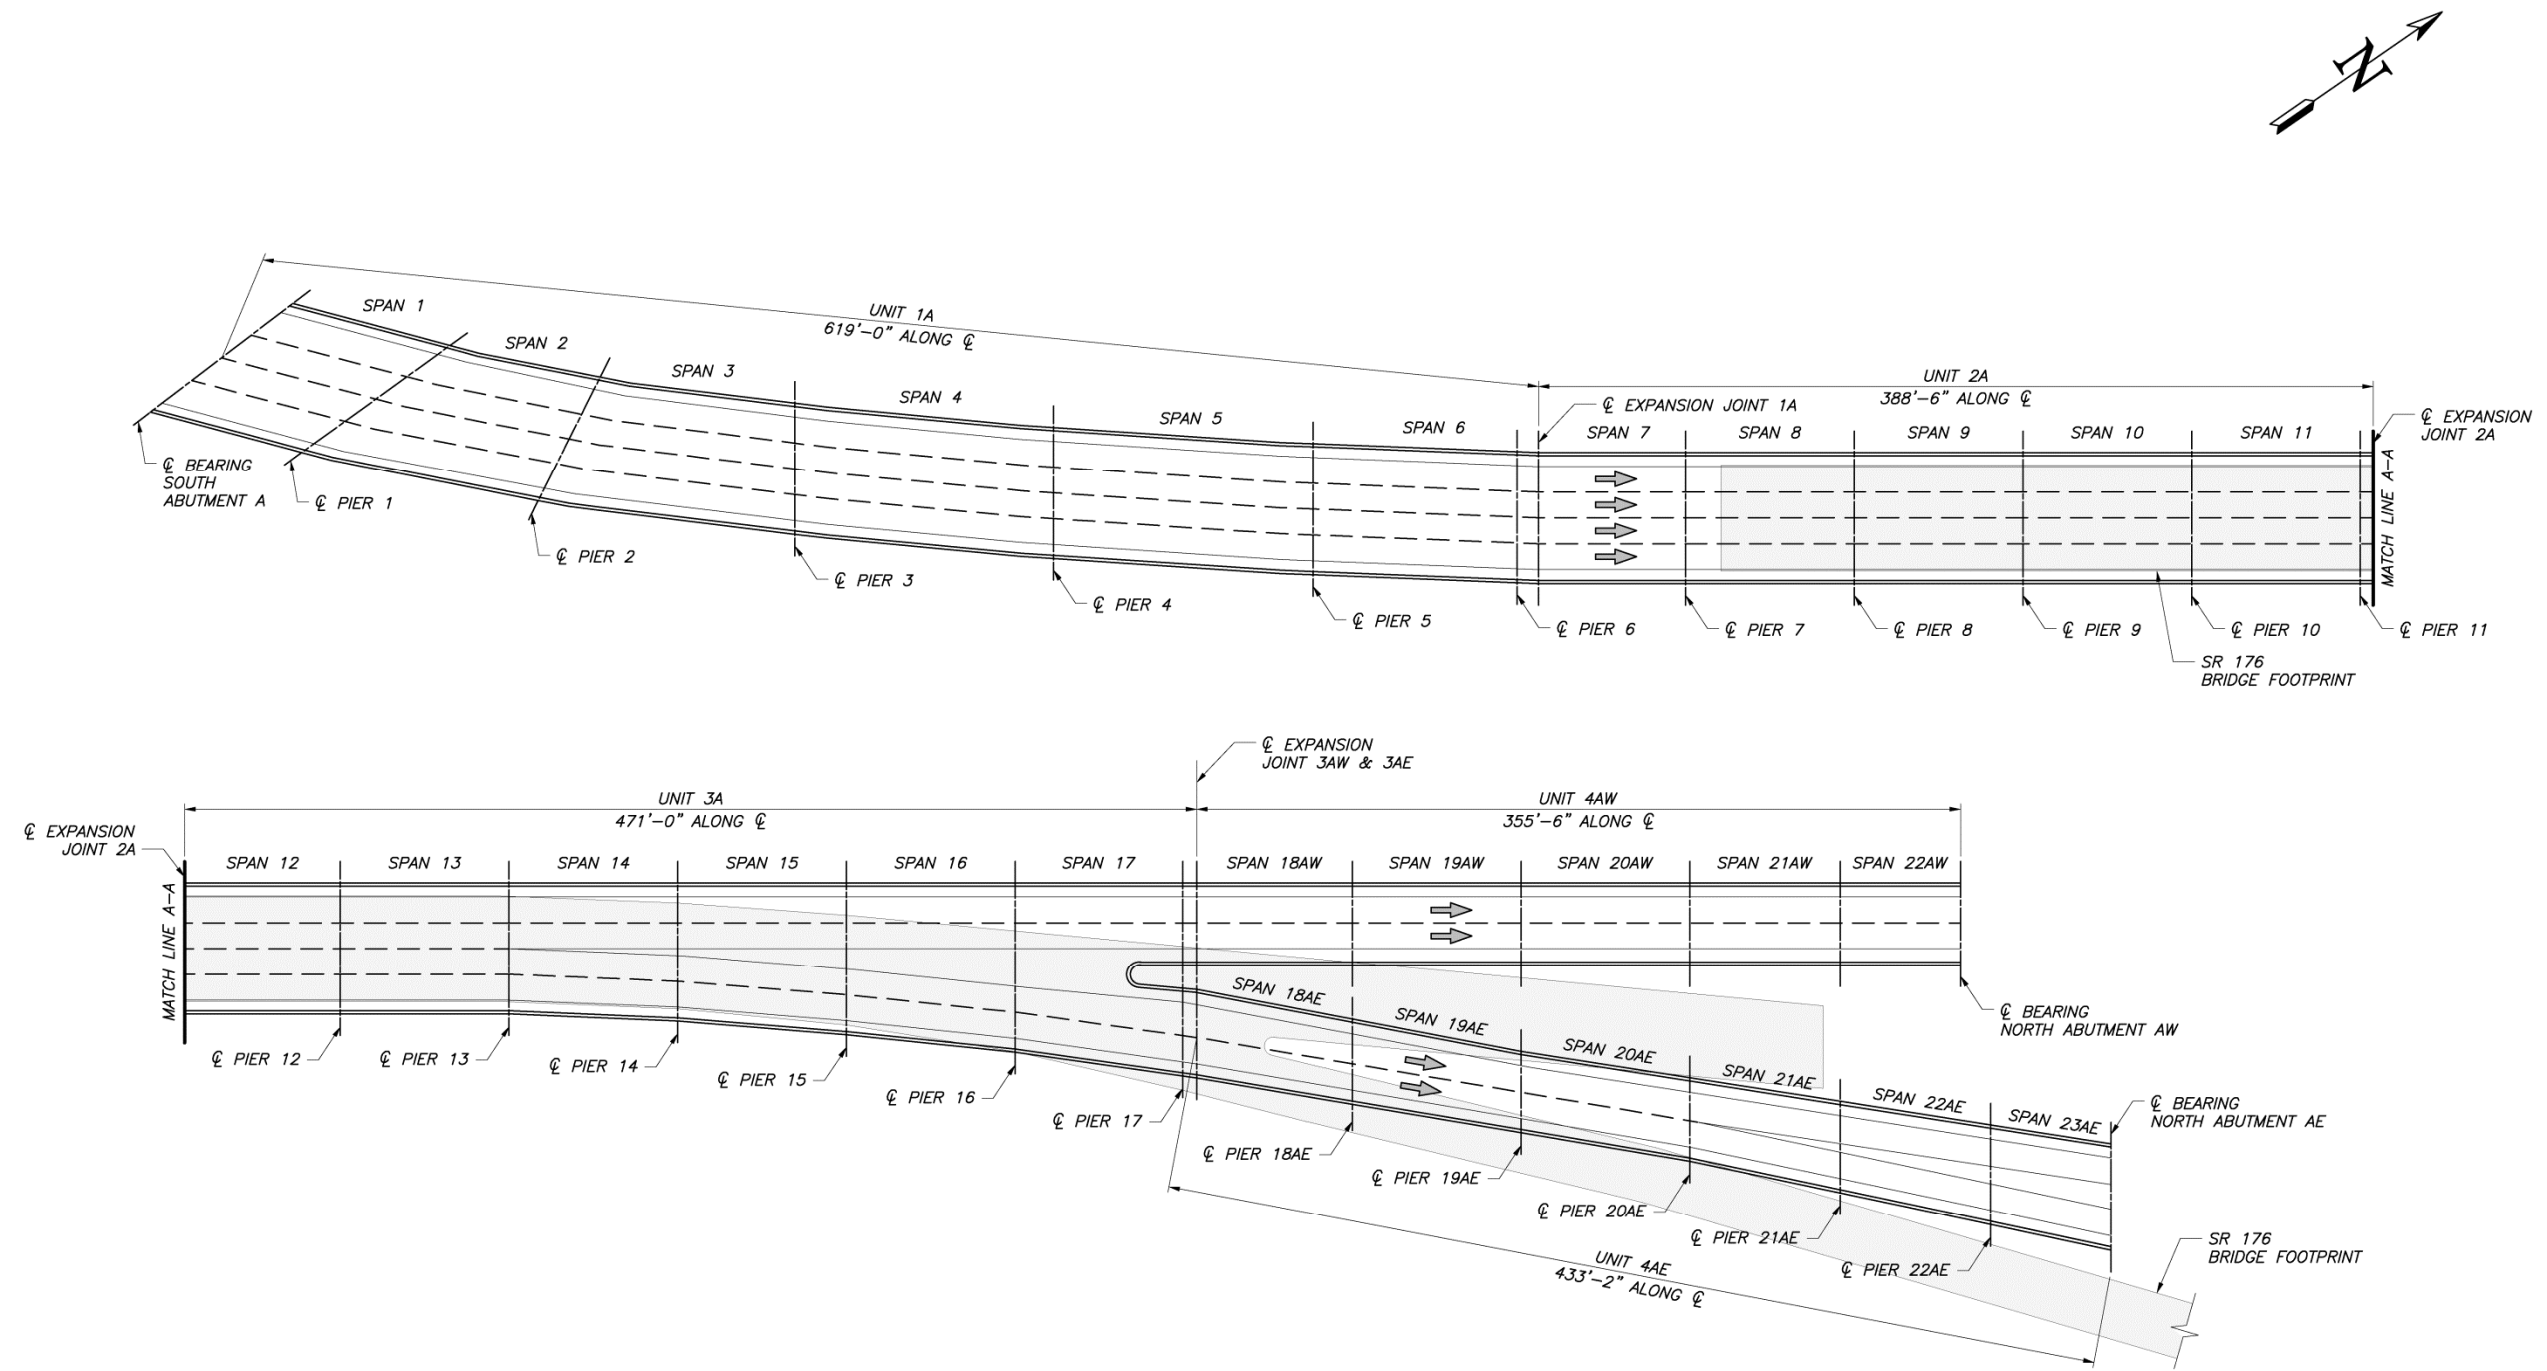
Figure 2 – General Plan.

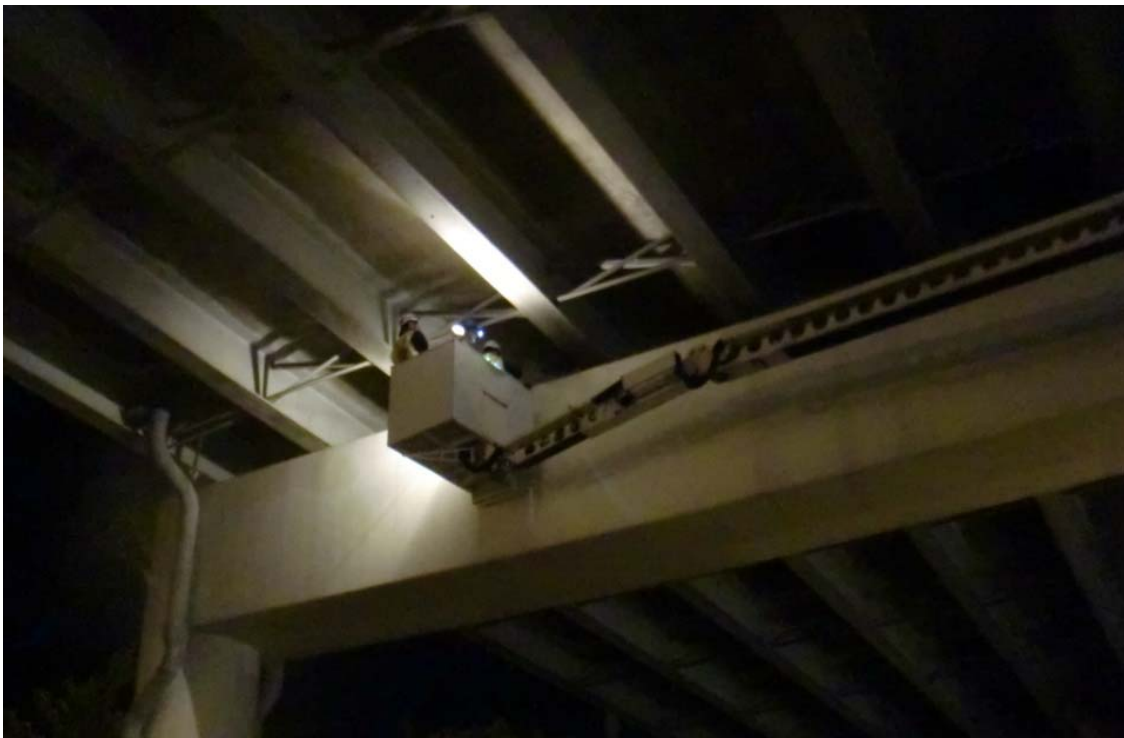
Photo 3 – Snooper Access Using Bucket Mounted Lamps.

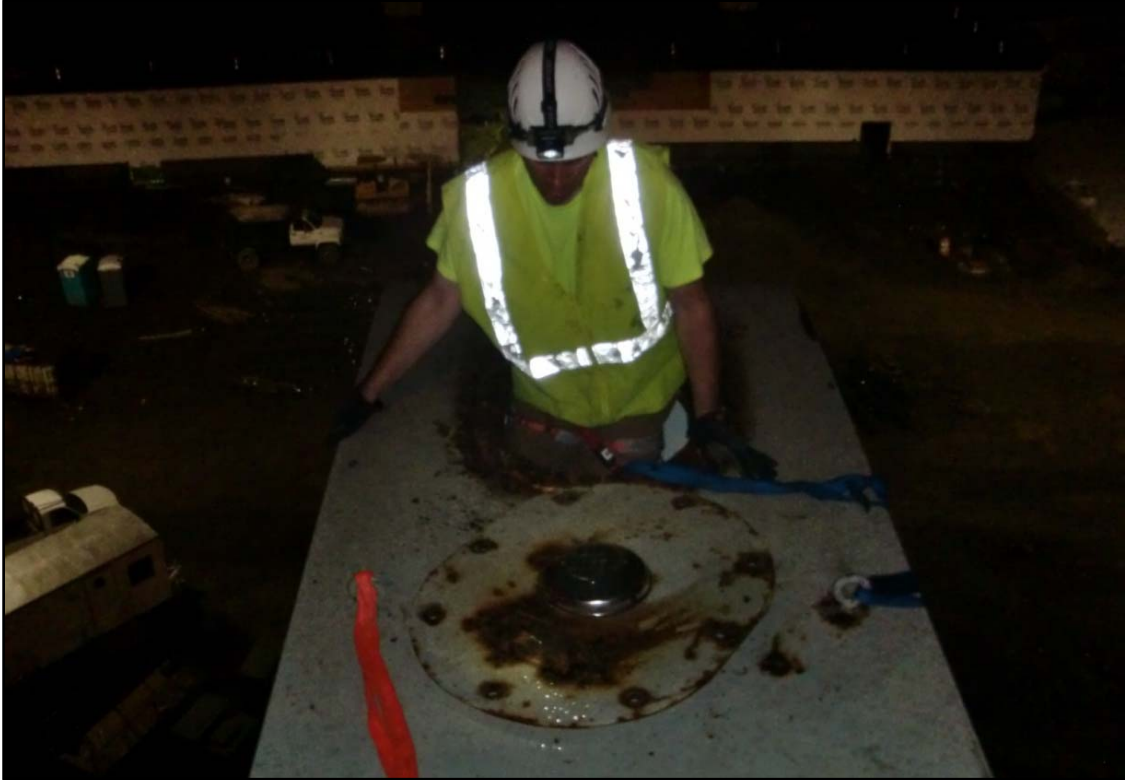
Photo 4 – Climbing Procedure to Pier 17 Steel Box Interior.

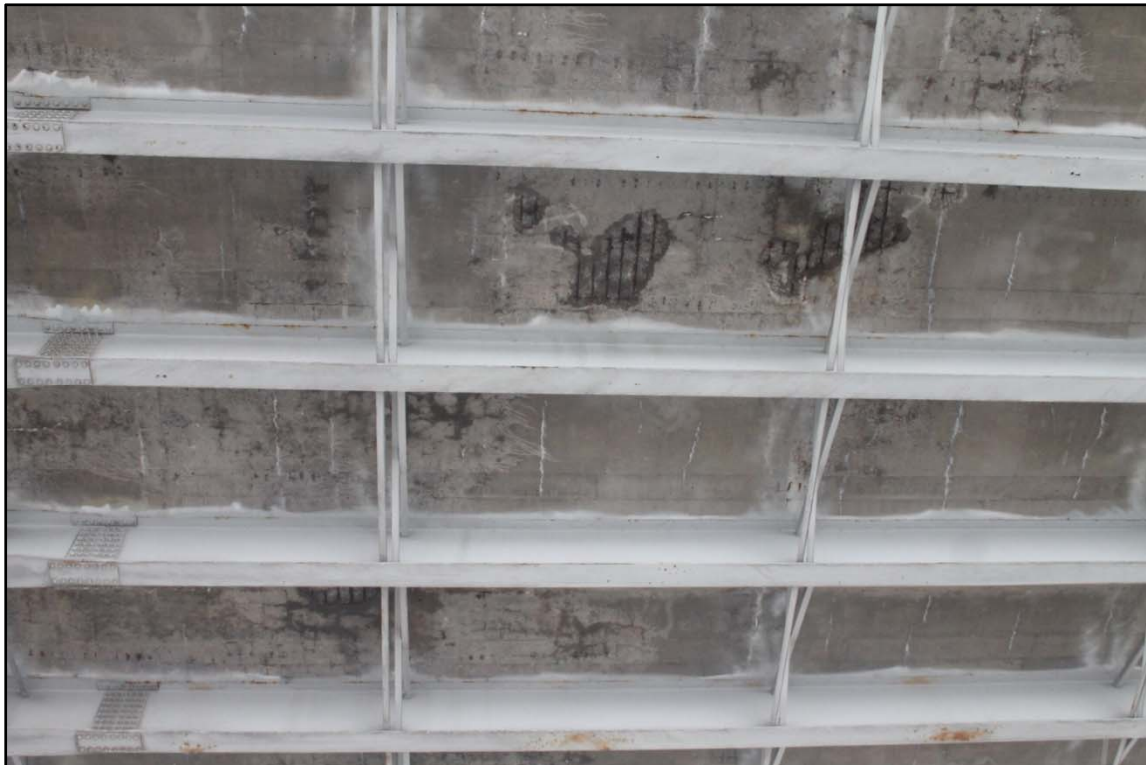
Photo 5 – Spalled Soffit over SR 176 NB Vehicular Lanes with Adjacent Mottled Concrete Surfaces, Span 8.

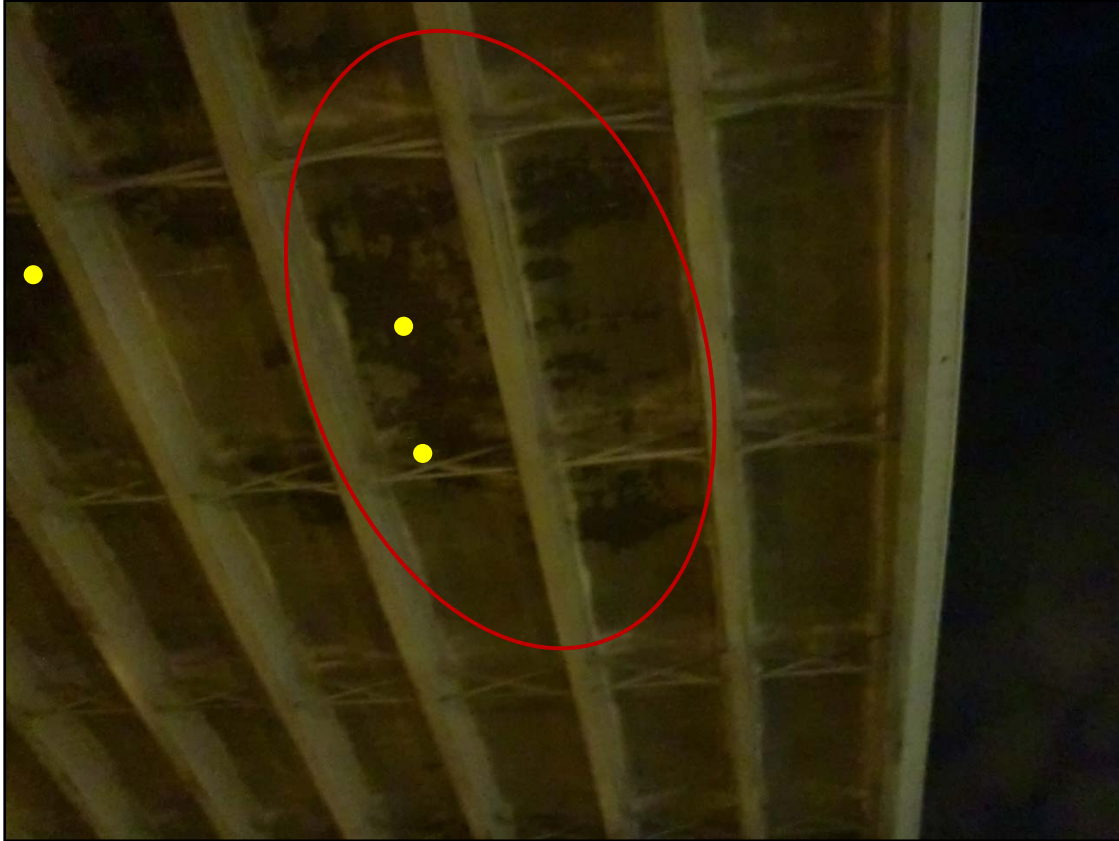
Photo 6 – Water Infiltration Through Floor Following Rain. (Note: Area circled is location of mottled concrete in Photo 5, Locations marked with yellow dot are spalled surfaces.)

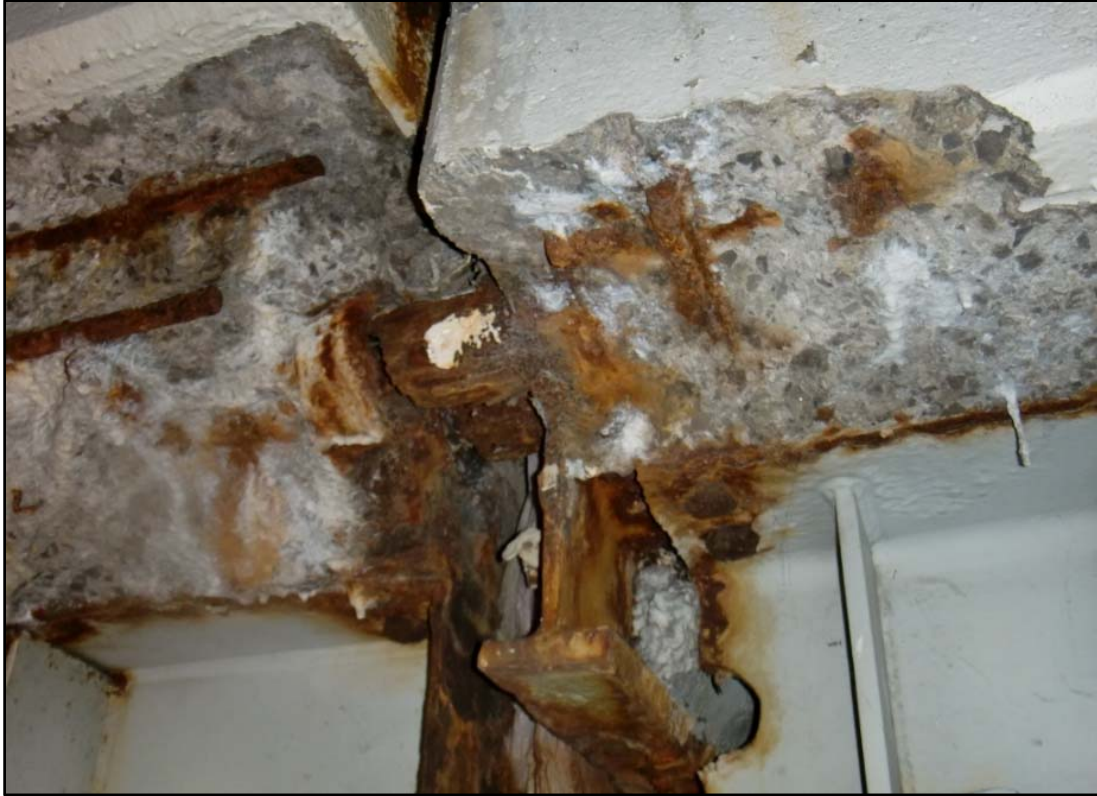
Photo 7 – Advanced Spalls on Edge of Floor at Expansion Joint 1A.

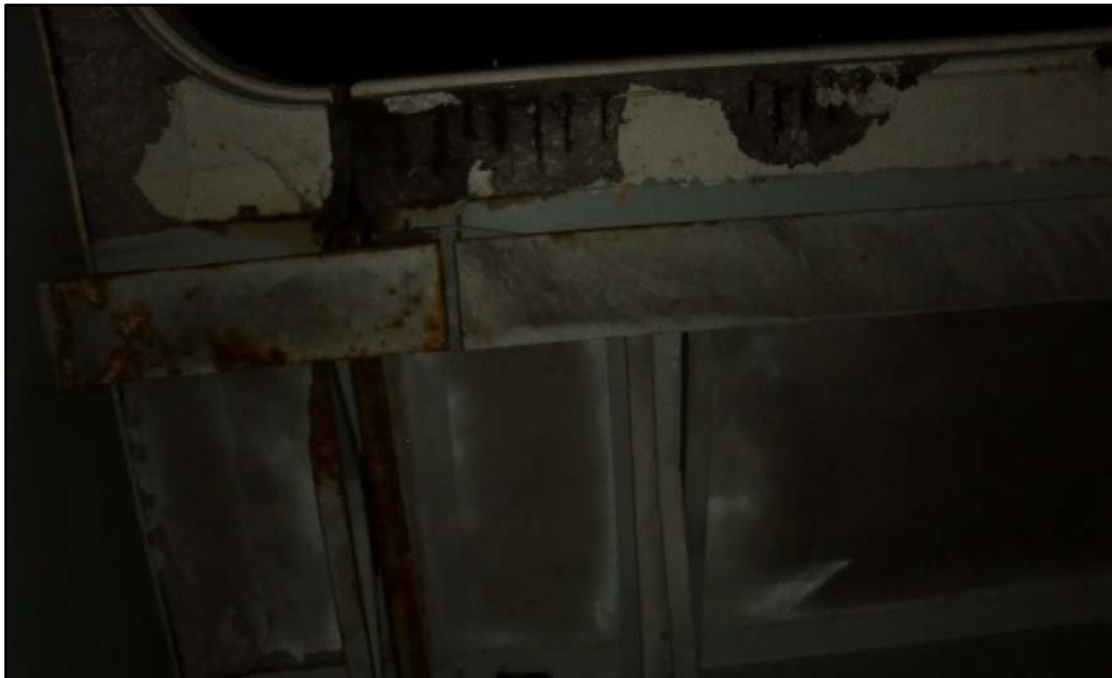
Photo 8 – Spalled Edge of Floor, Spans 17 & 18AW at Expansion Joint 3A.

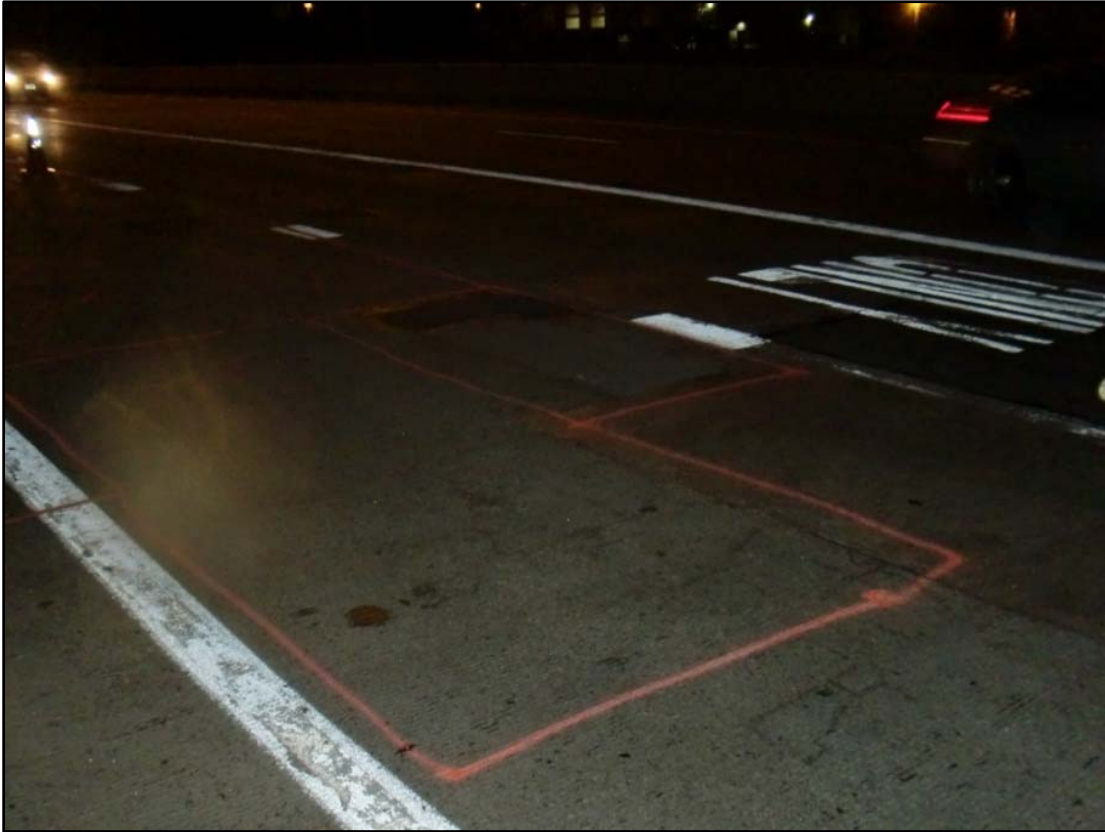
Photo 9 – Large Wearing Surface Delamination, Span 9 Right Lanes.

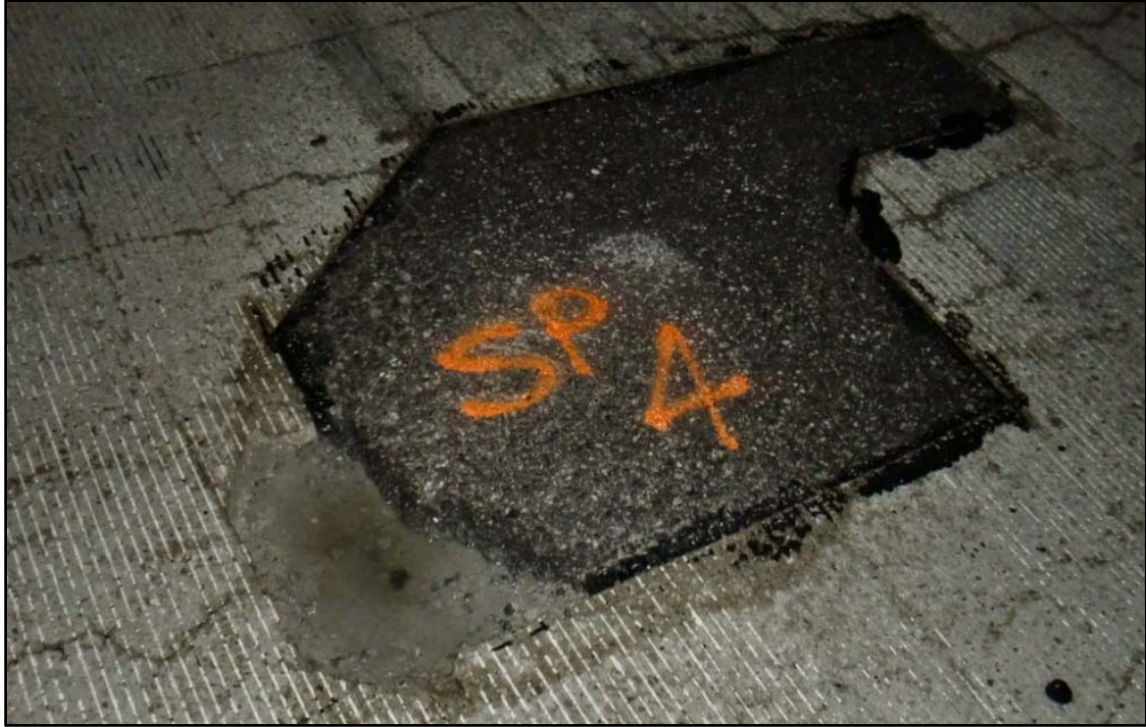
Photo 10 – Asphalt Wearing Surface Patch, Span 4.

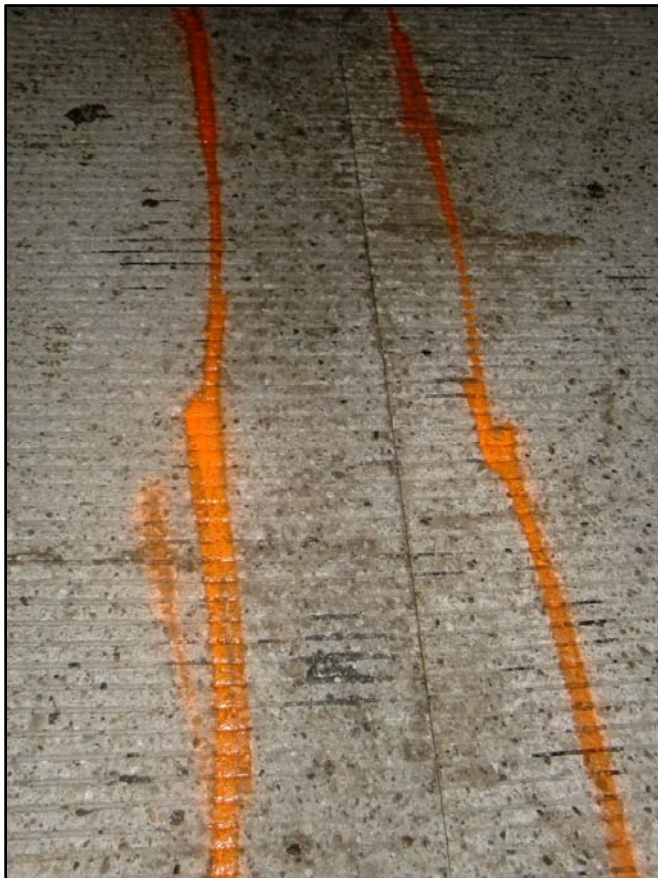
Photo 11 – Delaminated Wearing Surface Along Longitudinal Cold Joint.

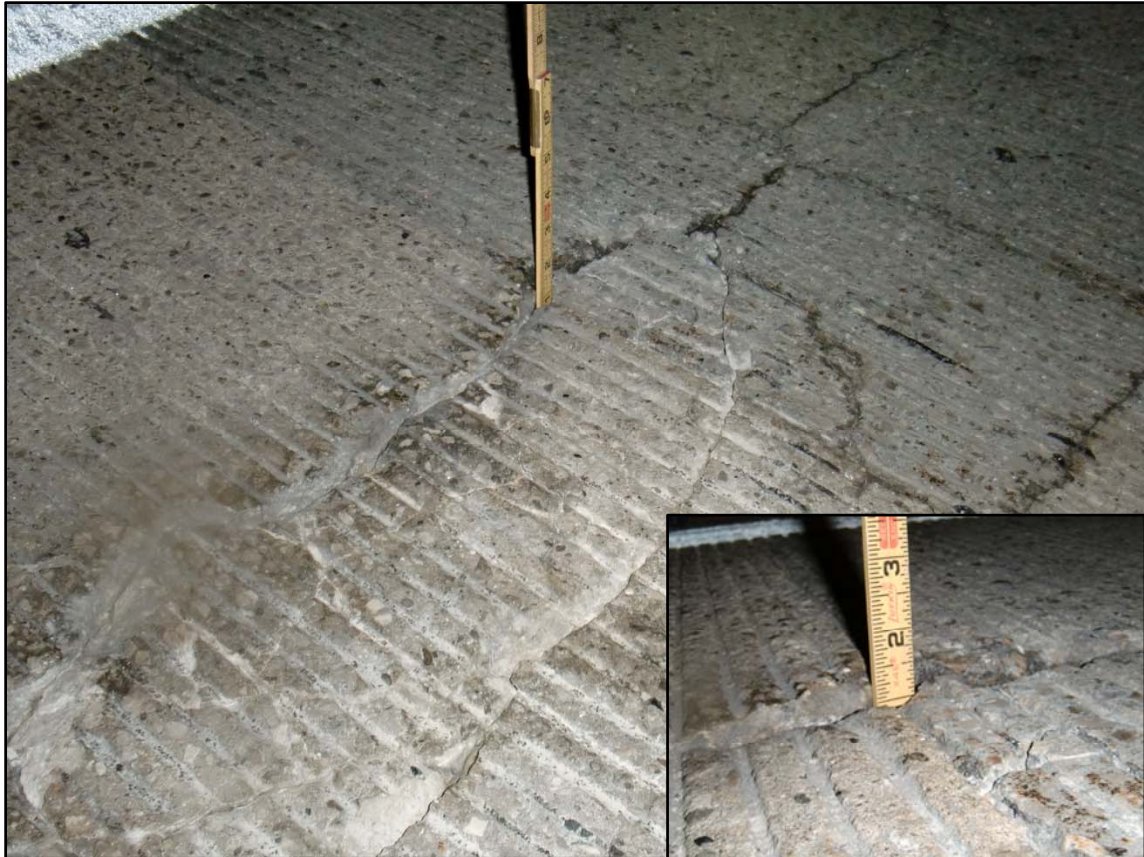
Photo 12 – Wide Crack in Wearing Surface, Over One-Inch Deep, Span 16.

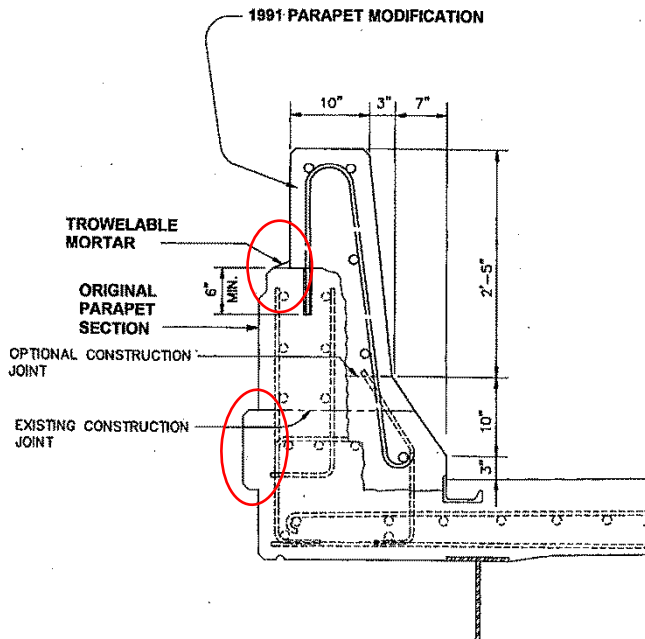
Figure 4 – 1991 Parapet Modification With Common Deterioration Locations Circled.

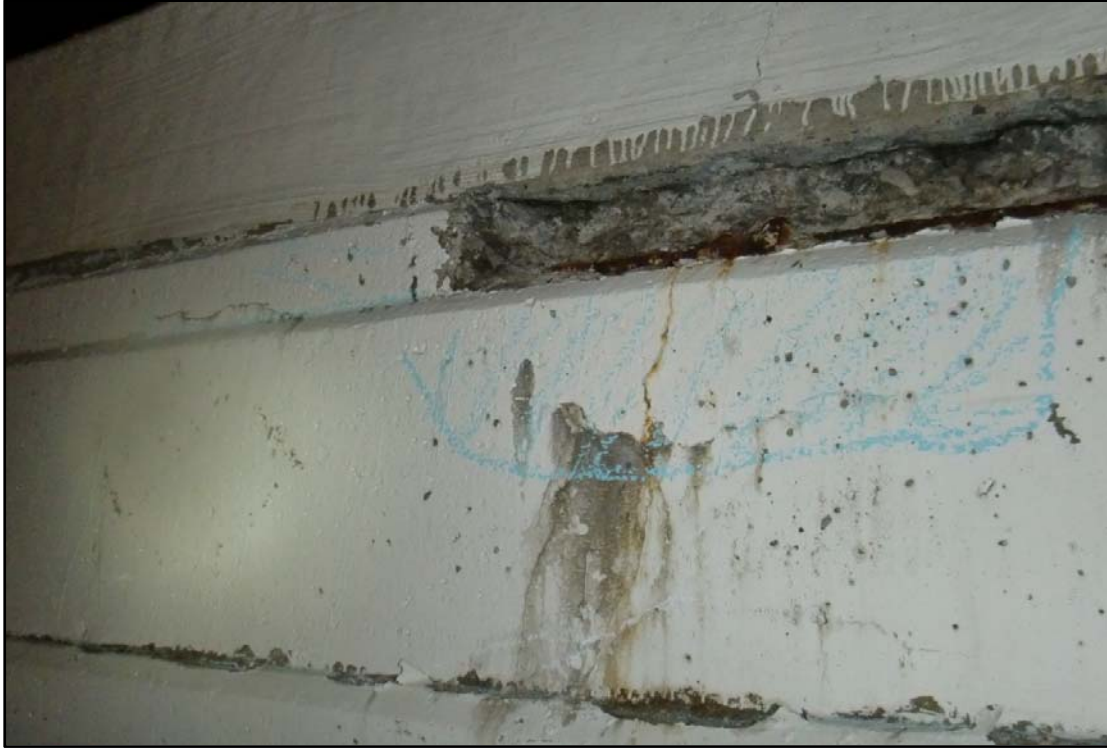
Photo 13 – Loose Concrete Removed With New Delamination Below (Highlighted in Chalk), Span 2 over SR 176 SB.

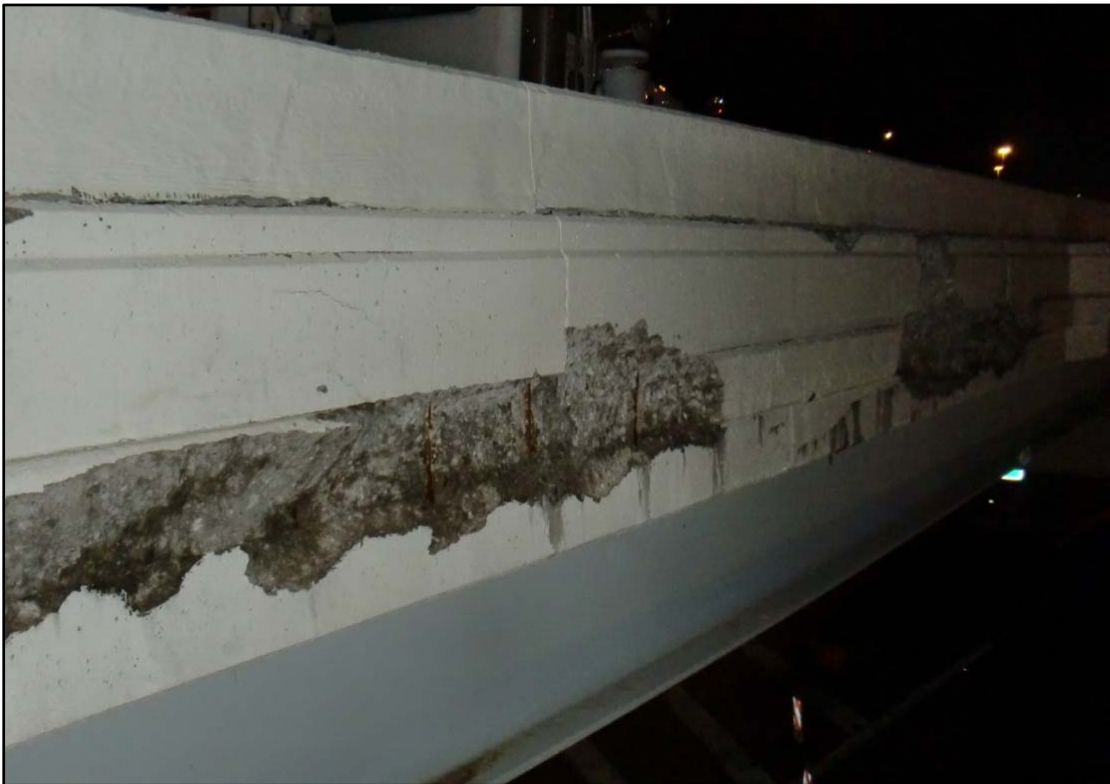
Photo 14 – Loose Lower Exterior Parapet Concrete Removed over SR 176 Traffic Lanes.

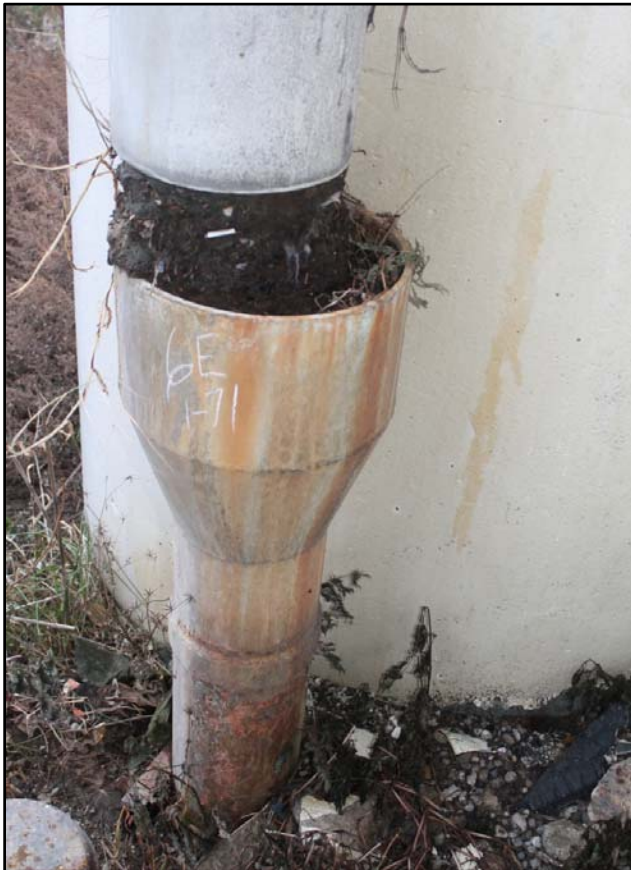
**Photo 15 – Clogged Collector and Drain Pipe,
Pier 6E.**

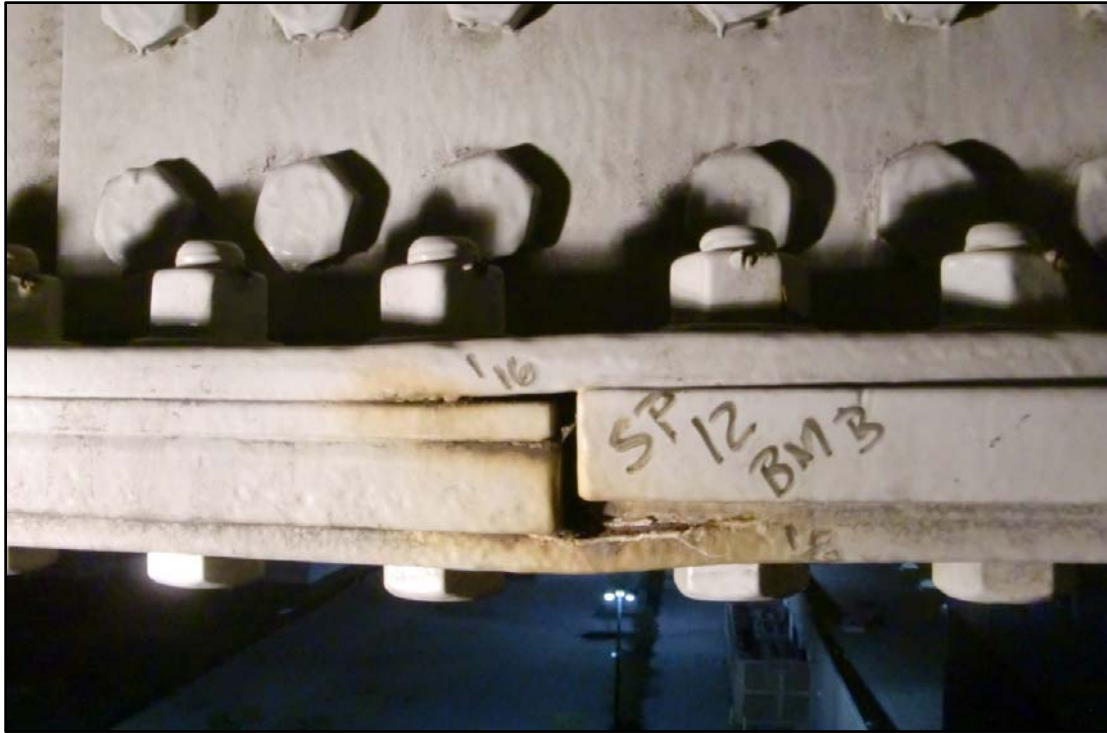
Photo 17 – Common Misaligned Bottom Flange Splice Plate.

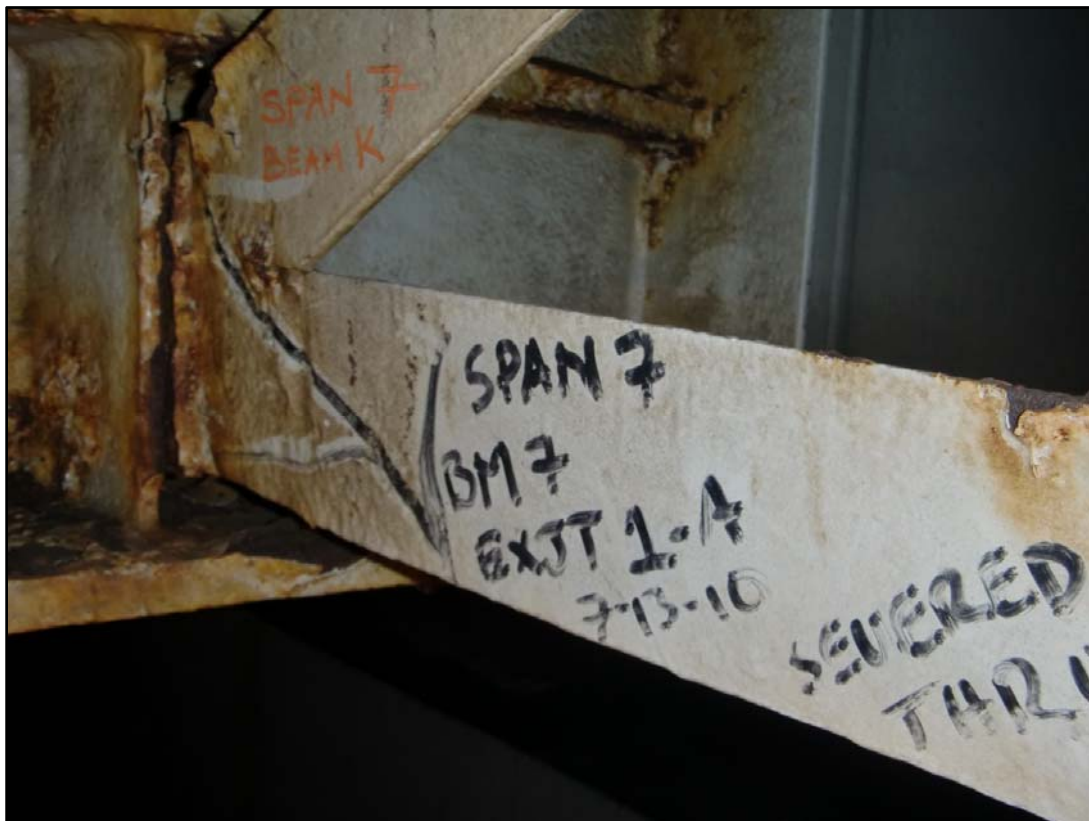
Photo 18 – Cracked Cross Frame Weld Due to Pack Rust.

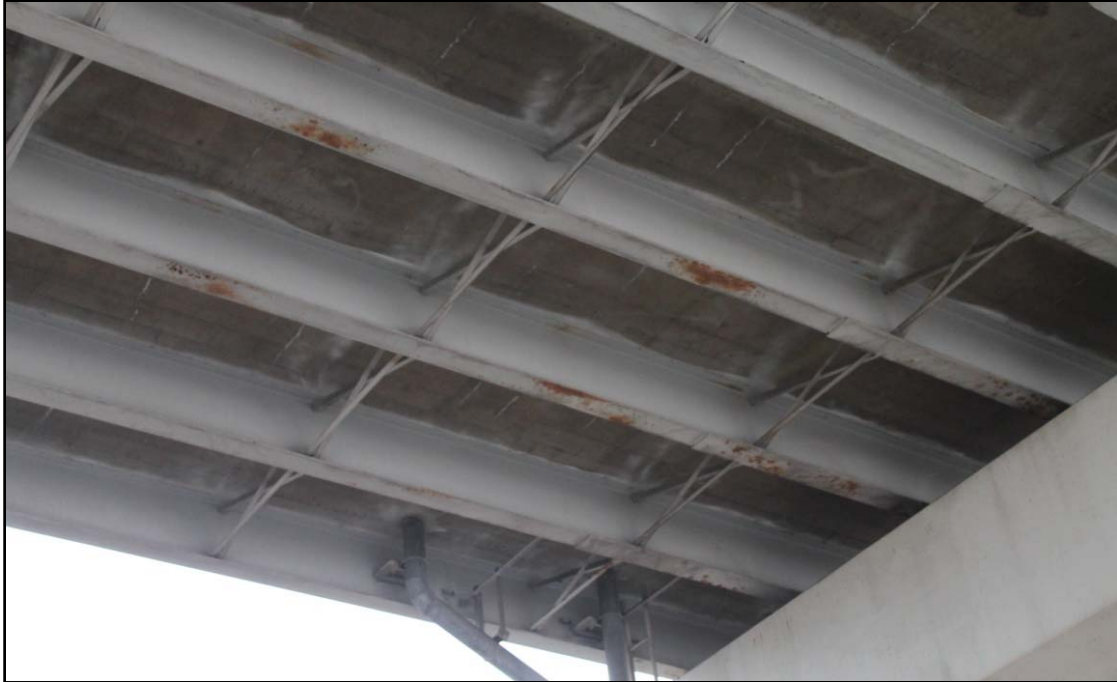
Photo 19 – Typical Isolated Failed OZEU Paint on Girder Bottom Flanges.

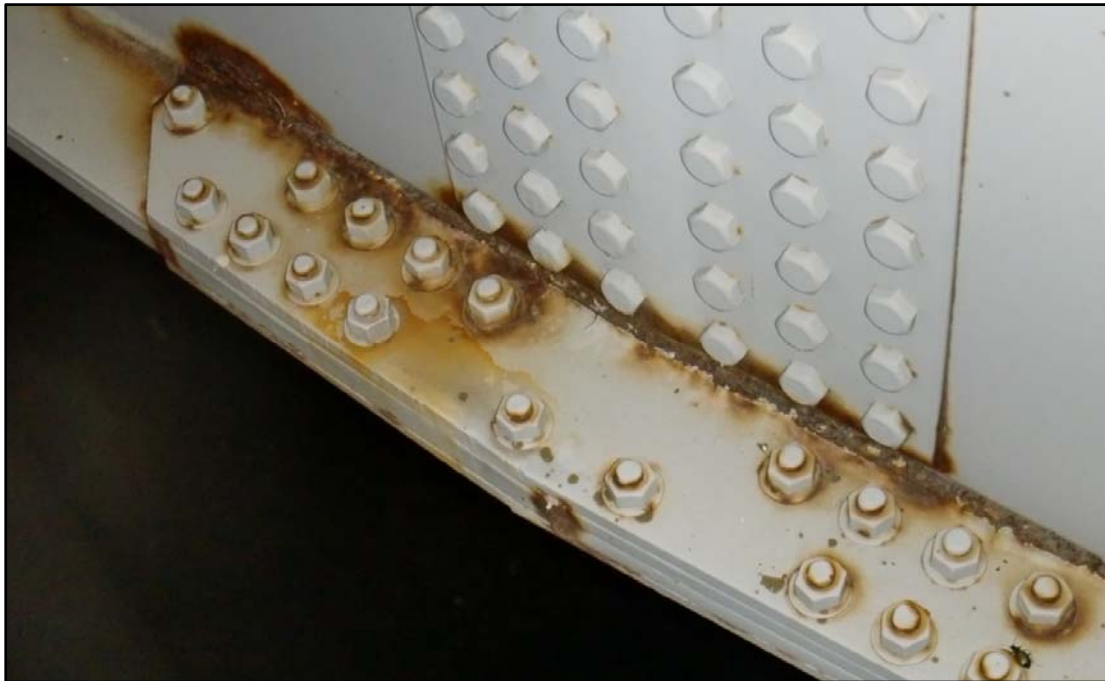
Photo 20 – Typical Local Failed Protective Coating at Girder Bottom Flange Field Splice With Minor Section Loss.

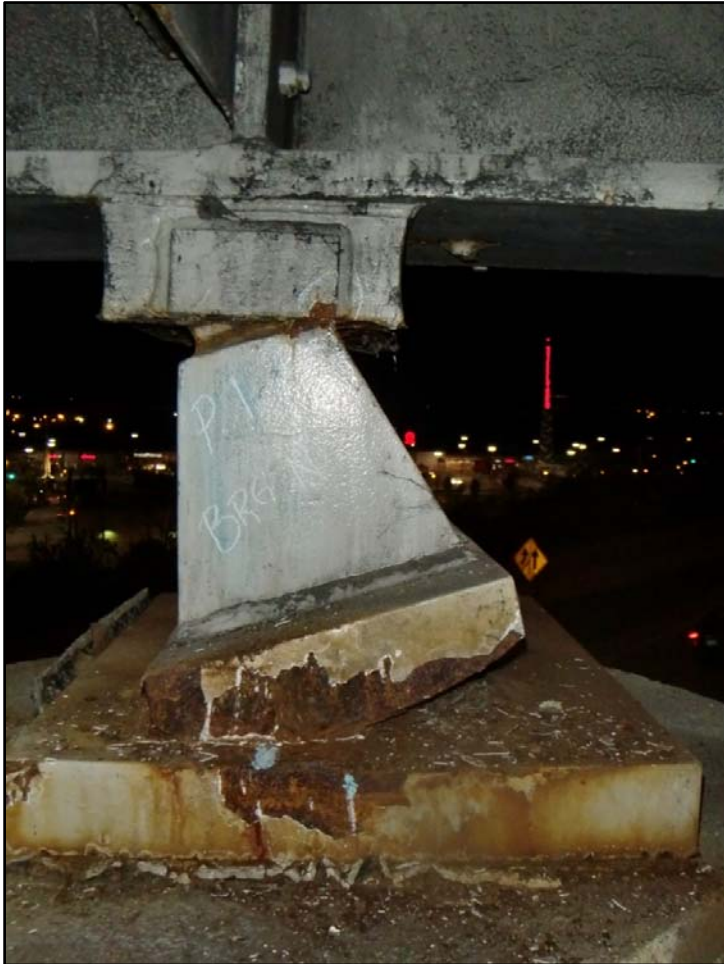
Photo 21 – Excessive Contraction of Fascia Bearing N, Pier 1.

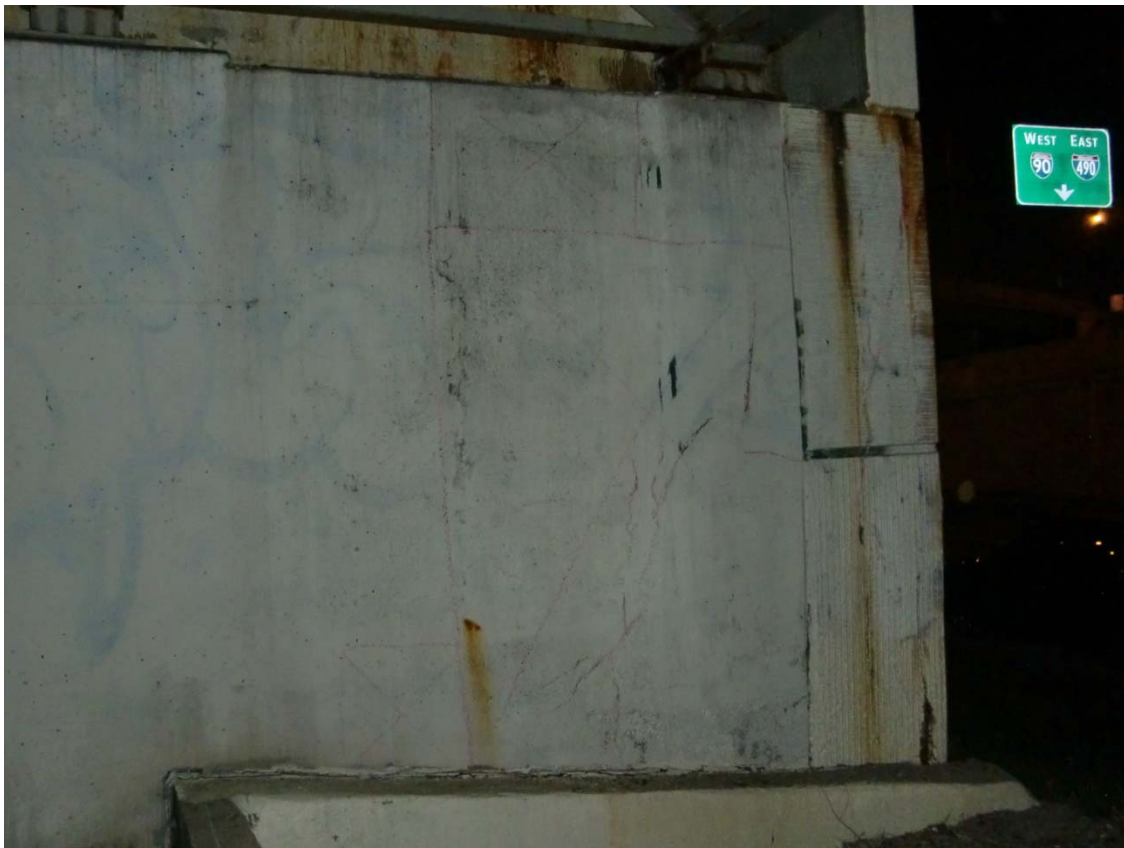
Photo 28 – Delaminated Abutment Barrel Face Between Beams E & F, North Abutment AW.

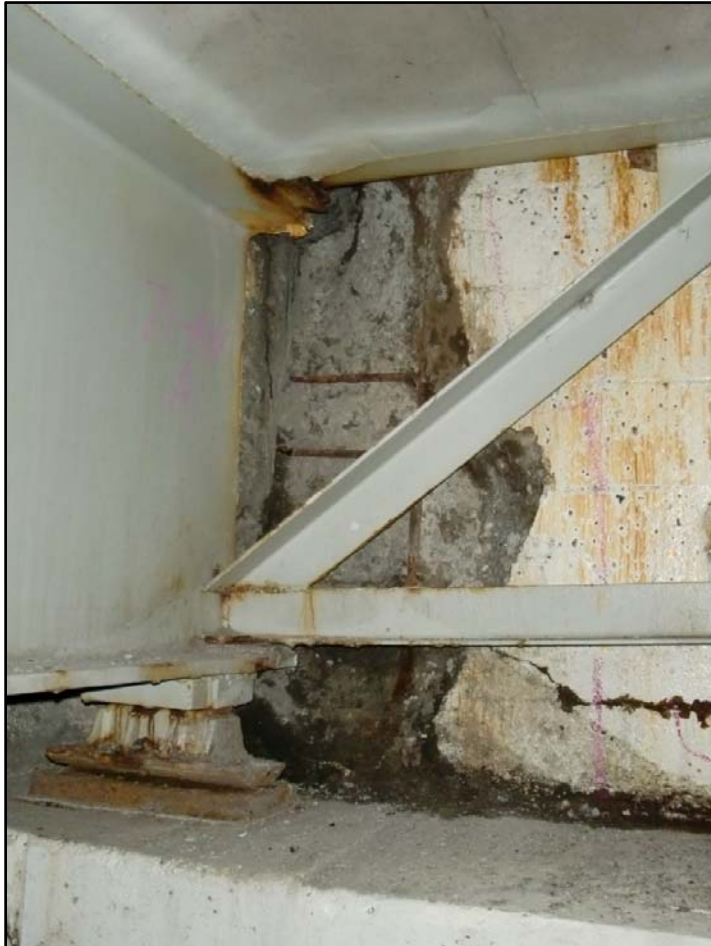
Photo 29 – Backwall Spall Below Failed Expansion Joint Membrane, North Abutment AW.

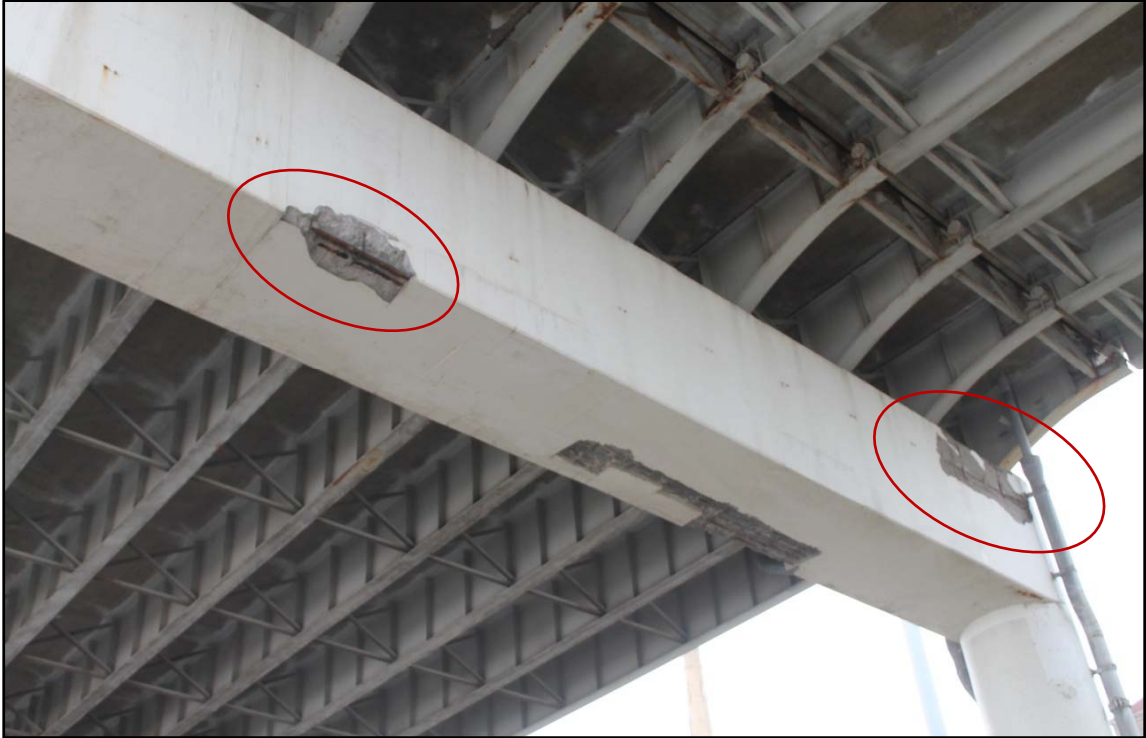
Photo 30 – Active Spalled Concrete (Circled) With Removed Deteriorations (Center), Pier 6.

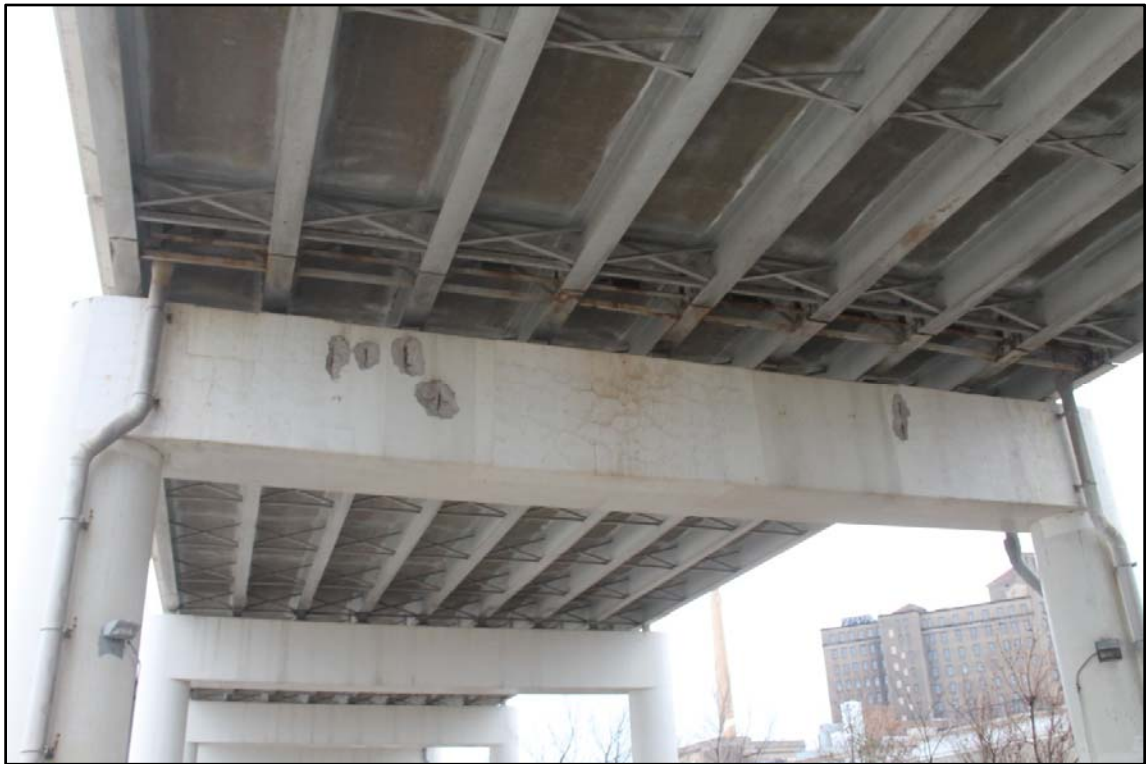
Photo 31 – Local Spalls With Rust-Stained Map Cracking, North Face of Pier 11 Cap.
