**OHIO DEPARTMENT OF TRANSPORTATION
2014 PHYSICAL CONDITION REPORT**

**I-71 NB OVER SR 176 NB
BRIDGE NO. CUY-71-1791R**

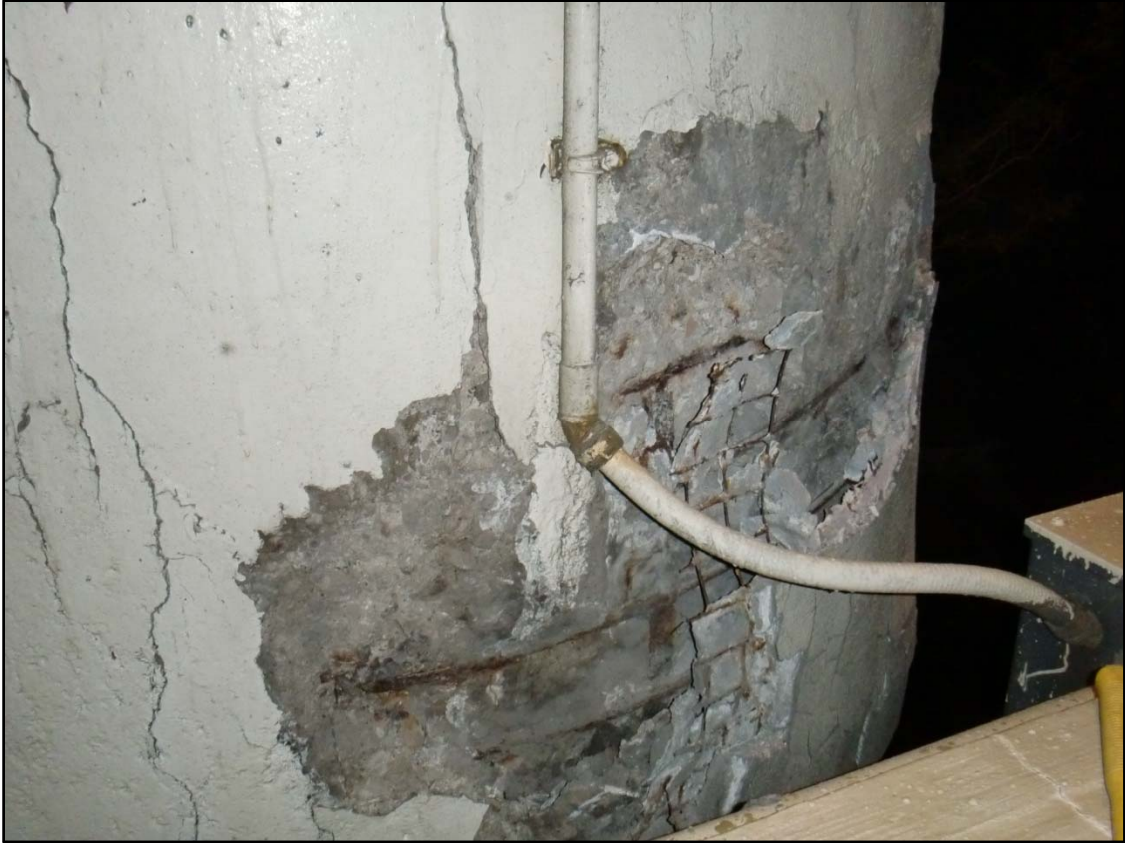
Photo 32 – Failed Patch With Surrounding Delamination, Pier 14 East Column.

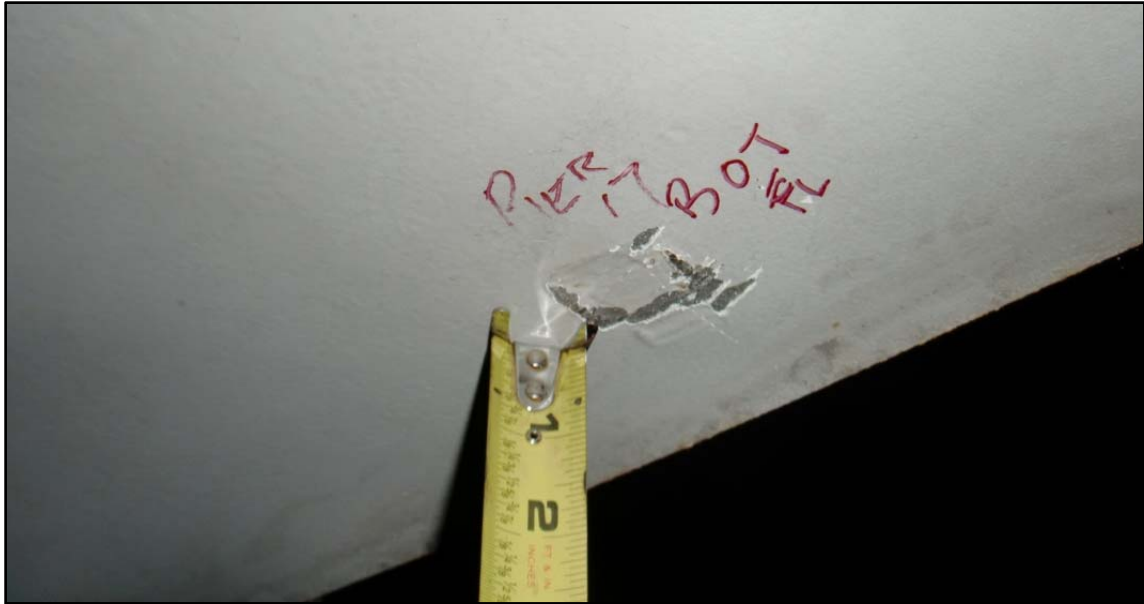
Photo 33 – Weldment on Bottom Flange, Steel Pier Cap 17.

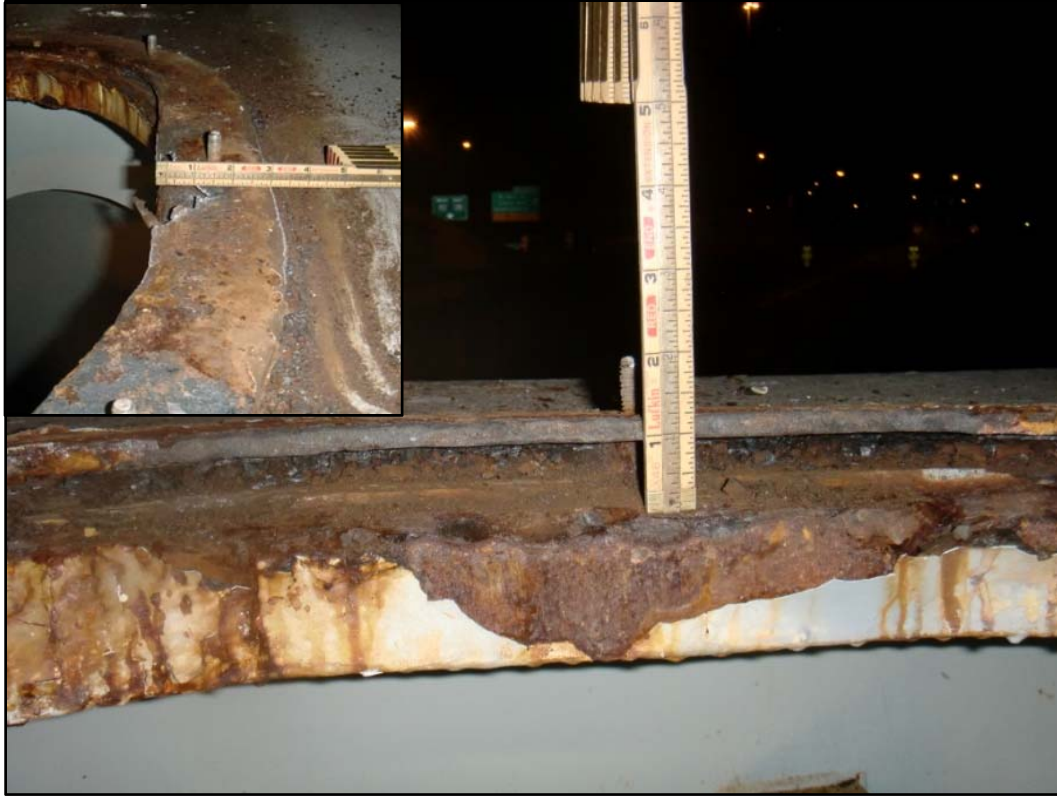
Photo 35 – Pack Rust & Section Loss (See Inset) Along Hatch Rim, Steel Pier Cap 17.

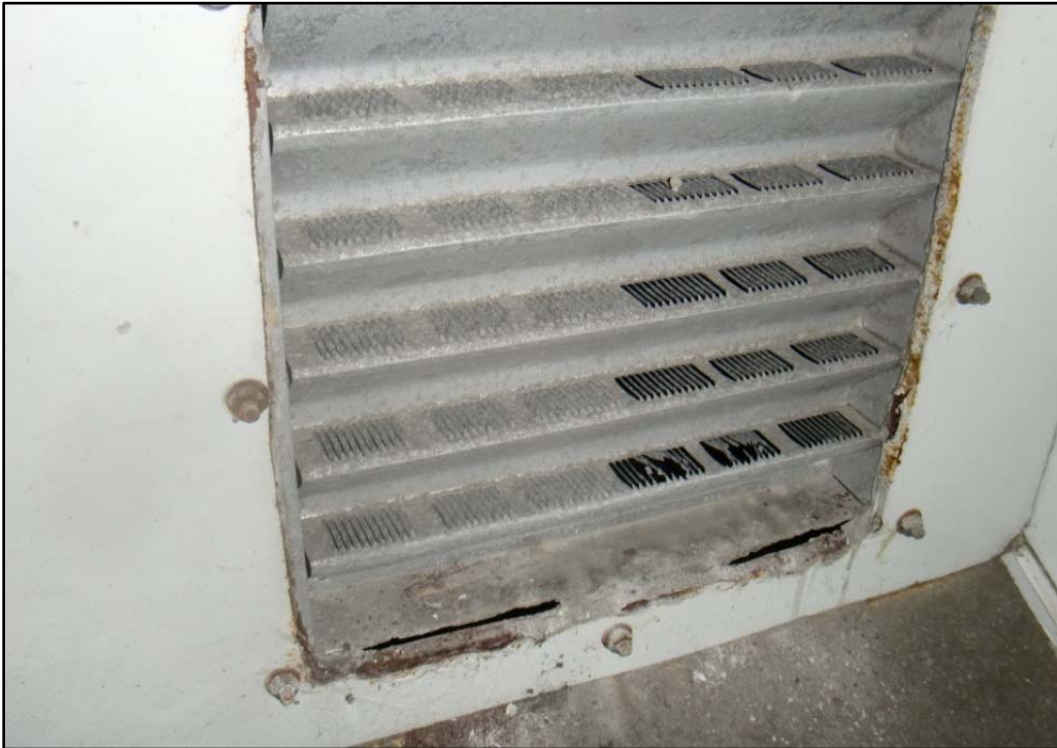
**Photo 36 – Galvanic Corrosion & Perforations on Aluminum Vent,
East End of Steel Pier Cap 17.**

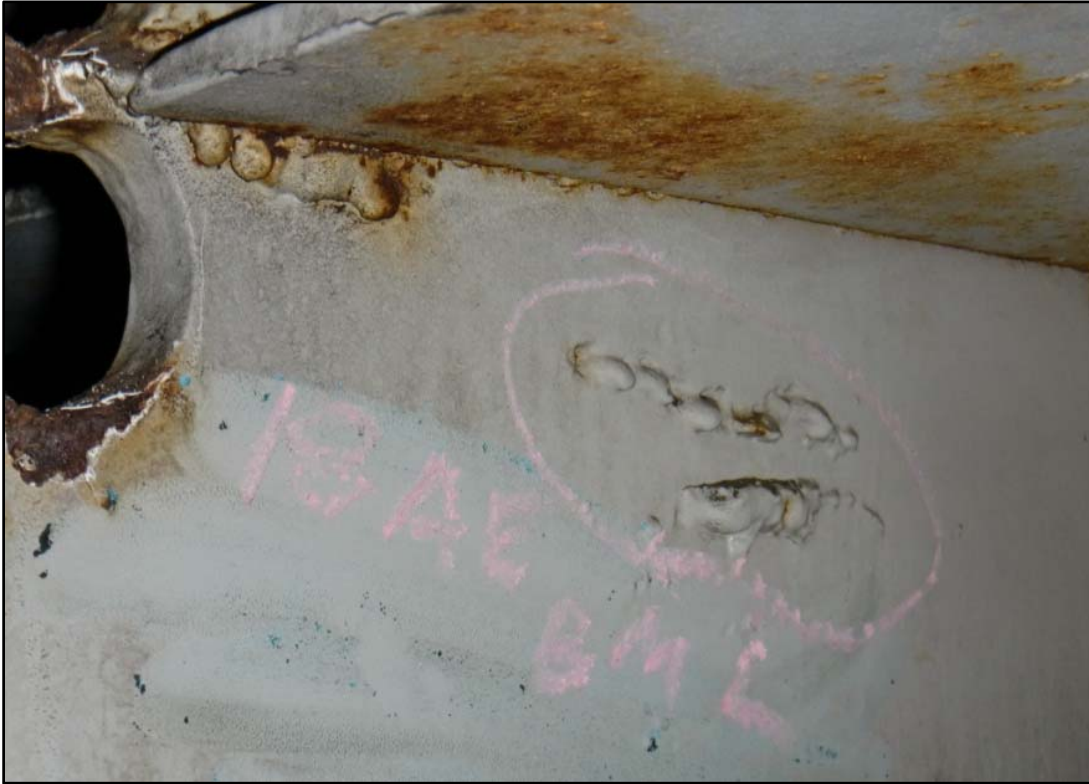
Photo 37 – Weldment on South Web Face, Steel Pier Cap 18AE.

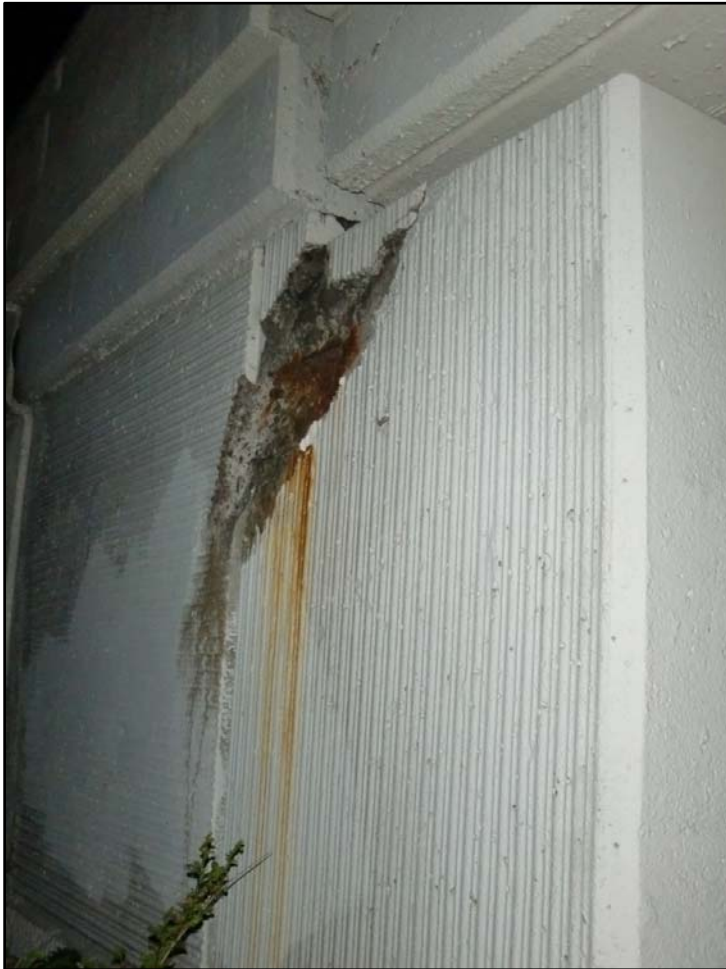
Photo 38 – Increasing Spalls on West Wingwall & Mask Wall, North Abutment AW.

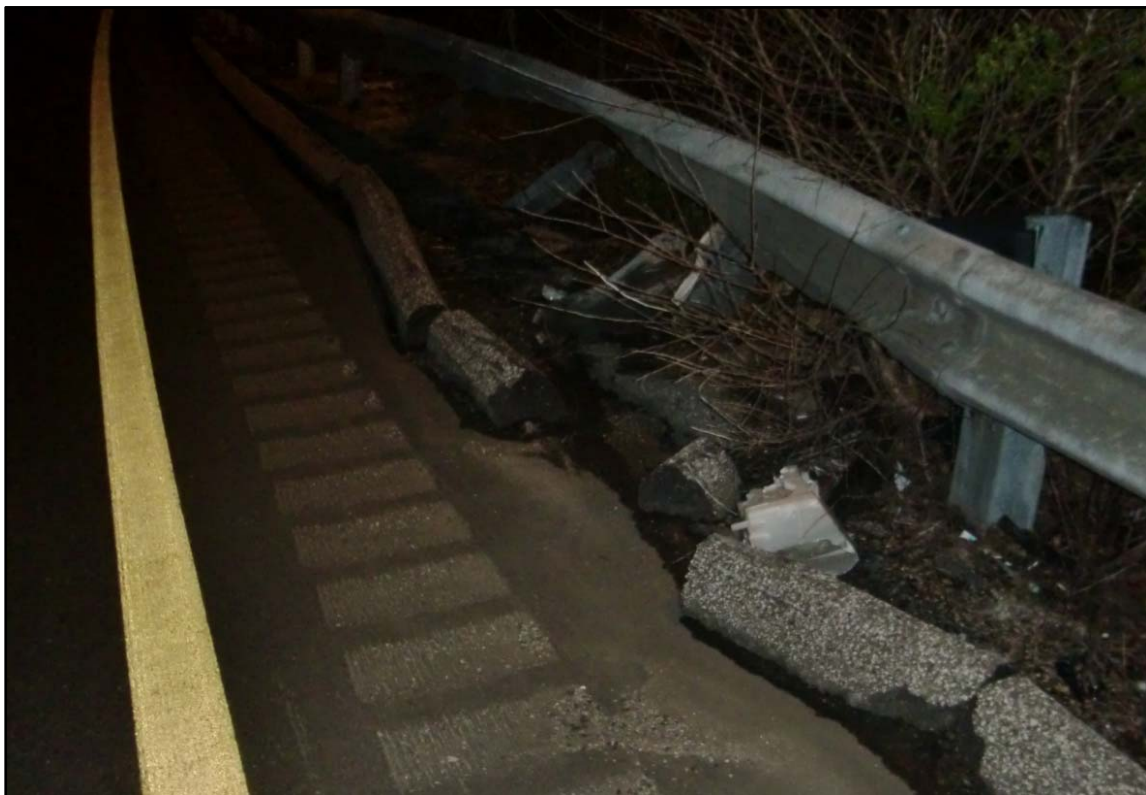
Photo 39 – Broken Asphalt Curb, South Approach.

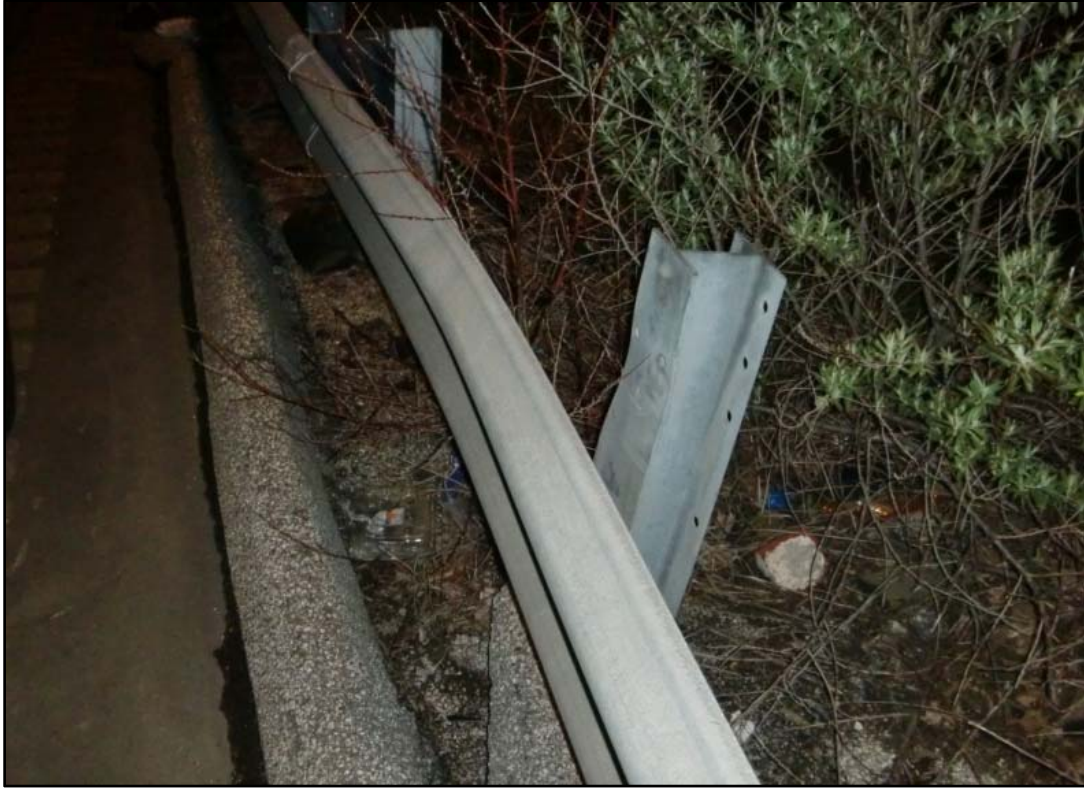
Photo 41 – Detached Approach Guard Rail, Left Side of South Approach.

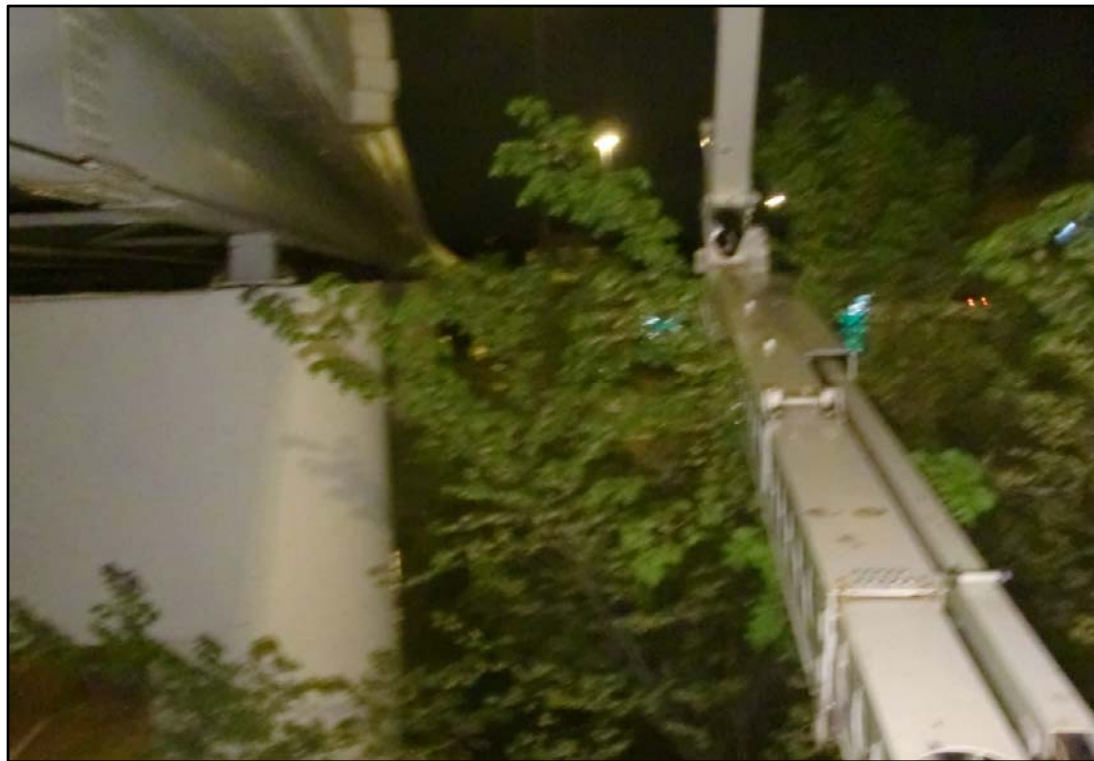
Photo 41 – Tree Growth within I-71 Median Obstructing Snoopers Access.
