2006 PHYSICAL CONDITION REPORT

*I-71 NB BRIDGE OVER JENNINGS FREEWAY
&
SR 176 BRIDGE UNDER I-71*

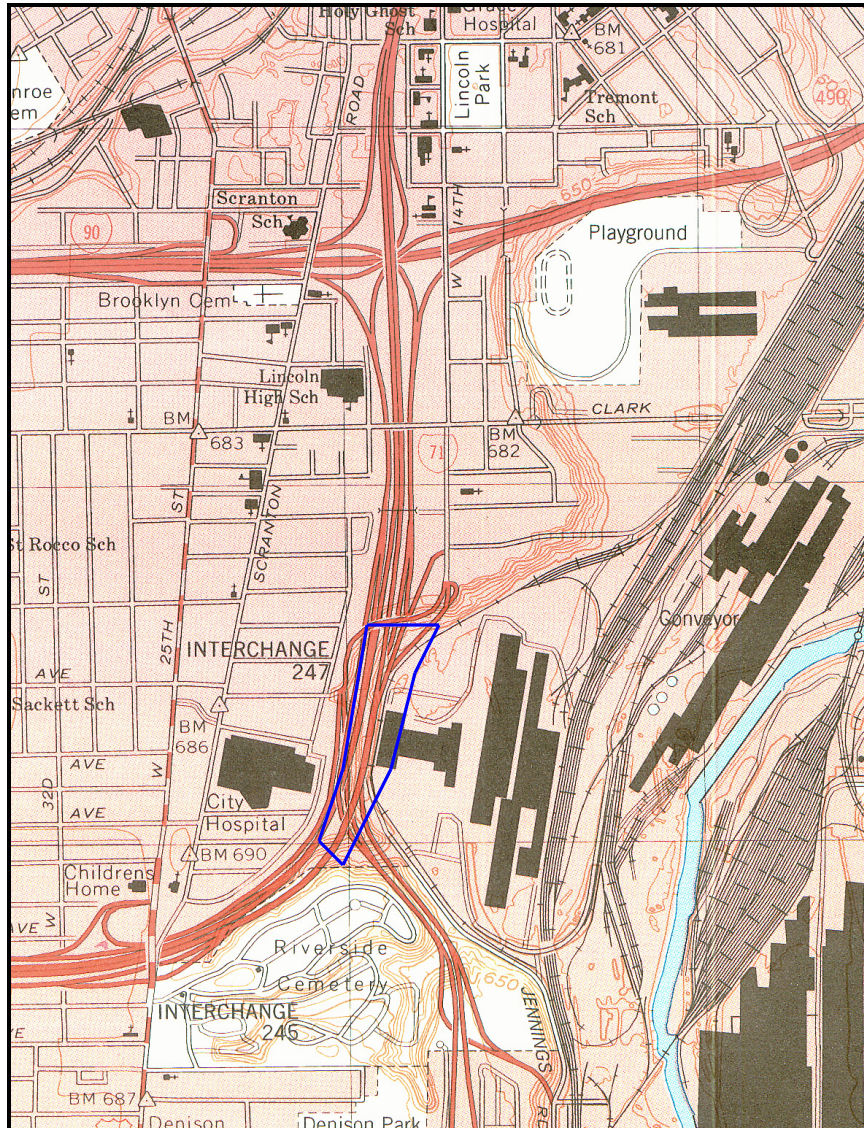
**Figure 1 – Location Map, CUY-71-1791R & CUY-176-1334
(Outlined in Blue), Cleveland, Ohio**

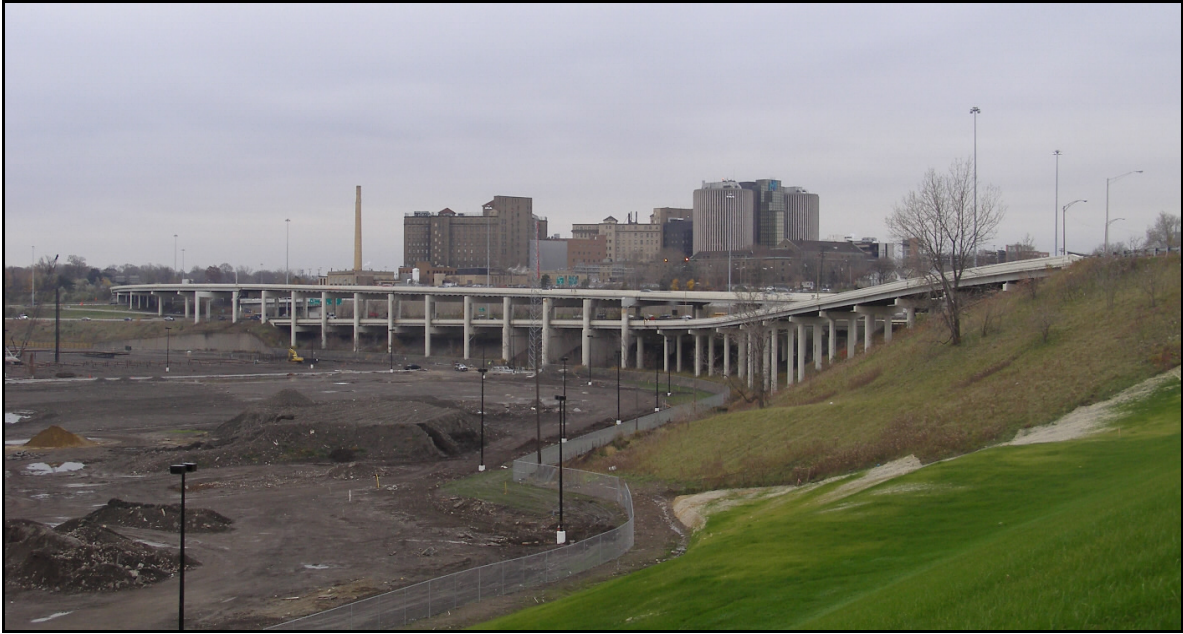
Photo 1– Elevation View of CUY-71-1791R & CUY-176-1334

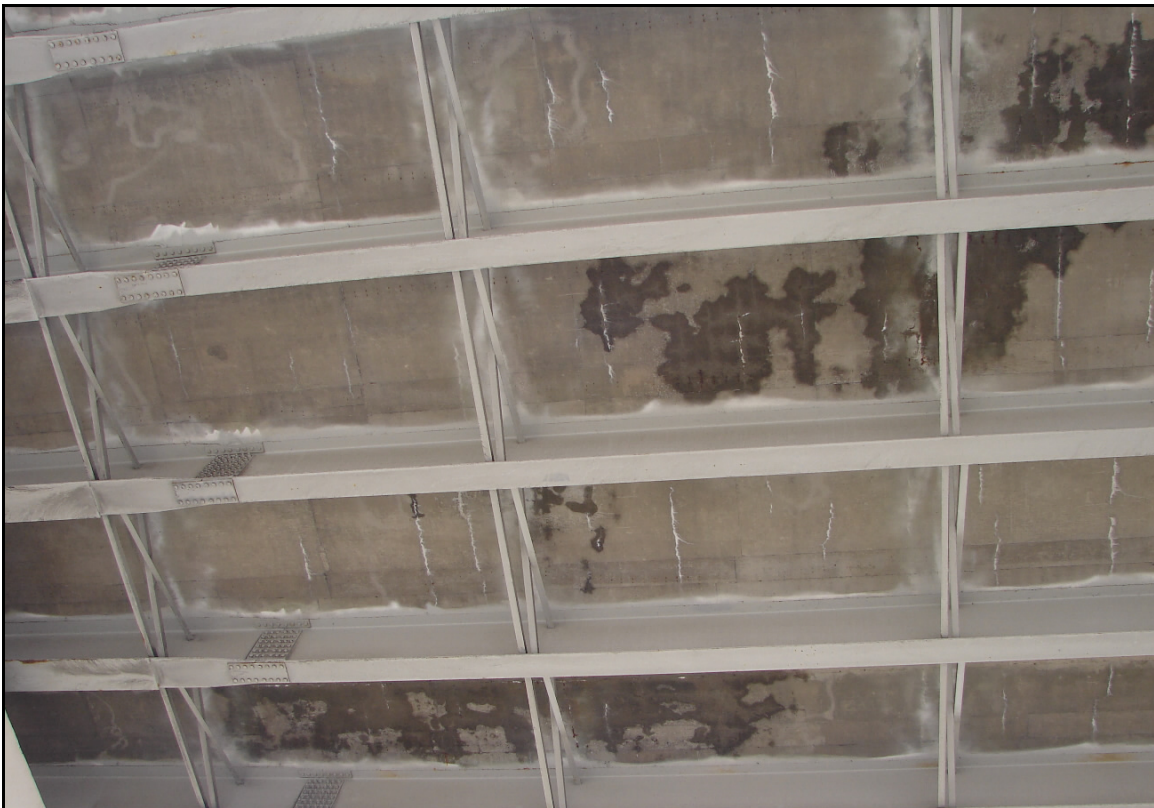
Photo 3 – Damp Areas to Underside of Floor, Span 7

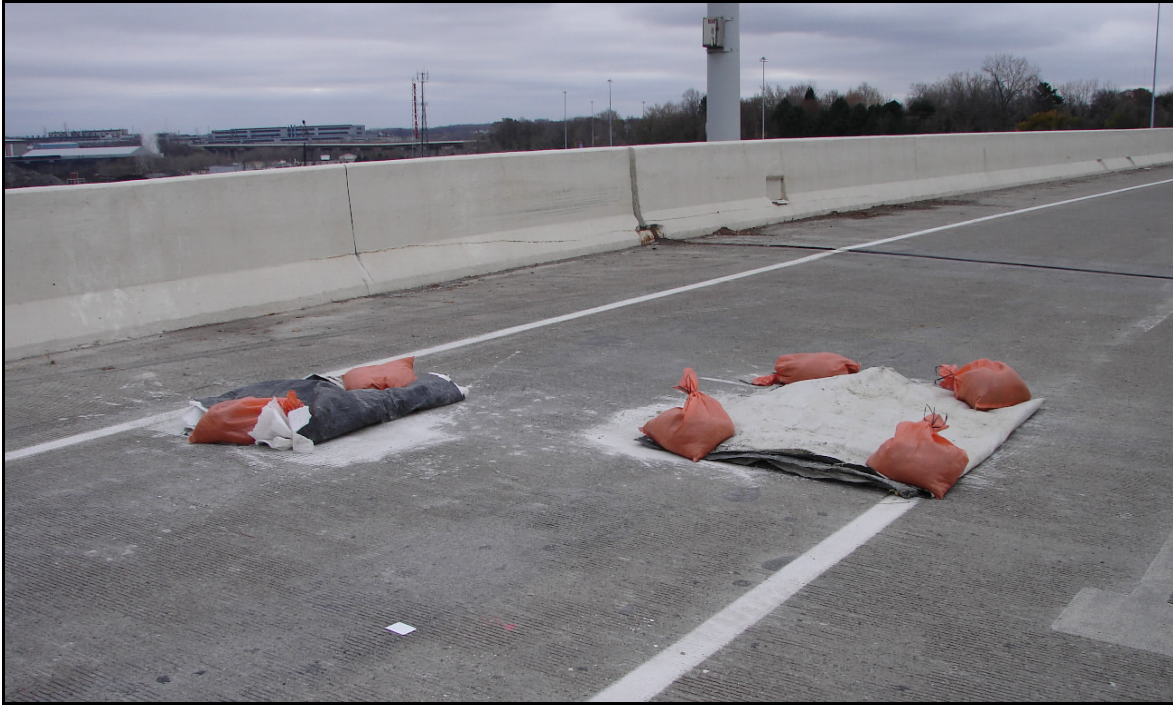
Photo 4 – Wearing Surface Repair, Lane 4, Span 7

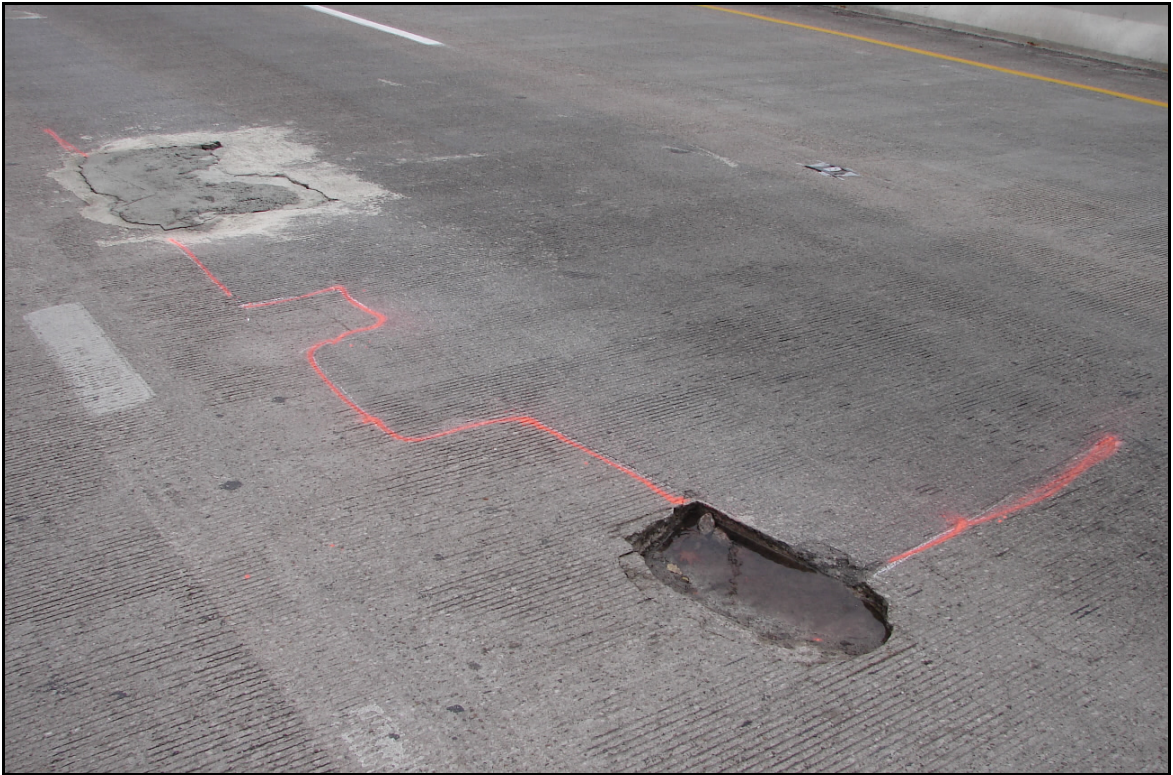
Photo 5 – Spall Adjacent to 1991 Patch, Lane 2
(Note: Paint lines partially outline perimeter of earlier repair.)

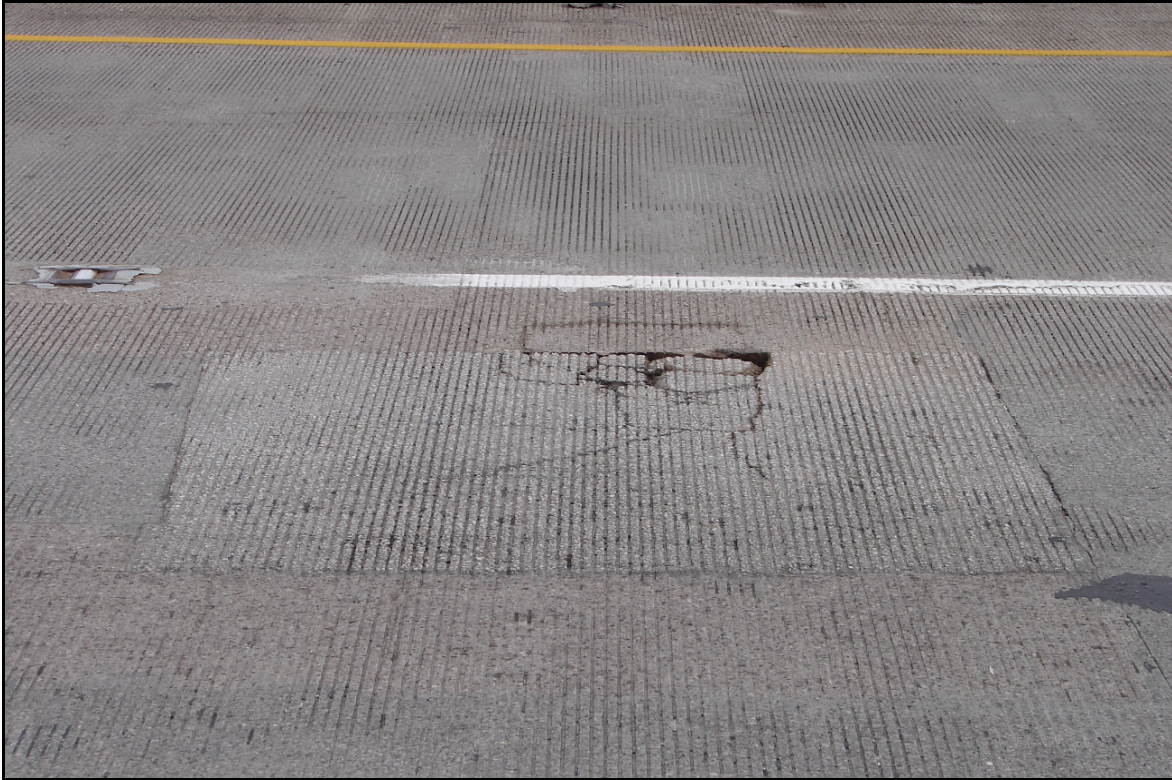
Photo 6 – Cracked Wearing Surface Within 1991 Patch

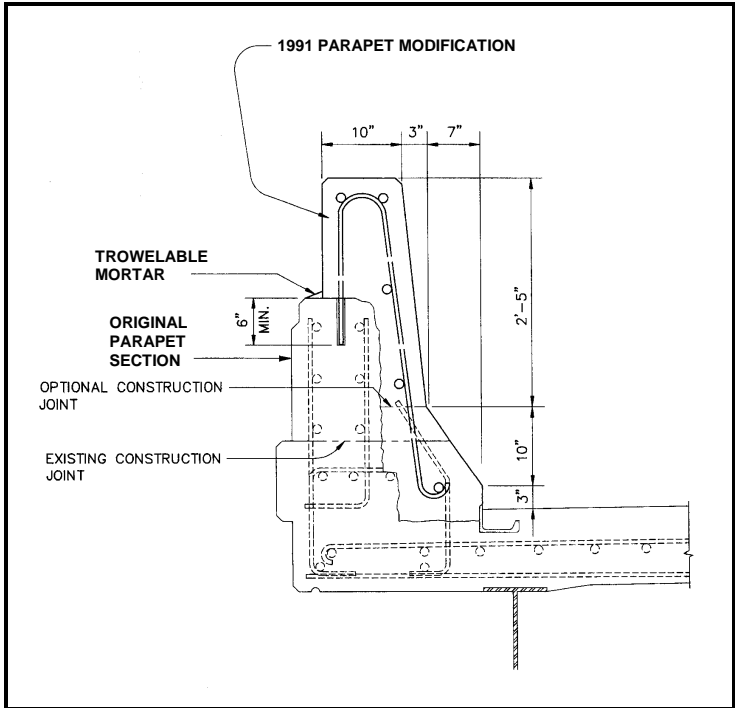
Figure 7 – Modified Deflector Shape Parapet Typical Section

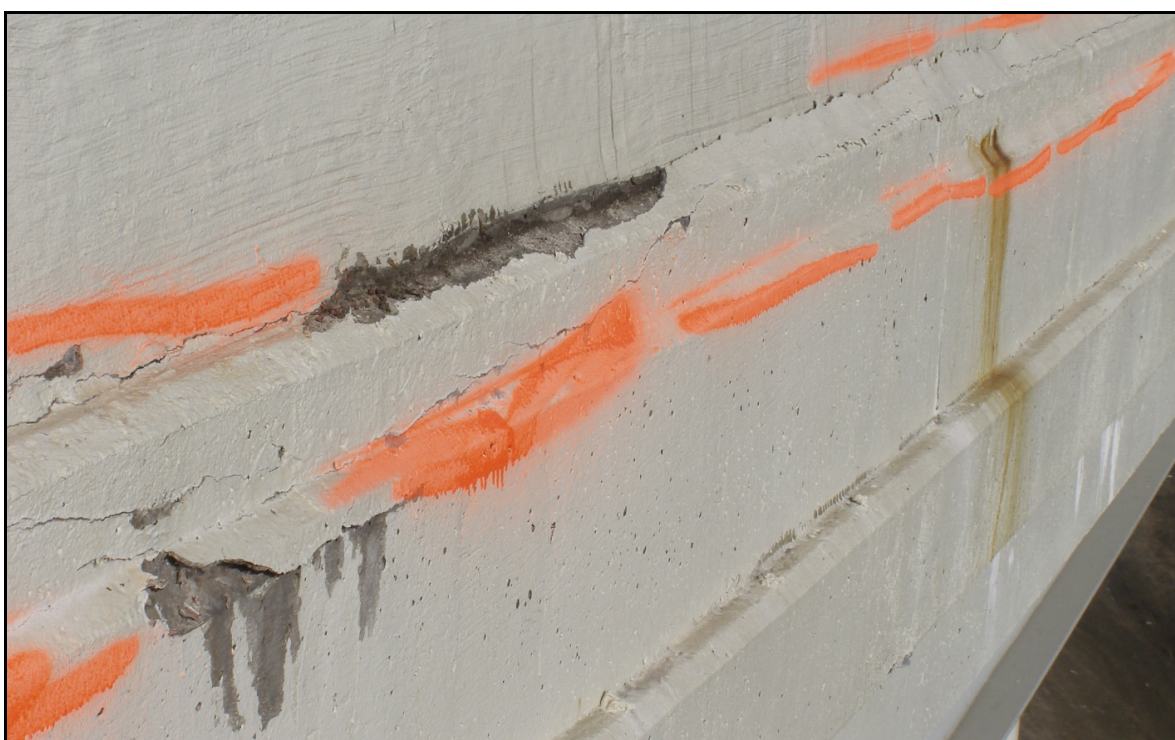
Photo 7 – Cracked Exterior Parapet Face (Note: Upper spall is actually fallen trowelable mortar)

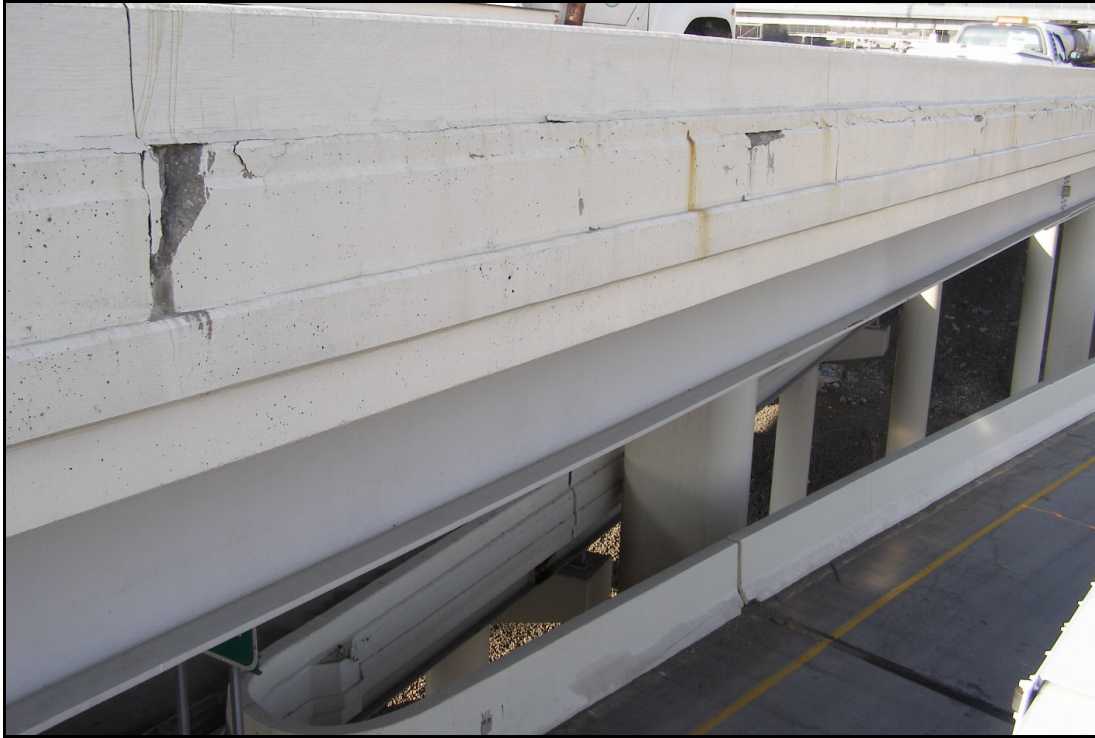
Photo 8 - Spalled and Delaminated Concrete to Parapet over NB Jennings Freeway to W. 14th Street Ramp

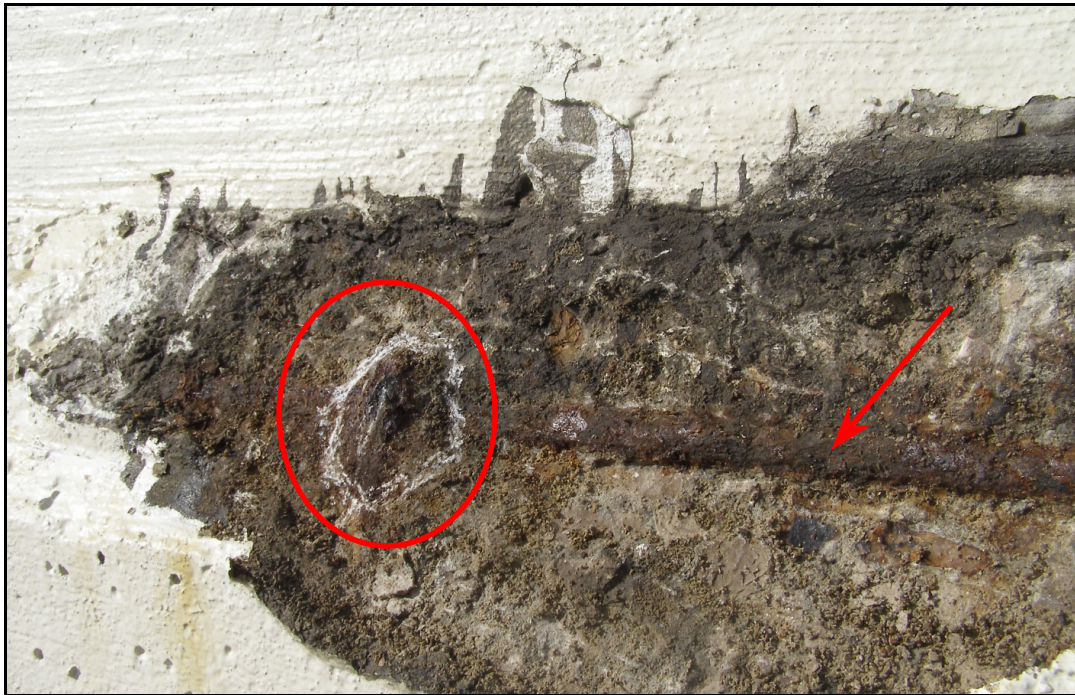
Photo 9 – Close-up of Parapet Spall with Deficient Cover to Original Rebar (Original vertical bar circled and horizontal bar noted with arrow.)

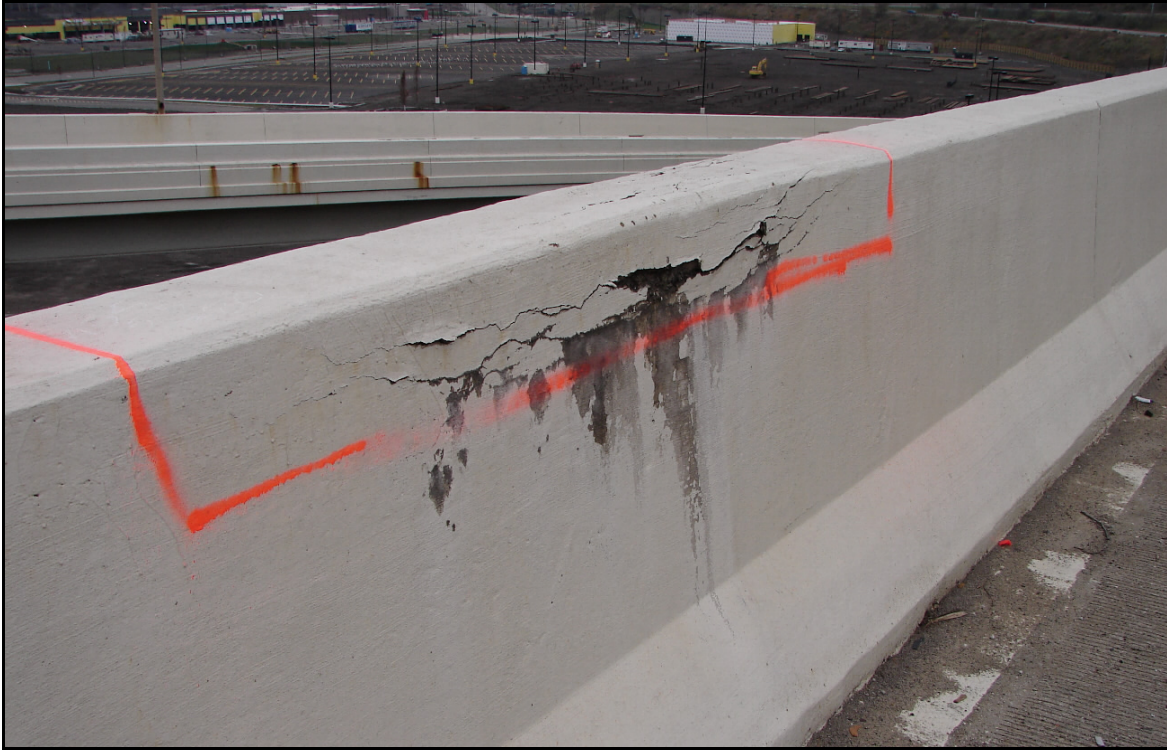
Photo 10 – Deteriorating Safety Parapet Shape, Unit 4AE

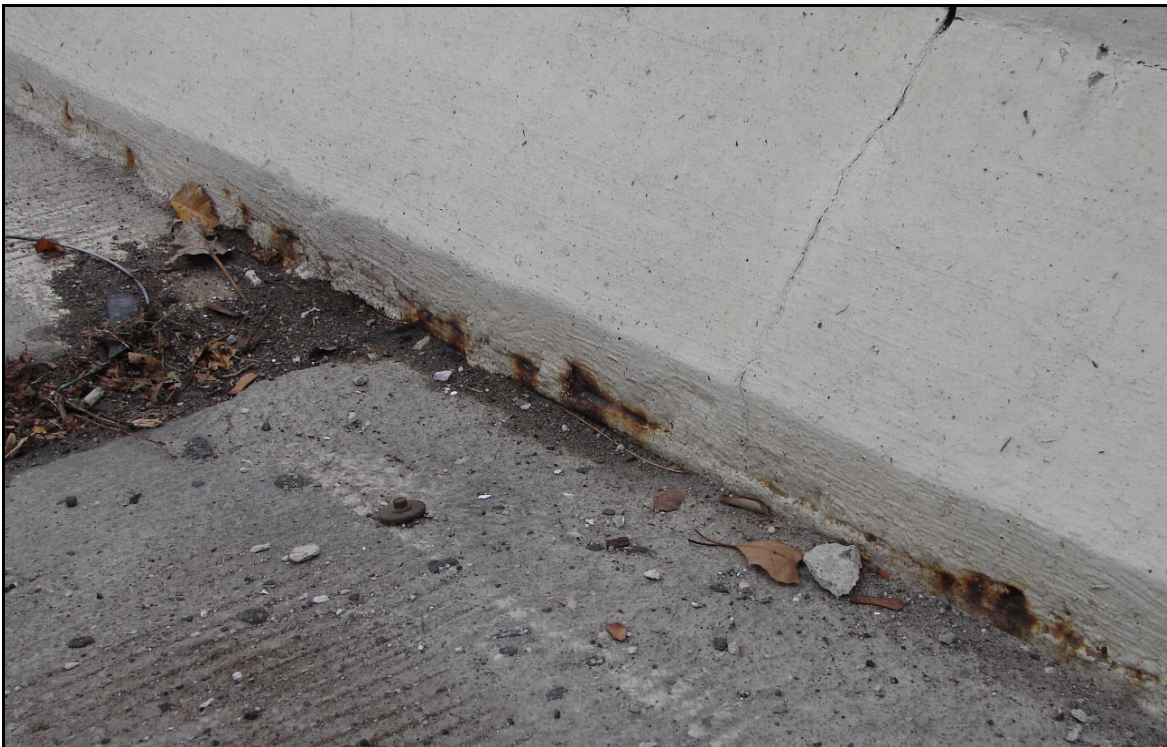
Photo 11 – Concrete Corrosion at Parapet Toe, Unit 4AE

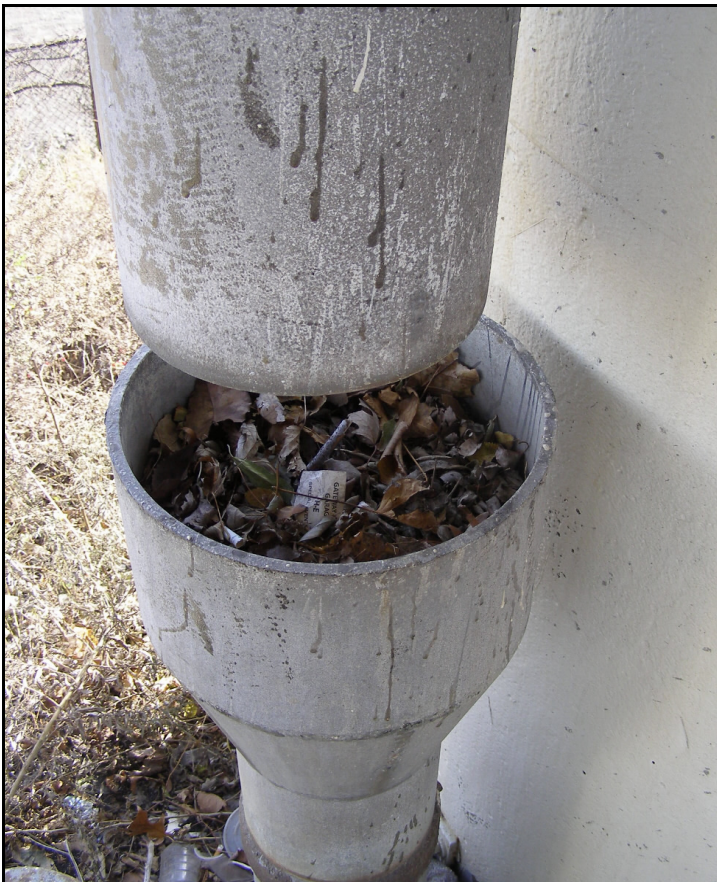
**Photo 12 – Clogged Drainage Collector,
Pier 6**

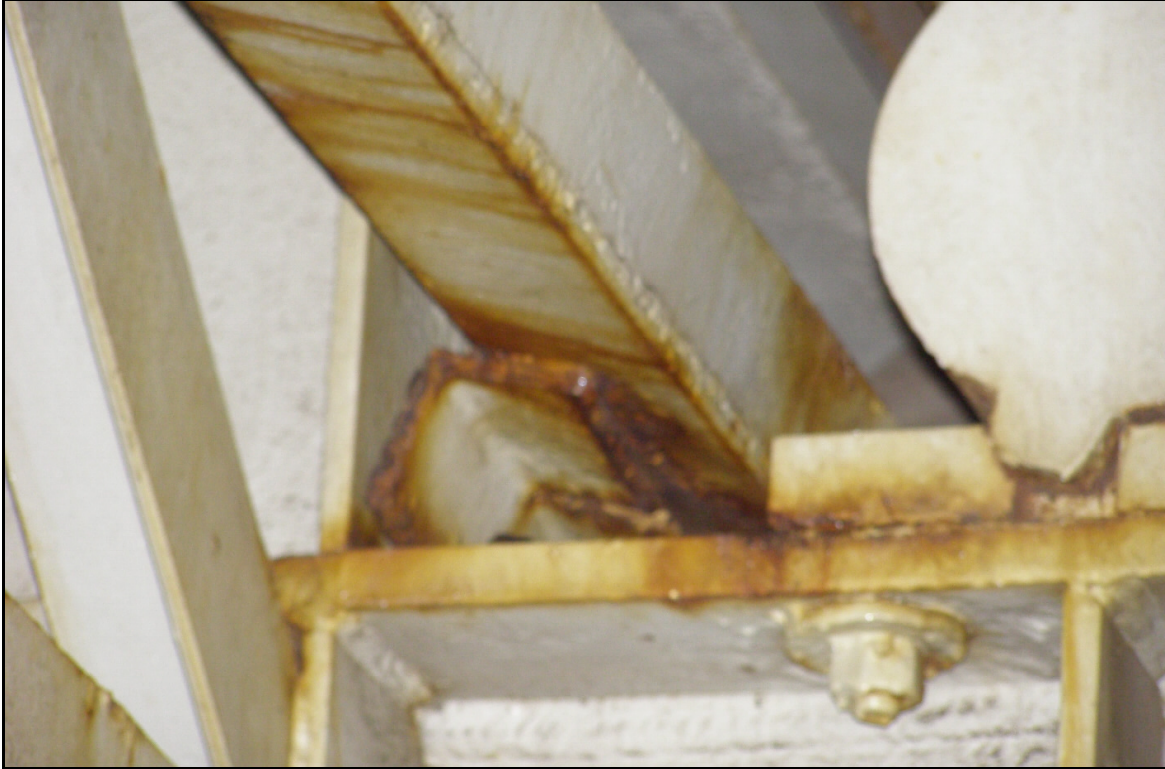
Photo 13 – Broken Drain Trough Bracket and Loose Trough, Expansion Joint 2A

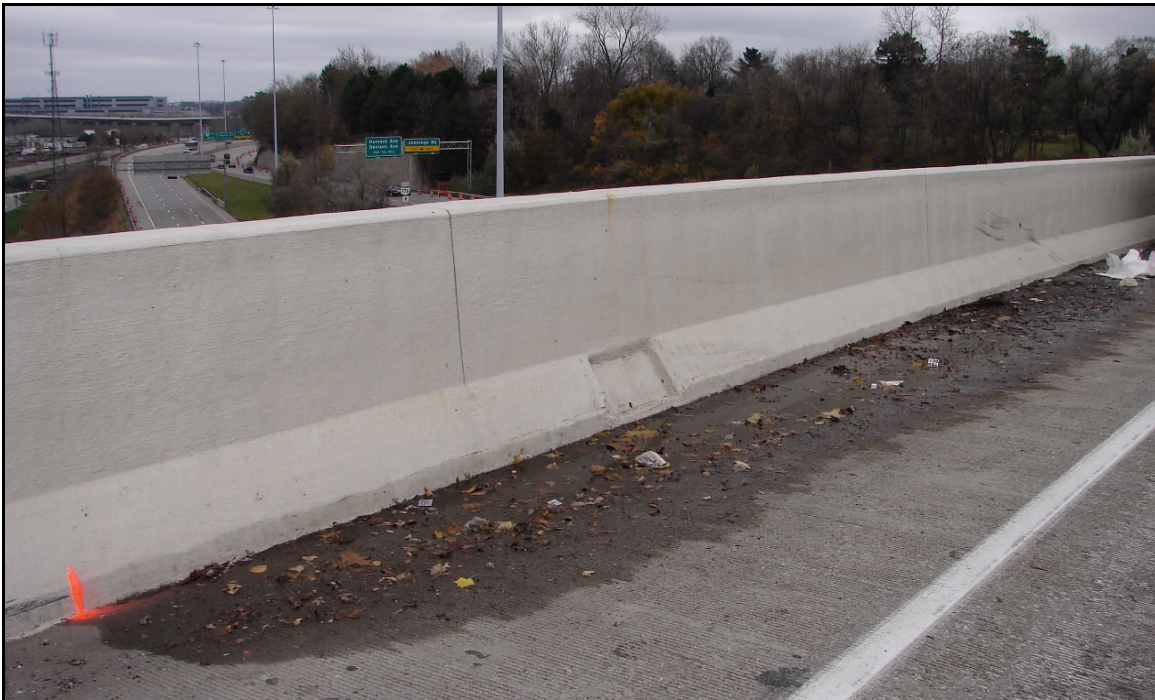
Photo 14 – Standing Water in Right Gutterline, Span 3

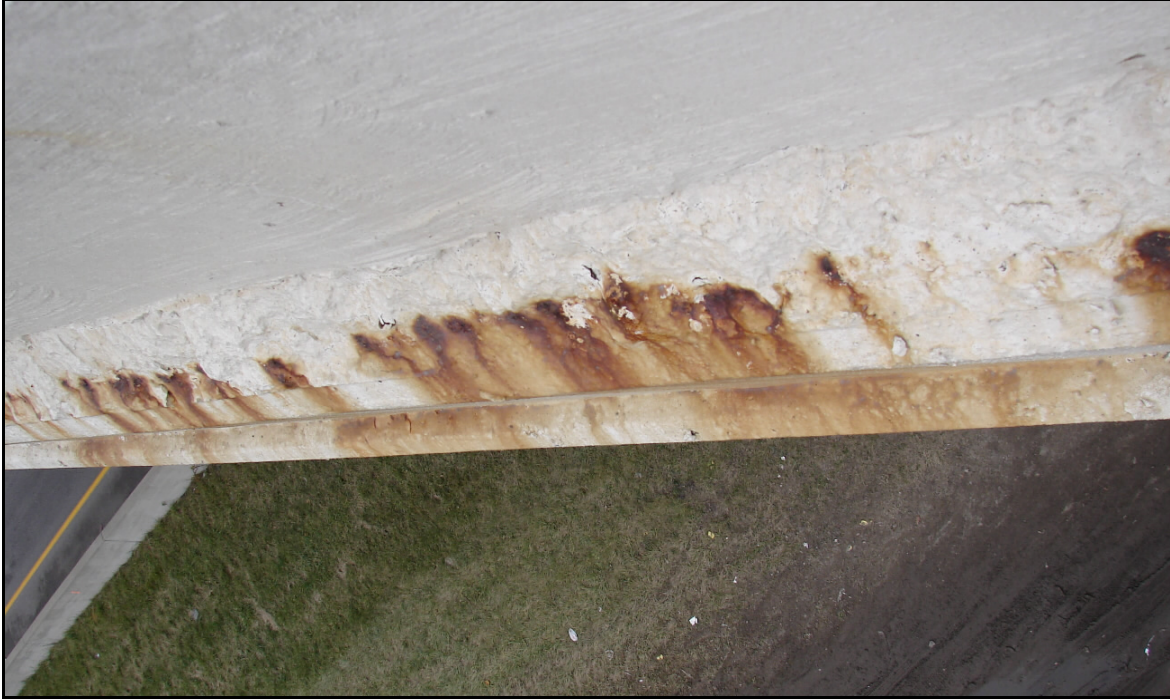
Photo 15 – Active Concrete Corrosion at Parapet Base, Outside Gutterline Ponding

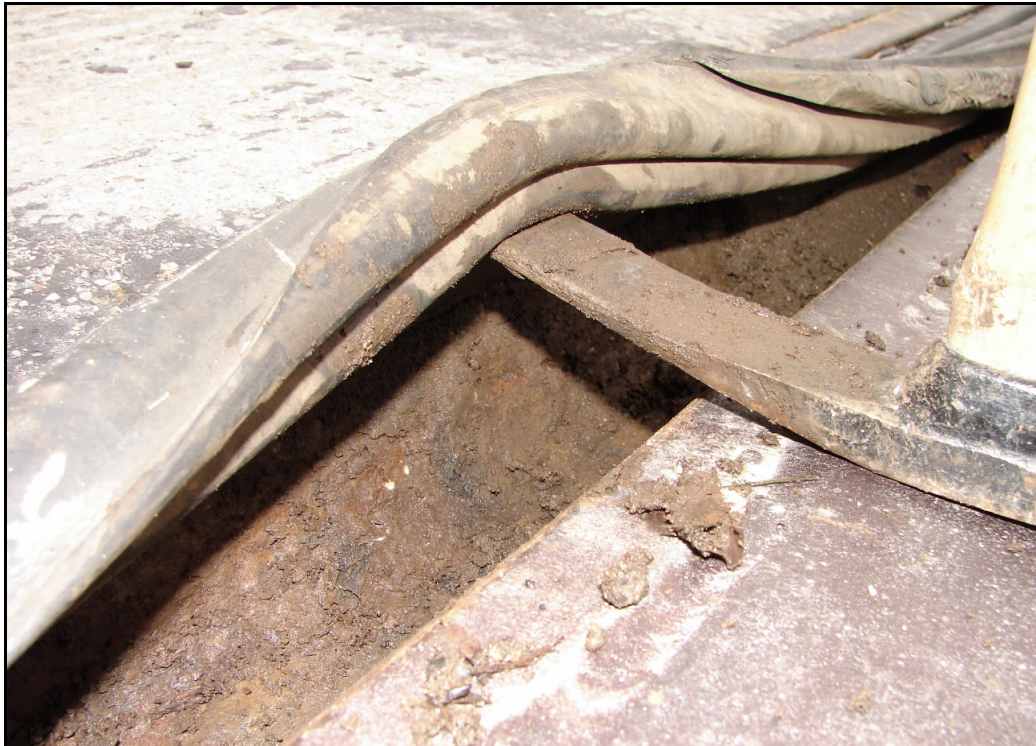
Photo 16 – Torn Membrane, Expansion Joint 1A

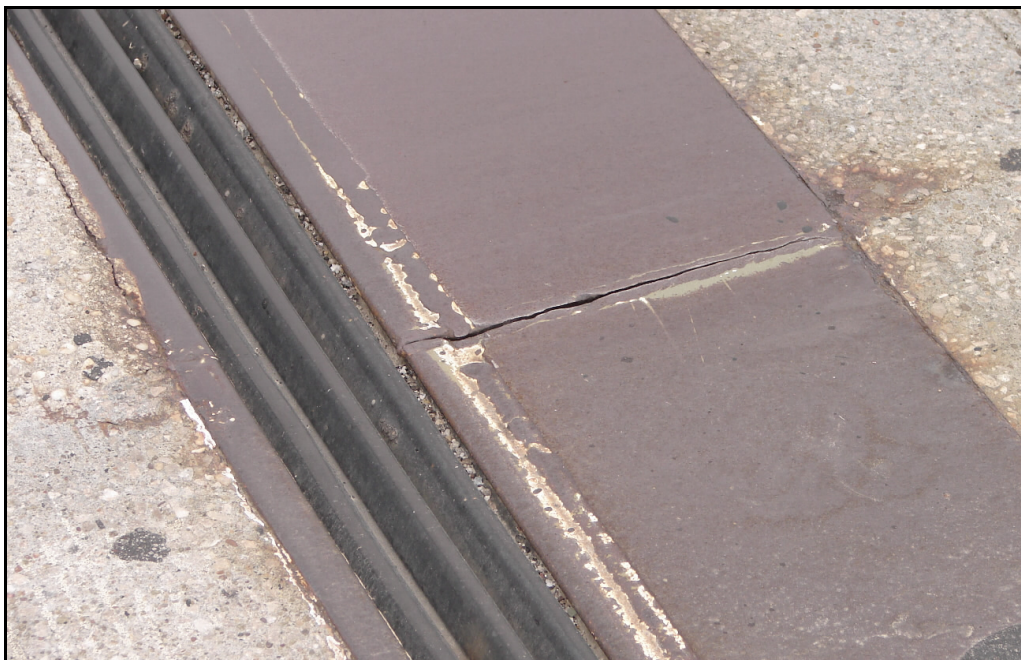
Photo 17 – Missing Seal Weld, Expansion Joint 1A

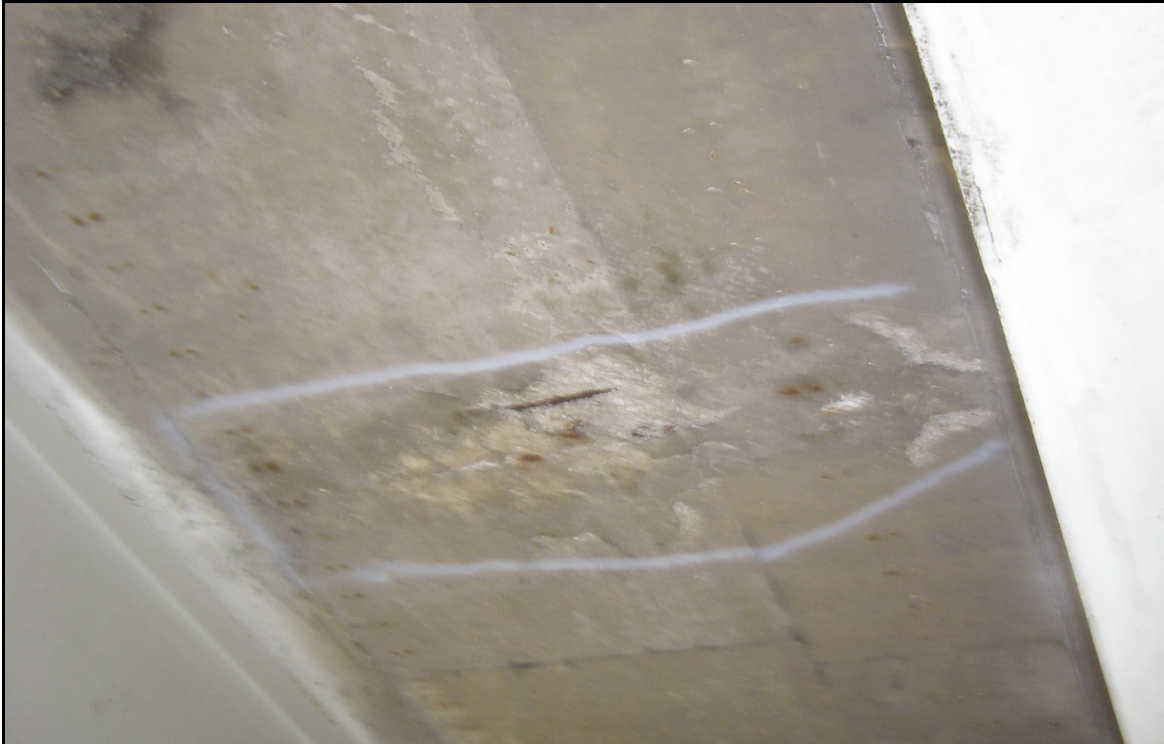
Photo 18 – Underdeck Spall & Delamination, Span 26E

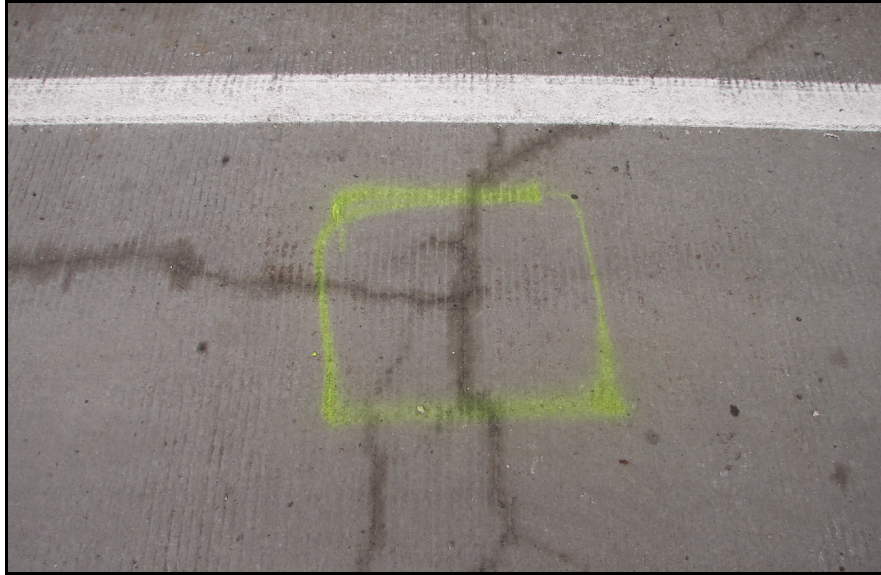
Photo 19 – Typical Delaminated Wearing Surface and Deck Cracks, Unit 1B

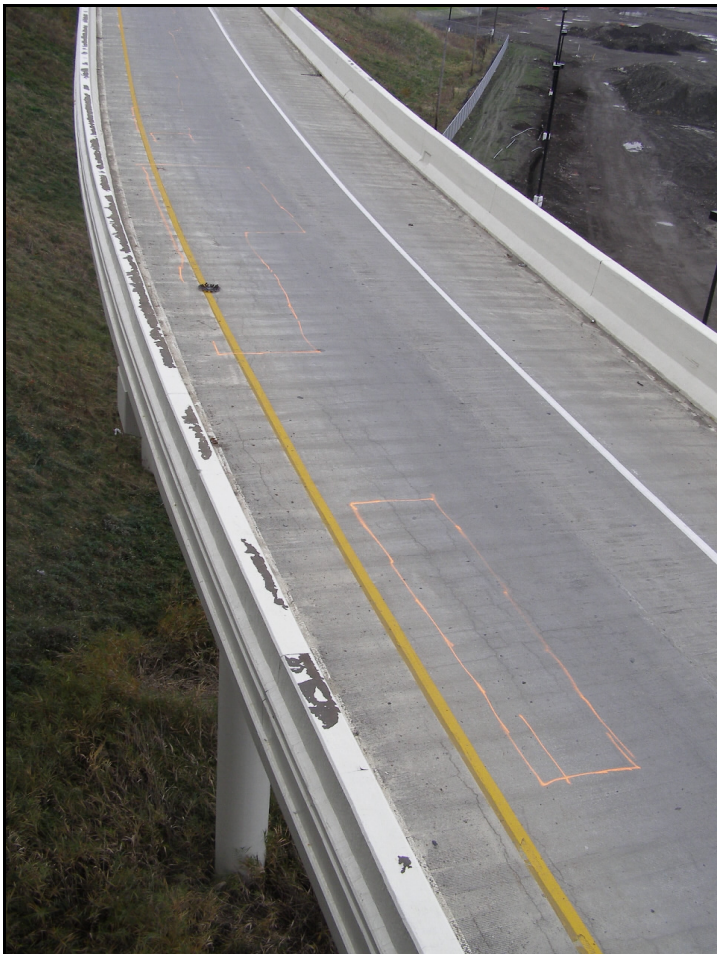
Photo 20 – Delaminated Wearing Surface Outlined in Paint, Unit 3BE

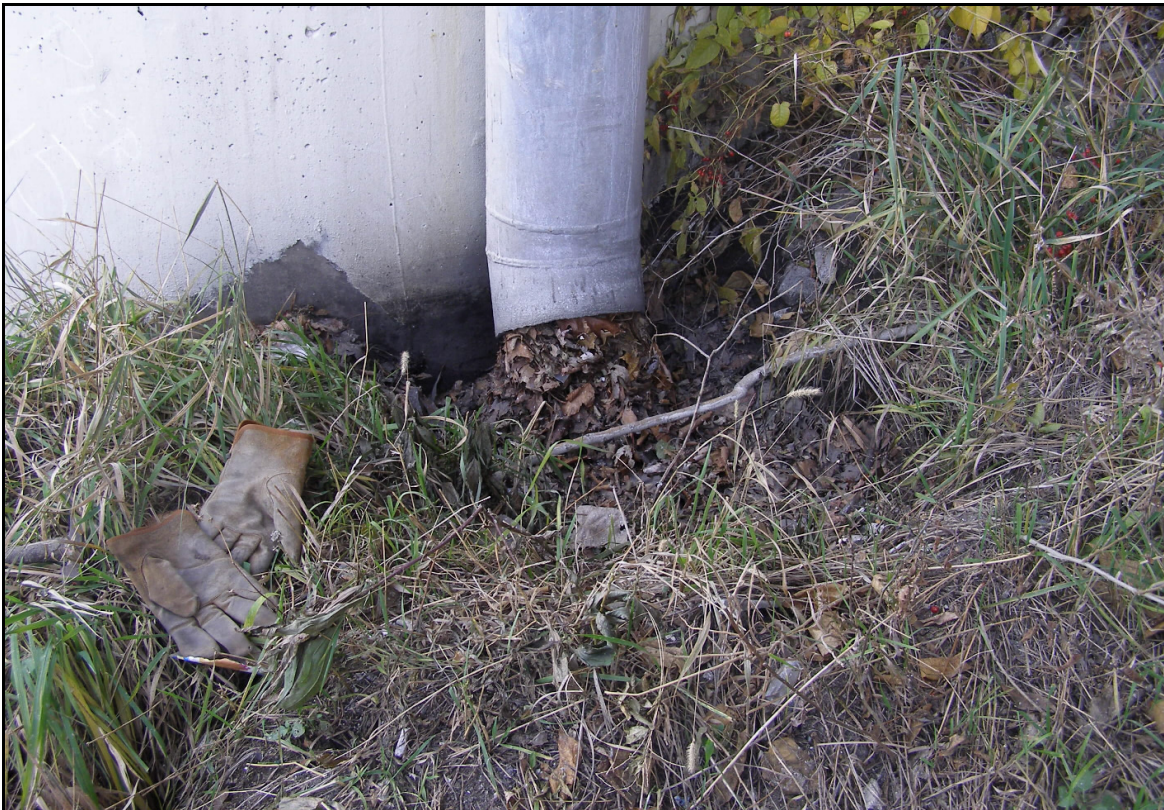
Photo 21 – Typical Debris Back Up into Drain Pipe

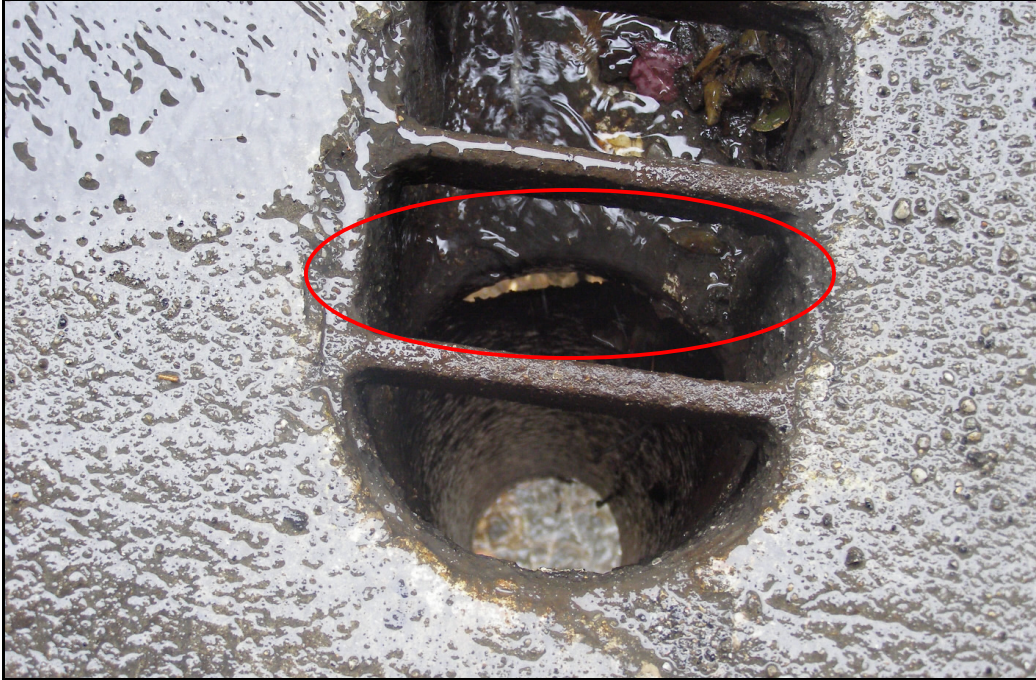
Photo 22 – Corroded Pipe (Circled) at Bottom of Deck Level, Near South Abutment B

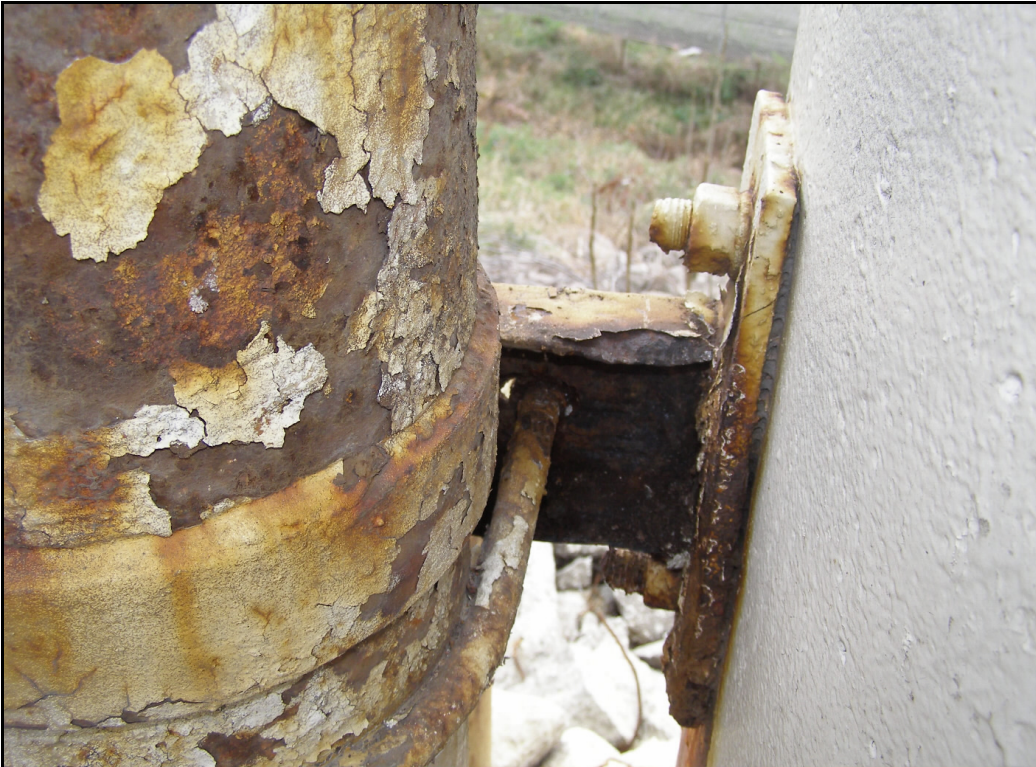
Photo 23 – Heavily Corroded Drainage Bracket, Pier 24BE

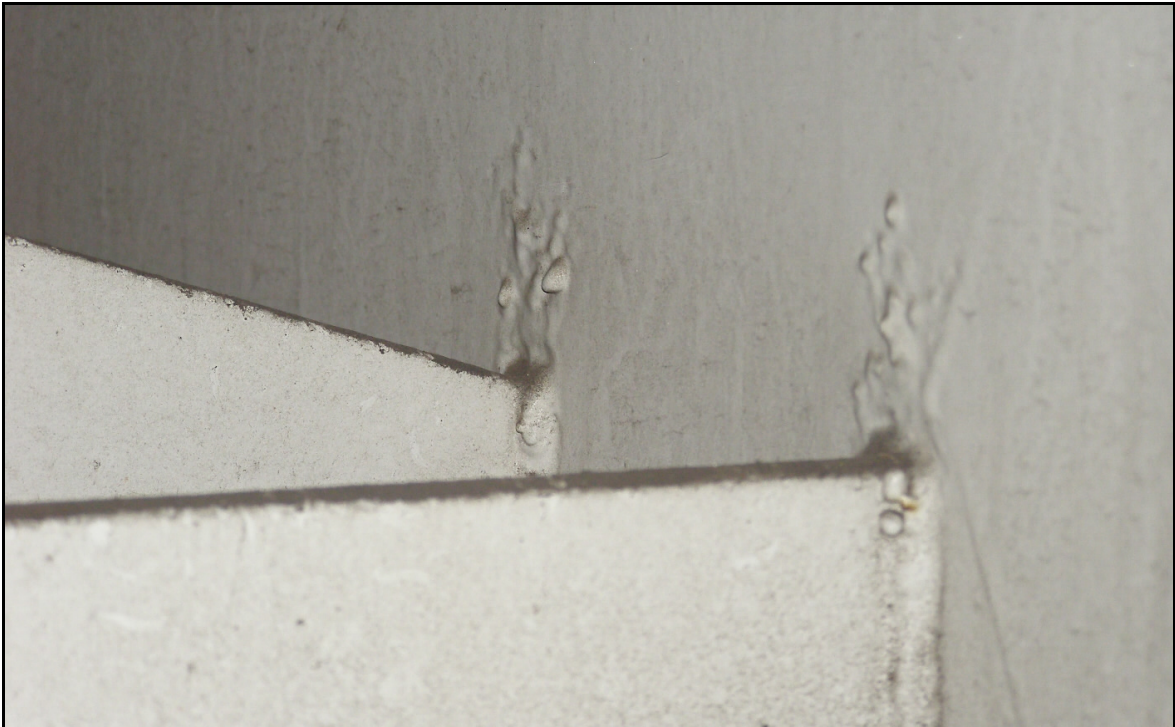
Photo 24 – Typical Diaphragm Weld Undercut to Beam Web

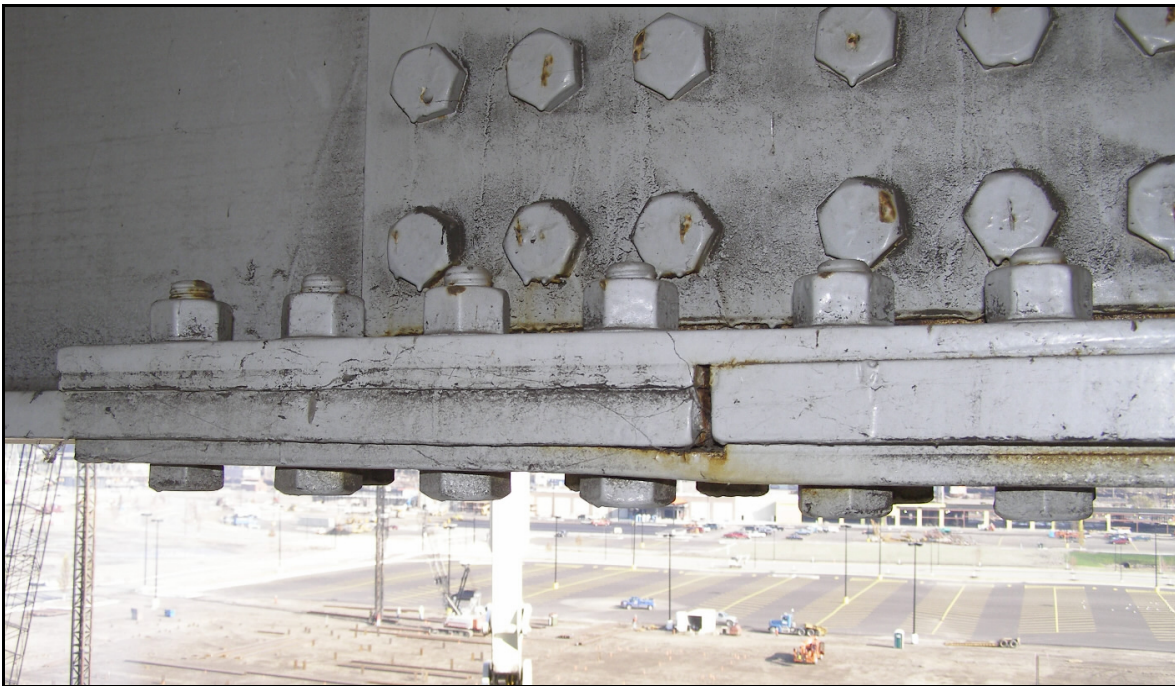
**Photo 25 – Draw Down and Corrosion to Bottom Flange Splice Plates,
Span 8A Field Splice**

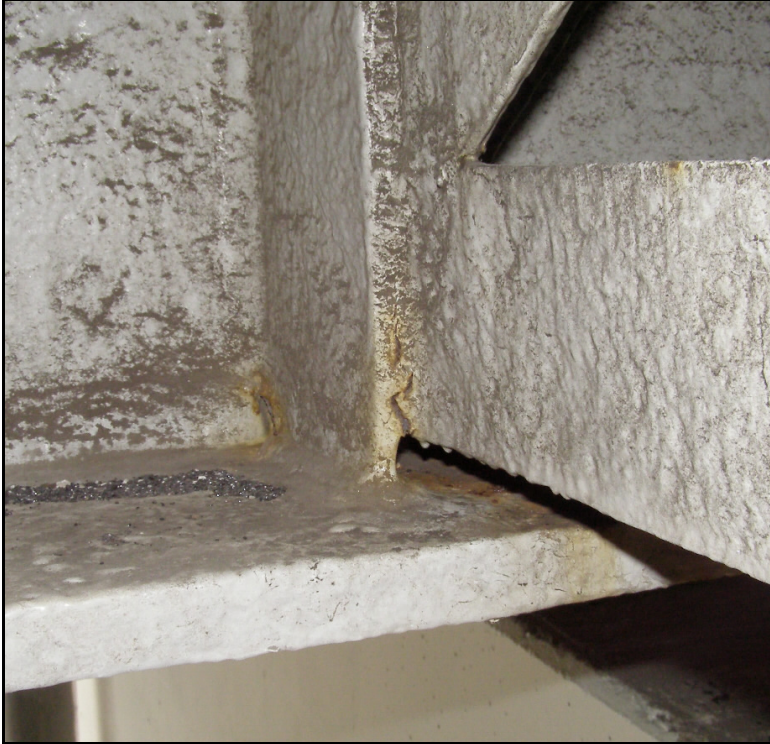
Photo 26 – Cracked Diaphragm Weld Due to Pack Rust

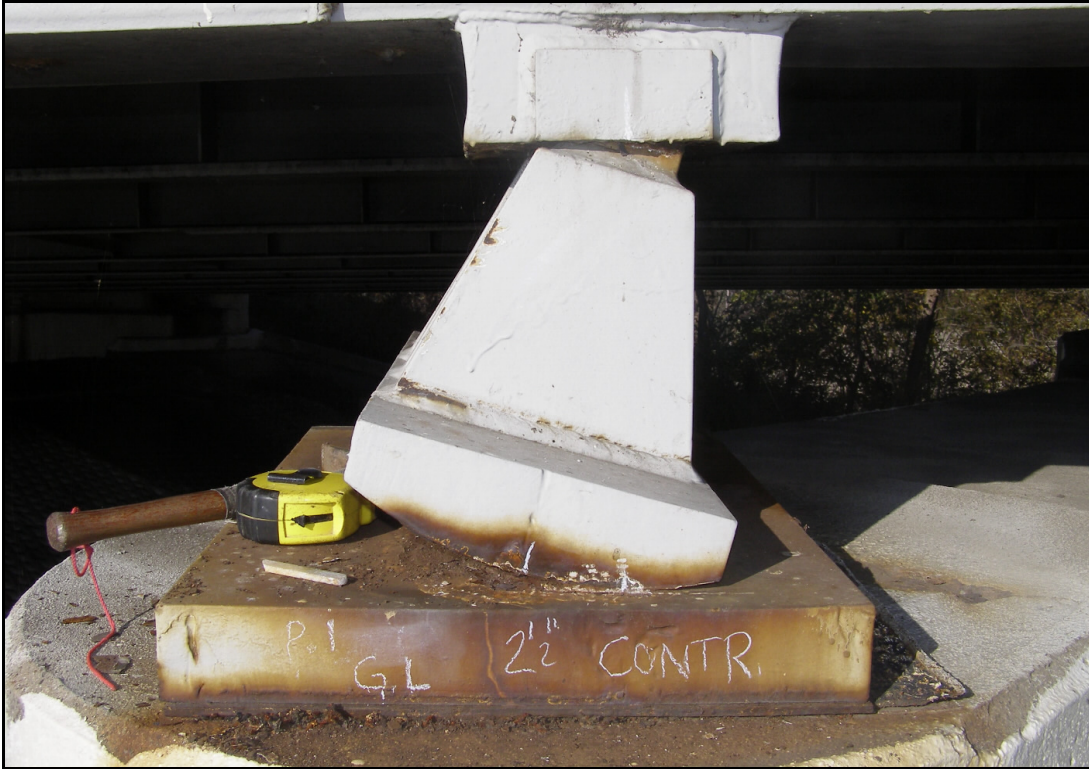
Photo 27 – Over-Contracted Bearing and Sliding Base Plate, Pier 1

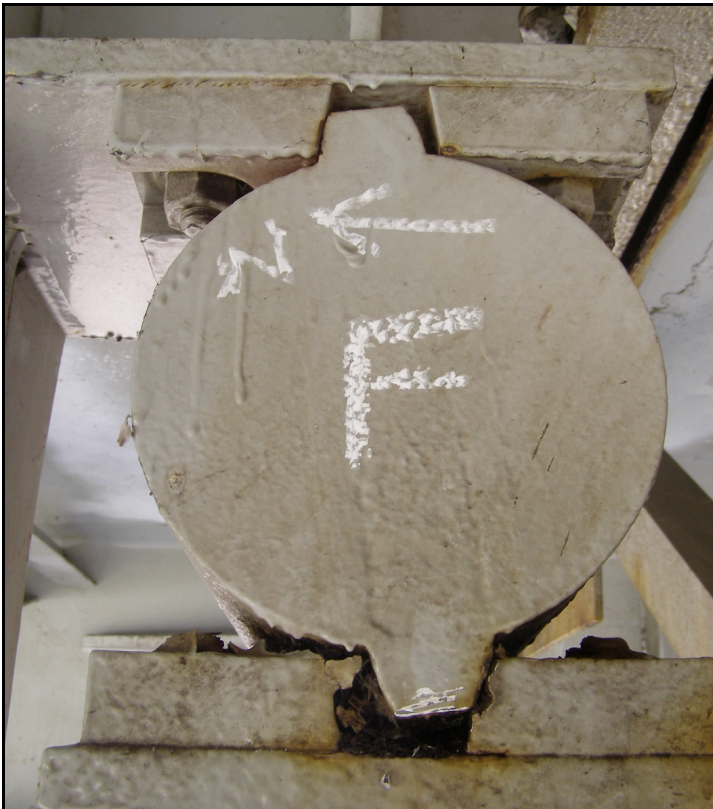
Photo 28 – Typical Wear to Hinge Keeper Teeth and Plates
