2006 PHYSICAL CONDITION REPORT

*I-71 NB BRIDGE OVER JENNINGS FREEWAY
&
SR 176 BRIDGE UNDER I-71*

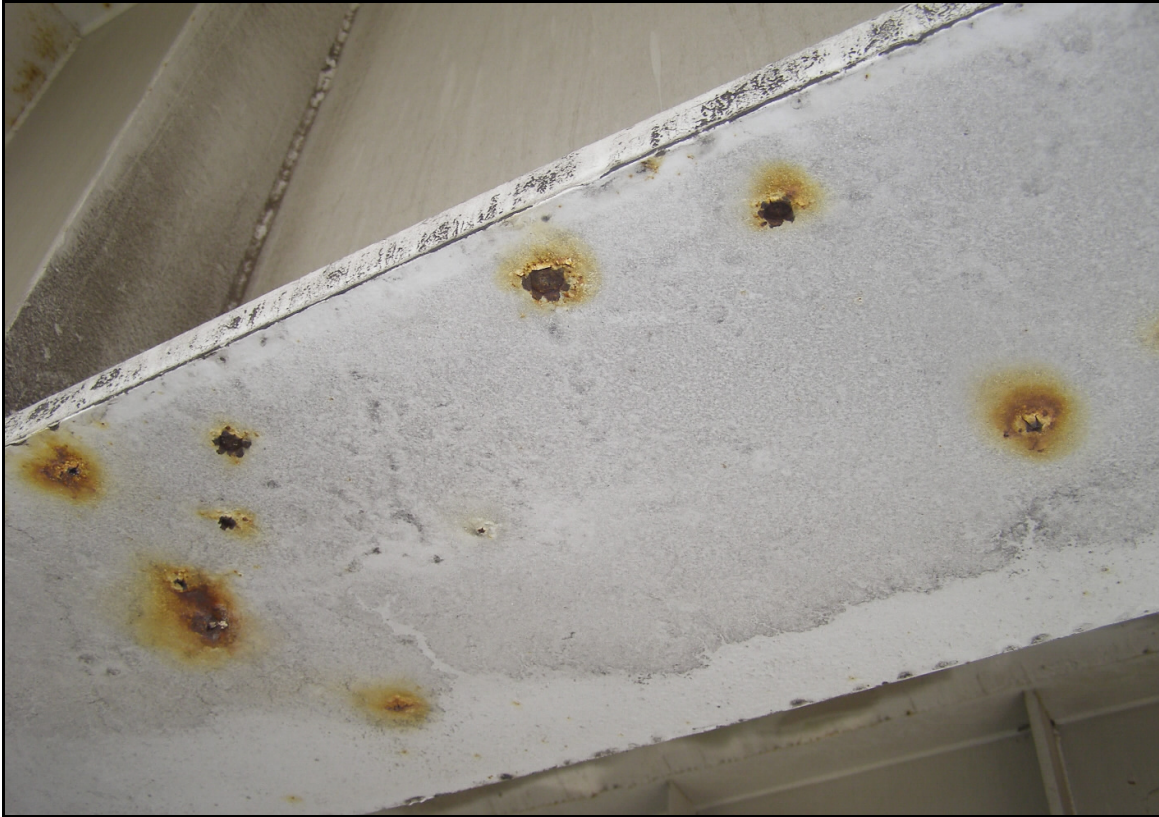
Photo 29 – Typical Corrosion Blooms to Bottom Flange

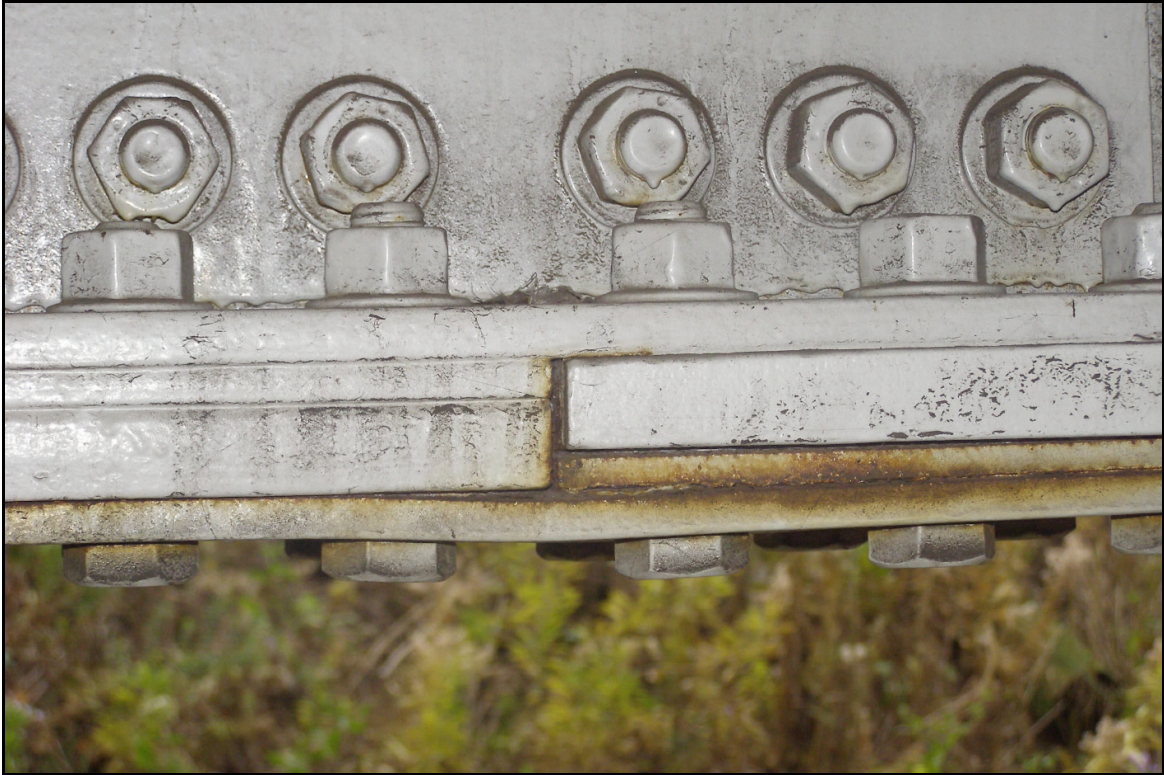
Photo 30 – Typical Pack Rust at Bottom Flange Splice Plates

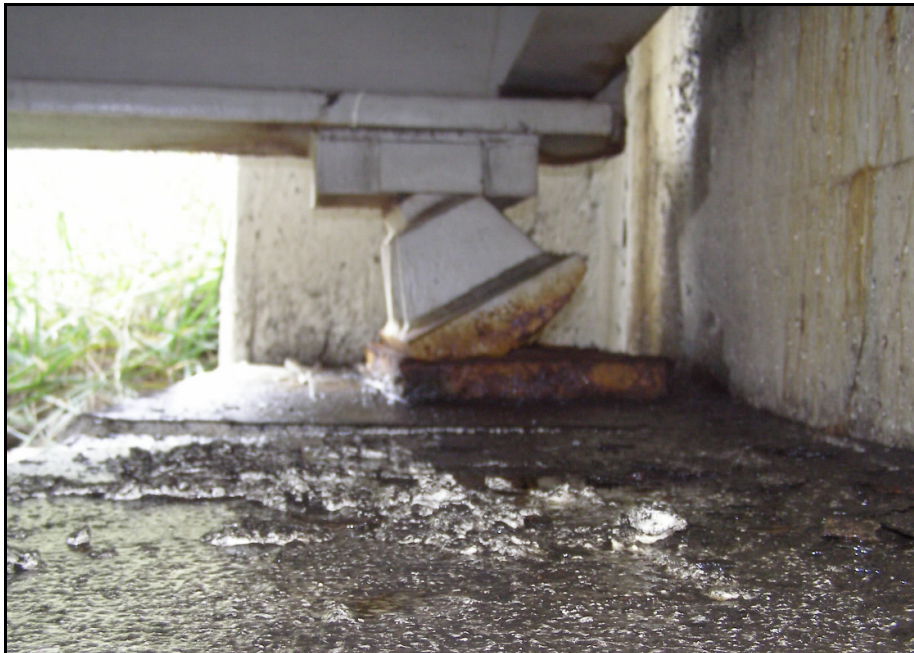
Photo 31 – Over-Contracted Bearing G, North Abutment BE

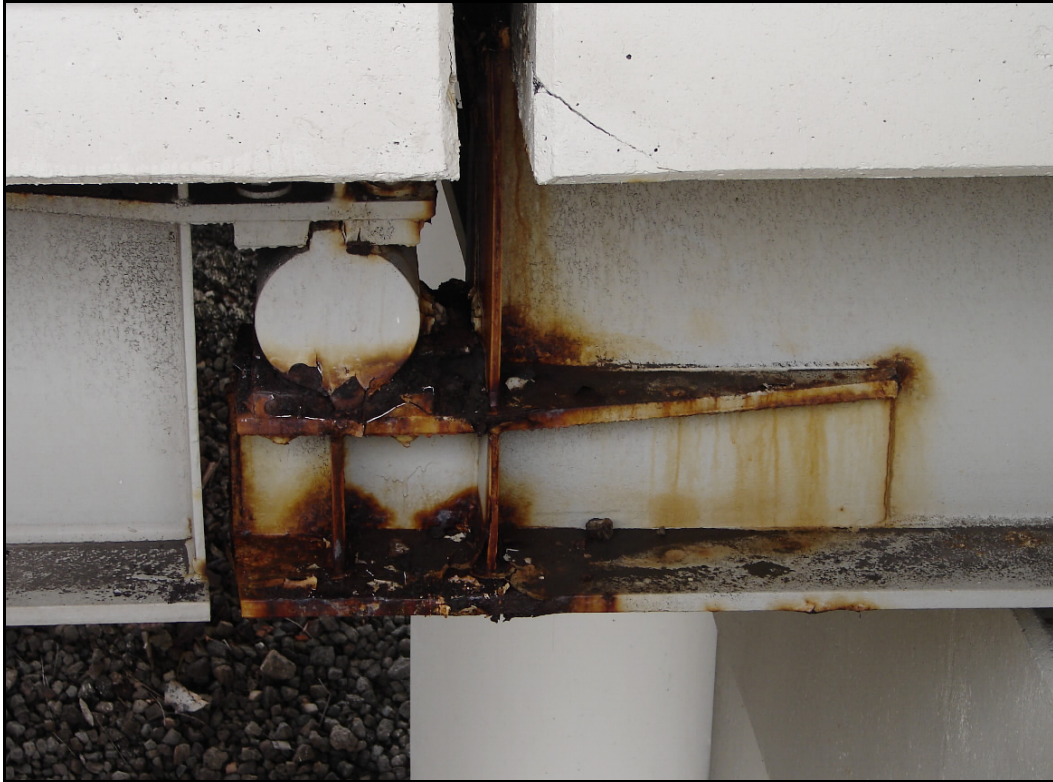
Photo 32 – Typical Corrosion at Expansion Hinge

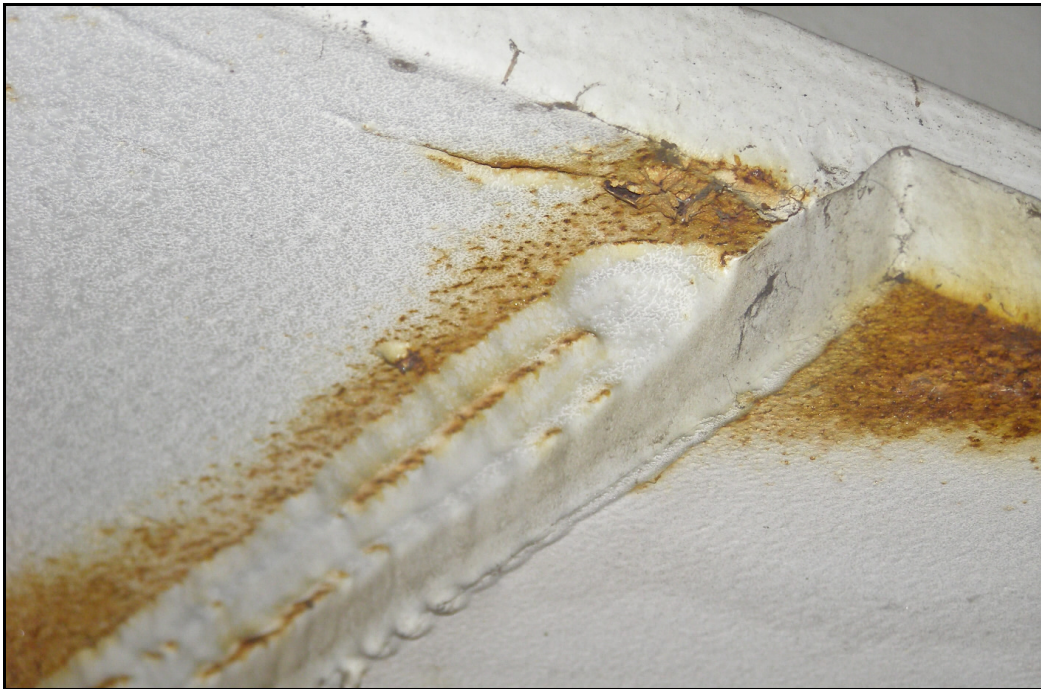
**Photo 33 –End Weld to Bottom Flange Cover Plate
(Embedded Top Flange Cover Plate Welds Assumed Similar)**

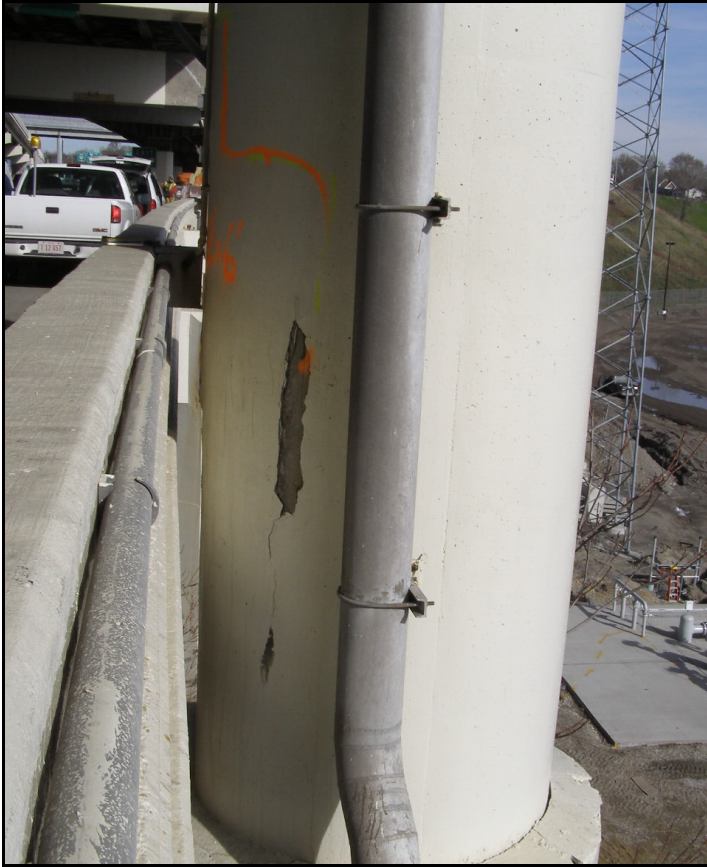
Photo 34 – Delaminated Concrete to Pier Column along Jennings Freeway Traffic, Pier 14, I-71 Bridge

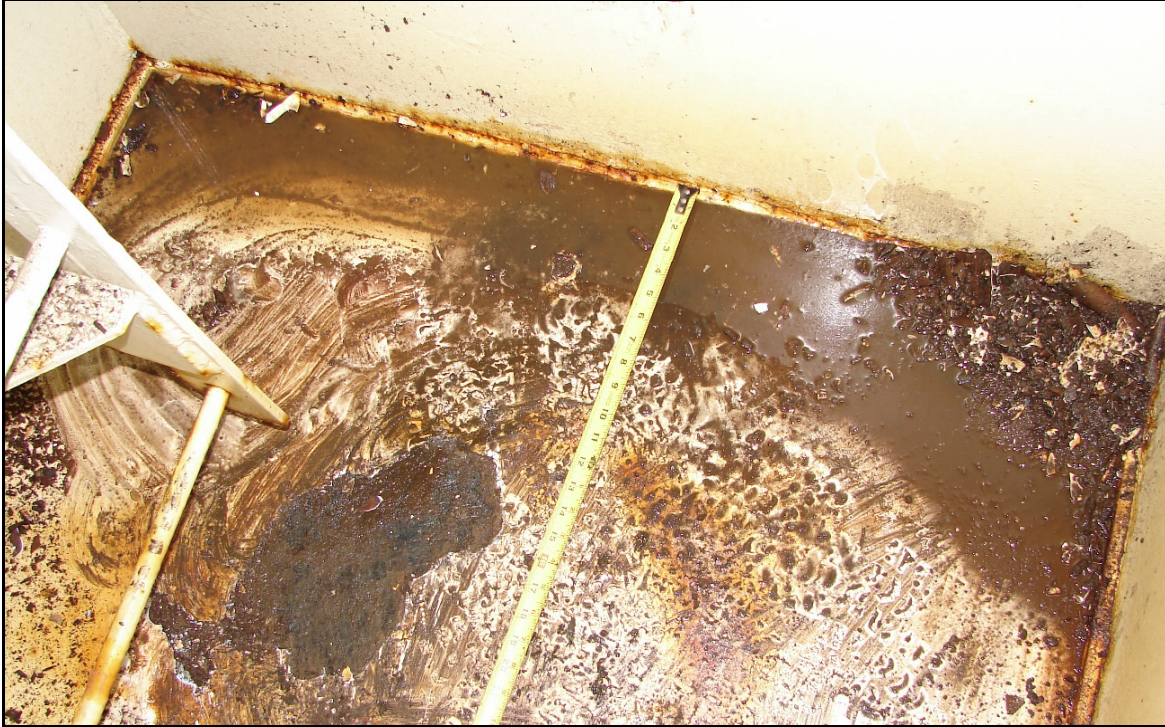
Photo 36 – Small Amount of Standing Water and Light Corrosion to Box Floor, Panel 21

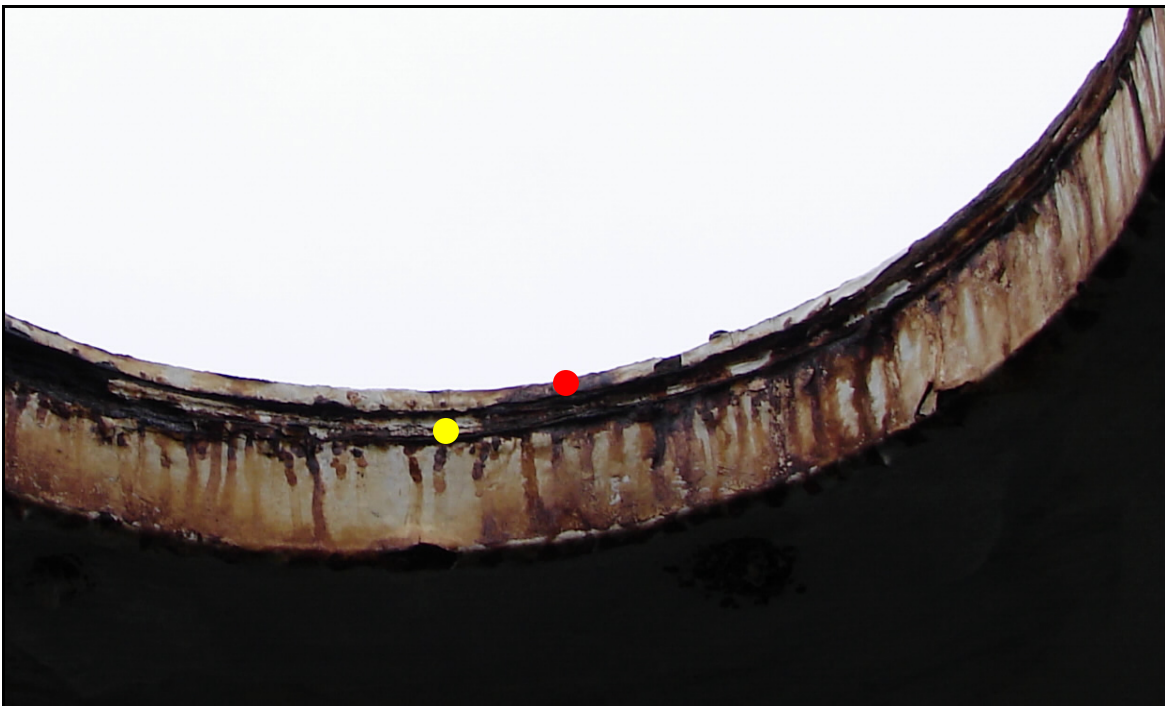
Photo 37 – Pack Rust Between Stiffener Plate (Red Dot) and Top Flange Plate (Yellow Dot), Steel Pier Cap 17A

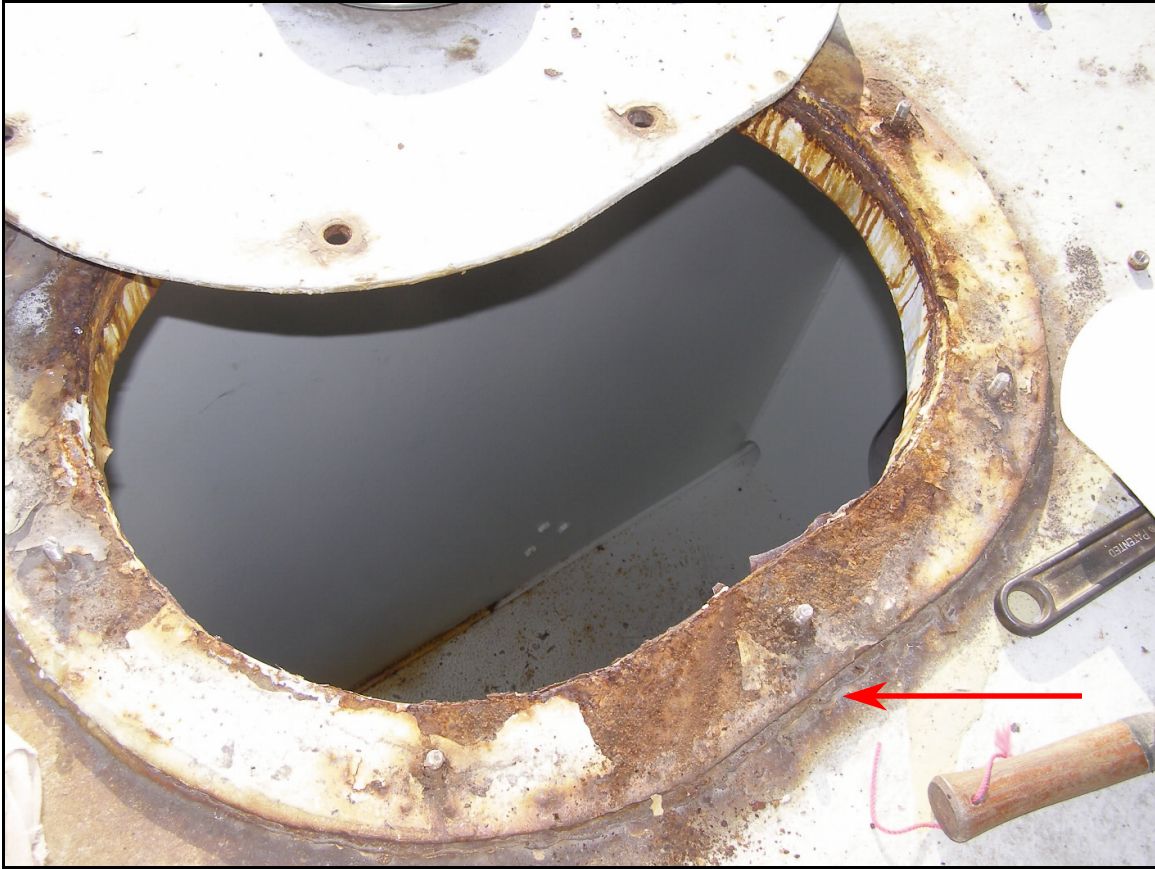
Photo 38 – Corrosion To Stiffener Plate and Cracked Weld to Top Flange Plate (See Arrow), Steel Pier Cap 17A

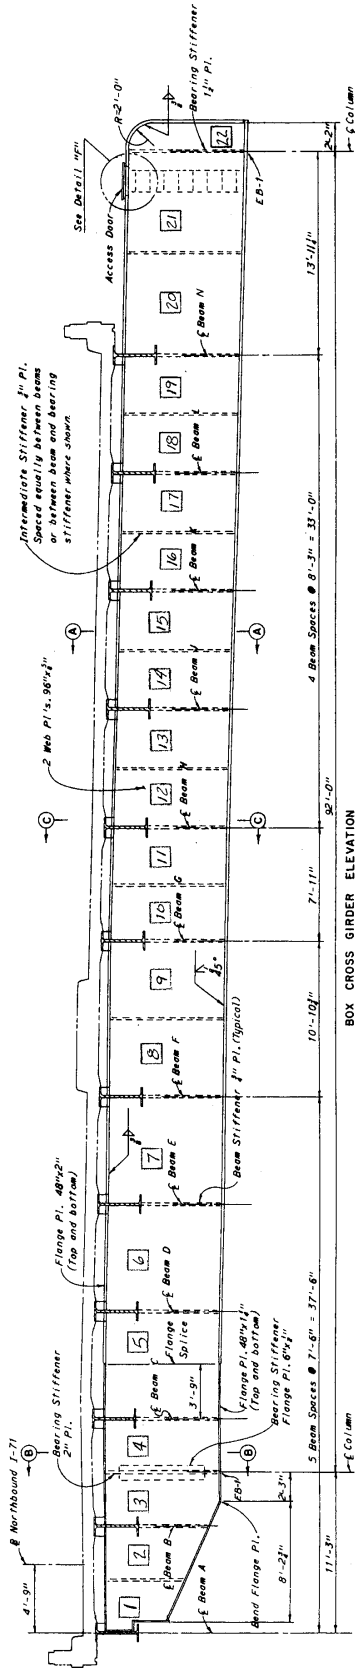
X - Interior Box Panel No.

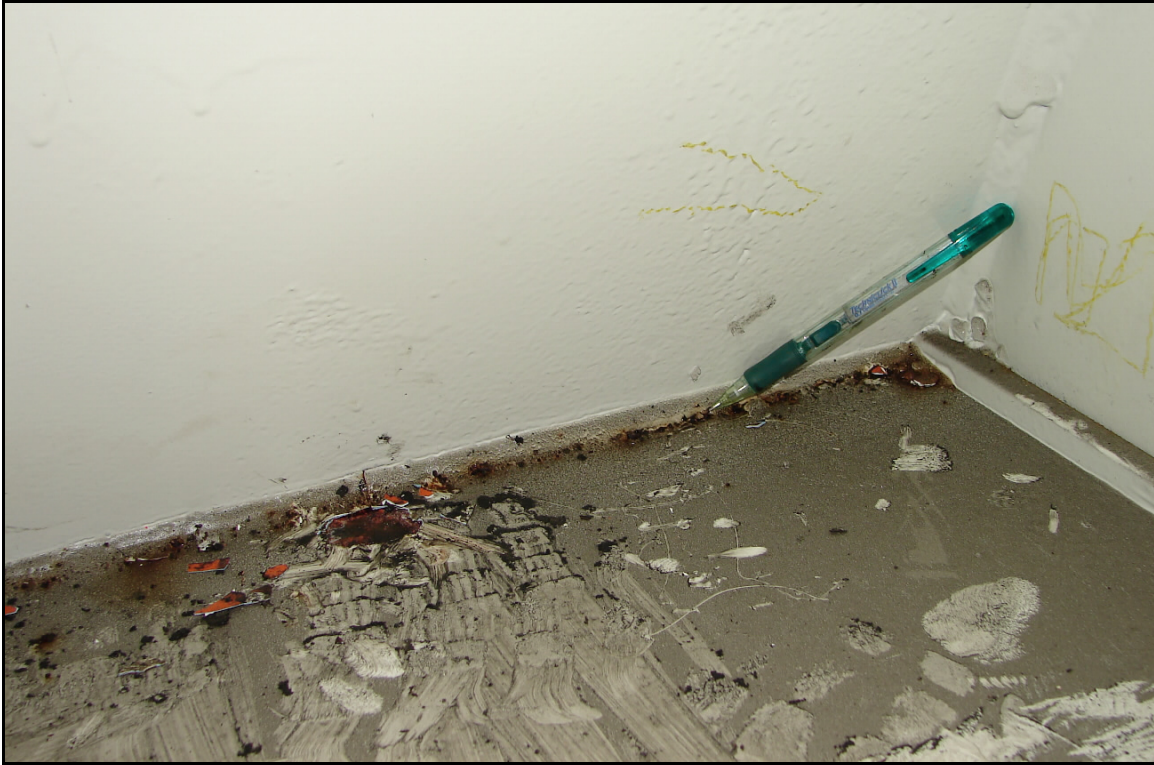
Photo 39 – Slight Corrosion and Dirt to Interior Floor, Panel 3

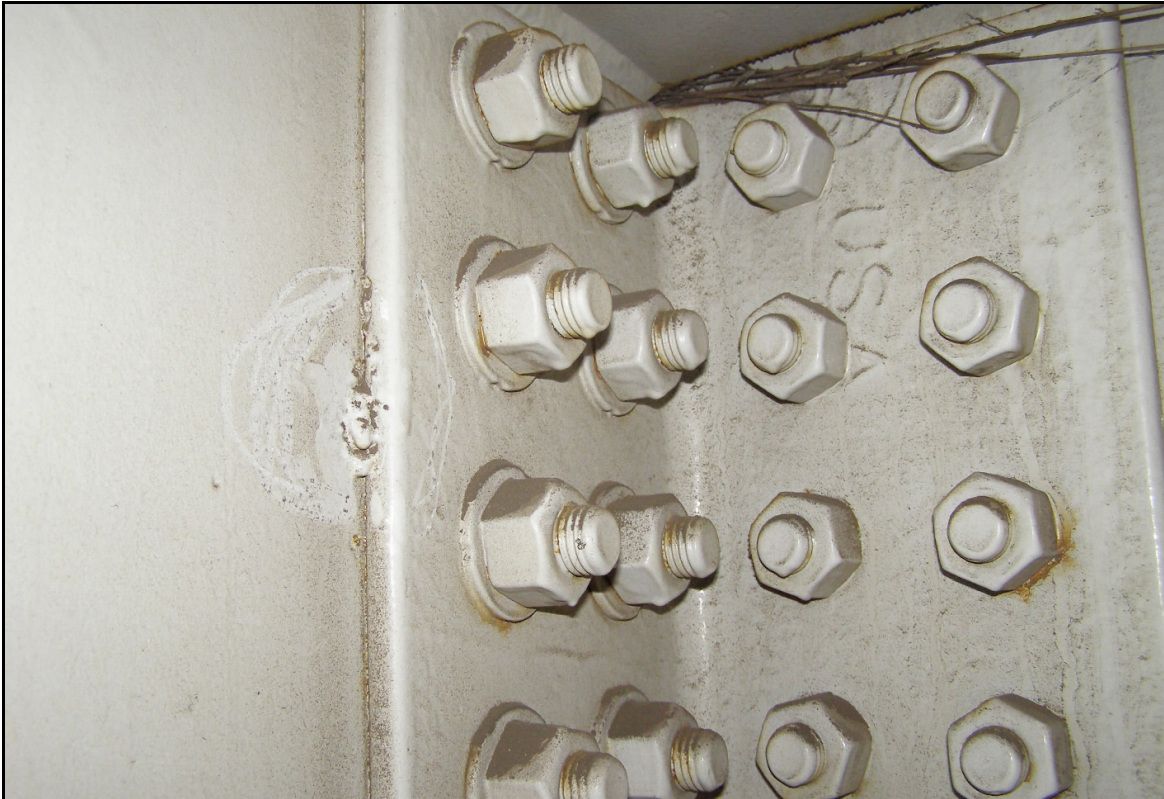
Photo 40 – Tack Weld (Circled) Between Beam A Web and Pier Cap Clip Angle, Pier 22AE

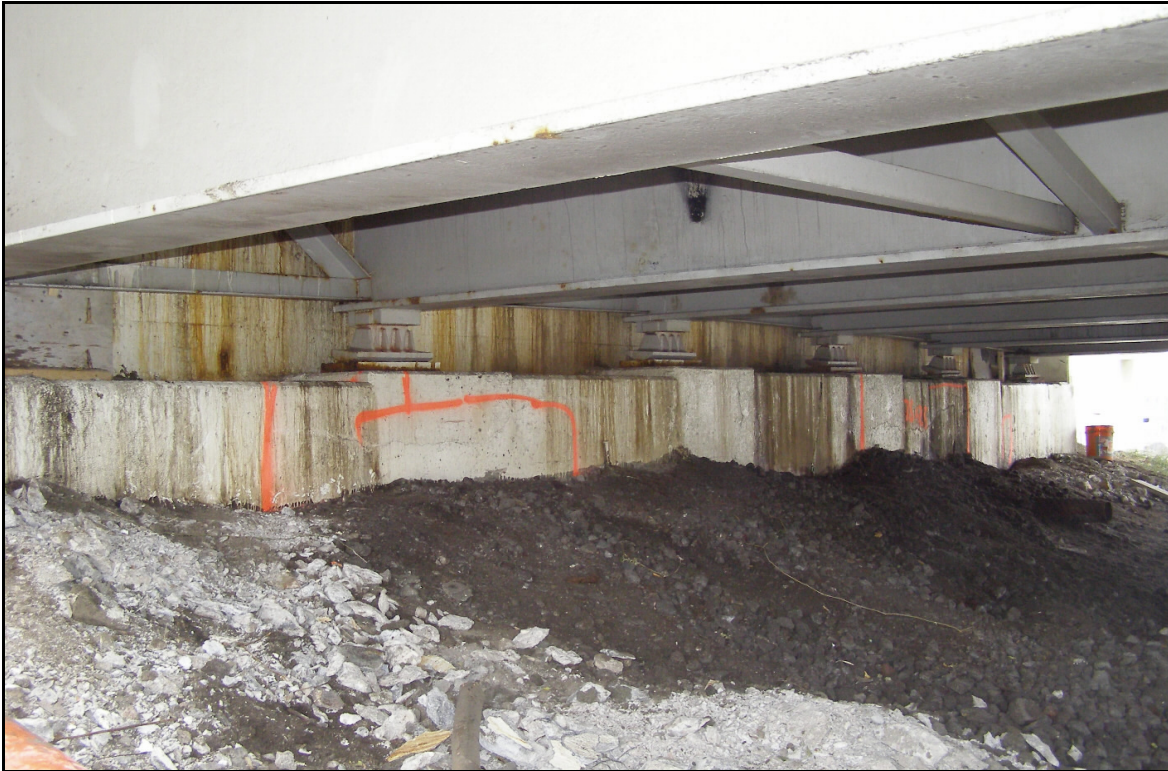
Photo 41 – Delaminations to Abutment Barrel, North Abutment BW

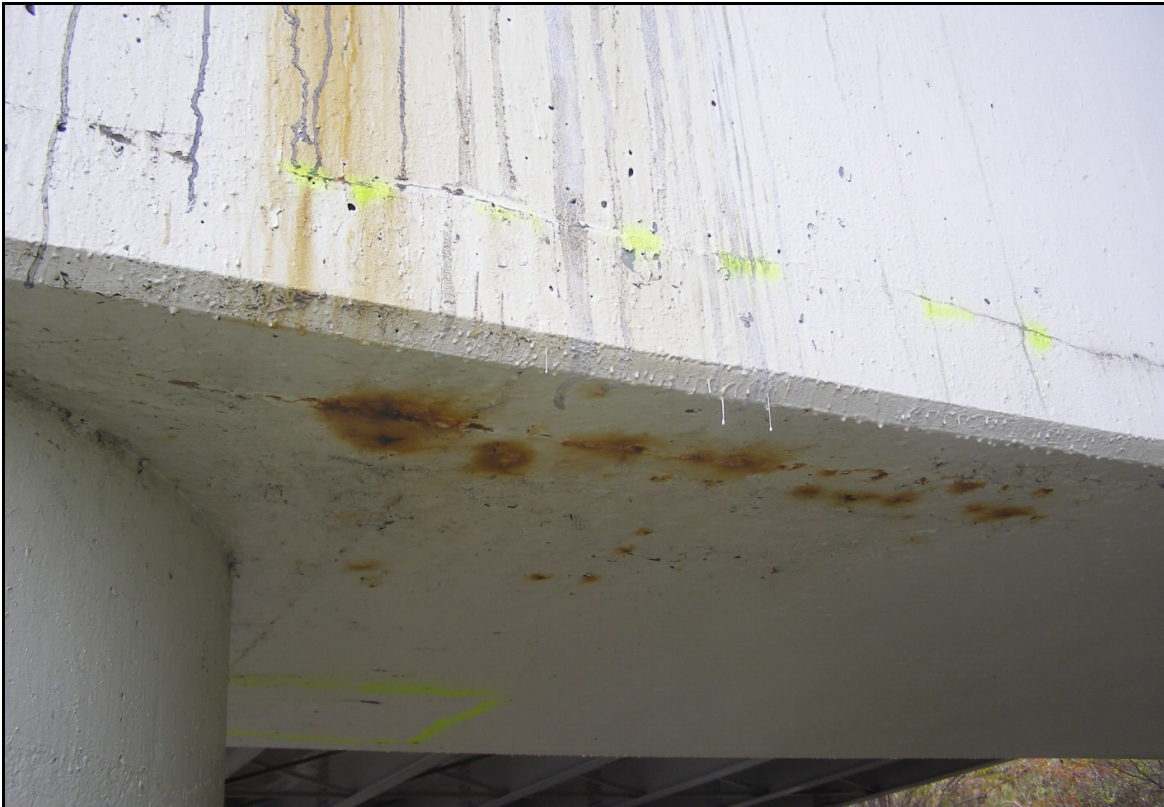
Photo 42 – Early Delamination Crack to Pier Cap Horizontal and Bottom Faces, Pier 11, East End

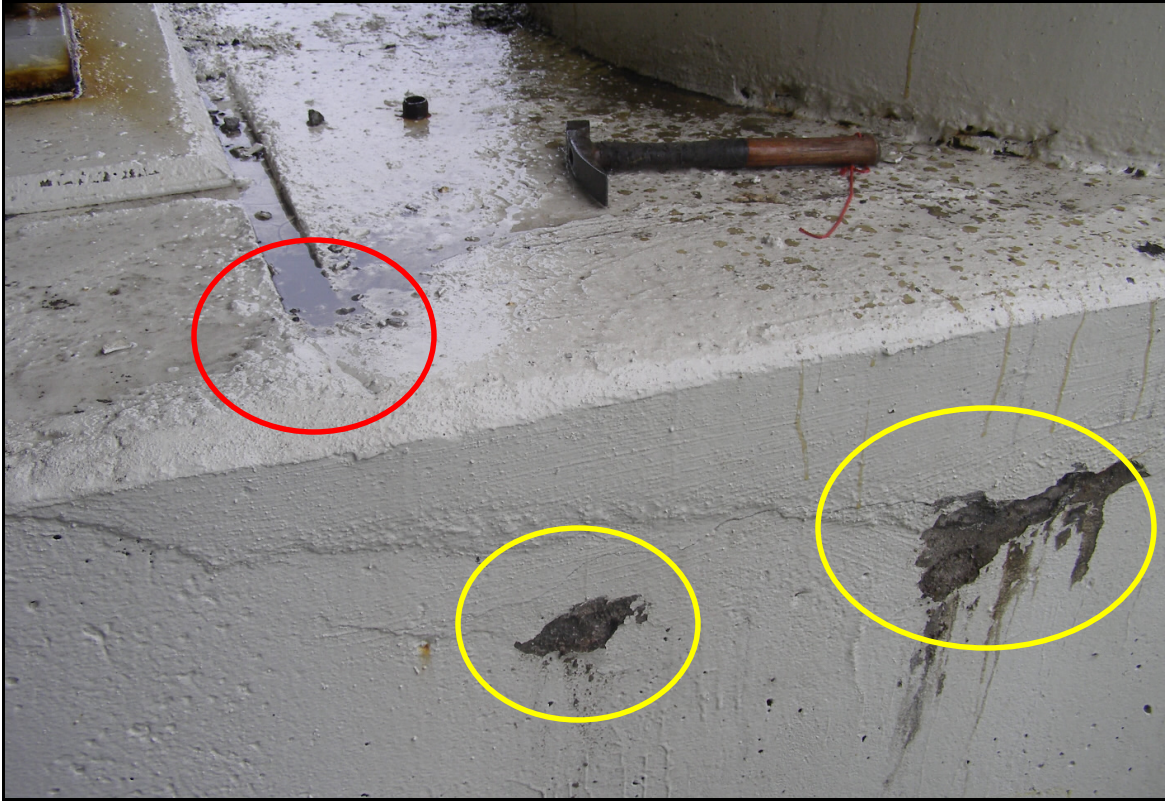
Photo 43 – Concrete Dam (Circled in Red) and Blistering Sealer (Circled in Yellow)

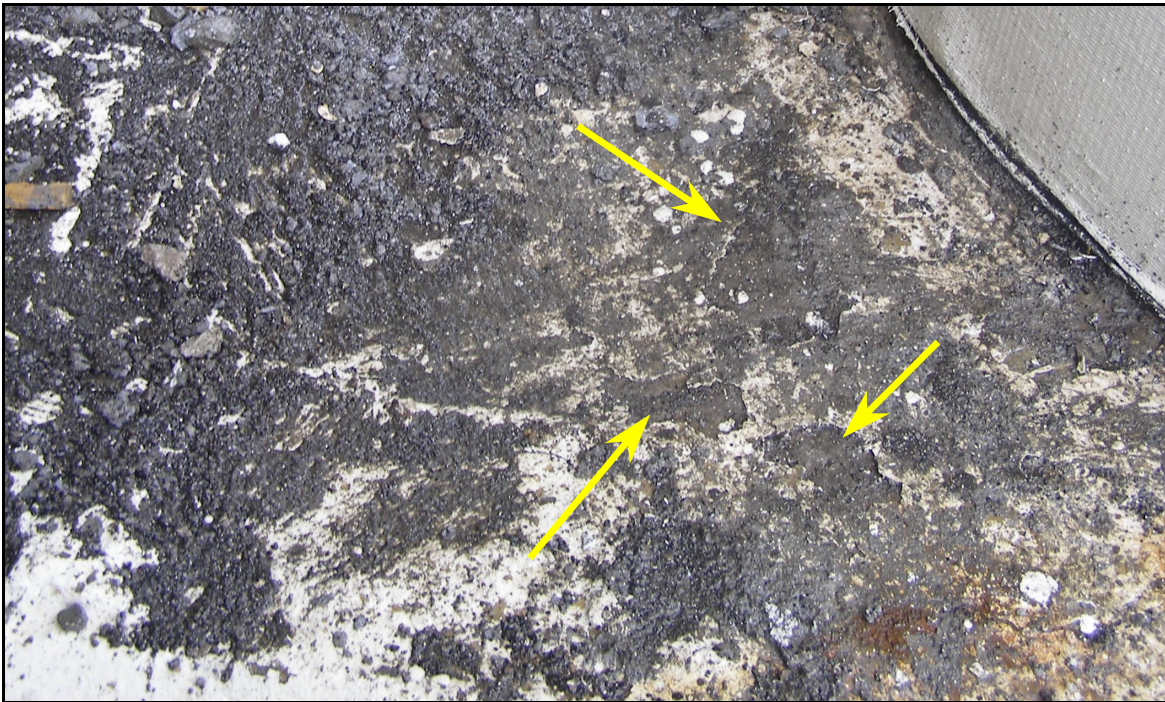
**Photo 44 – Typical Sealer Flaking (See Arrows) to Pier Cap Top
(Note: Black debris is from current maintenance repairs.)**

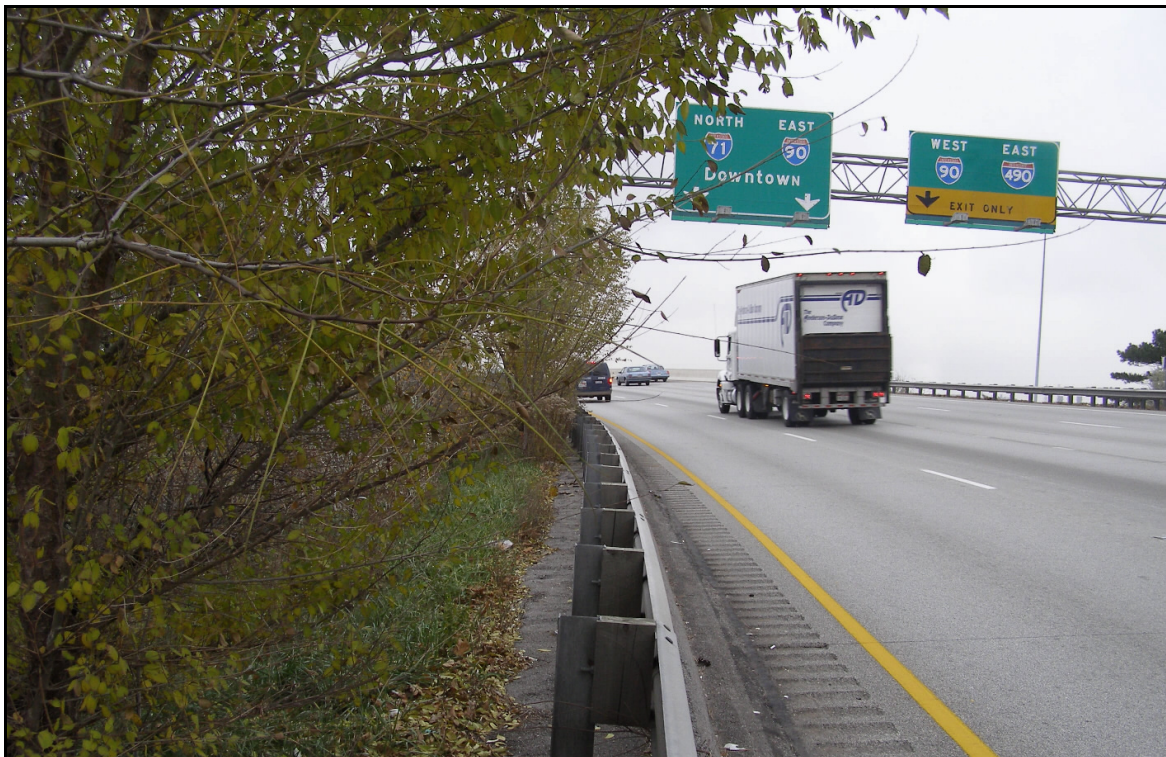
Photo 45 – Encroaching Tree Branches Limiting Stopping Sight Distance, South Approach, I-71 Bridge

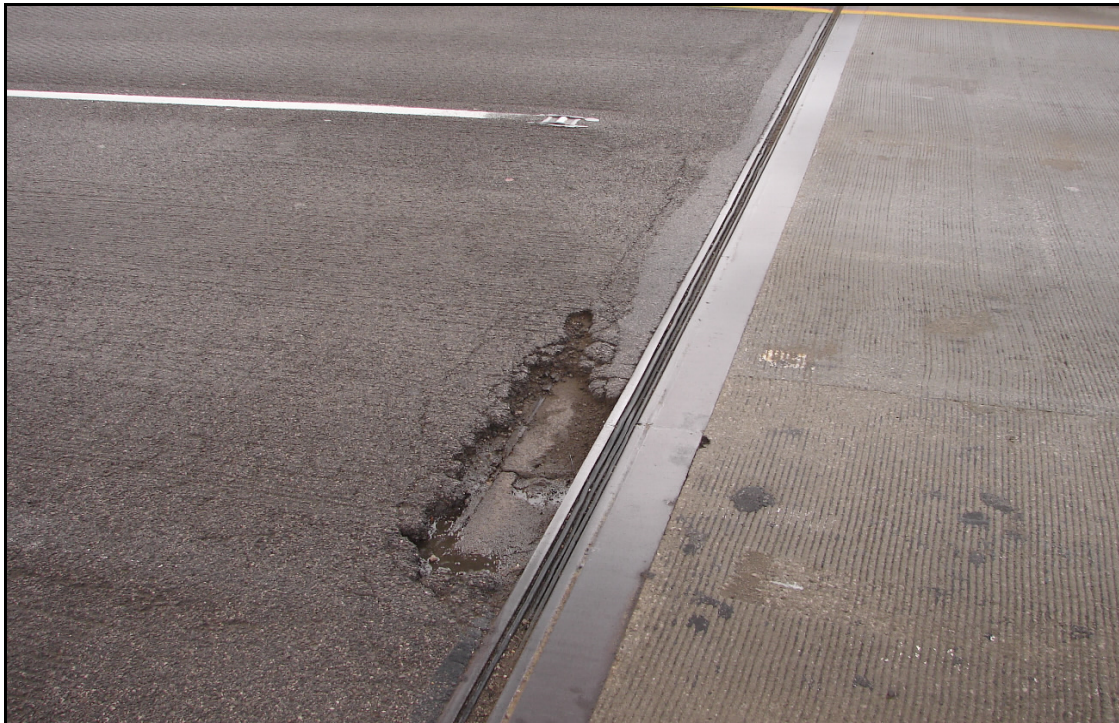
Photo 47 – Approach Slab Spall, Rear Approach, Jennings Freeway Bridge

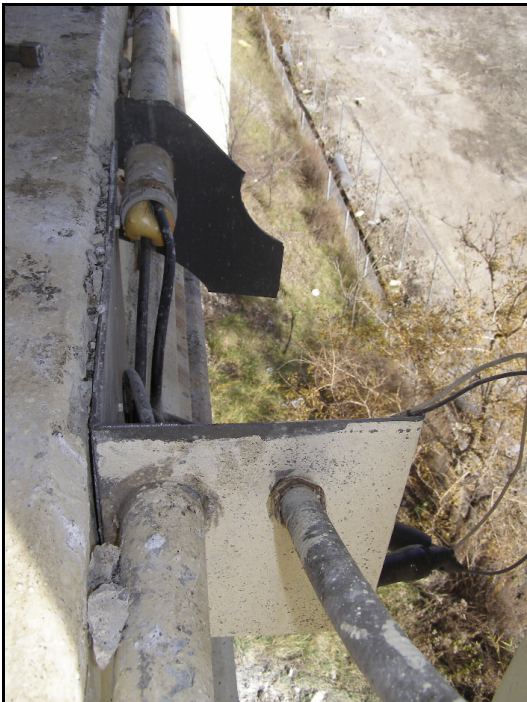
Photo 49 – Missing Junction Box and Exposed Wiring, Right Parapet at Pier 11

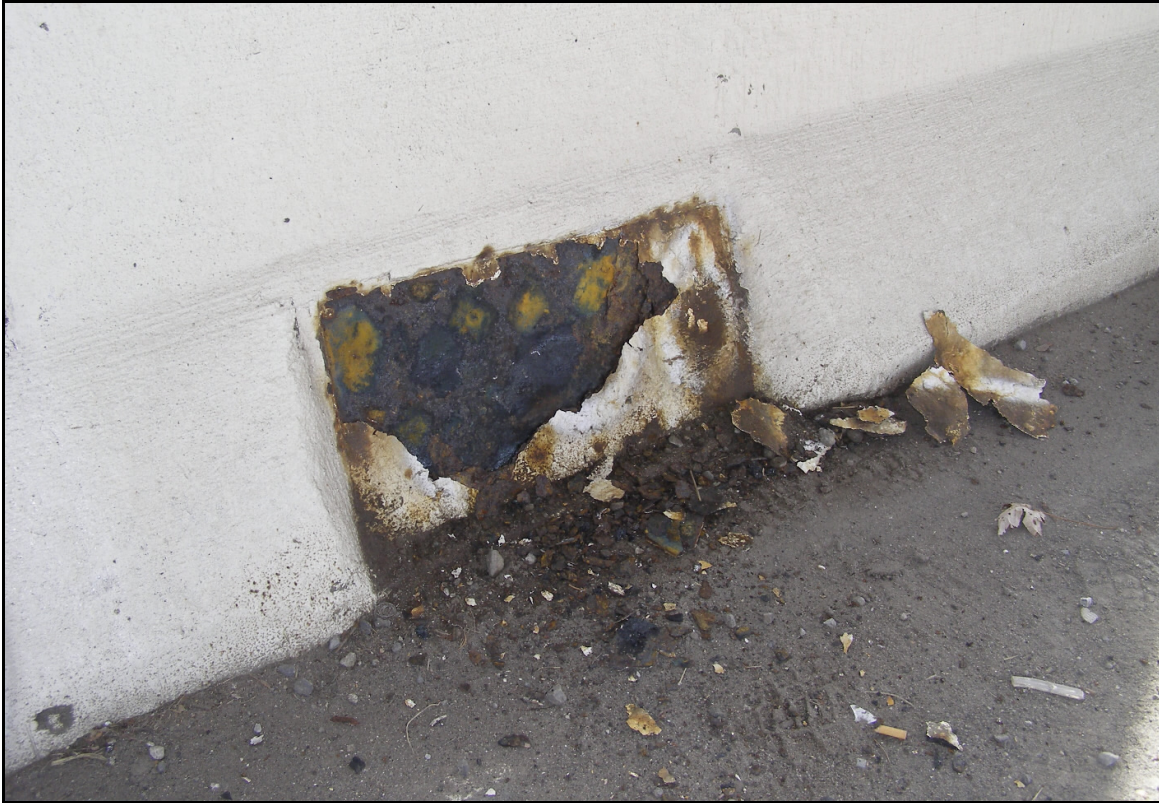
Photo 50 – Typical Heavy Corrosion Pull Box Cover, Jennings Freeway Bridge

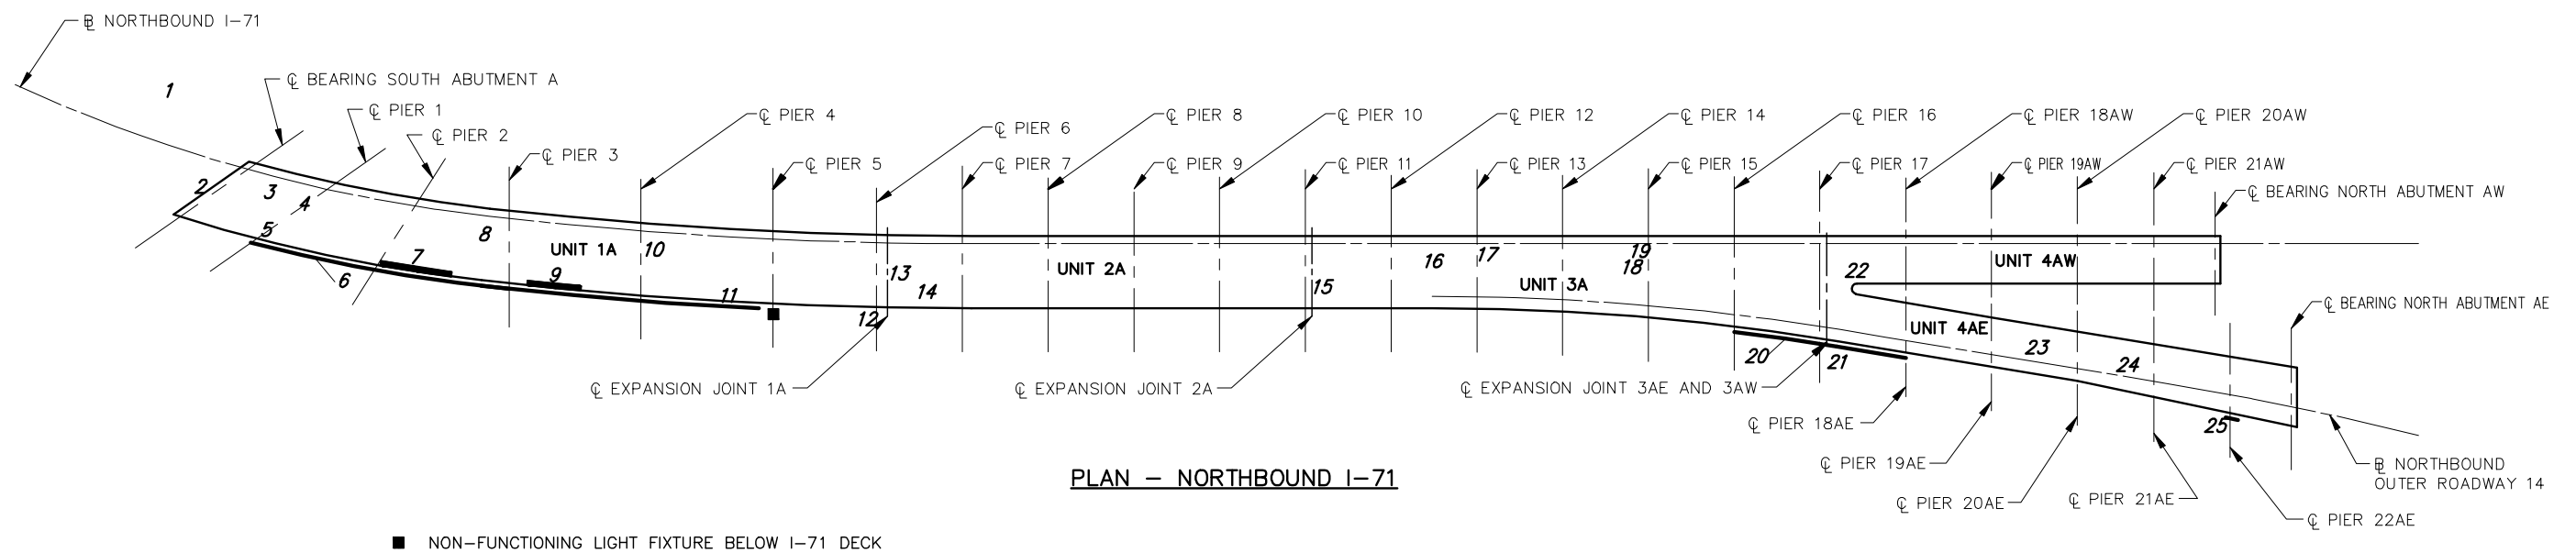
ITEM	DEFICIENCY
1	MEDIAN VEGETATION ENCRDACHING ON DRIVER'S LINE OF SIGHT
2	BEARING F OVEREXPANDED, SOUTH ABUTMENT A
3	15 SF DELAMINATION AND CRACKS TO WEARING SURFACE
4	2 SF SPALL TO WEARING SURFACE
5	BEARING L & N OVEREXPANDED, PIER 1
6	LOOSE CONCRETE OVER TRAFFIC TO PARAPET EXTERIOR, PIER 1 TO PIER 5
7	WATER PONDING ALONG PARAPET INTERIOR
8	DELAMINATION ALONG WEARING SURFACE PATCH
9	WATER PONDING ALONG PARAPET INTERIOR
10	BROKEN WEARING SURFACE PATCH, LANE 2
11	VERTICAL CRACK TO PARAPET
12	CLOGGED DRAIN COLLECTOR AT GROUND LEVEL
13	BROKEN SEAL WELD TO EXPANSION JOINT ARMOR
14	DAMPNESS TO DECK UNDERSIDE
15	LOOSE DRAIN TROUGH BELOW EXPANSION JOINT

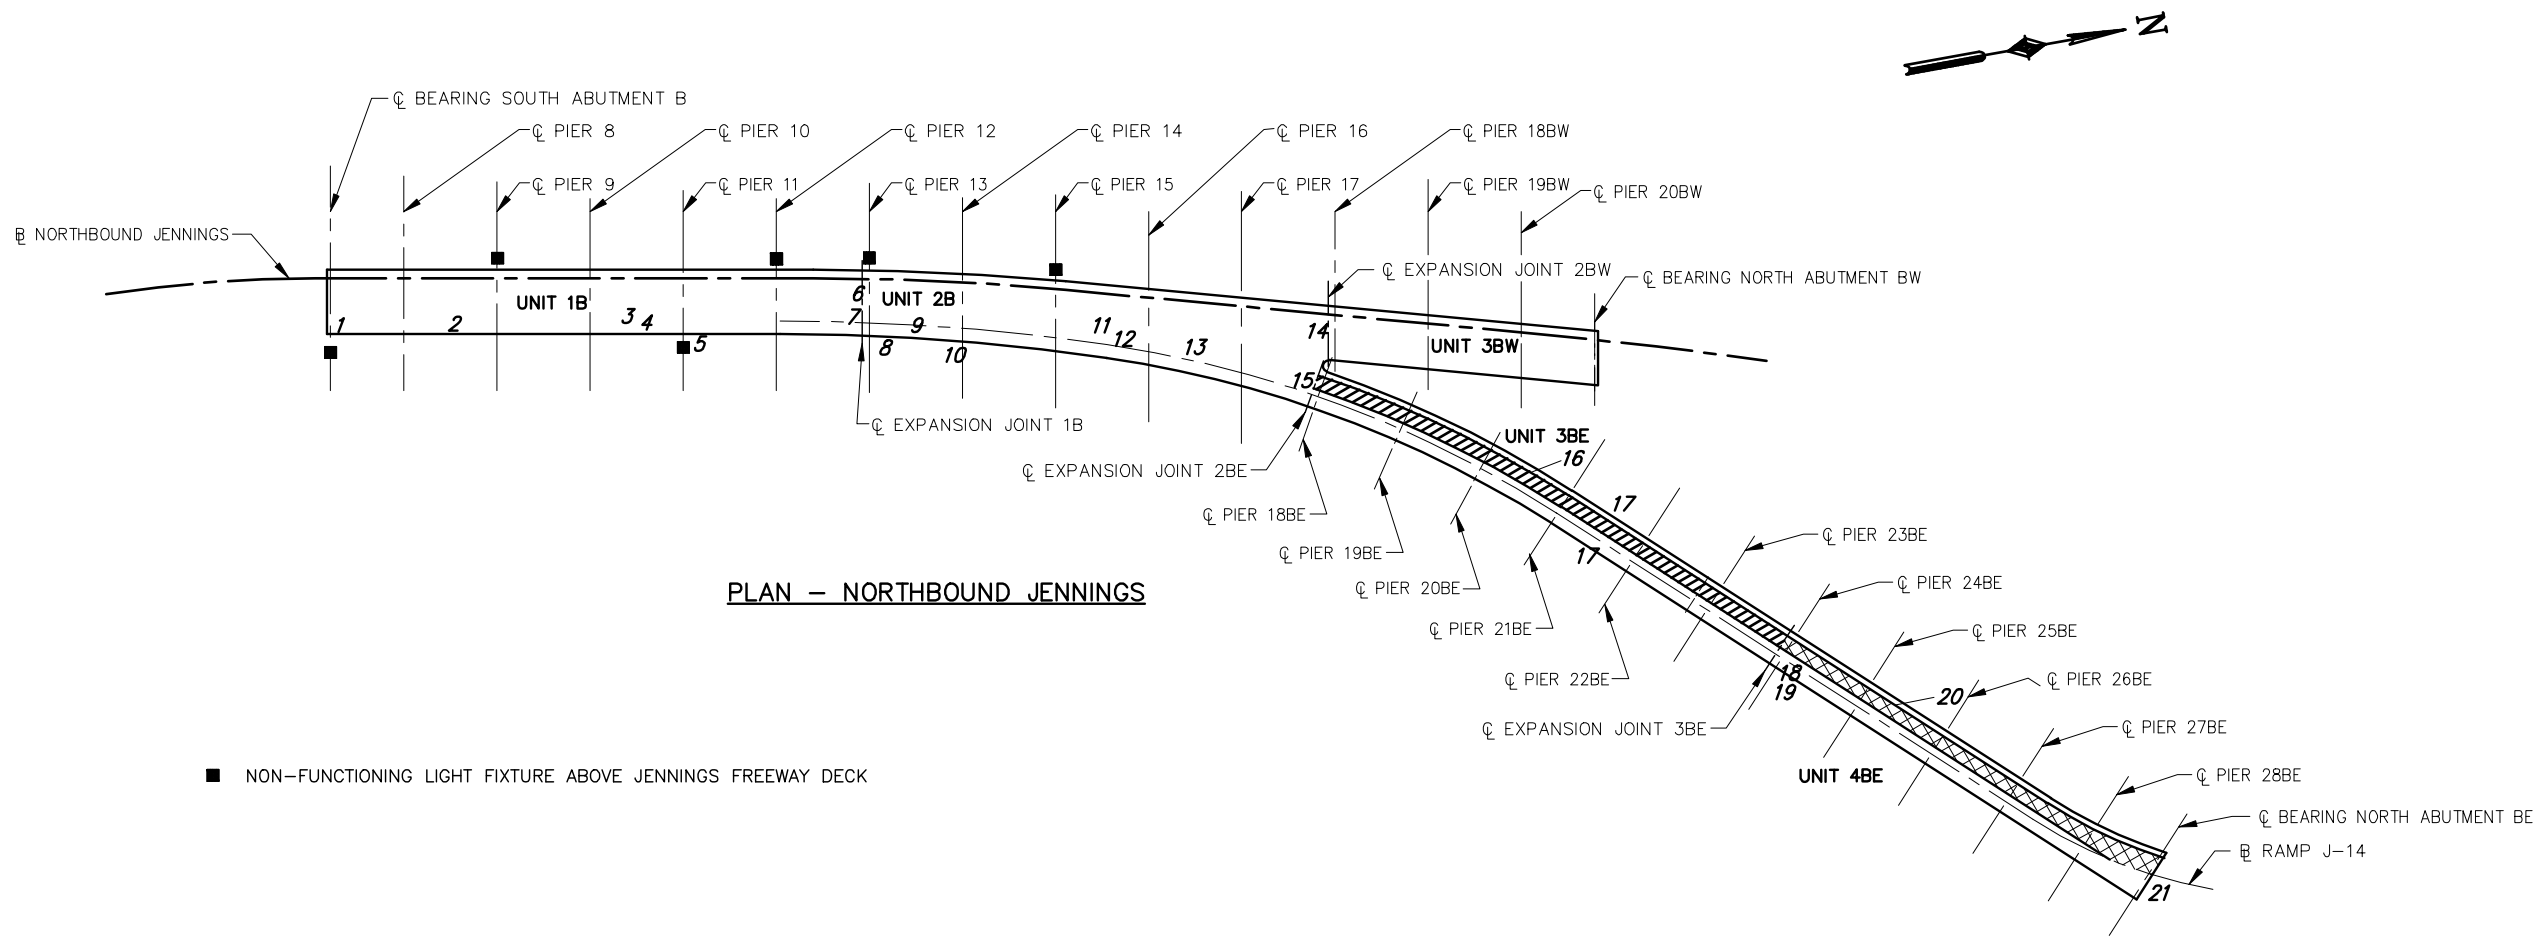
PLAN - NORTHBOUND JENNINGS
