## BRIDGE INSPECTION REPORT

1805436  
Structure File Number

BRIDGE NUMBER CUY 00176 1334

DIST 12 Bridge Type 322 TYPE SERVICE 1 0 IR-71NB (CUY-71-1791R)

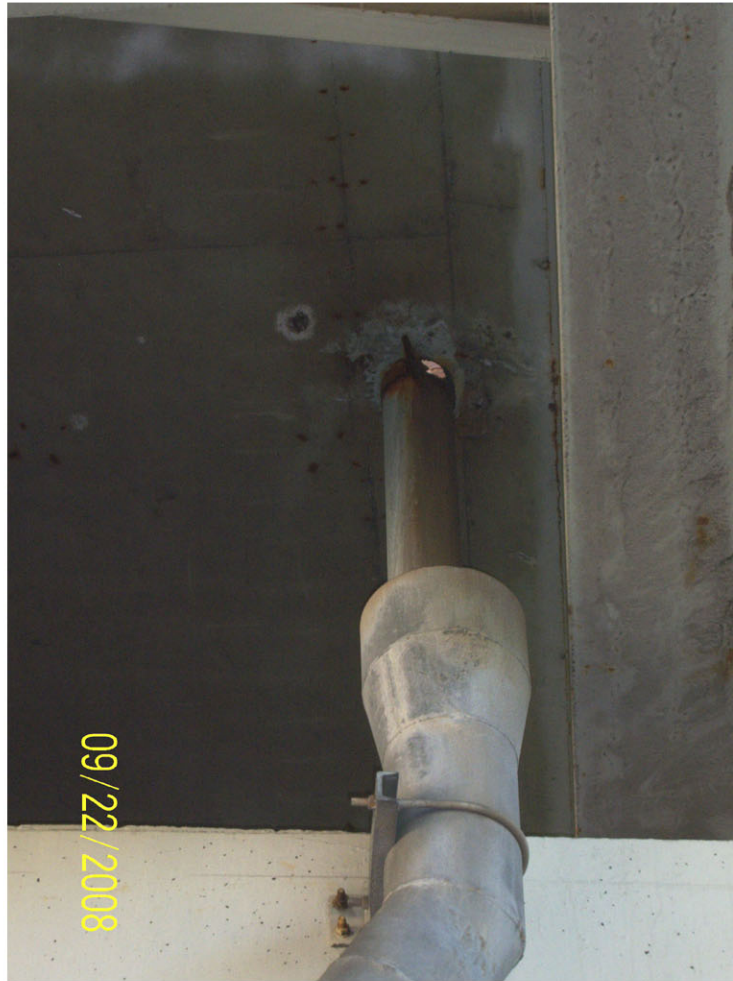
DRAINAGE: RUST THRU HOLES IN DOWNSPOUTS AT START ABUTMENT,  
PIER 15 AND PIER 18 BW. SEE ATTACHED PHOTO DATED  
09/22/08. DOWNSPOUT AT EAST END OF PIER 18 BE IS  
PLUGGED WITH CONCRETE AT GROUND.

Thru Hole in downspout at Pier 18 AW.JPG
