BRIDGE INSPECTION REPORT

1805436
Structure File Number

BRIDGE NUMBER CUY 00176 1334

DIST 12 Bridge Type 322 TYPE SERVICE 1 0 IR-71NB (CUY-71-1791R)

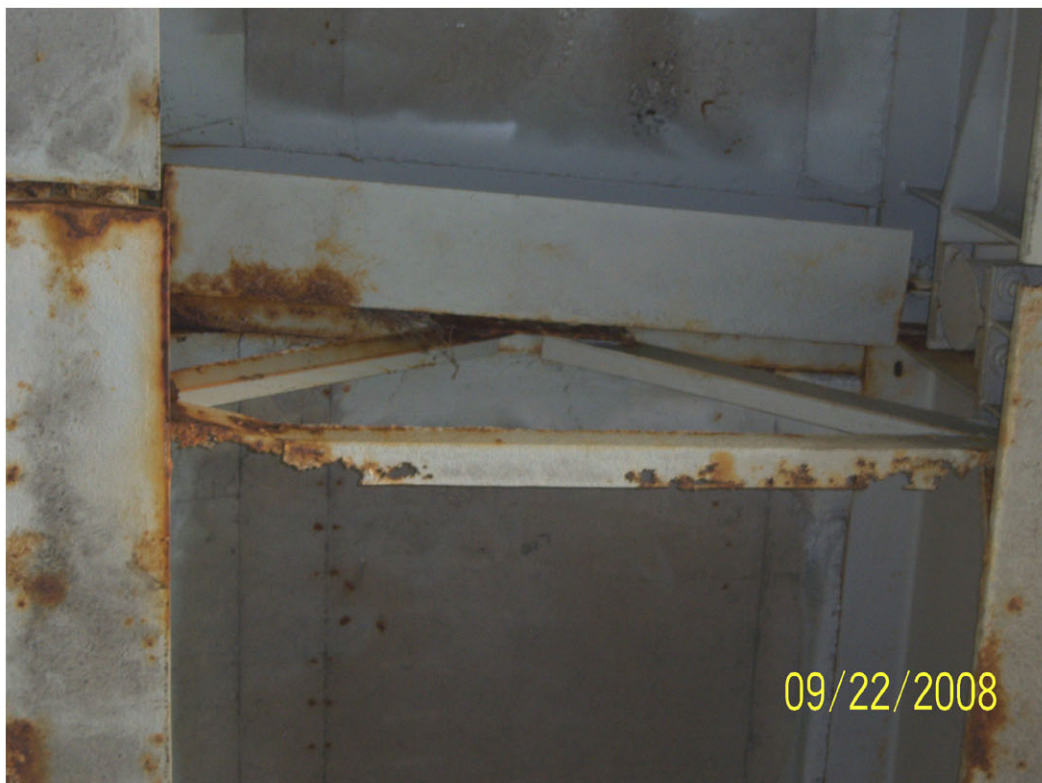
XFRAMES: RUST THRU HOLES UNDER INTERMEDIATE EXPANSION JOINTS
AND IN BAY 1 AT FINISH (NORTH) MAINLINE ABUTMENT.
SEE ATTACHED PHOTO DATED 09/22/08.

Thru holes in xframe at Intermediate Expansion 2 BW.JPG
