2012 In-Depth Inspection Report

I-71/SR 176 Double Decked Bridge – (SR 176 Lower Deck)

**CUY-00176-1334
(SFN 1805436)**

Inspection Dates: 07/30/2012 to 08/10/2012

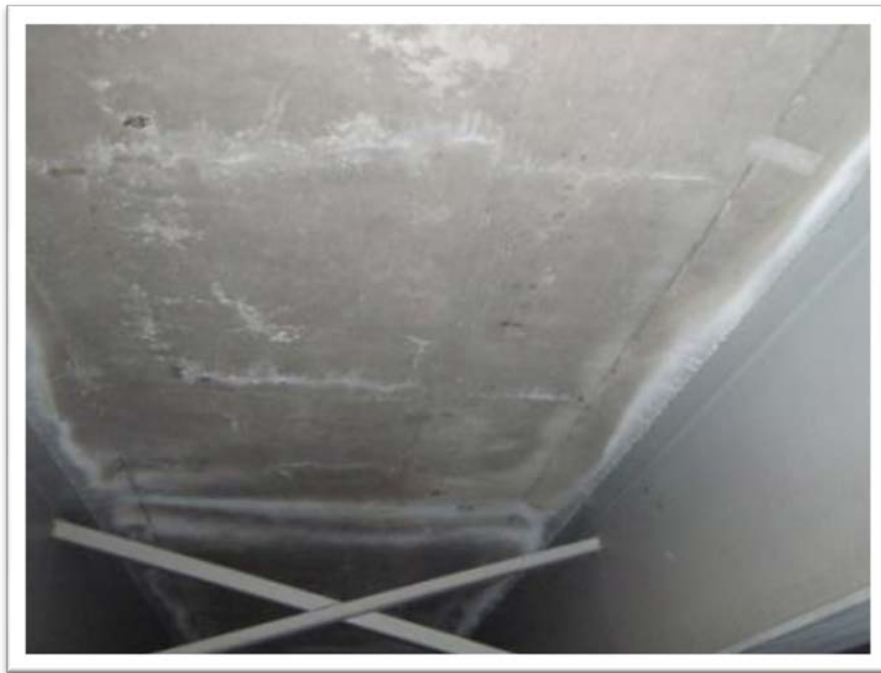
- There is hairline to narrow transverse cracking in Ramps BW and BE. Efflorescence is typical.

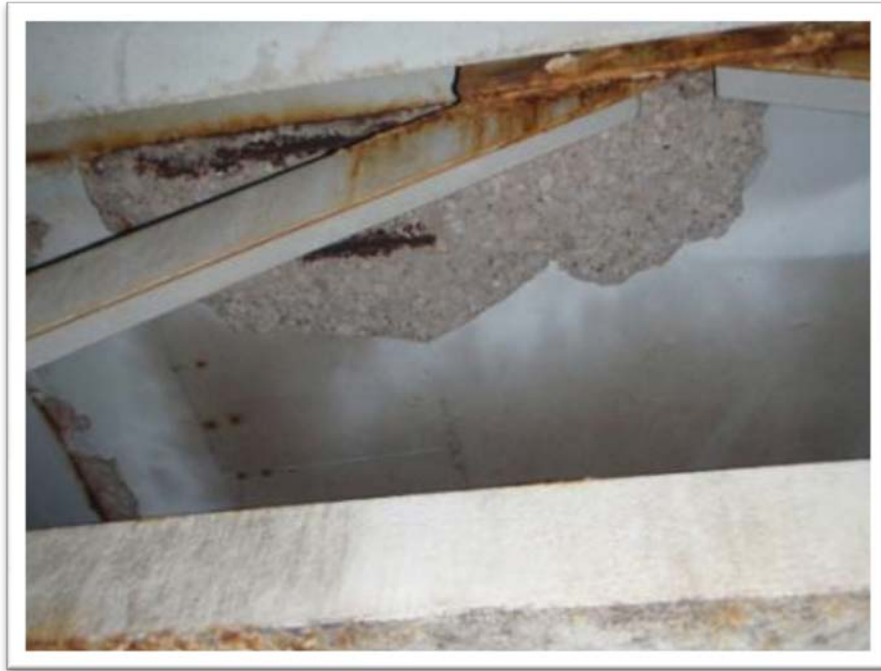
- One 10” diameter area of honeycombing in Span 14.
- Map cracking exists in Spans 24BE and 25BE.

- Spalling exists in Spans 11, 13, 14, 17, 18BW, 18BE, 22BE, 24BE, and 28BE.

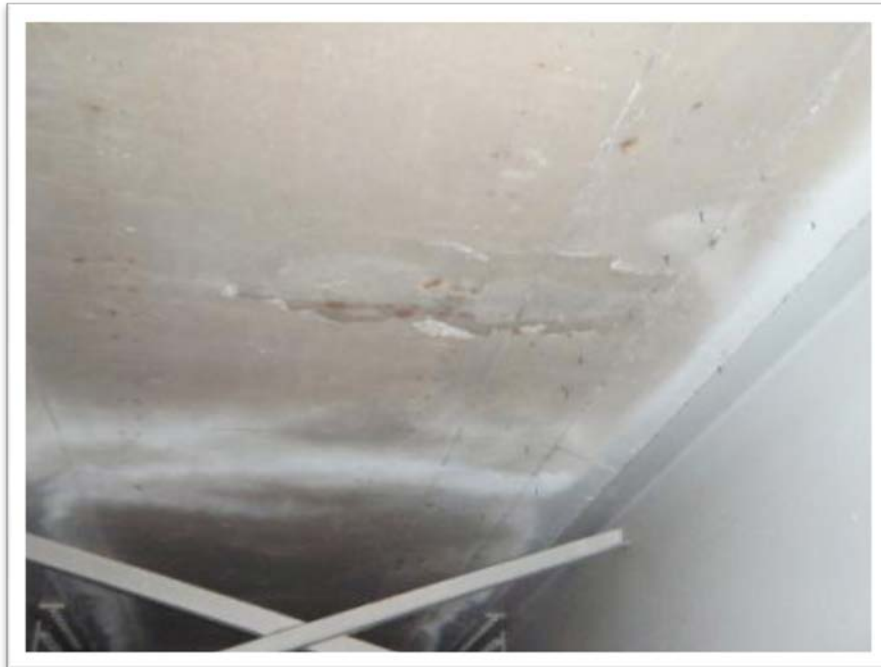
- Delaminations exist in Spans 17, 19BE, 20BE, 23BE, 24BE, 25BE, 26BE, and 27BE.

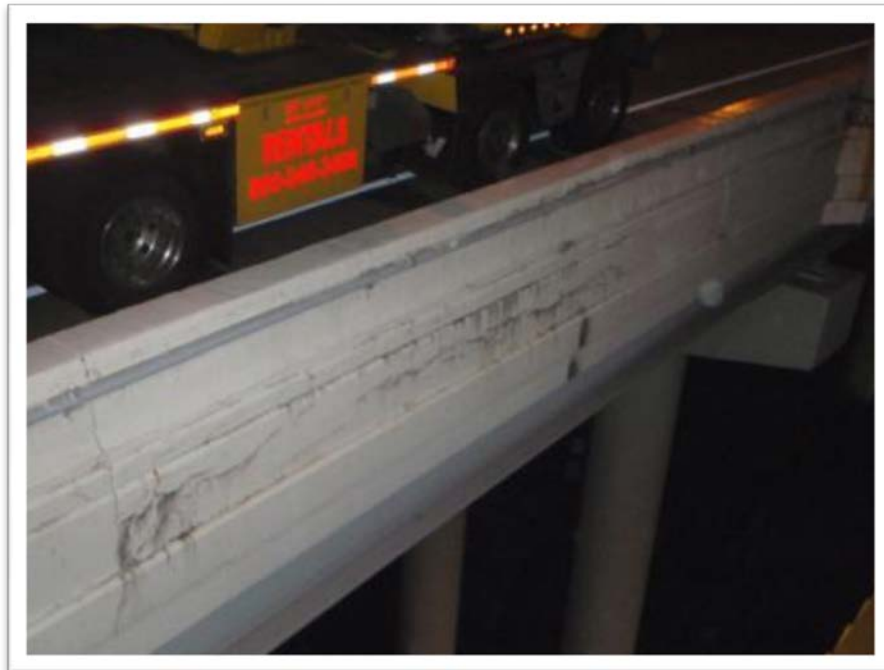
- Spalls and deteriorations exist along the large portions of the toe of the barrier, especially on the low (east) side of the structure.
- Random vertical cracks exist in both barriers.
- Longitudinal cracking with efflorescence in the rail's exterior face in Span 19BE.

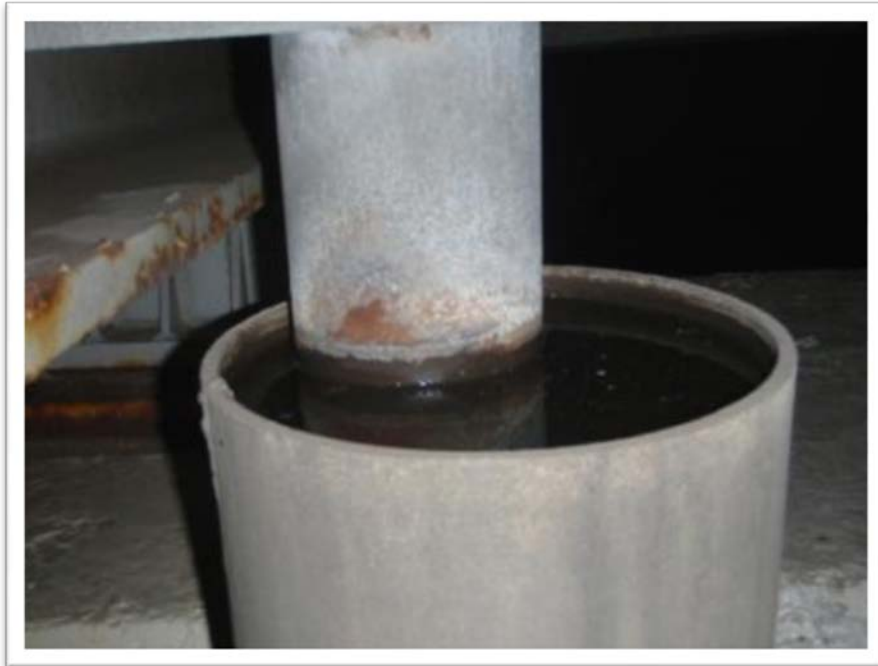
- The drains at Piers 16 and 18BE are clogged with debris and water is not draining properly.
- The scupper pans in the top of the deck are clogged with debris in most locations. See Appendix C for details.
- Drains are clogged at the following locations.
 - ♦ Span 16, near Pier 16
 - ♦ Span 19BE, near Pier 18BE

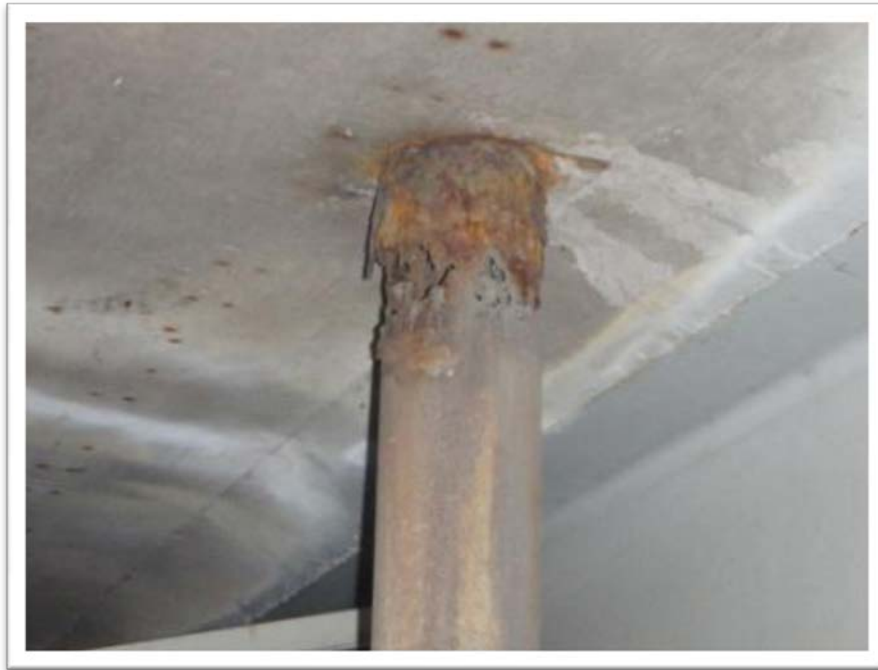
- Corroded downspout with section loss in Span 25BE near Pier 24BE.

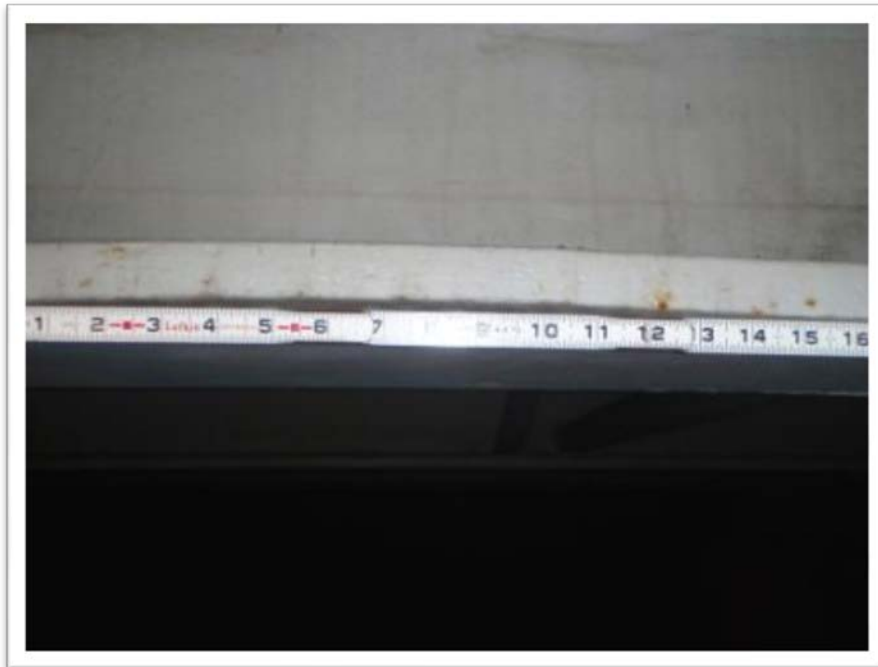
- Bottom flange of beam bent at the following locations
 - ♦ Beam D (Span 16) – 1/8” over a 1’-0” length.

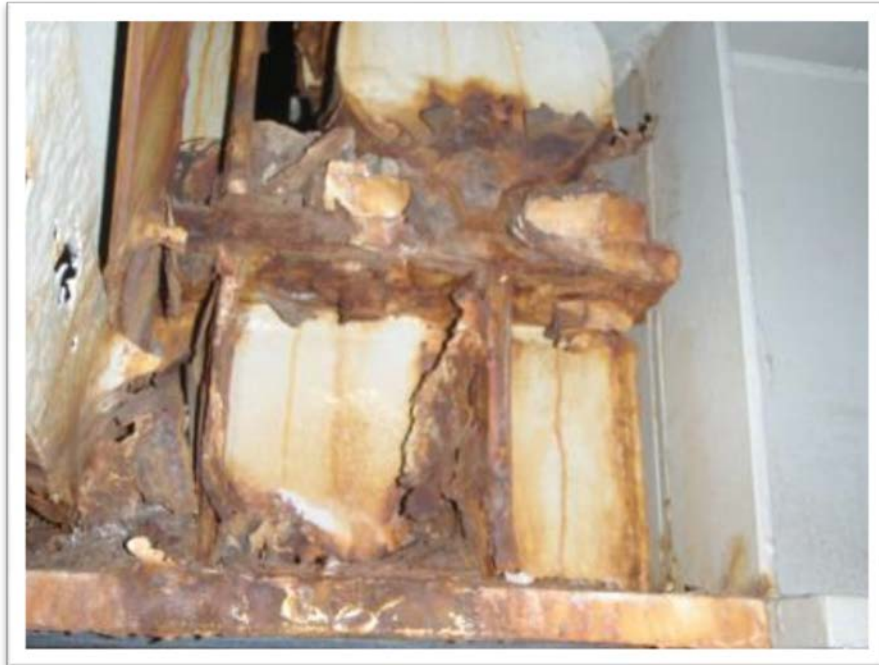
- Light surface corrosion with isolated locations of moderate corrosion on the web and flanges, specifically the bottom flange.
- Surface corrosion at the seated hinges with up to 1/16" section loss.

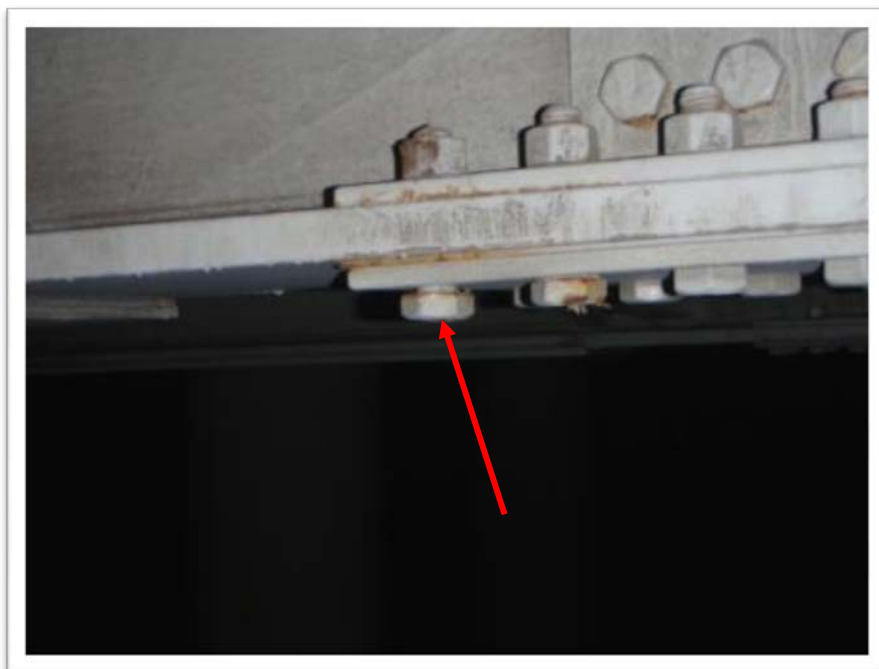
- There is a loose bolt in the bottom cover plate of the splice in Span 18BW, Beam C.

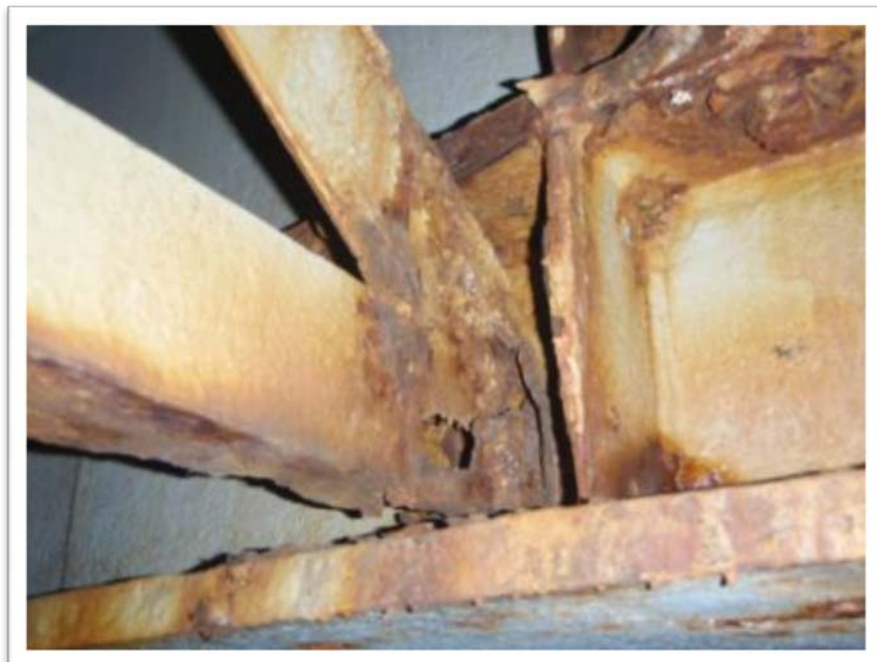
- Corrosion holes exist at the following locations.
 - ♦ Beam F between Beams E & F in Span 18BW.
 - ♦ Beam L between Beams F & L in Span 13.

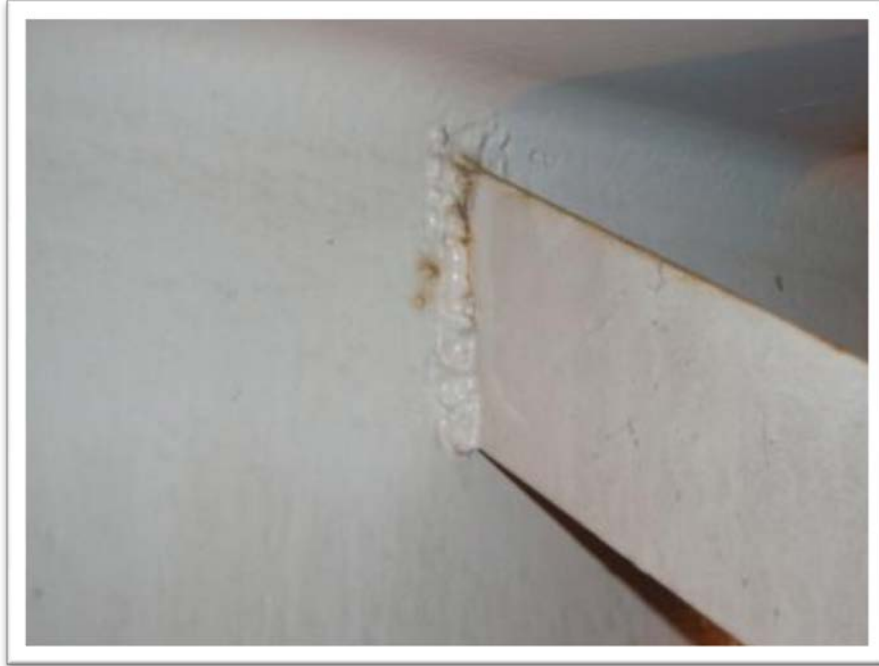
- There are angles welded to the ends of the crossbracing in order to lengthen them in Span 14 and others.
- A paint crack exists in the weld where the crossbracing is attached to the web of Beam L in Span 15. Monitor this location.

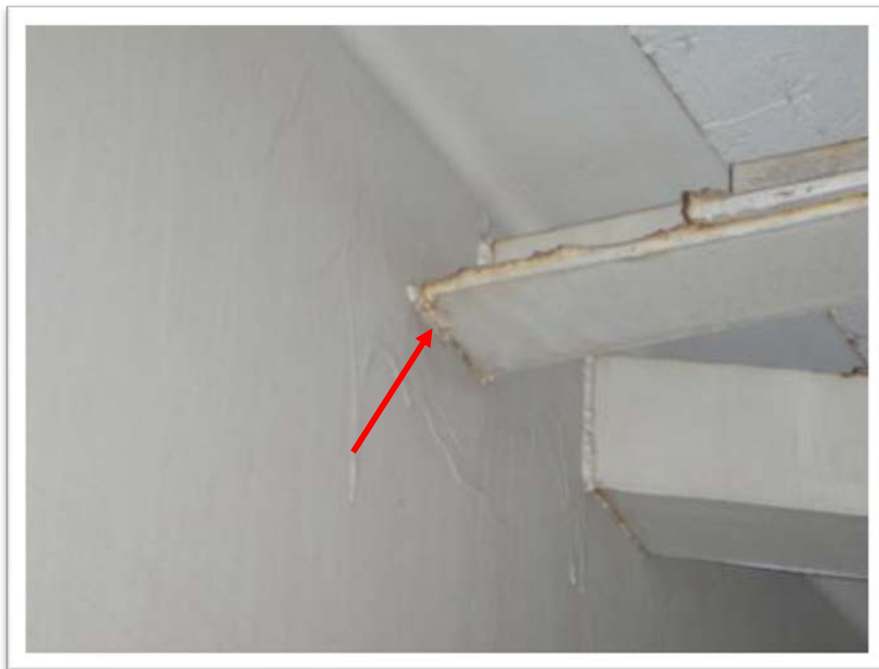
- Surface corrosion exists at various locations. Section loss in Span 18BW at seated hinges.
- There is an incomplete weld with gaps in Beam A in Span 15.

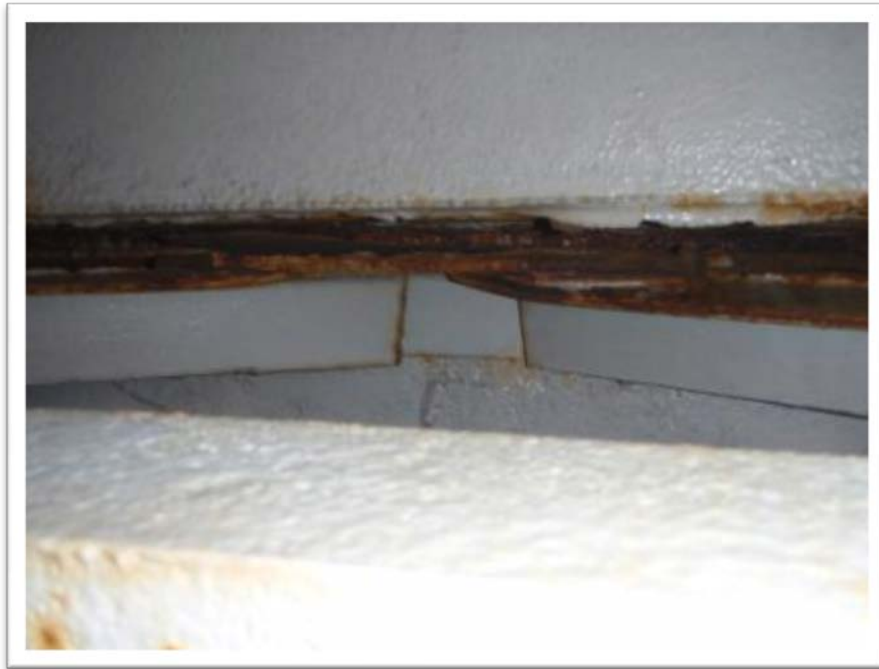
- Pack rust and 1" bowing exists at the top gusset plate in Span 18BW.

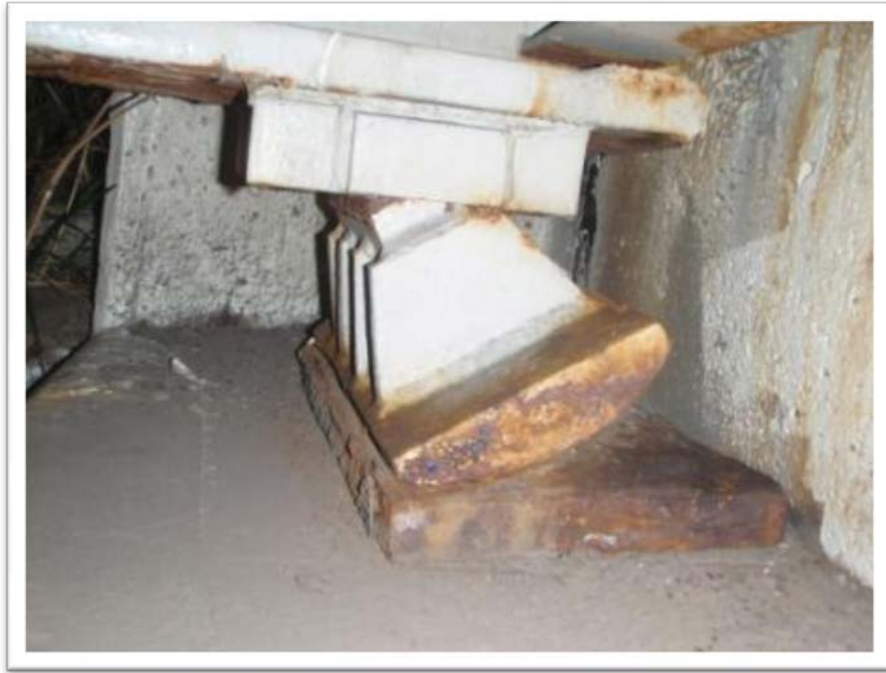
- Surface corrosion is typical. The exterior bearings show a moderate amount of corrosion.
- Six bearings are rocked $\geq 10^\circ$.
 - ♦ South Abut 10°S Bearing F
 - ♦ South Abut 10°N Bearing L
 - ♦ North Abut BW 17°N Bearing E
 - ♦ Pier 28BE 10°S Bearing L
 - ♦ North Abut BE 32°S Bearing G
 - ♦ North Abut BE 15°S Bearing J

- One bearing is rocked beyond recall (Horizontal Distance > $\frac{1}{3}$ H).
 - ♦ North Abut BE 32°S Bearing G

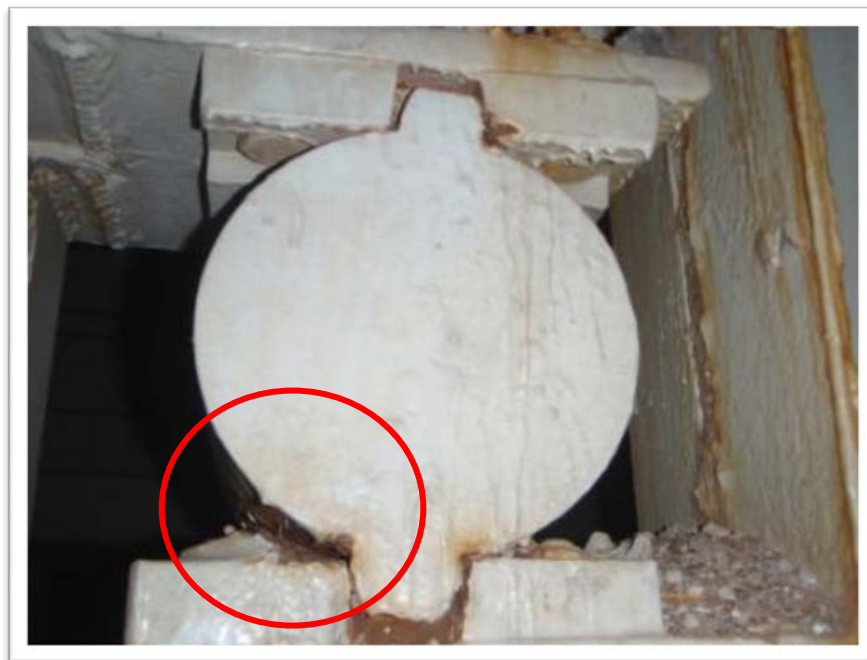
- Surface corrosion. Heavier corrosion at the groove.

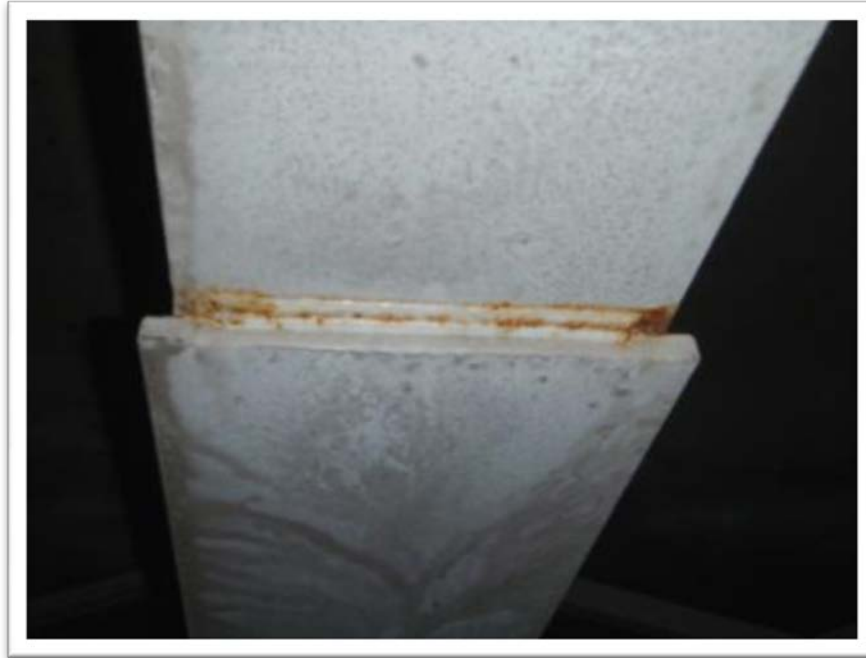
- Surface corrosion on the intersecting welds under the seated hinge.
- Surface corrosion on the welds along the bottom cover plate and at the ends.

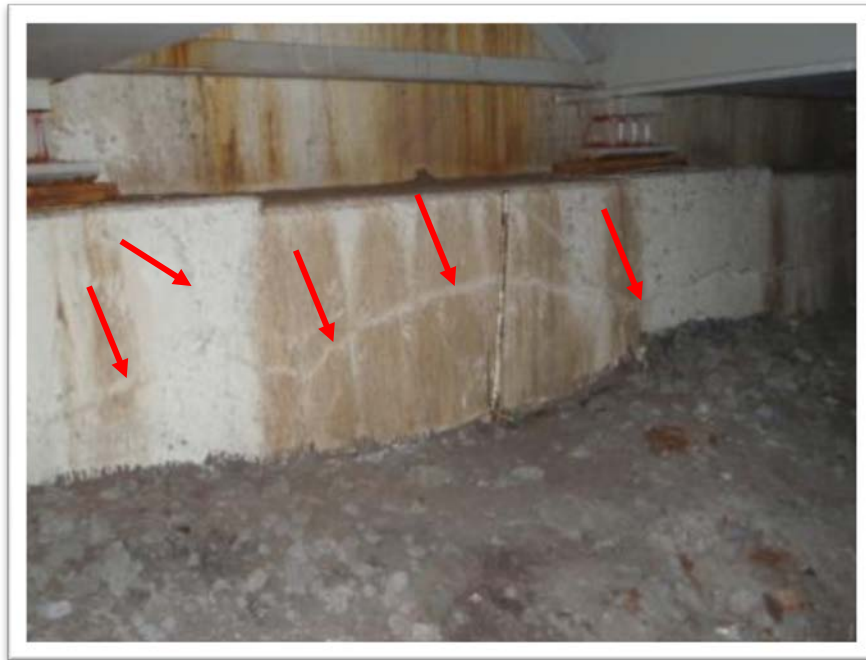
- North Abutment AE – Rust staining is evident on the breastwall.
- North Abutment BE – Some rust staining is evident on the breastwall.
- North Abutment BW – Map cracking on the breastwall.

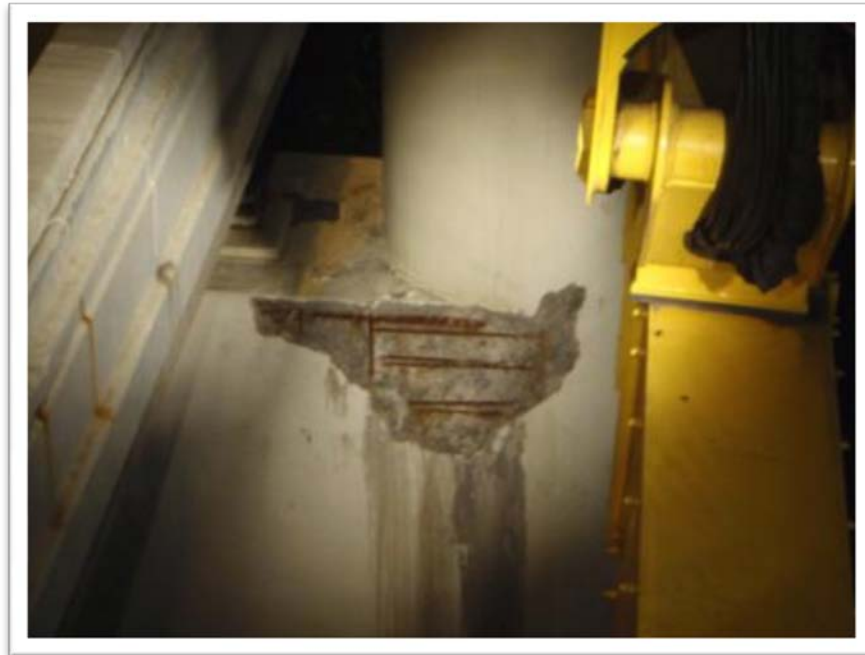
- Pier 8 – The pier cap has multiple cracks. The west side of the south face has cracking with a delamination. The east side of the south face has a 4' x 3' spall with exposed rebar. The east side of the north face has hairline cracking with a delamination.

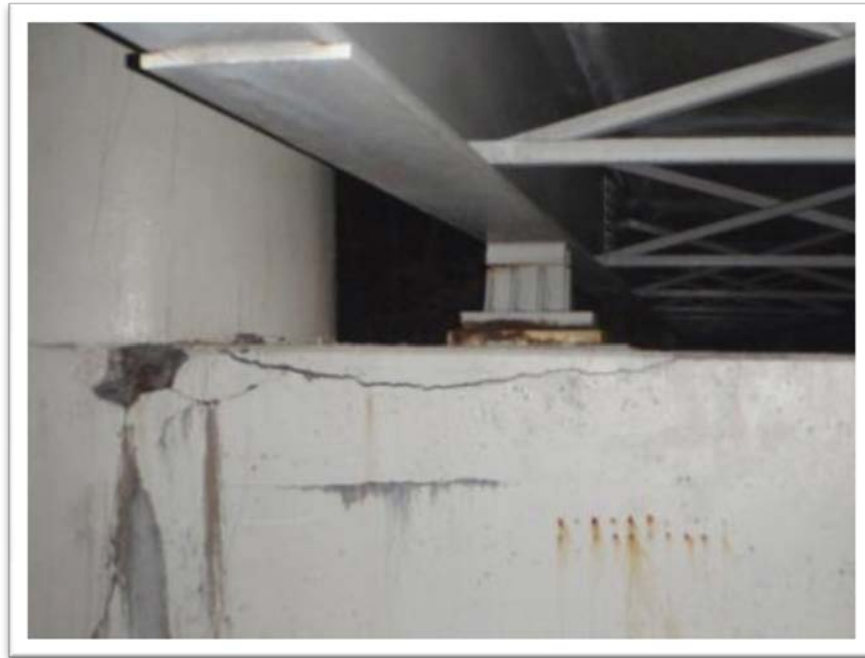
- Pier 9 – The pier cap has multiple cracks with some rust spots and a small delamination. There is a 5' horizontal crack with a delamination under Bearing A along with a 10" x 10" spall.

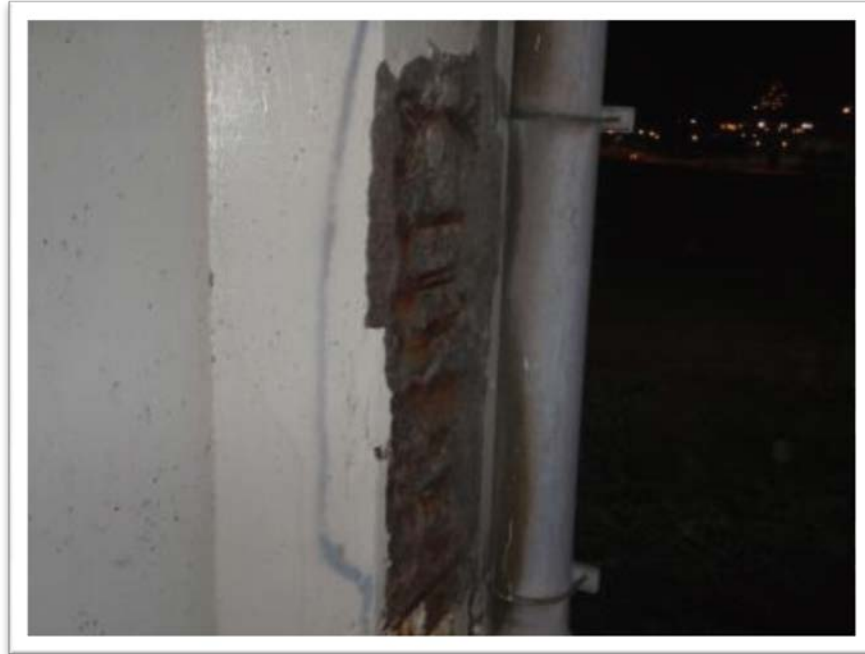
- Pier 14 – The pier cap has hairline cracking. The north side of the east column has multiple spalls with exposed rebar. The south side of the east column has three large spalls with exposed rebar; 5' x 2 ½', 4' x 2 ½', and 3 ½' x 2'.

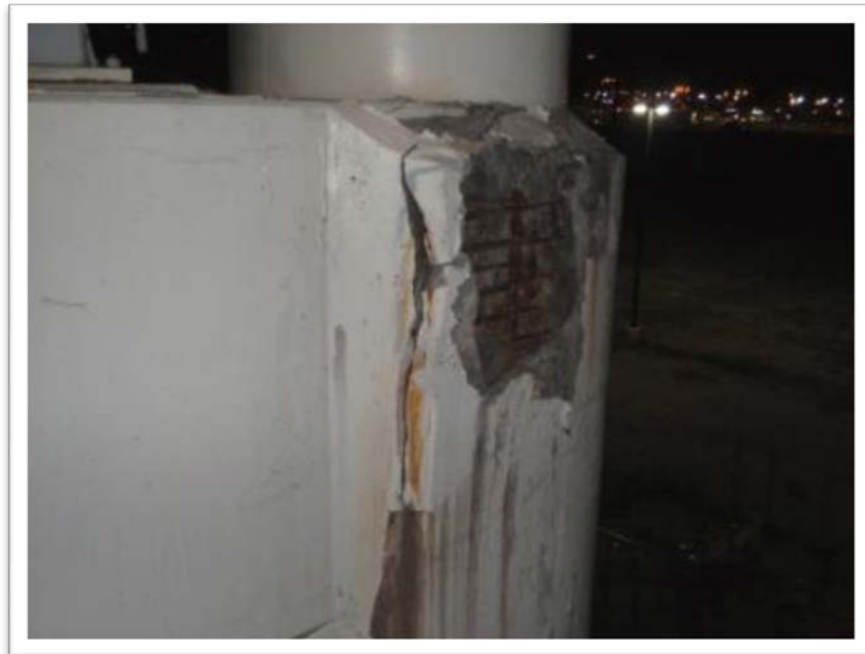
- Pier 15 – The pier cap has multiple cracks. The east side of the north face has a 3' x 2' and a 2' x 1' spall with exposed rebar. The east side of the south face has a 5' x 4' spall with exposed rebar and 4' x 2' and 3' x 1' delaminations. A 2' x 4" spall exists on the south wall.

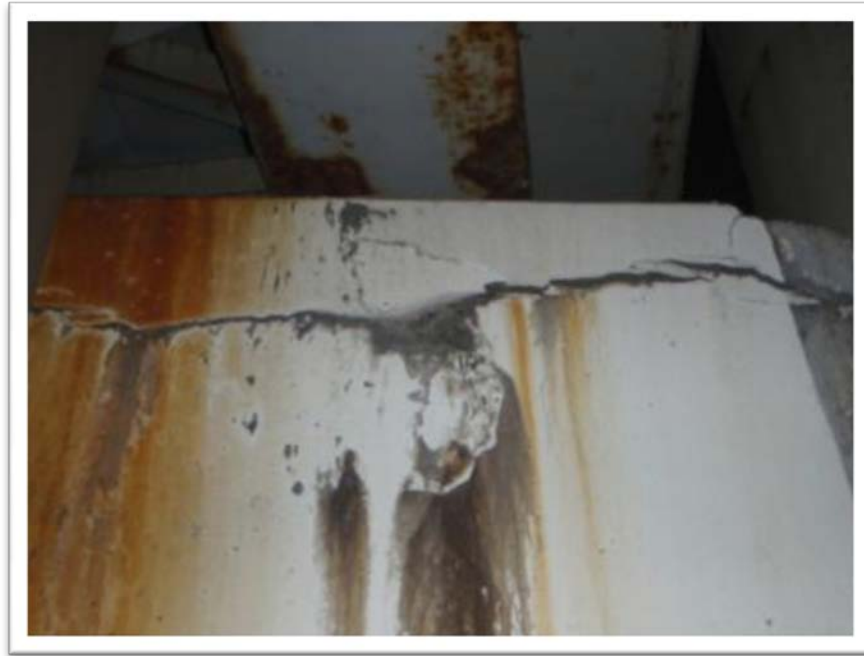
- Pier 16 – The pier cap has multiple cracks. There are two spalls on the east side of the south face, 3' x 2' and 2 ½' x 1'. The area below Beams K and L is delaminated.

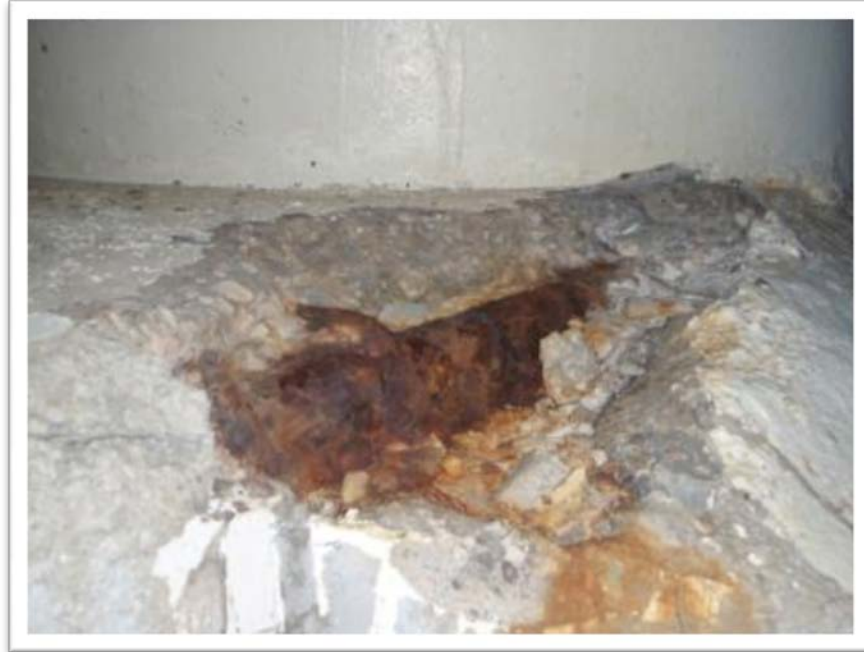
- There are multiple areas along the pier seat edge that are cracking or have delaminations.
- There is a 3' x 2' spall with exposed steel on the pier seat at Pier 16.

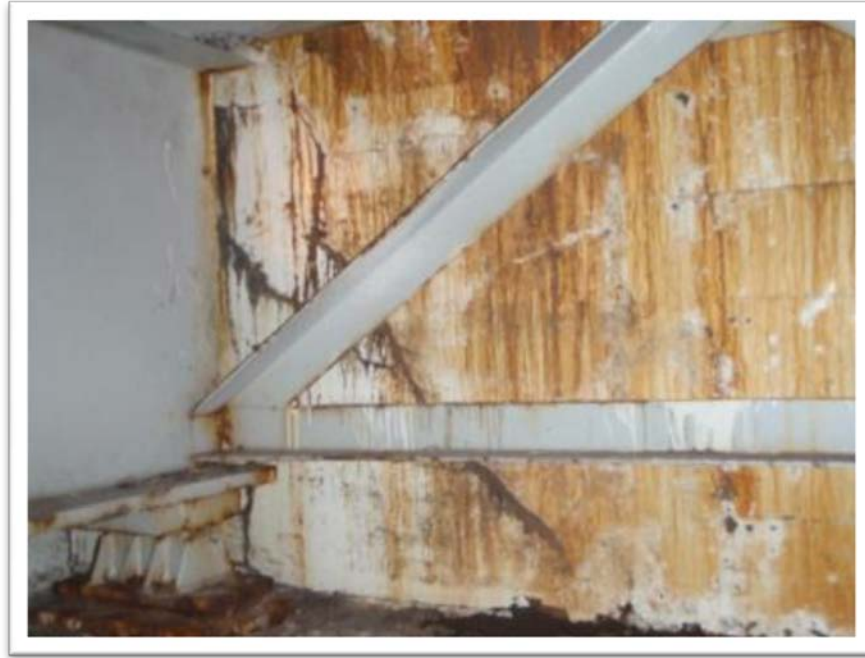
- North Abutment BW – Map cracking in the backwall.

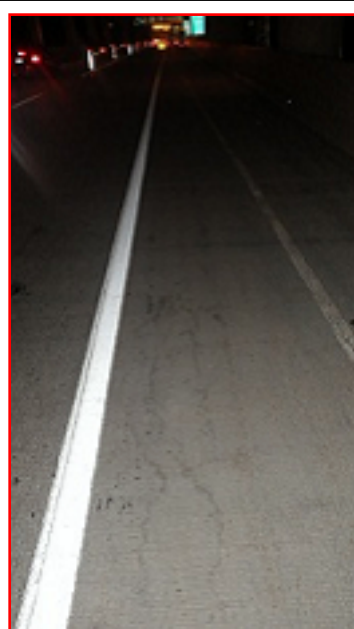
Longitudinal cracking in right shoulder.

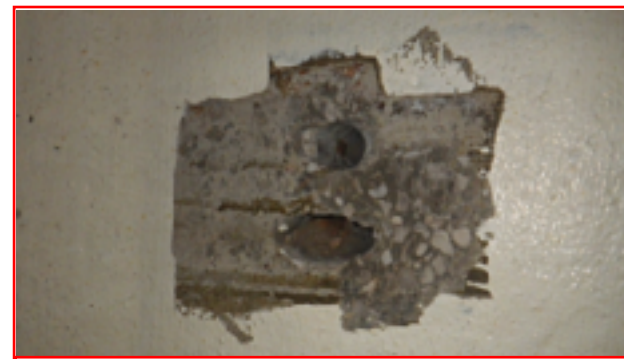
Two holes drilled through barrier.

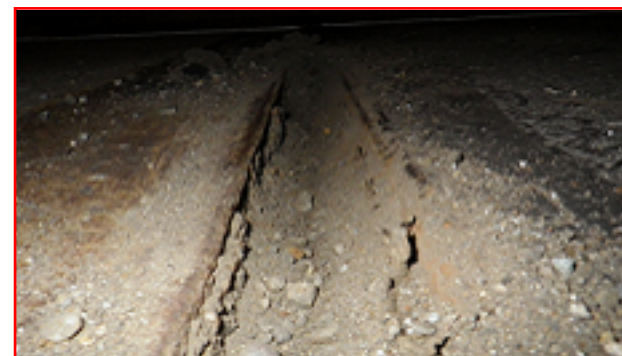
Elastomeric sealer missing from right portion of abutment joint.

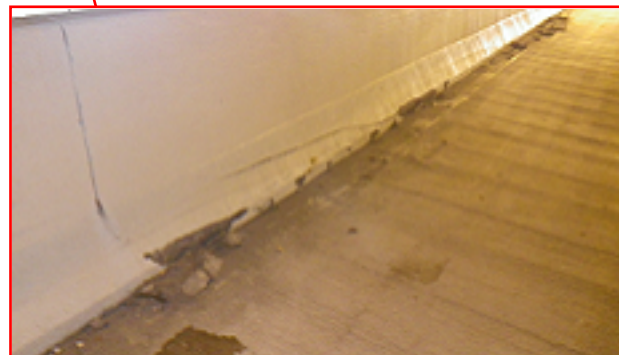
Typical spall at toe of barrier.

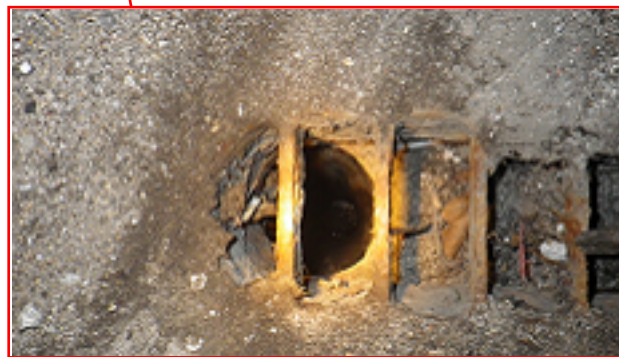
Typical clogged drain.

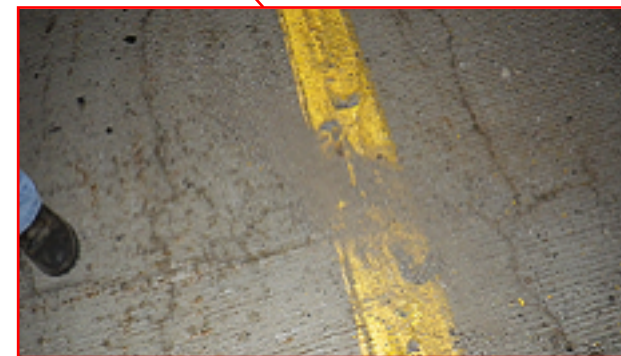
Typical RPM missing.
