**OHIO DEPARTMENT OF TRANSPORTATION  
2014 PHYSICAL CONDITION REPORT**

**SR 176 NB UNDER I-71 NB  
BRIDGE NO. CUY-176-1334**

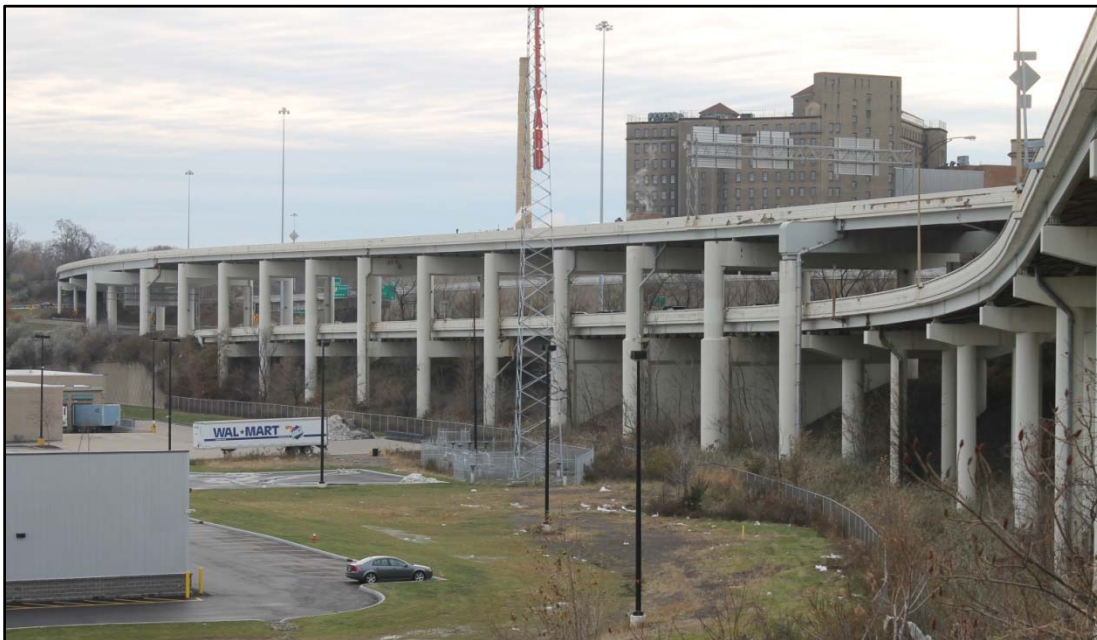
**Photo 1– SR 176 Bridge East Elevation.**

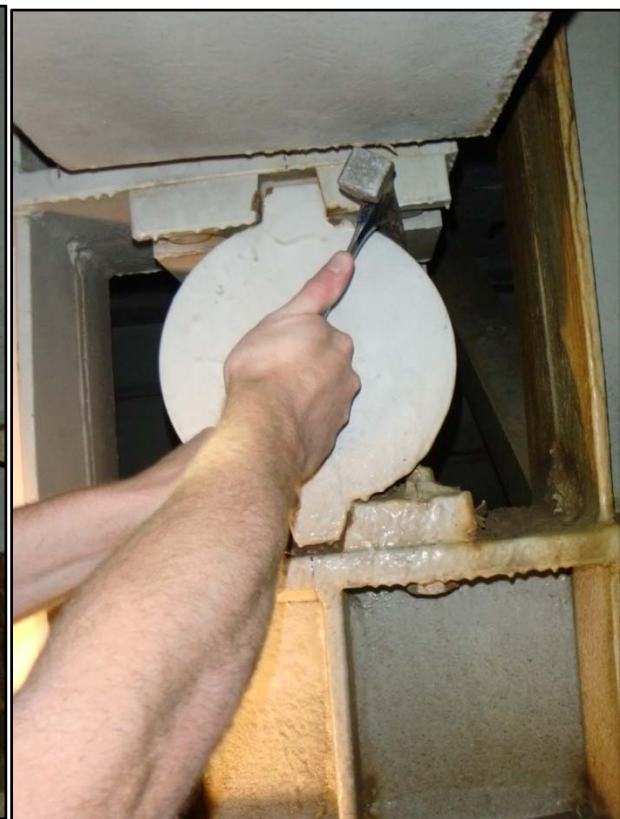
**Photo 4 – Prying Action for Hinge Bearing Check.**

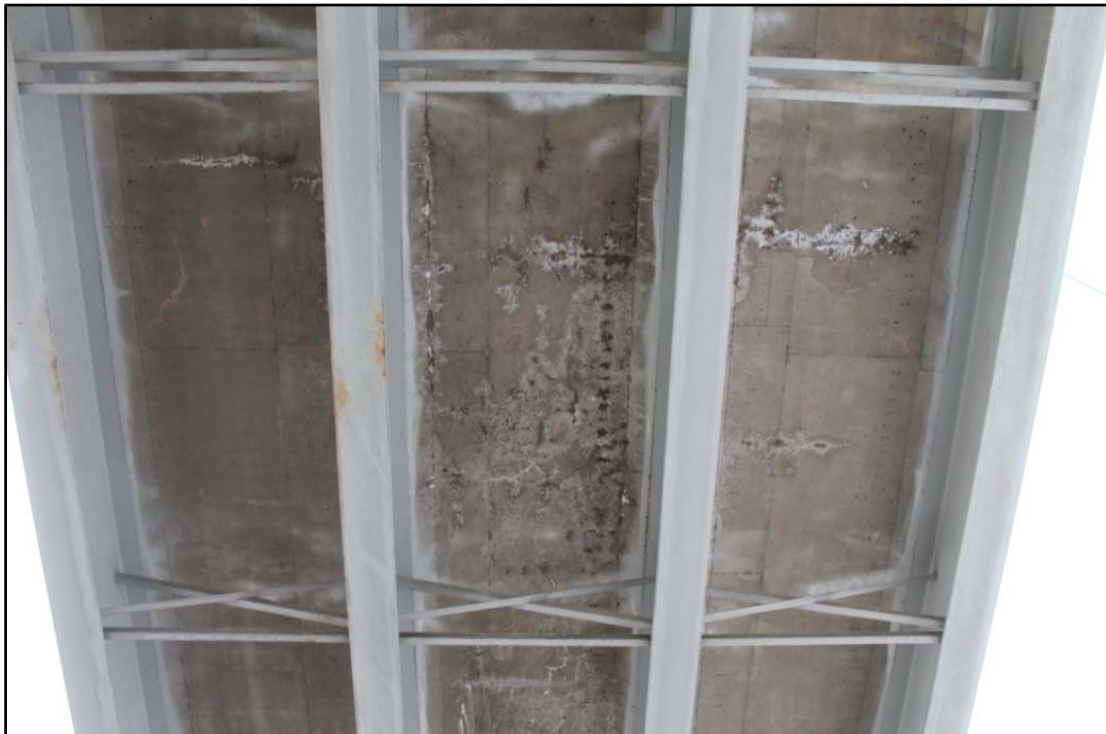
**Photo 5 – Mottled Floor Soffit with Efflorescence.**

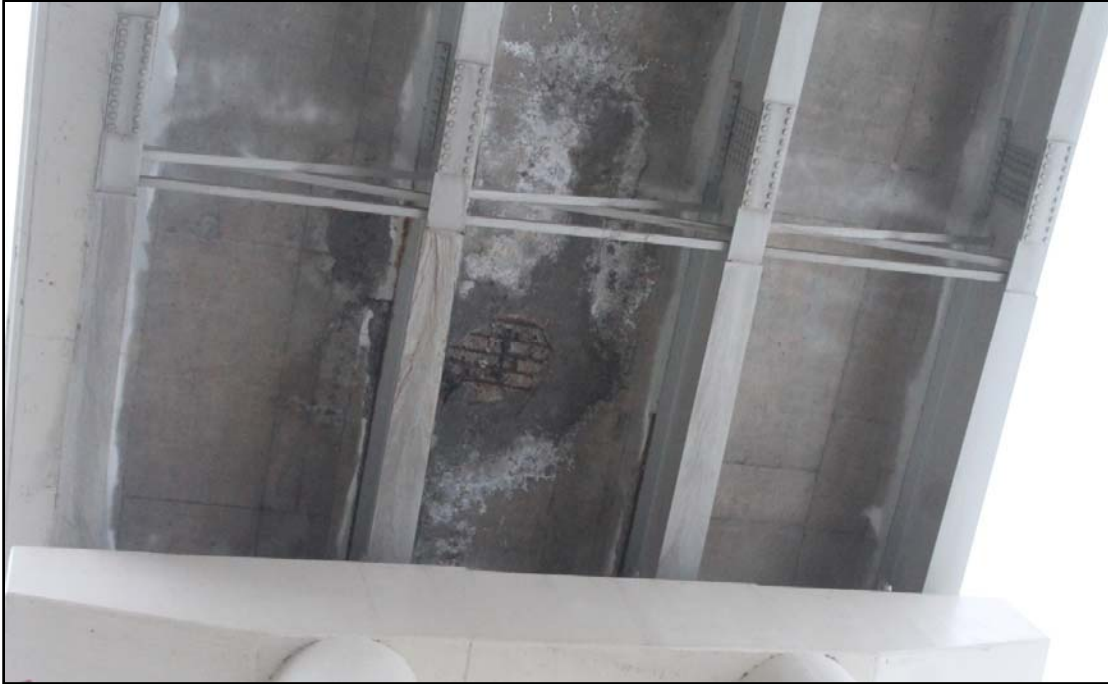
**Photo 6 – Floor Spall, Span BE.**

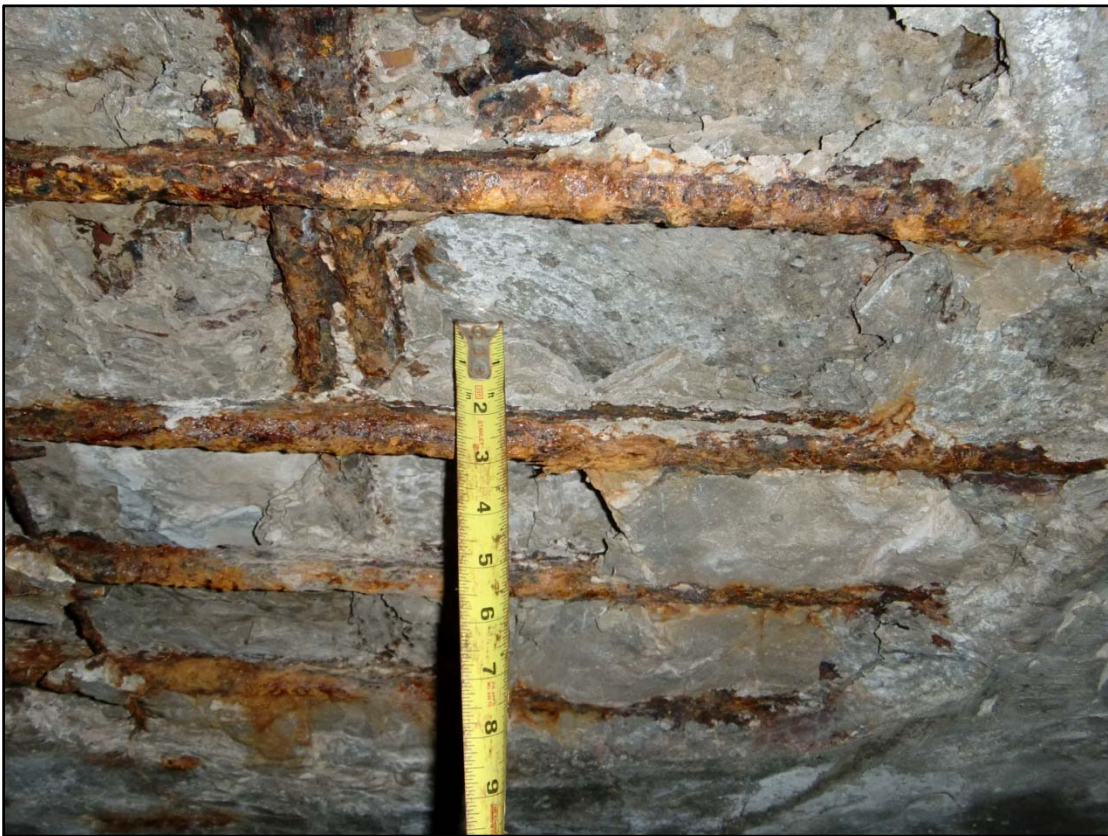
**Photo 7 – Four-Inch Deep Floor Spall Close-Up with Primary Reinforcement Section Loss, Span 21BE.**

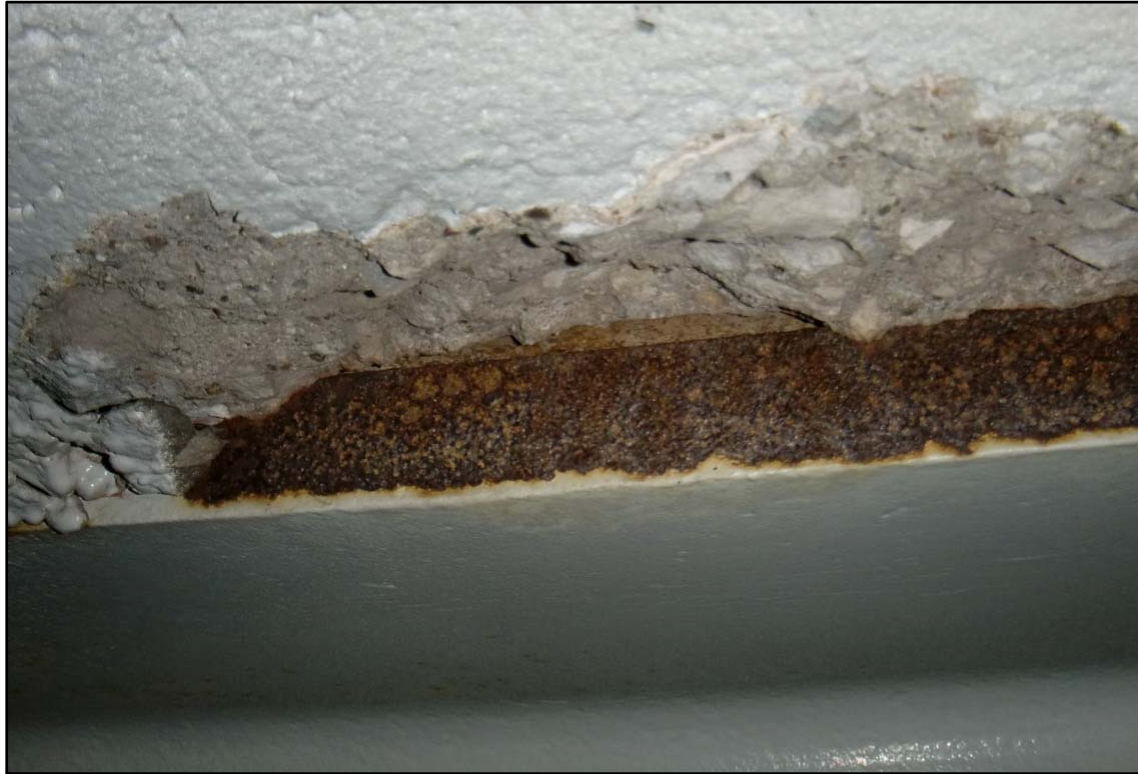
**Photo 7 – 1/4 -Inch Haunch Separation at Beam E, Span 18.**

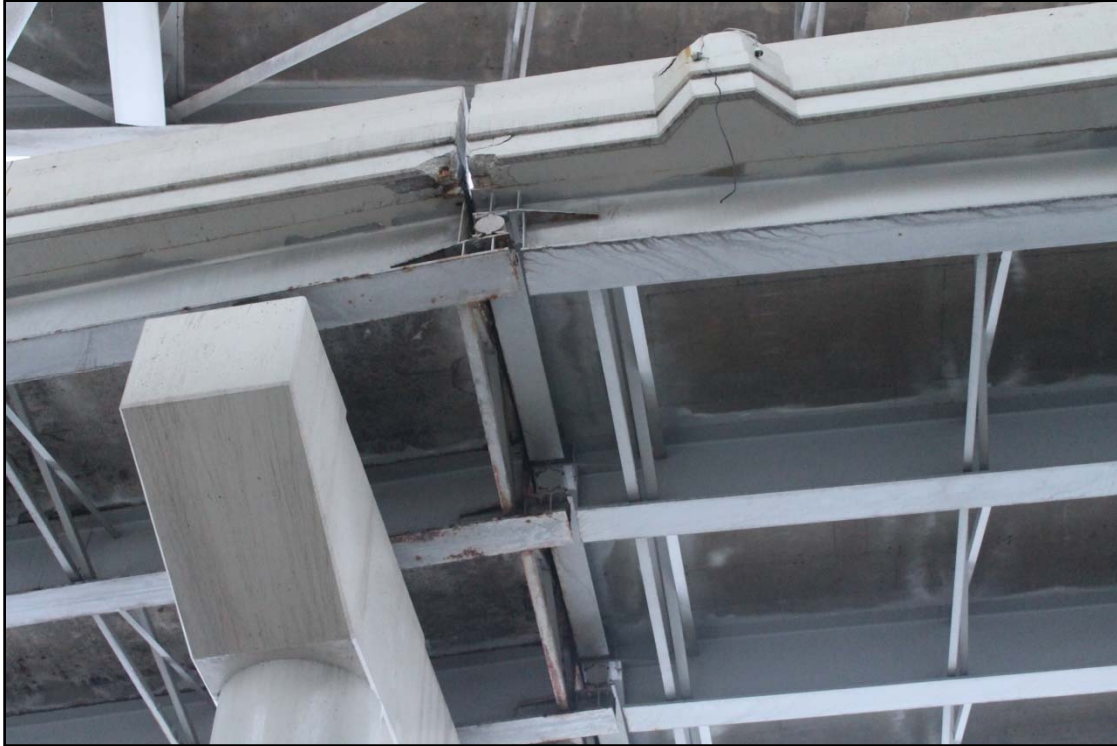
**Photo 8 – Edge of Floor Slabs at Expansion Joint 2BW.**

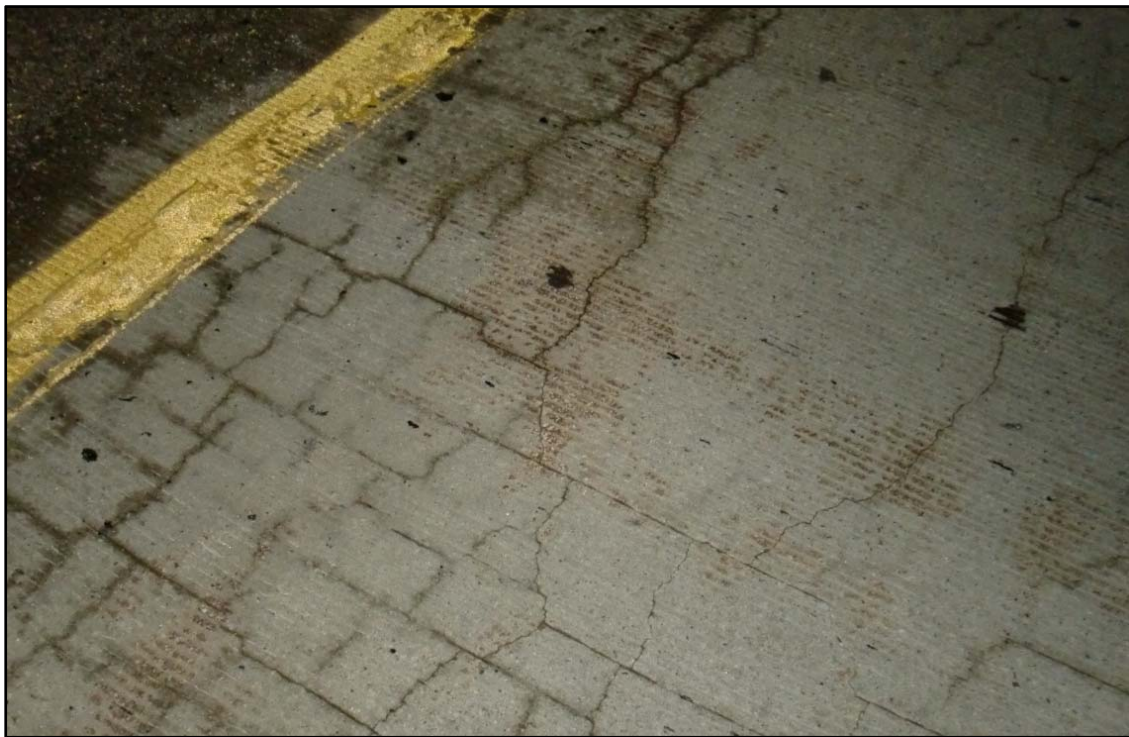
**Photo 9 – Map Cracking, Unit 4BE.**

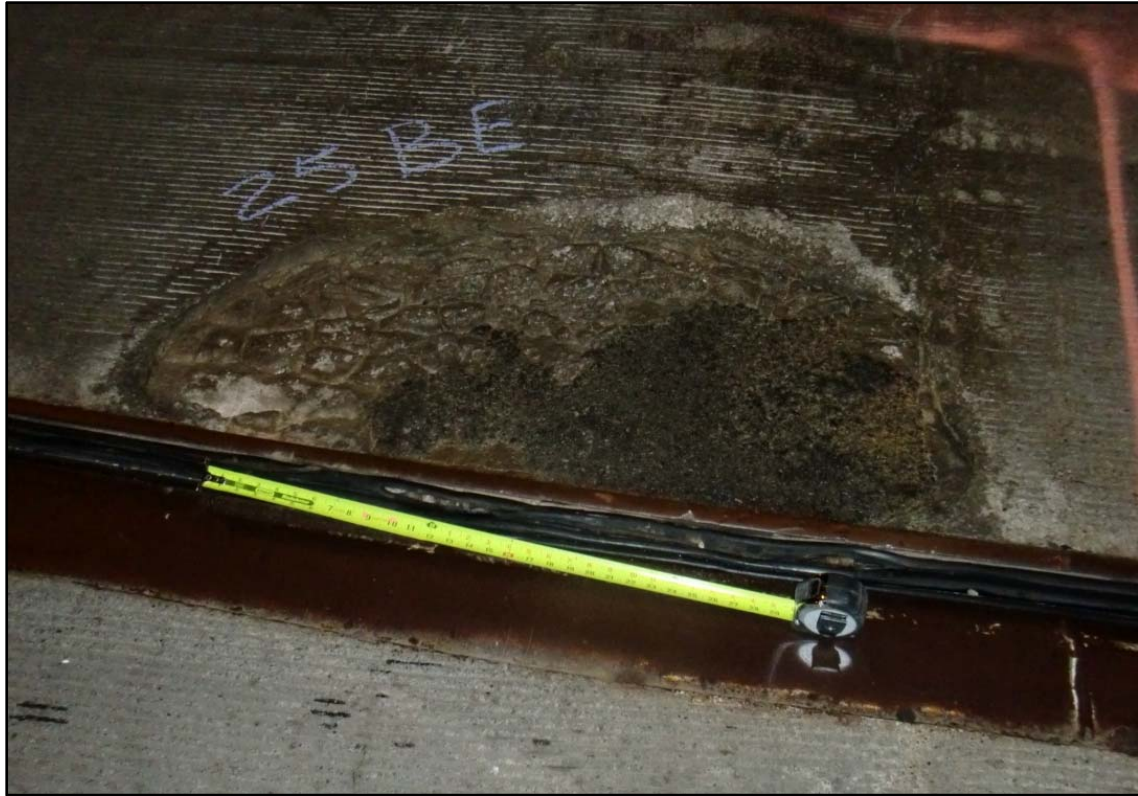
Photo 10 – Wearing Surface Patch, Span 25BE.

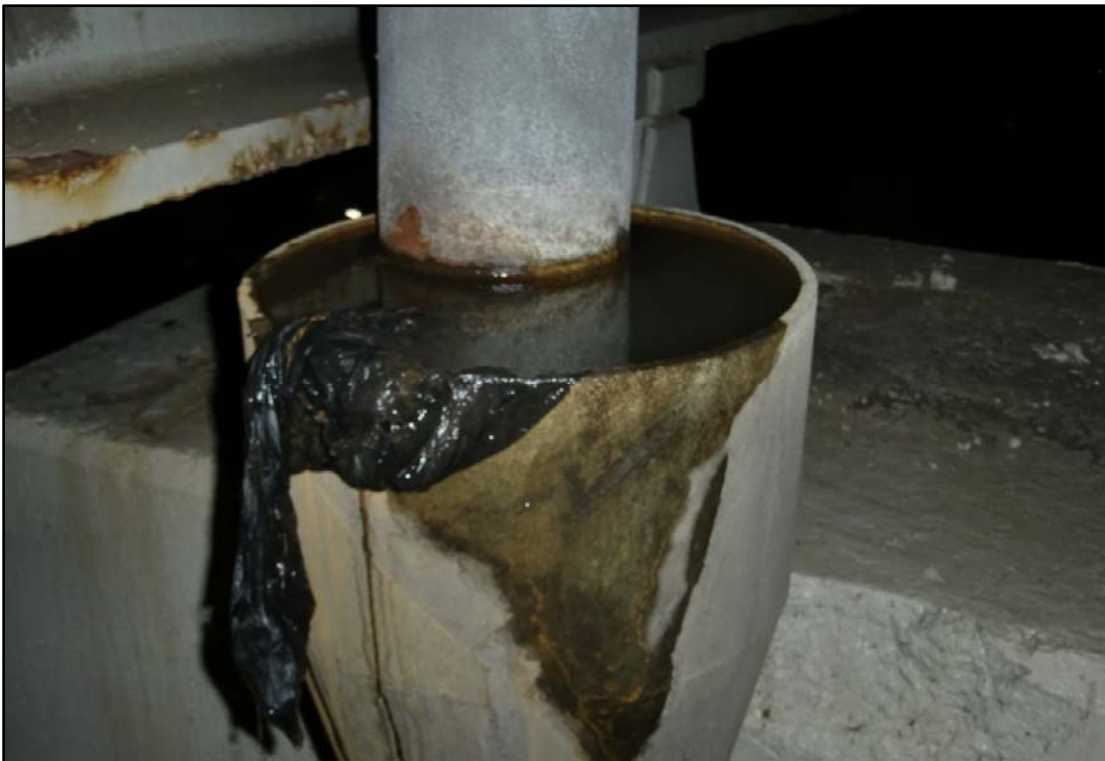
**Photo 11 – Clogged Collector & Overflowing Drain Water, Pier 18BE.**

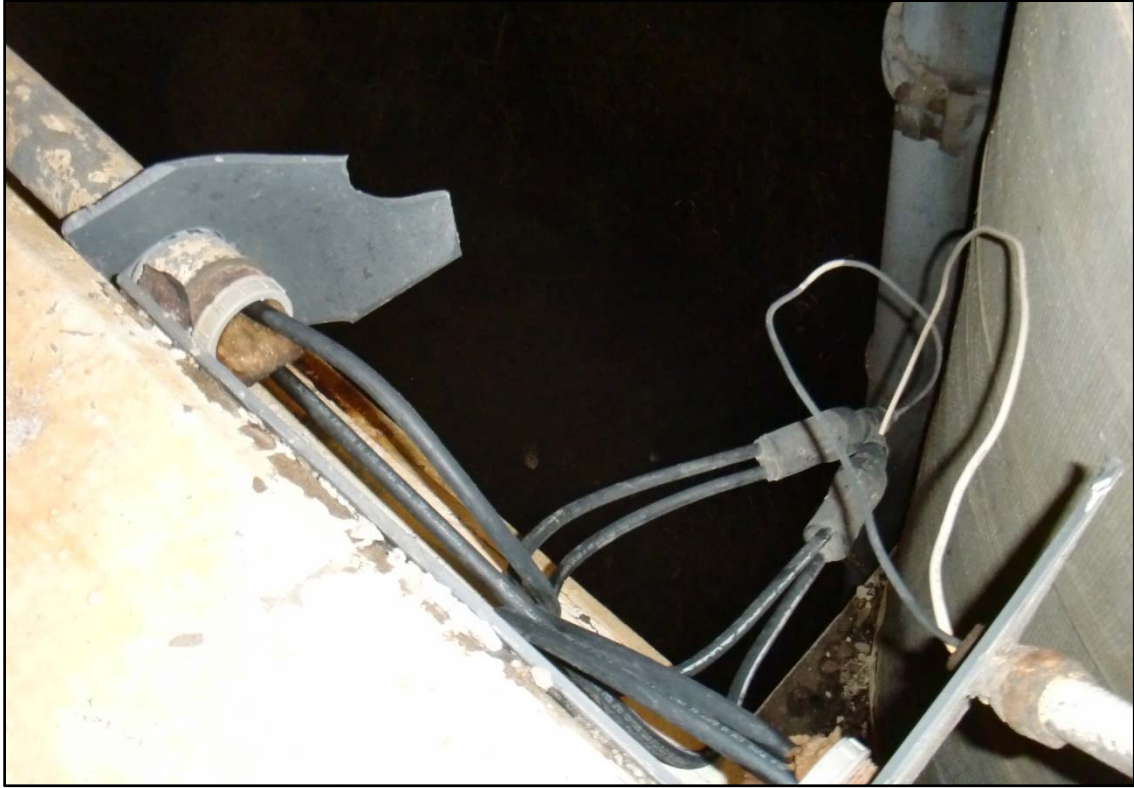
**Photo 13 – Broken Conduit & Exposed Wires,, Pier 11.**

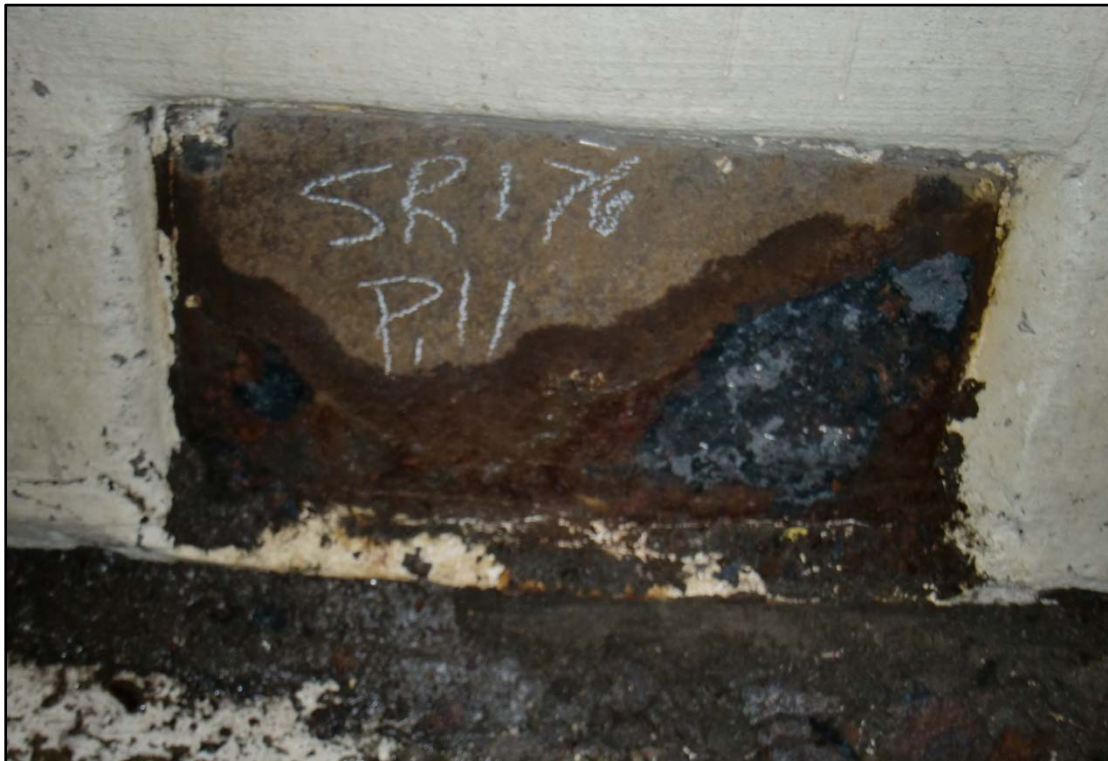
**Photo 14 – Corroded & Thin Pull Box Cover, Pier 11.**

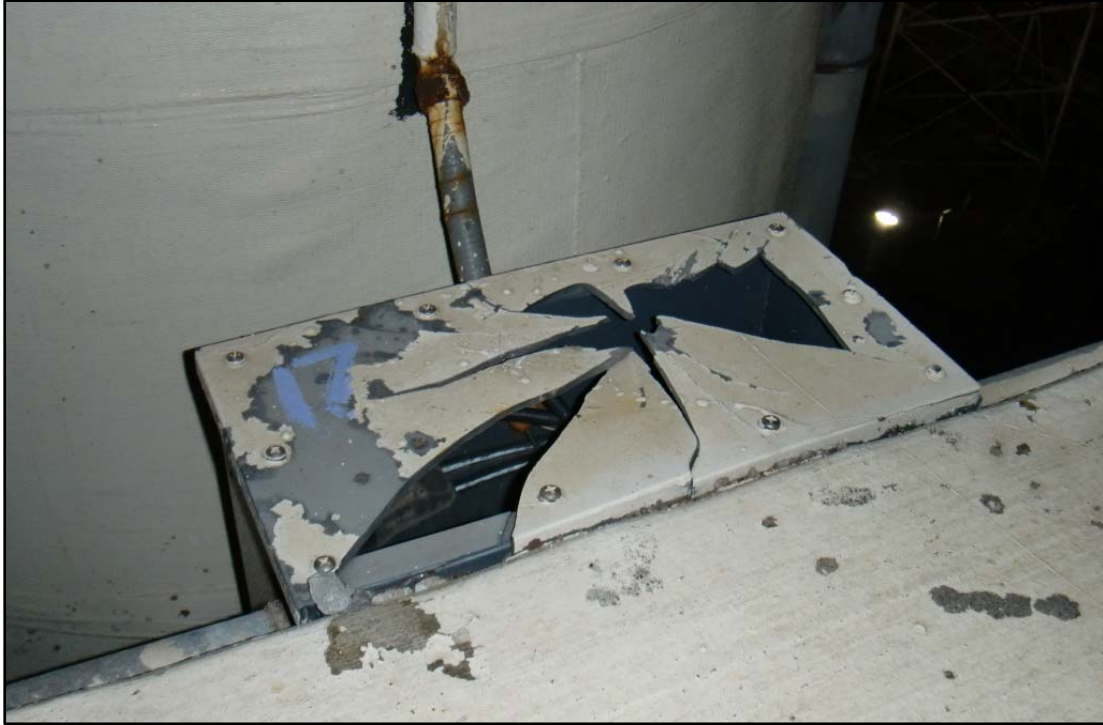
**Photo 15 – Fractured Junction Box Cover, Pier 17.**

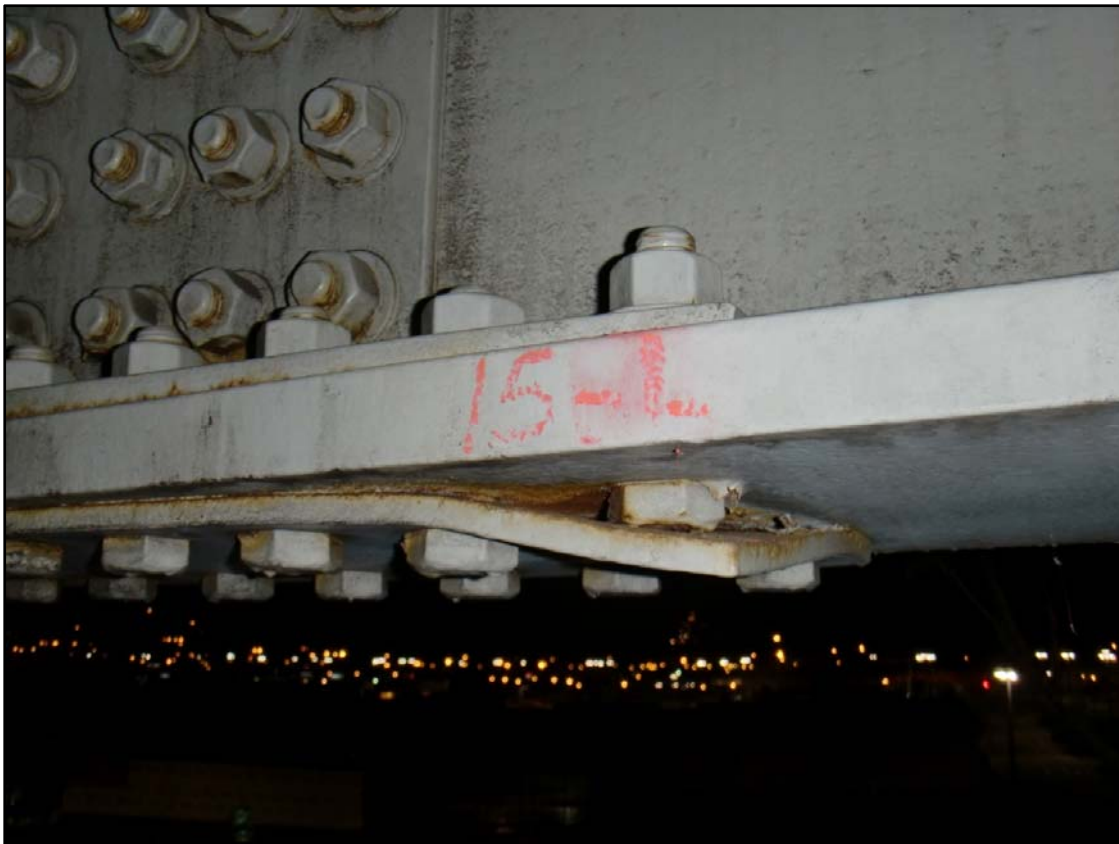
Photo 16 – Mis-erected Bottom Flange Splice Bolt, Beam L, Span 15.

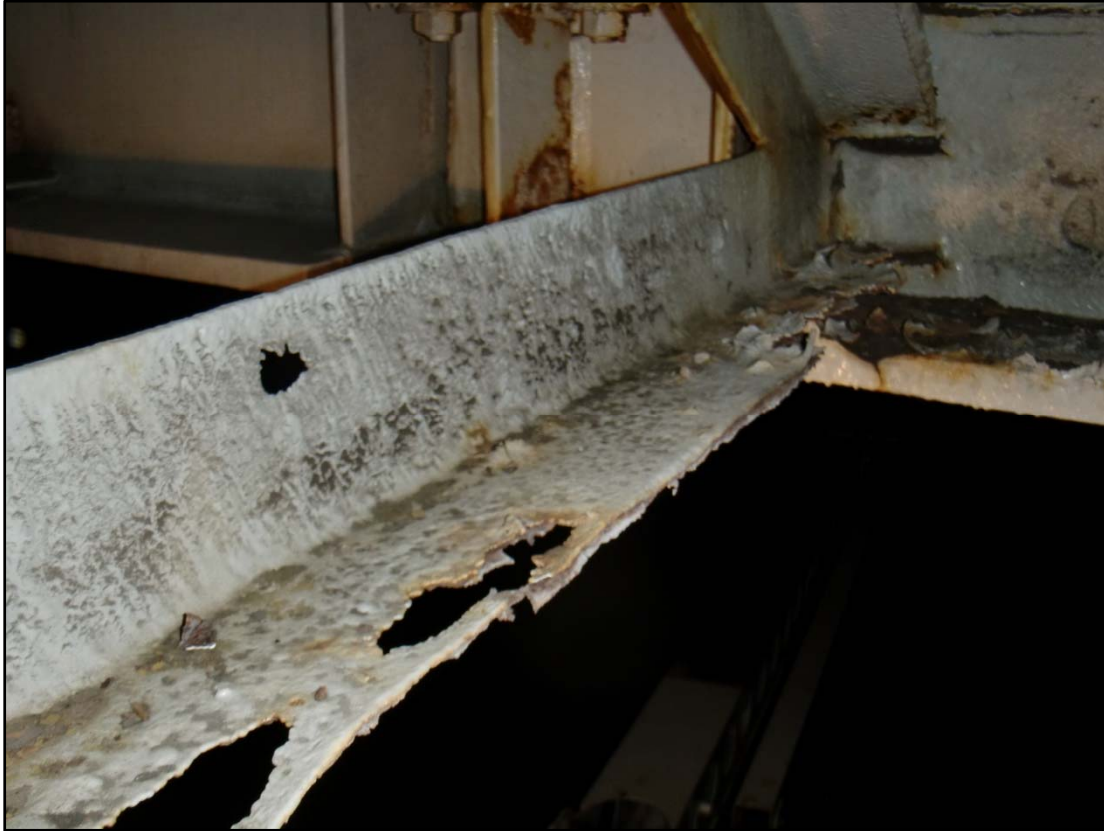
**Photo 17 – Advanced Section Loss on Cross Frame Horizontal Member,  
Beneath Expansion Joint 2-B, Span 18BW.**

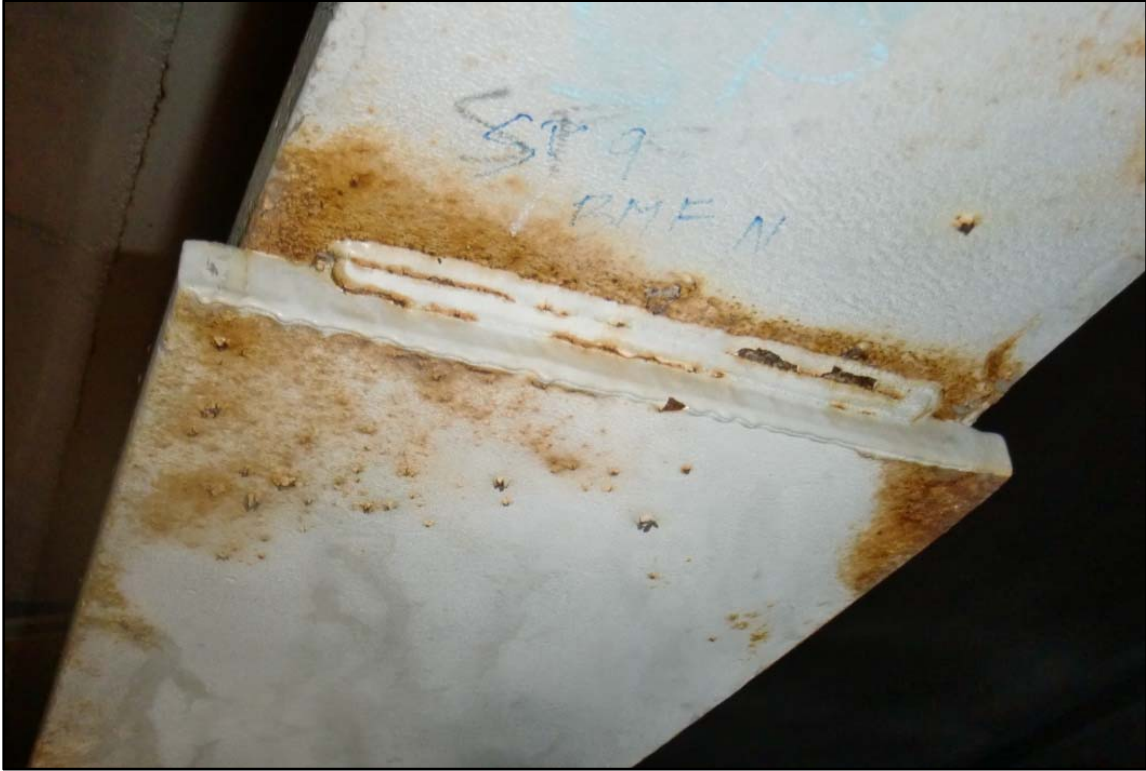
**Photo 19 – Typical Freckled Rust on Bottom Flange & Moment Plate Welds**

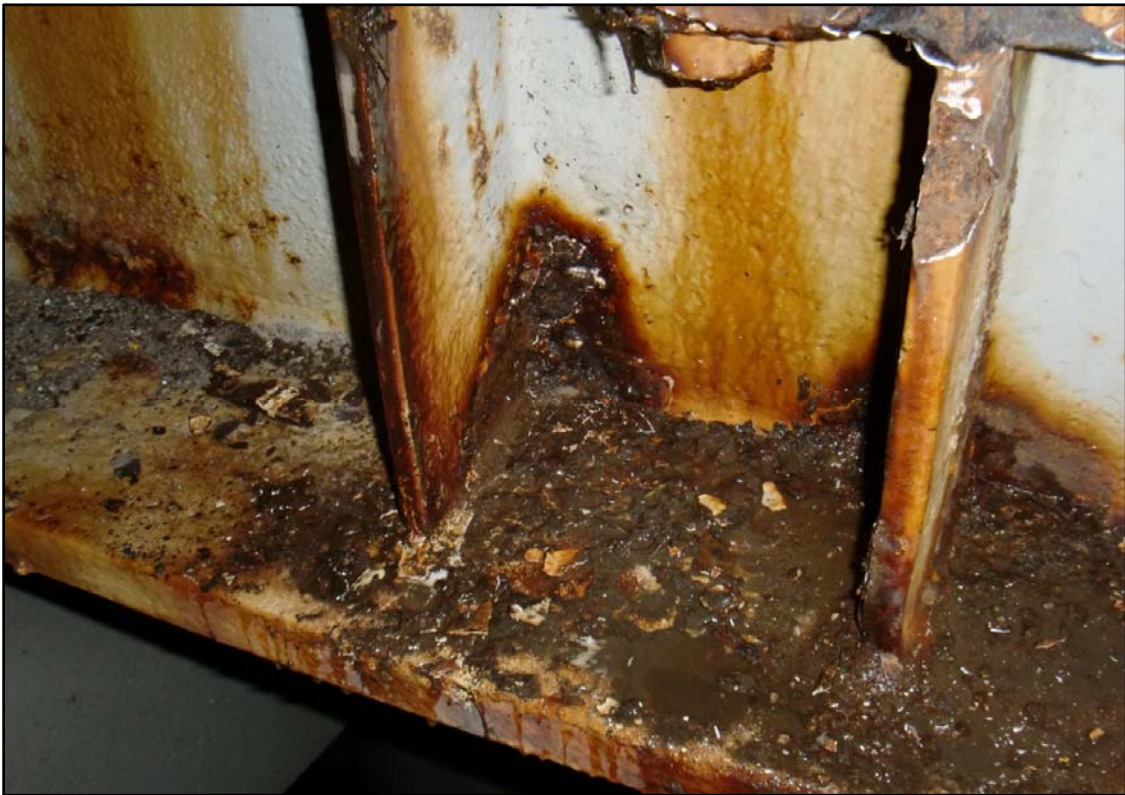
**Photo 20 – Typical Failed Paint & Active Corrosion at Hinges.**

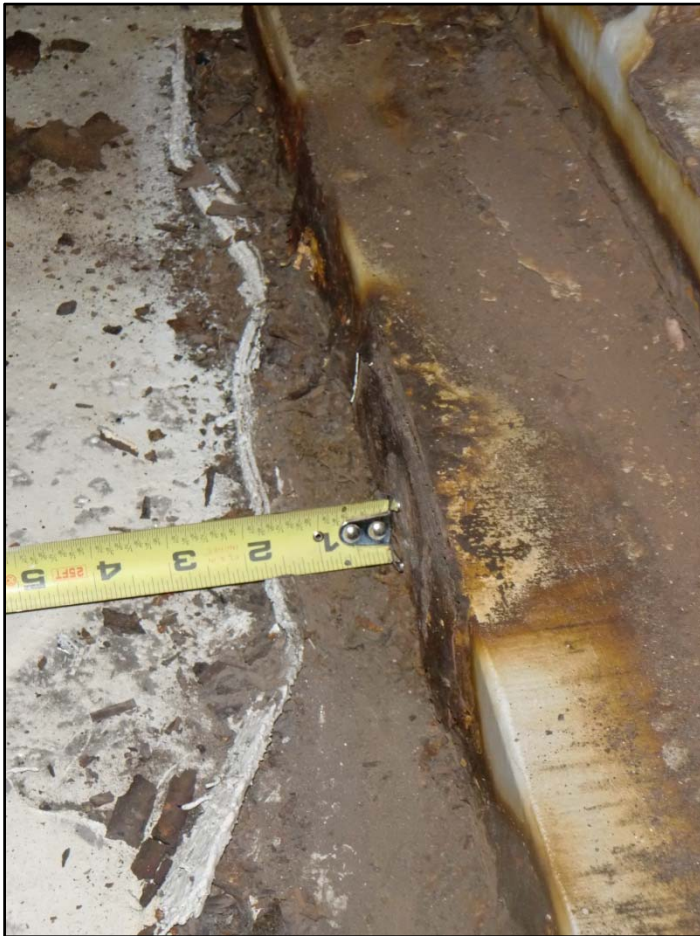
**Photo 21 – 1 1/2-Inch Bearing Plate Misalignment, Beam A, Pier 13.**

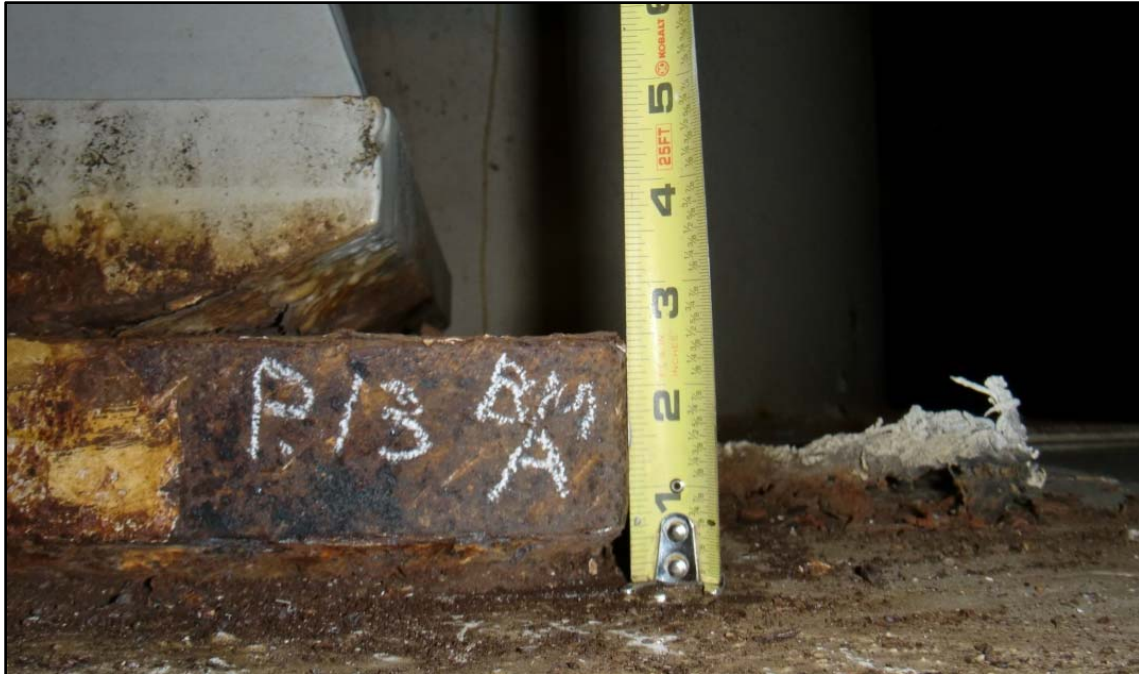
**Photo 22 – Rust Accumulation &  $\frac{9}{16}$ -Inch Lift on Bearing Plate, Beam A, Pier 13.**

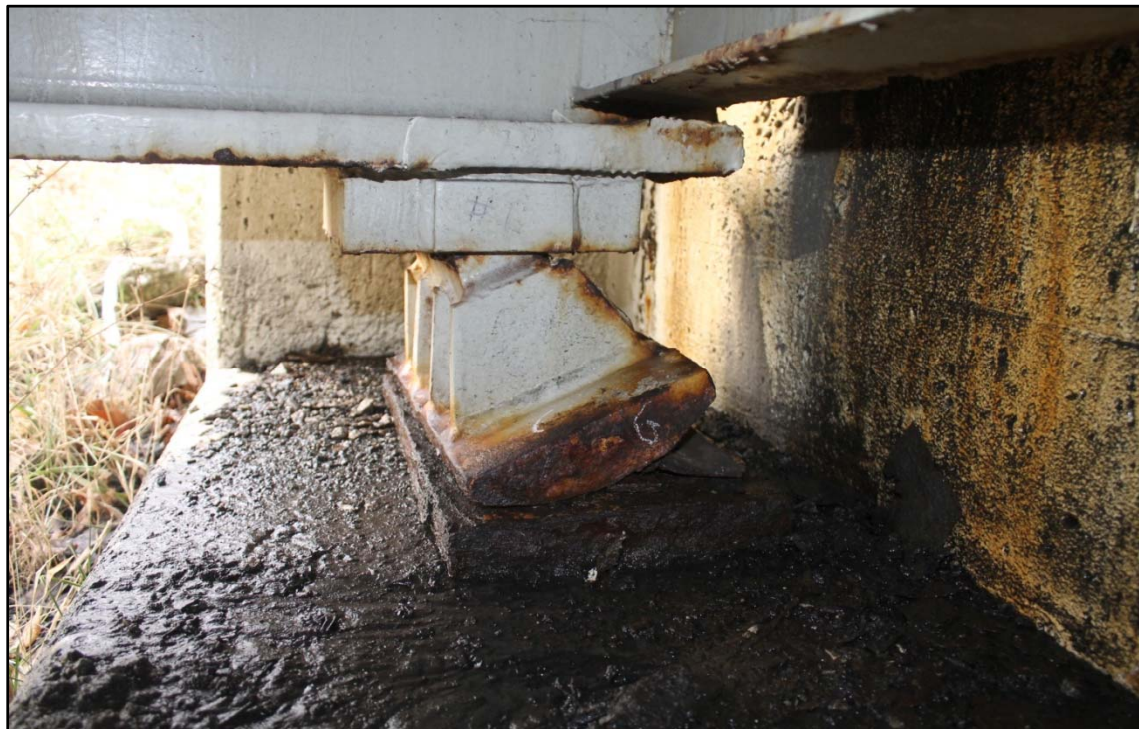
**Photo 22 – Maximum Rotation of Bearing G with Shifted Bearing Plate, North Abutment BW.**

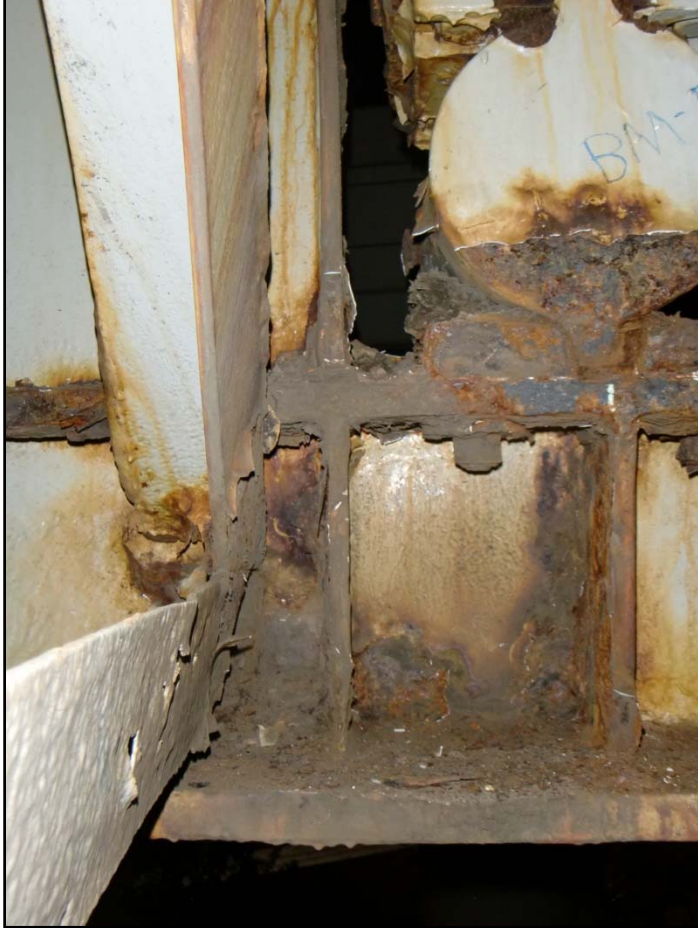
**Photo 24 – Advanced Rust & Debris Accumulation at Expansion Joint/Hinge 3B.**

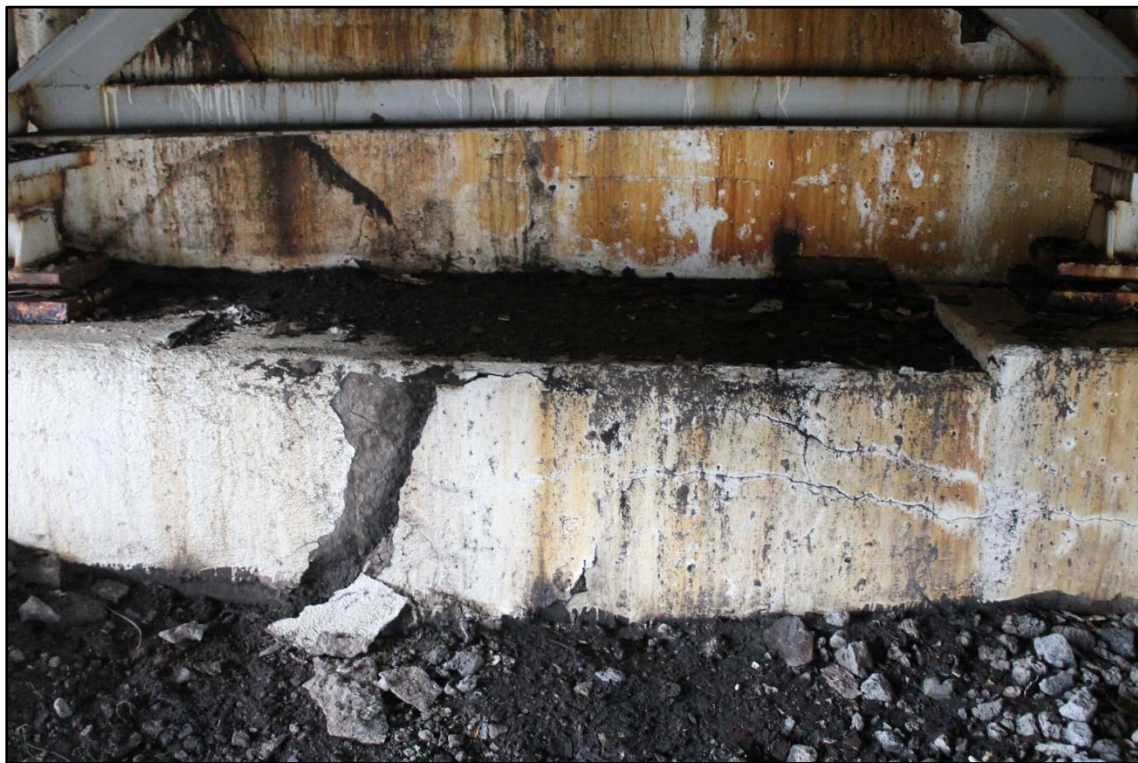
Photo 25 – Delaminated Surface above Horizontal Crack, Abutment BW.

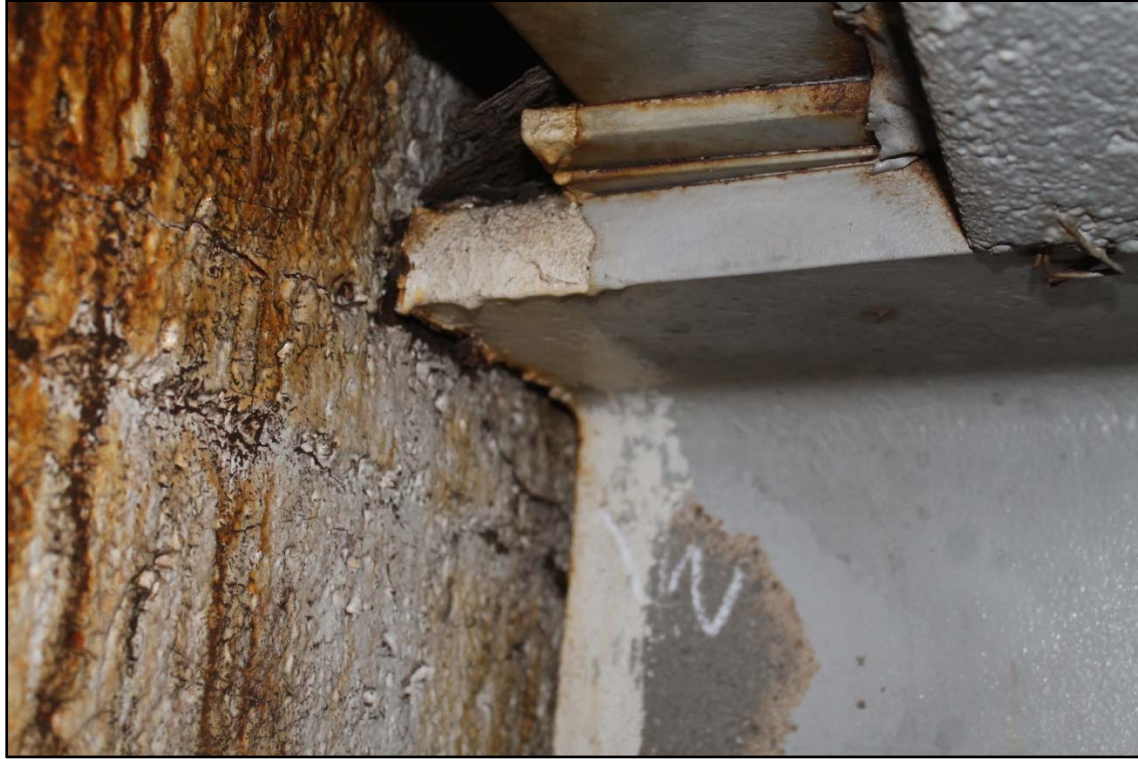
**Photo 26 – Backwall Contact with Beam C, Abutment BW.**

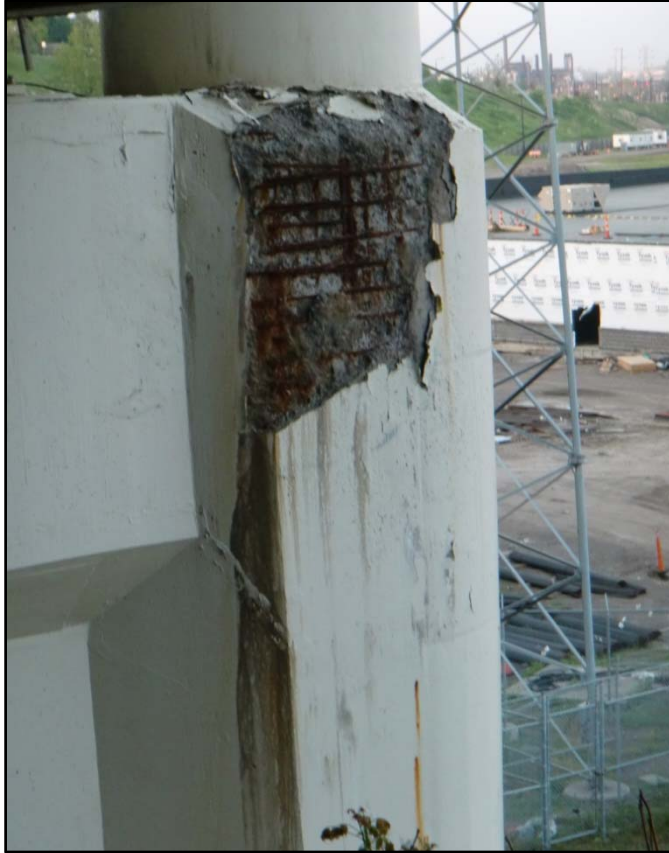
**Photo 27 – Nine-foot x Six-Foot Spall on East Pier Column, Pier 15.**

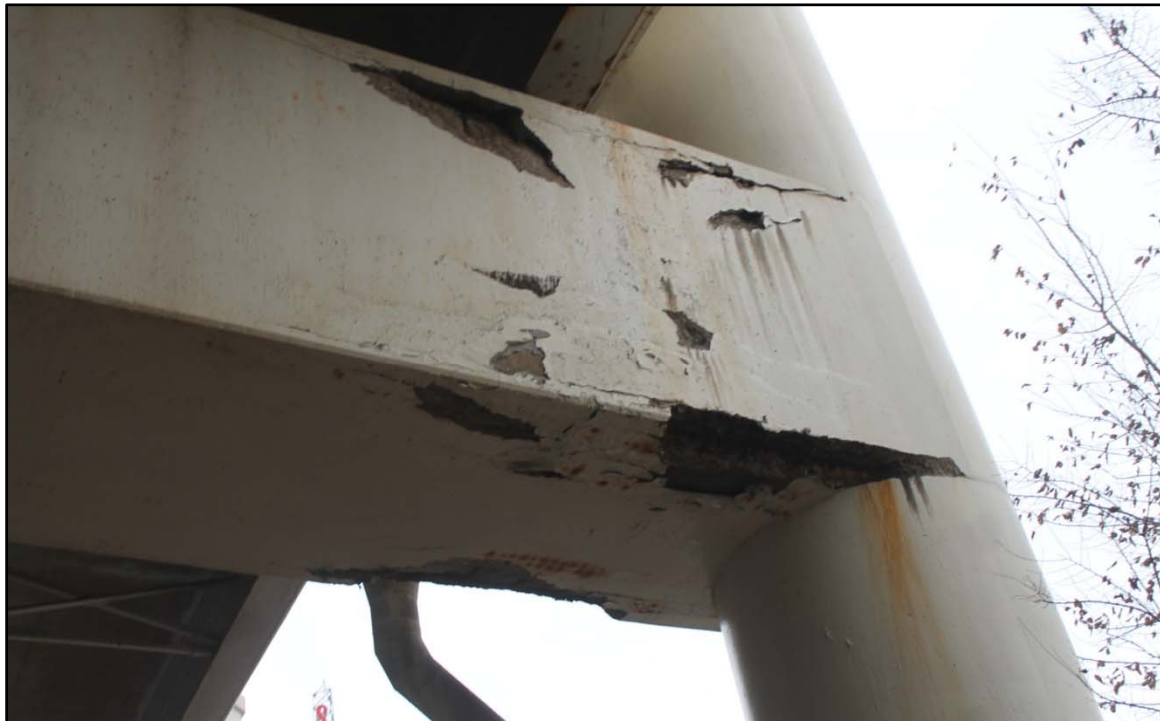
**Pier 28 – Pier Cap Spalls & Delaminations, Pier 13 East Face.**

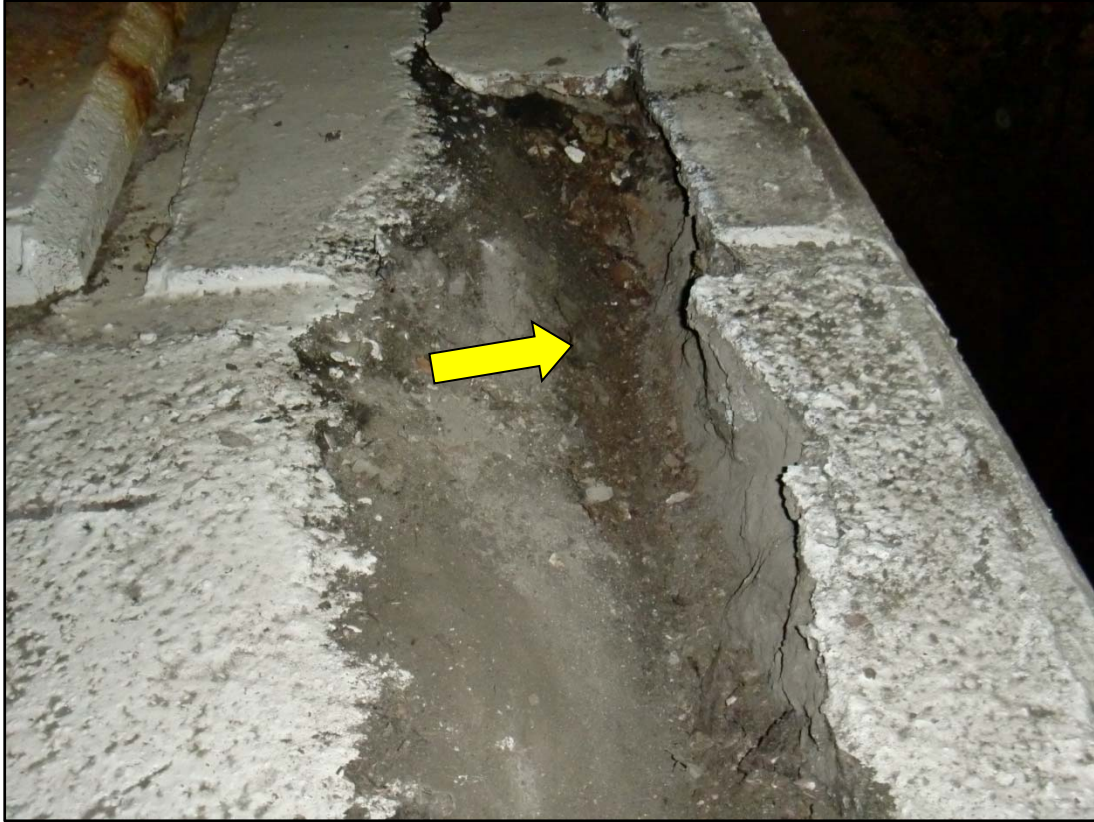
**Photo 29 – Diagonal Top Spall approximately 3” Deep to indicated No. 18 Bar, Pier 13.**

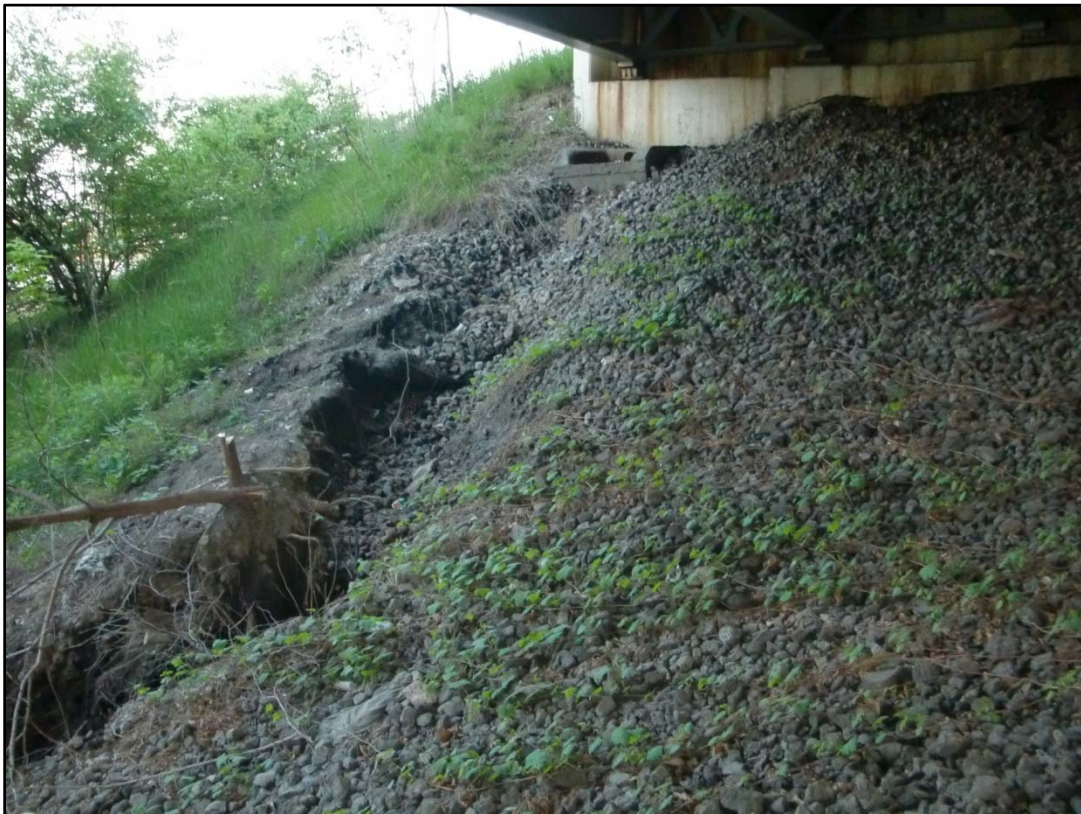
**Photo 30 – Slope Protection Erosion, South Abutment.**
