BRIDGE INSPECTION REPORT

BRIDGE NUMBER CUY 00077 1318

Interstate Route 77 over Morgana Run, City of Cleveland
(Brick and Reinforced Concrete Culvert)

KCI Associates of Ohio	
ODOT District 12 2006 Underwater Inspections	
Bridge No.: CUY-77-1318 (SFN: 1806564)	
I-77 OVER MORGANA RUN, CITY OF CLEVELAND

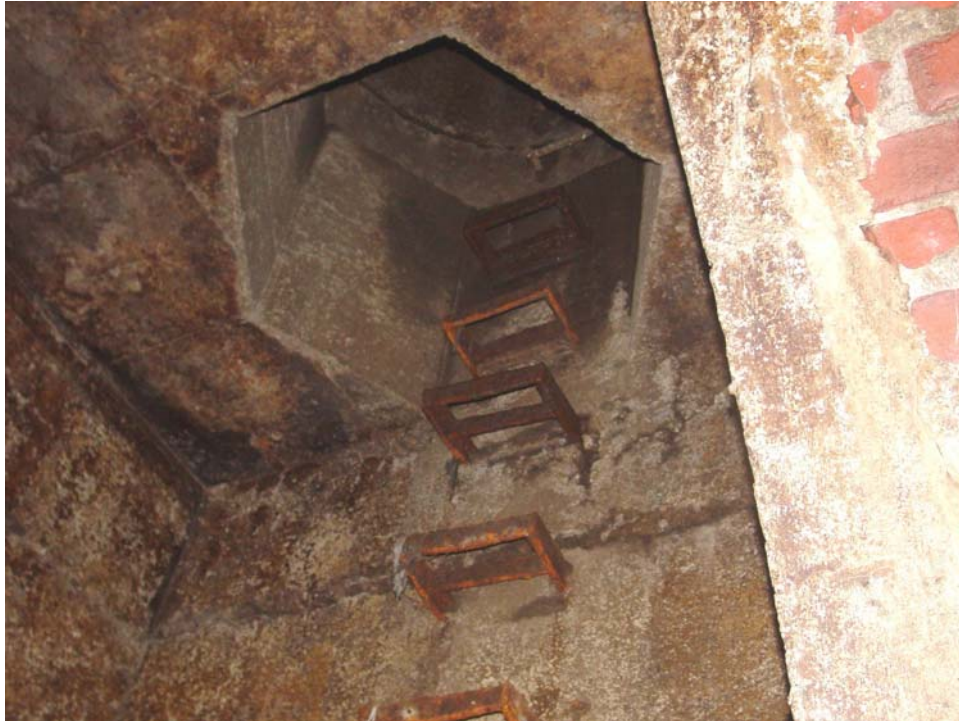
- The concrete around the 49th Street Manhole entry ladder had up to 1/2" deep scaling. The ladder rungs were in poor condition.
- The diversion weir located below the 49th Street Manhole has a hairline vertical through crack at the center. *Photos 2 and 4* show this crack.

Photo 1 – Facing up and South. View of the 49th Street Manhole Ladder.

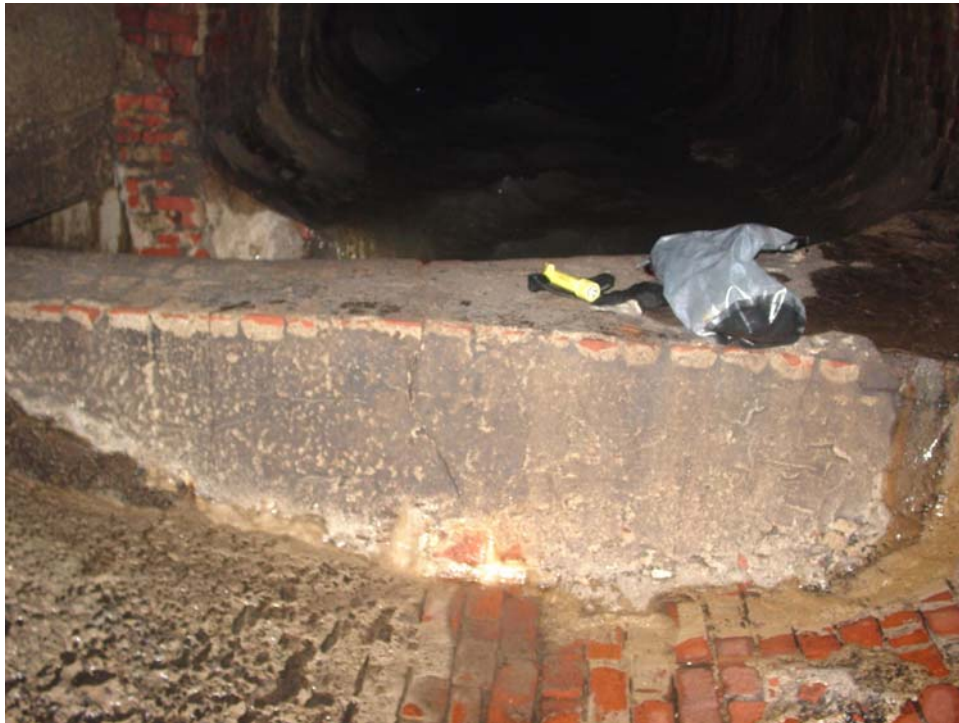
Photo 2 – Facing East. Elevation view of the weir wall near 49th Street manhole.

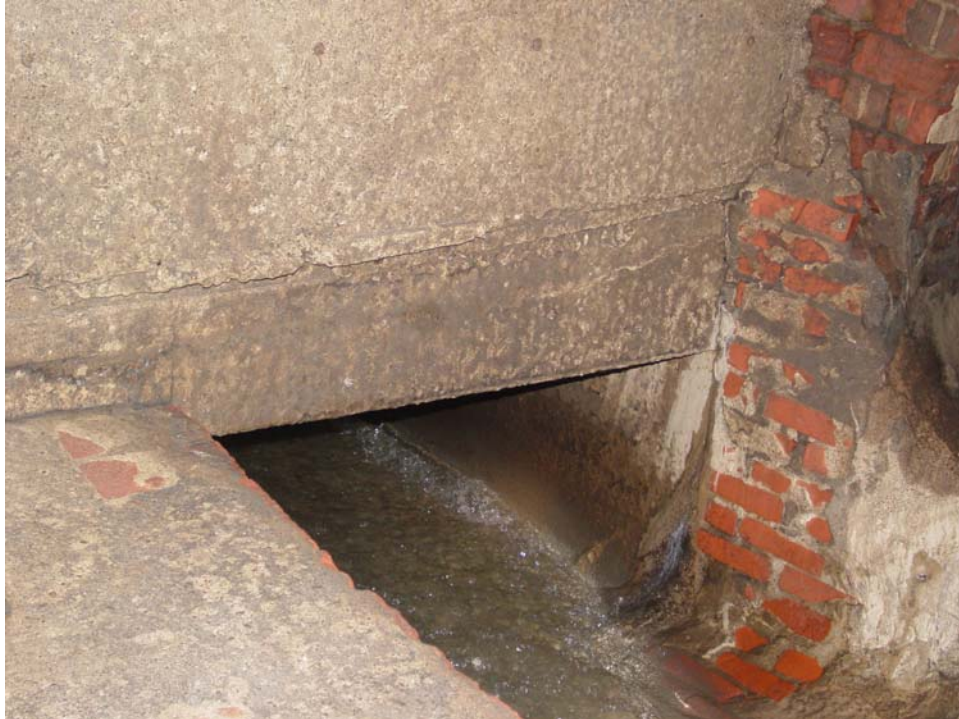
Photo 3 – Facing northeast. View of the diversion channel at weir wall, water exiting beneath Finish (north) wall.

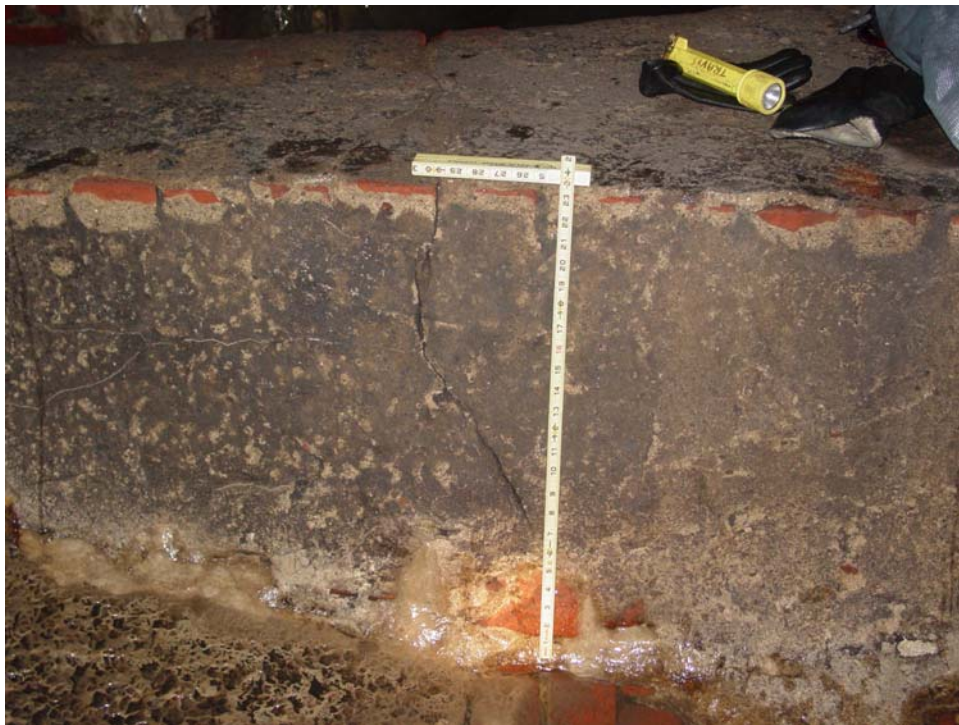
Photo 4 – Facing East. View of crack through weir wall.

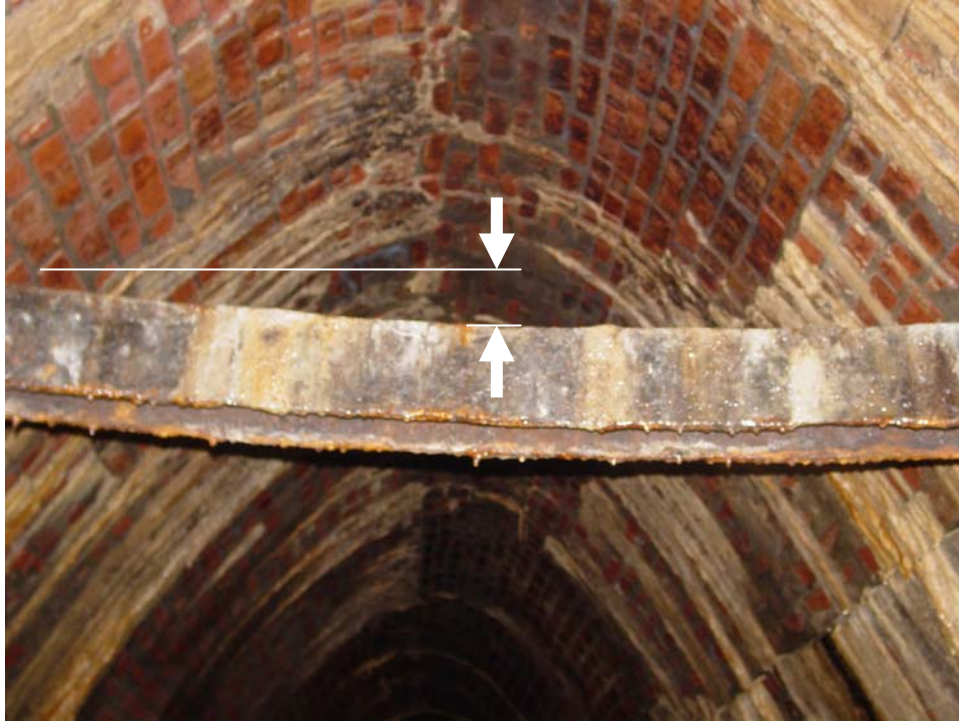
- The horizontal 6" centering beam located 370' from the Mittal Steel entry manhole has a 2" deflection (*See Photo 5*).
- The brick walls have been patched in the areas where the beam is located. *Photo #6* shows missing brick, patching and heavy efflorescence around the beam penetration on the finish (north) wall.

Photo 5 – Facing West. View of 6” centering beam. Note bend or deflection (~2”).

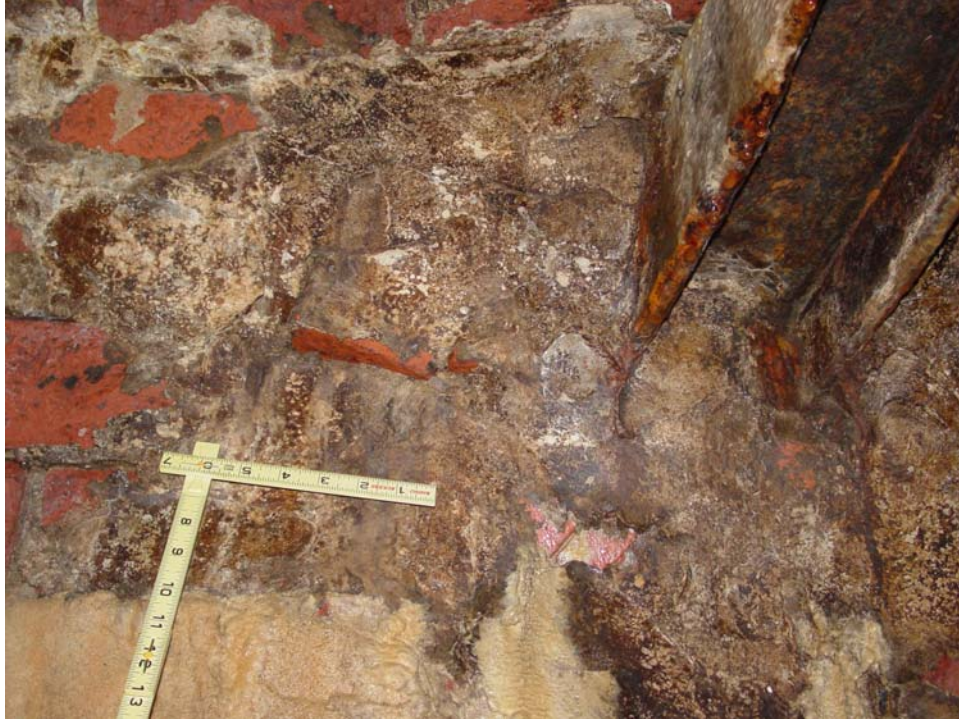
Photo 6 – Facing North. View of the beam/brick interface.

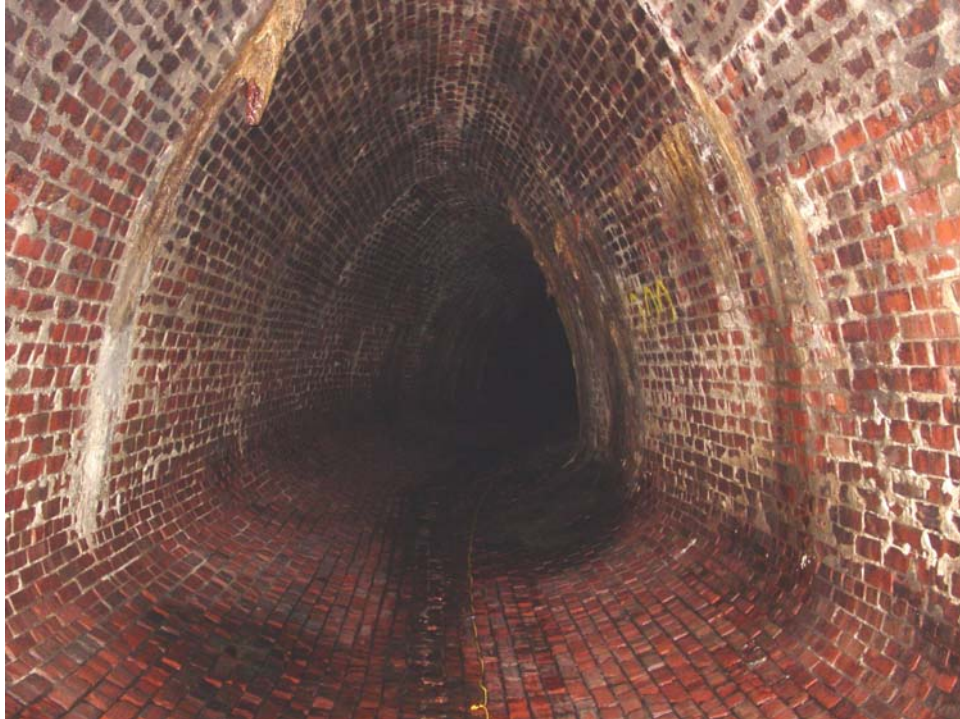
- A semi-continuous 1/2" horizontal crack is located in the mortar joint between brick at approximately 8' above the floor on the finish (north) wall. The horizontal crack jumps mortar joints as it extends west causing it to change elevation randomly from 7' to 9' above the floor. The crack is likely a construction joint related to where the culvert centering supports were changed or removed to finish the top of the teardrop shape. Water is actively seeping from these mortar joints and efflorescence is present. These conditions exist intermittently on both walls throughout the entire culvert (*See Photos 7, 11 and 12*).

Photo 7 – Facing West. Note water infiltration and heavy efflorescence along each wall.

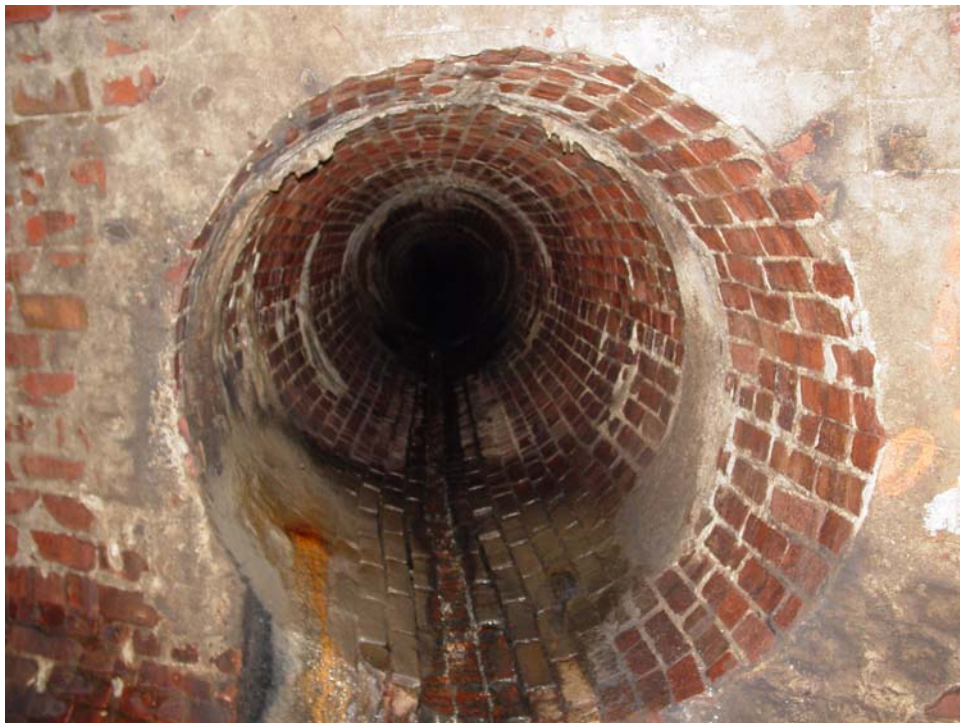
Photo 8 – Facing South. View of intersecting 48” diameter brick sewer.

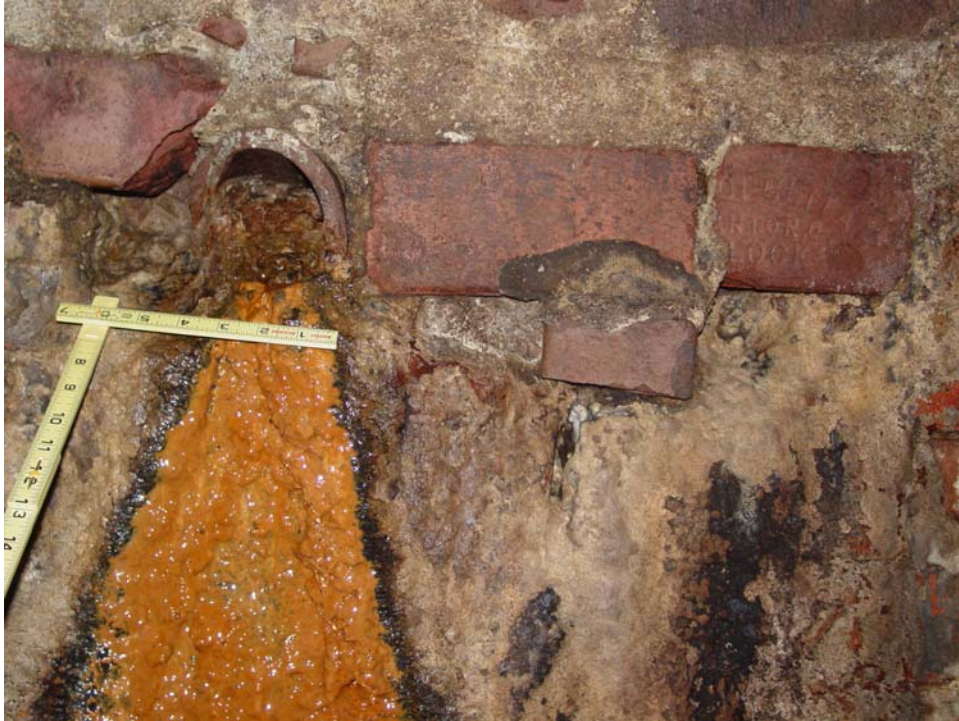
- At 160' from the Mittal Steel entry manhole on the finish (north) wall, is a 4" diameter clay tile pipe. The pipe, shown in *Photo 10*, is approximately 6' above the floor and 50% blocked by sludge and debris.

Photo 9 – Facing North. View of intersecting 4” diameter clay pipe drain. Note missing brick and concrete patching.

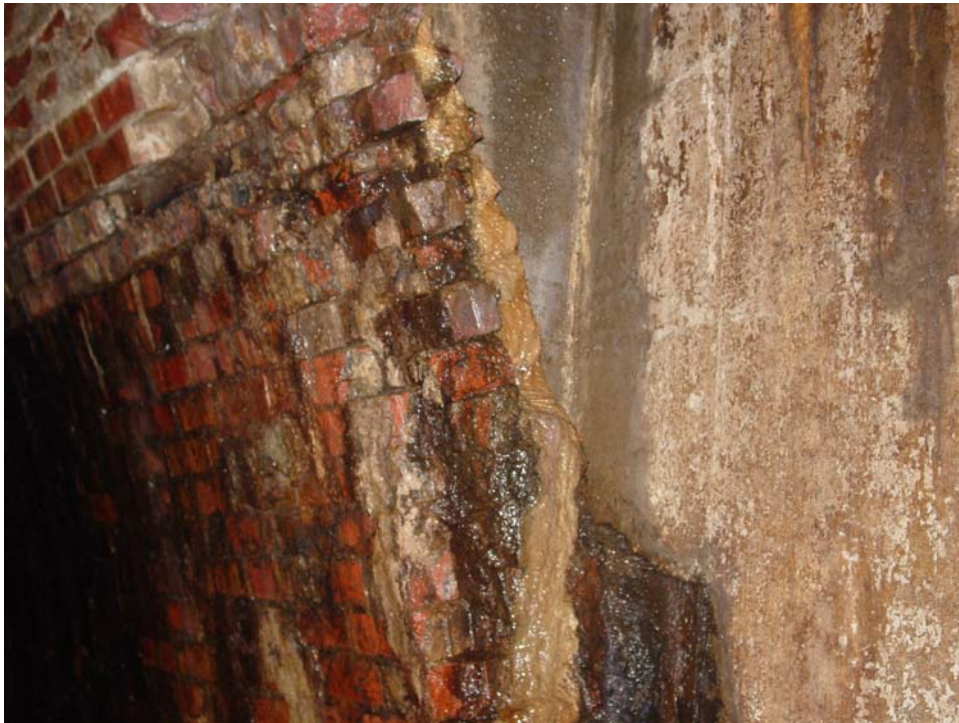
- Unlike the east end of the brick section, the transition from brick to concrete at this west end is not smooth. *Photos 10, 11 and 12* show this jagged transition with random missing brick.
- The concrete culvert above the tile had up to ¼” scaling on the concrete walls.
- The entry / exit manhole ladder rungs are offset, corroded and slippery. A tripod, winch and harness are necessary for safe extraction.

Photo 10 – Facing Southeast. View of abutting brick and concrete culvert sections along Start (South) wall.

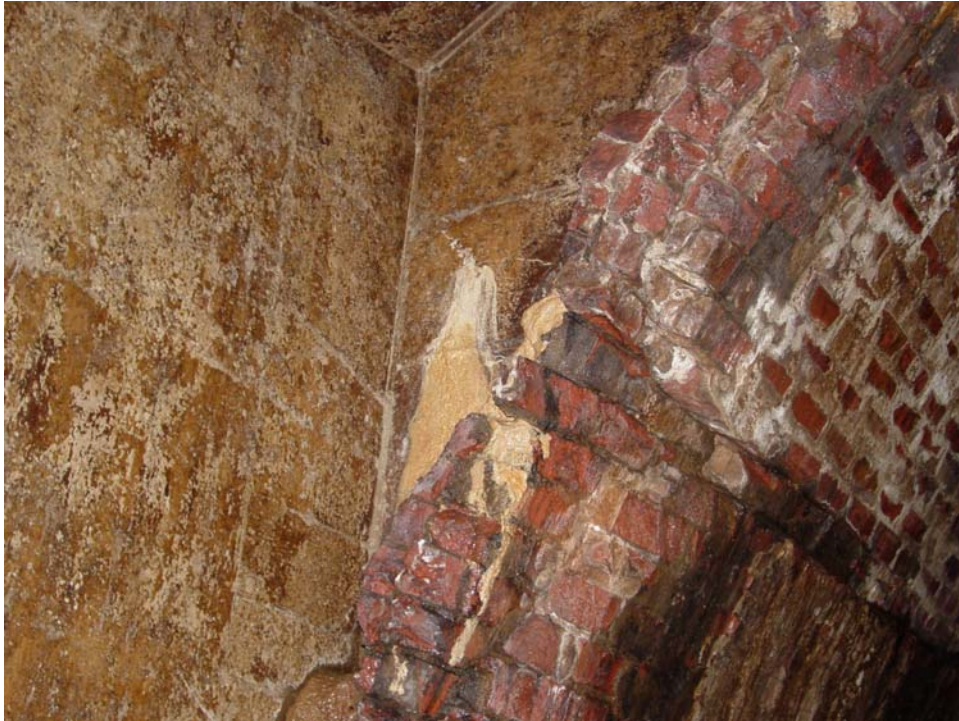
Photo 11 – Facing East. View of view of abutting brick and concrete culvert sections along Finish (North) wall.

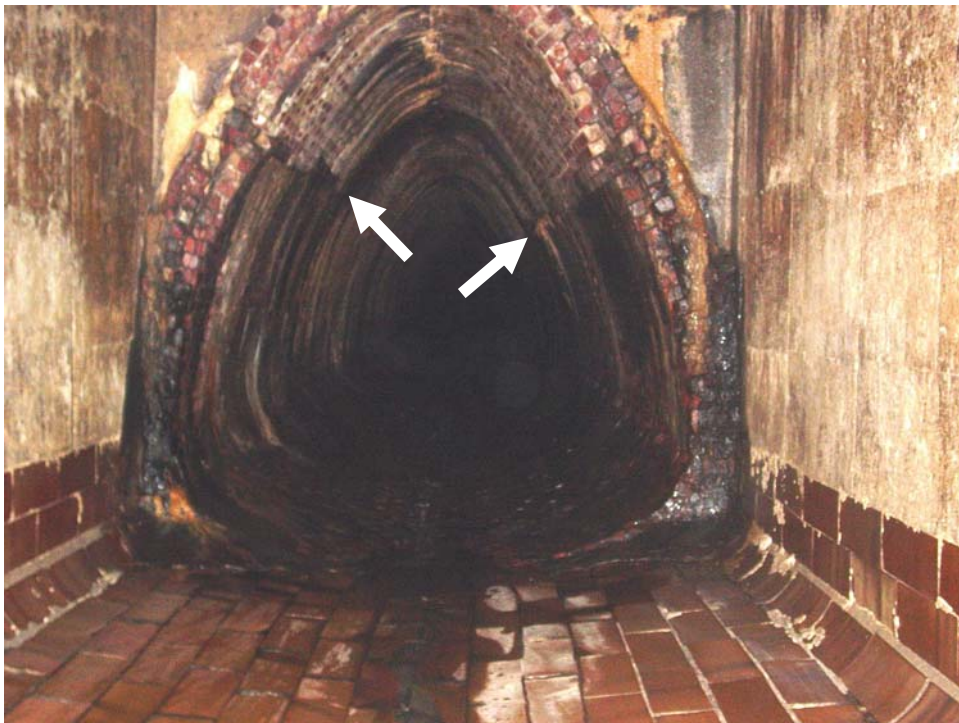
Photo 12 – Facing East. View of abutting brick and concrete culvert sections. Note line of water infiltration along horizontal cracks.

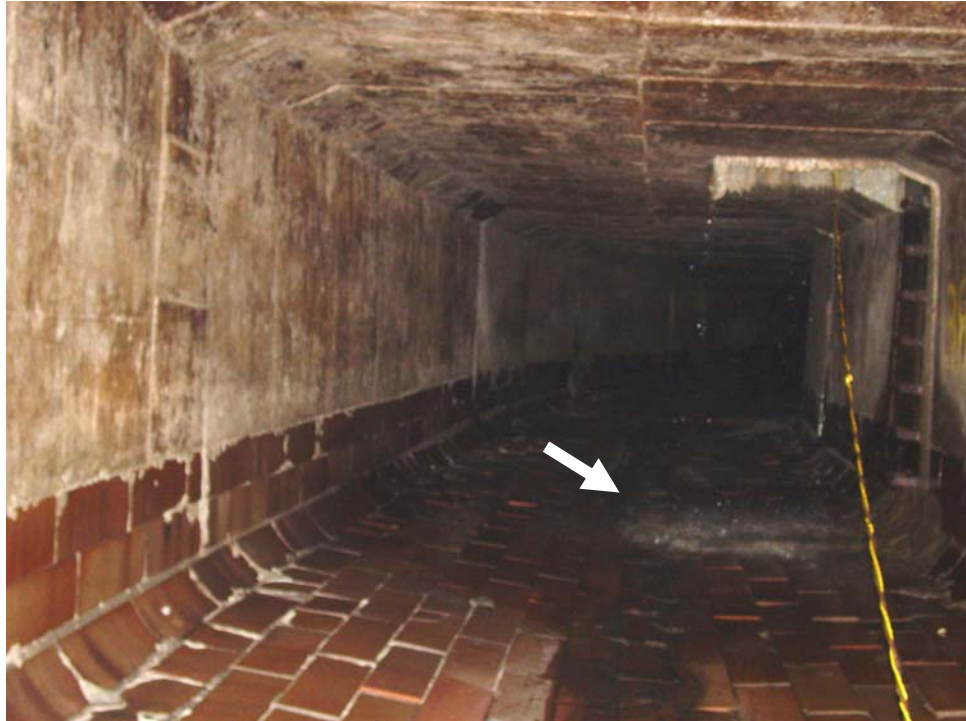
Photo 13 – Facing East. View of concrete and tile culvert section and the Mittal Steel manhole entrance ladder. Note heavy water intrusion.

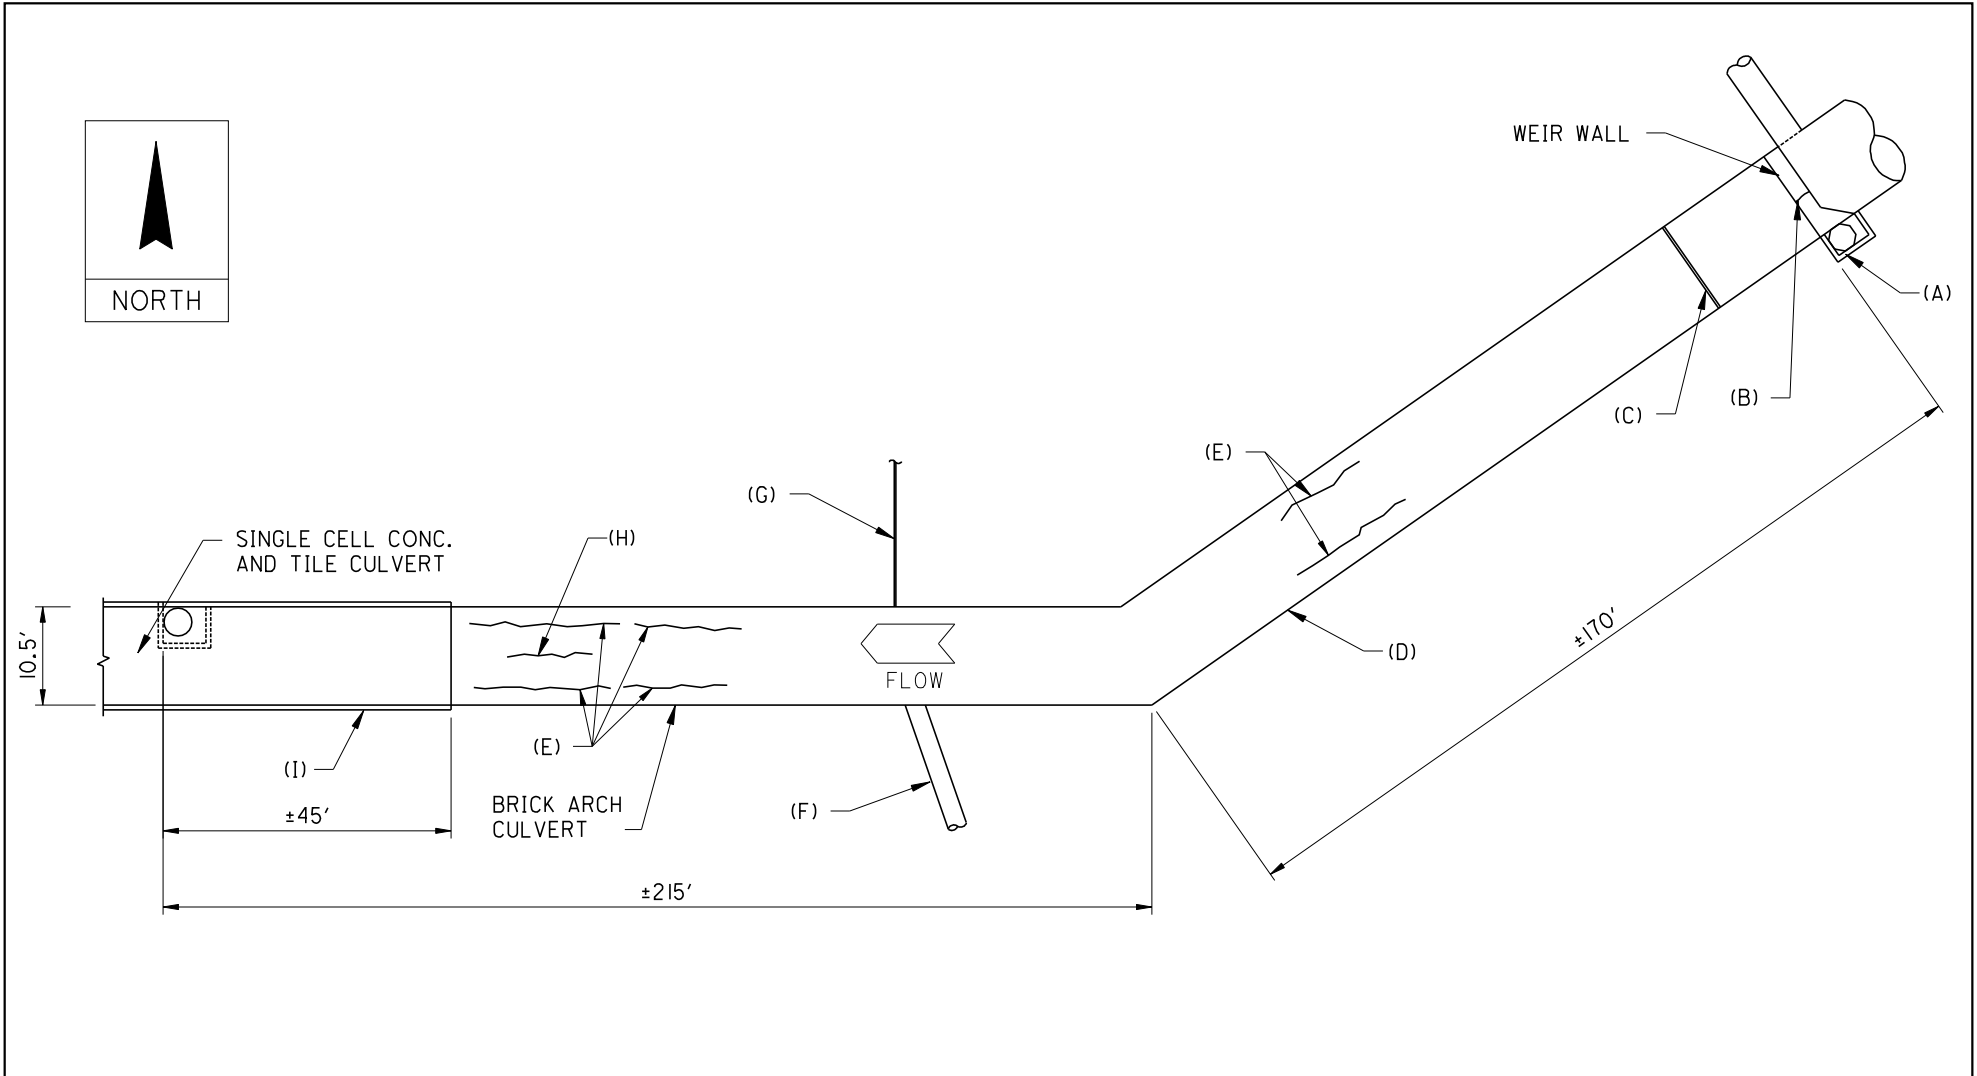
SCHEDULE OF OBSERVATIONS AND DEFECTS:

- (A) EAST 49TH STREET MANHOLE
- (B) WEIR WALL WITH HAIRLINE VERTICAL THROUGH CRACK.
- (C) 6" STEEL CAMBERING BEAM.
- (D) 3 SQ. FT. AREA OF MISSING BRICK (FIRST LAYER).
- (E) INTERMITTENT HORIZONTAL CRACK WITH INFILTRATION.
- (F) 48" DIAMETER BRICK PIPE.
- (G) 4" DIAMETER CLAY PIPE.
- (H) INFILTRATION AT THE PEAK OF THE ARCH.
- (I) JAGGED TRANSITION WITH RANDOM MISSING BRICK.
