BRIDGE INSPECTION REPORT

BRIDGE NUMBER CUY 00077 1318

Underwater Inspection Report for:

Interstate Route 77 over Morgana Run
Cuyahoga County, Ohio
(Brick and Reinforced Concrete Culvert)

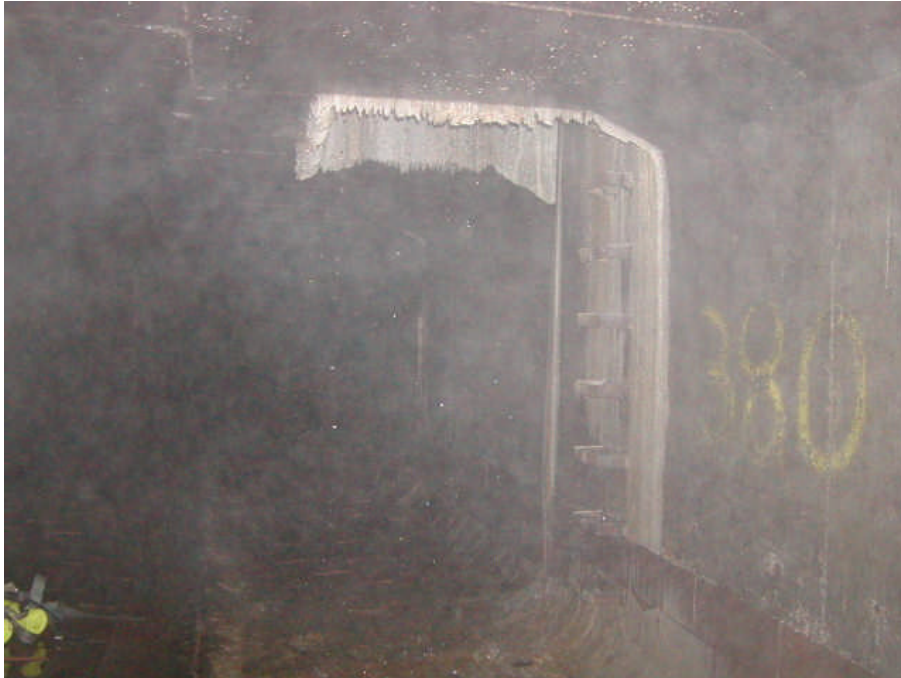
Photo 3. Mittal Street manhole entrance ladder.

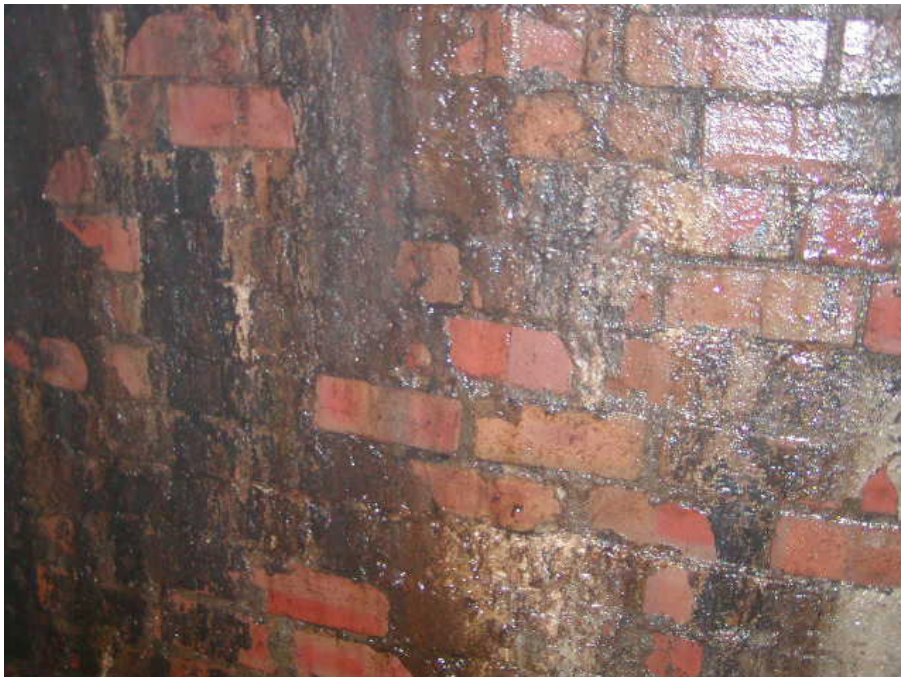
Photo 4. Typical brick culvert wall.

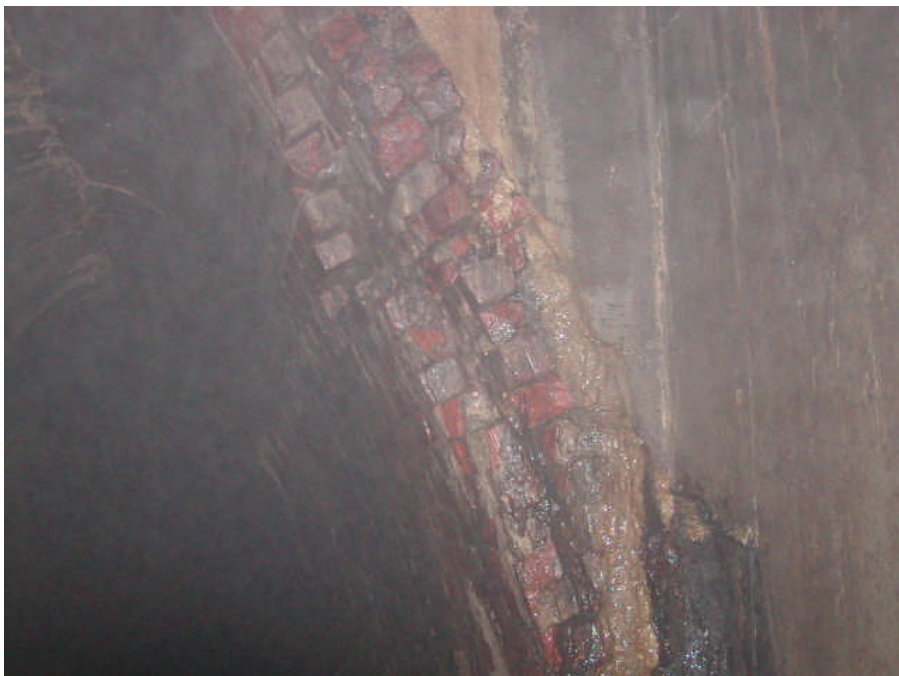
Photo 12. Joint between brick and concrete portion of the culvert.
