BRIDGE INSPECTION REPORT

BRIDGE NUMBER CUY 00077 1318

**Underwater Inspection Report for:**

**Interstate Route 77 over Morgana Run**  
Cuyahoga County, Ohio  
(Brick and Reinforced Concrete Culvert)

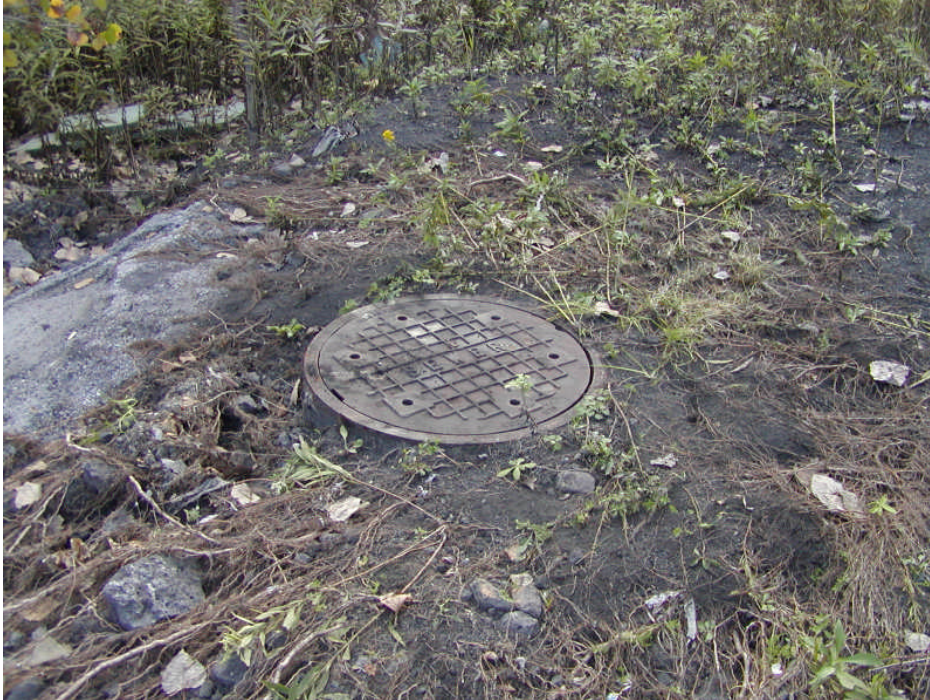
Photo 1. Mittal Street manhole.

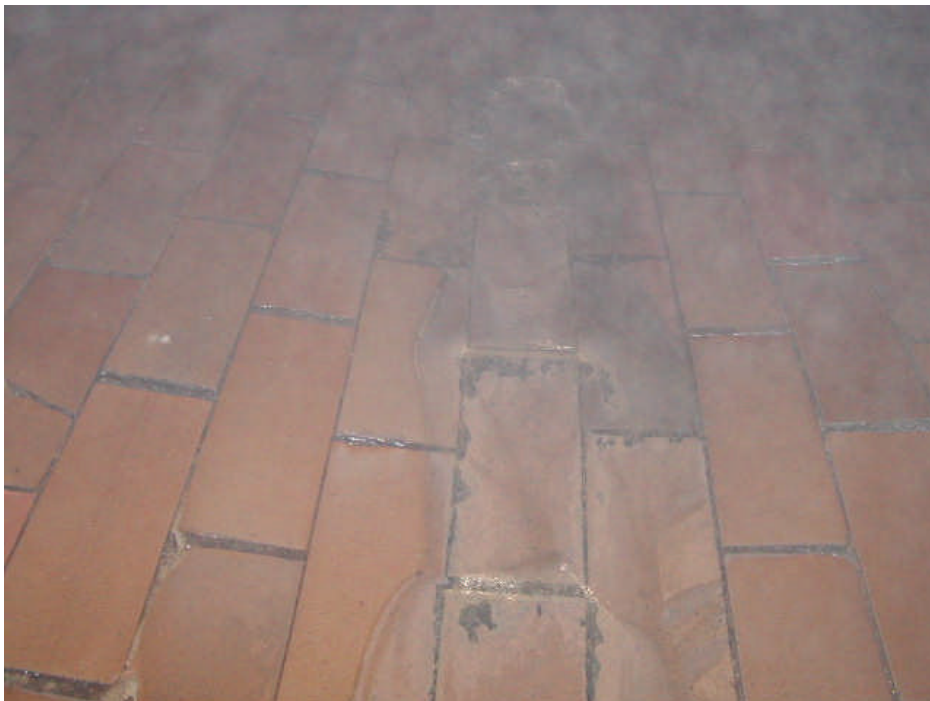
Photo 2. Culvert tile floor.

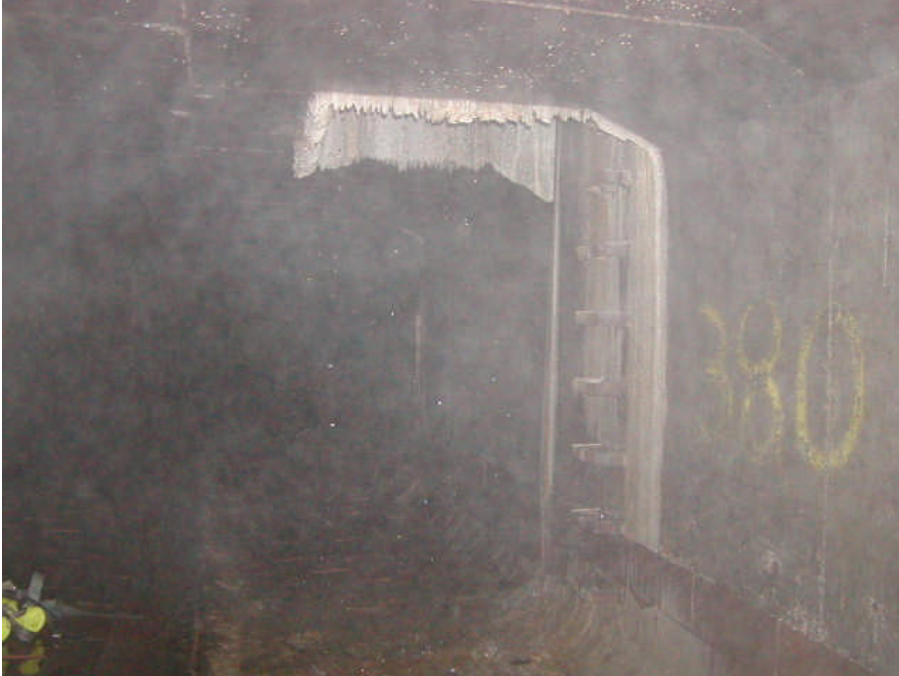
Photo 3. Mittal Street manhole entrance ladder.

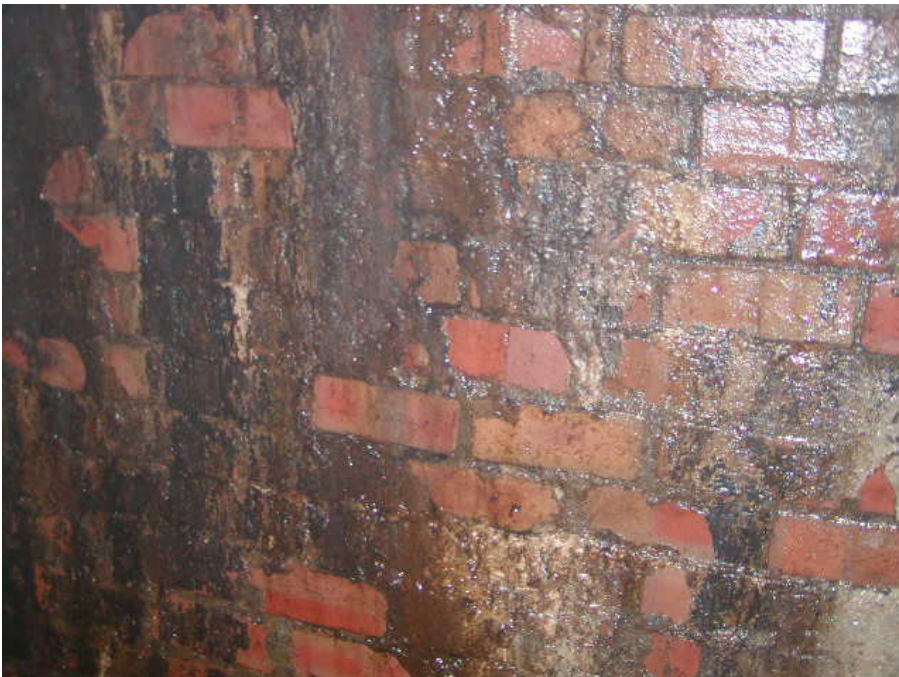
- The brick walls have been patched in the areas where the beam is located.
- There is a horizontal crack between the mortar joints of the bricks. The crack moves up and down in elevation through the joints.

Photo 4. Typical brick culvert wall.

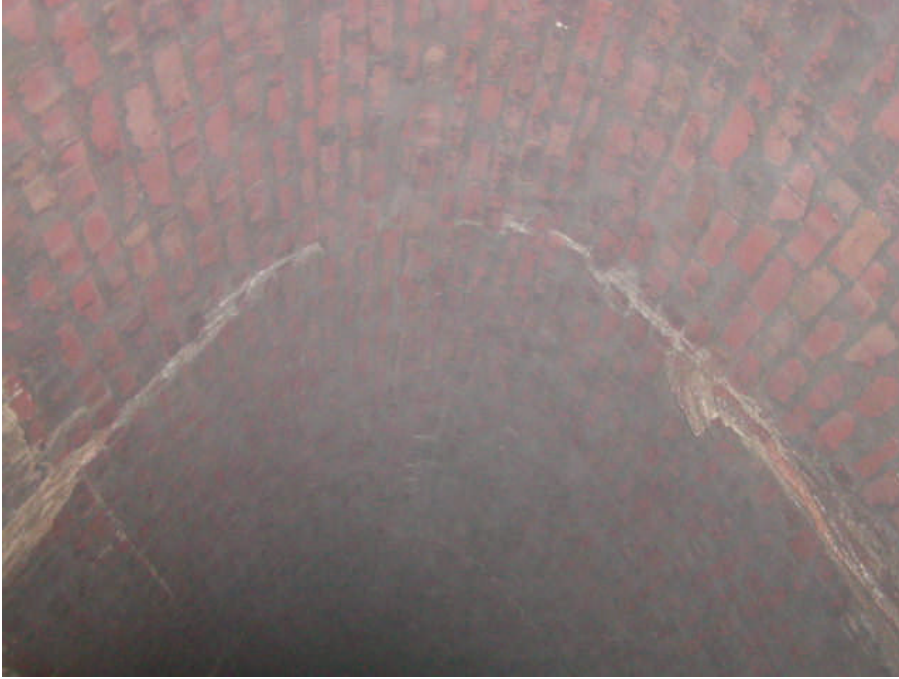
- There are several areas of water penetration from the top of the culvert with areas of efflorescence.
- The concrete around the East 49th Street Manhole entry ladder had up to 2 inches of deep scaling. The ladder rungs were in poor condition.

Photo 5. Culvert brick roof.

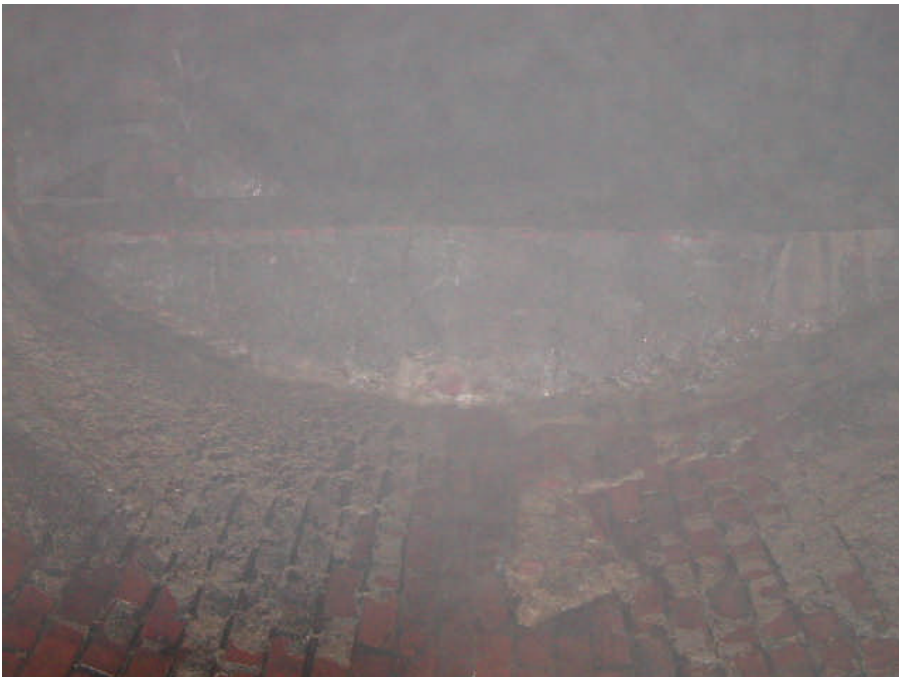
- There is a concrete diversion weir extending the width of the culvert directly below the East 49<sup>th</sup> street entry manhole. The weir measures approximately 19 inches wide by 2 feet tall.
- The water on the east side of the weir was 13 inches deep. Whereas the water in the culvert to the west was less than 2 inches deep.
- At 370 feet from the Mittal Steel entry manhole there is a horizontal 6 inch centering beam

- There is a vertical hairline crack in the center of the diversion weir.
- There is approximately 2 inches of deflection in the horizontal steel beam located near the diversion weir. There are several patches in the location of the horizontal steel beam.

Photo 6. Concrete weir.

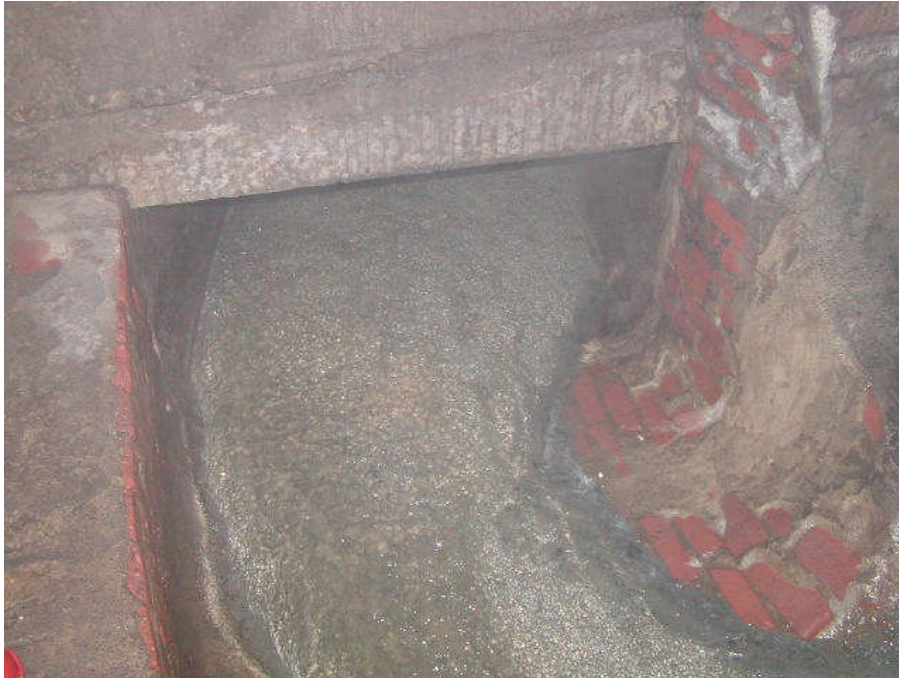
Photo 7. Drain just upstream of concrete weir.

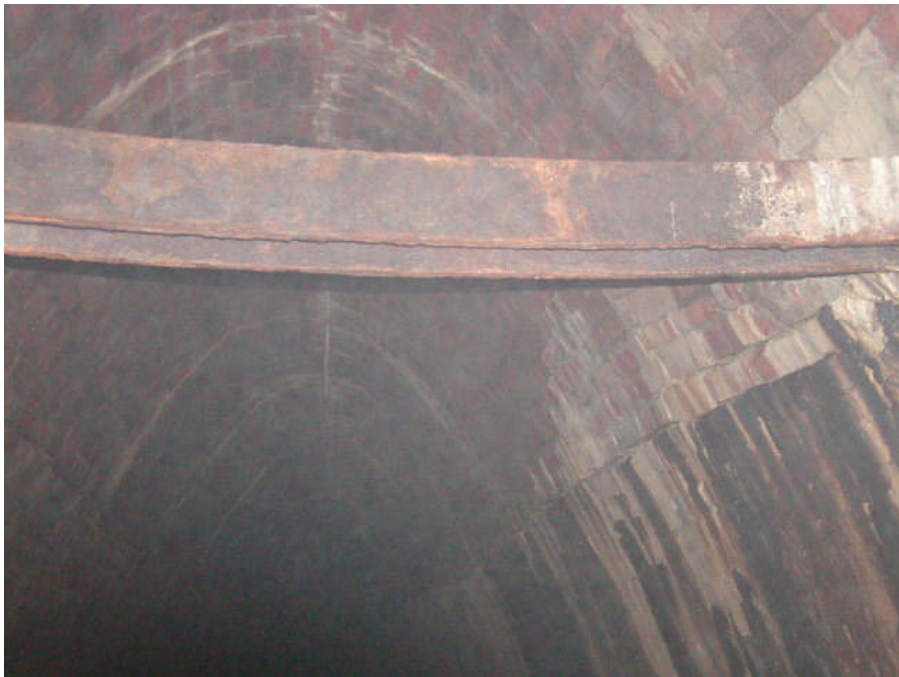
Photo 8. Horizontal steel beam.

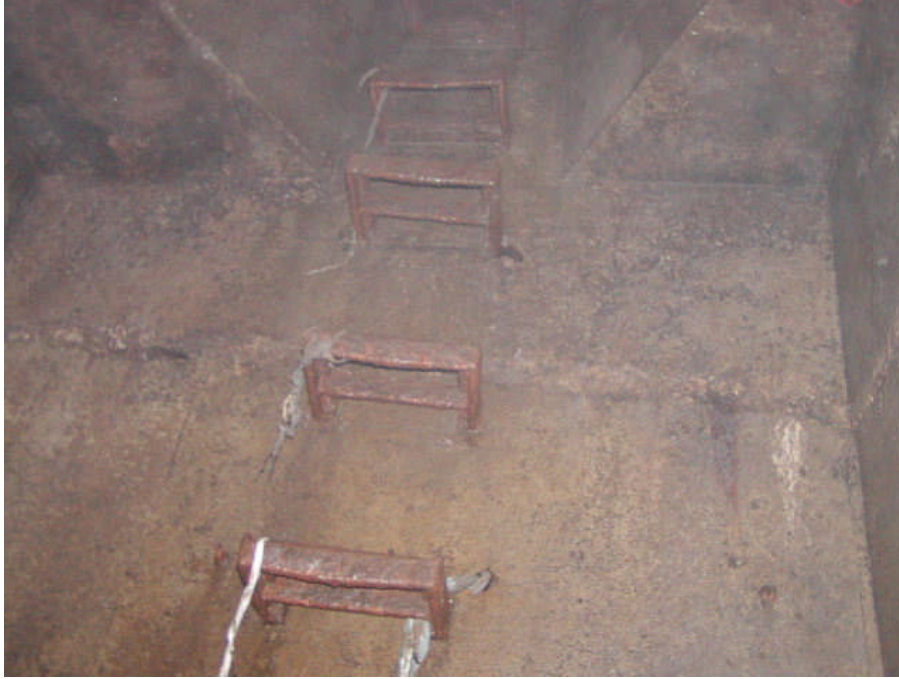
Photo 9. 49<sup>th</sup> Street manhole entrance ladder.

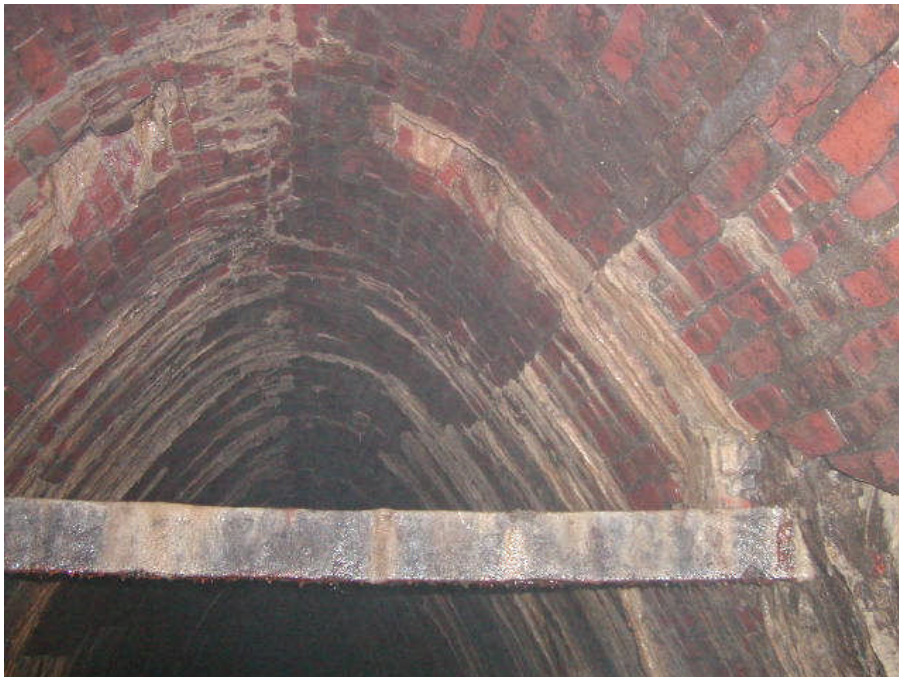
Photo 10. Brick roof and horizontal beam.

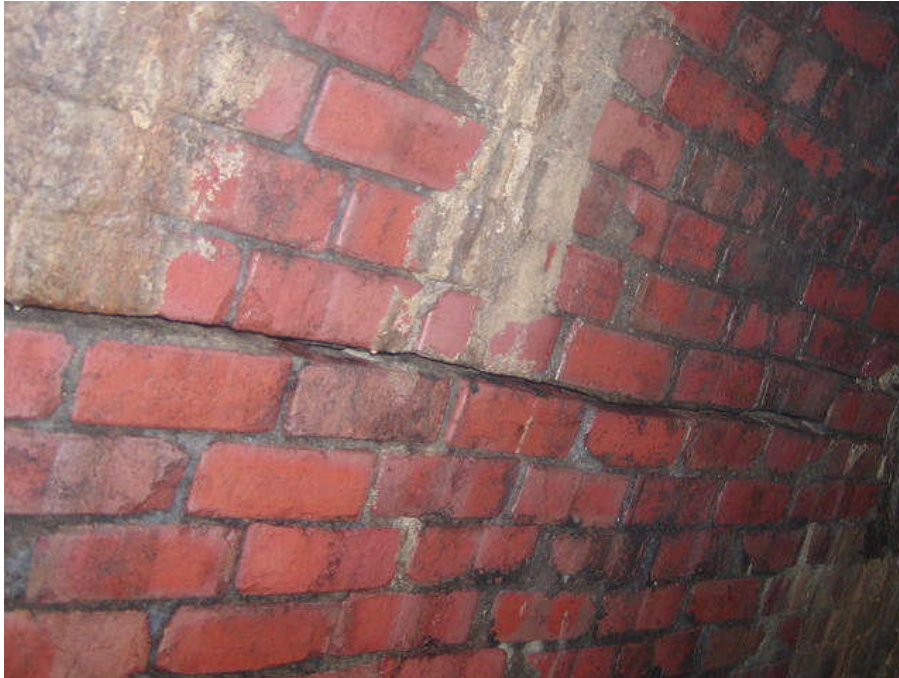
GENERAL: CRACKS IN MOTAR WITH AREAS OF HEAVY EFFLORESCENCE.  
LOCALIZED AREAS OF MISSING BRICK. SEE ATTACHED  
DIVER REPORT DATED 9/25/07.

Photo 11. Missing mortar between bricks.

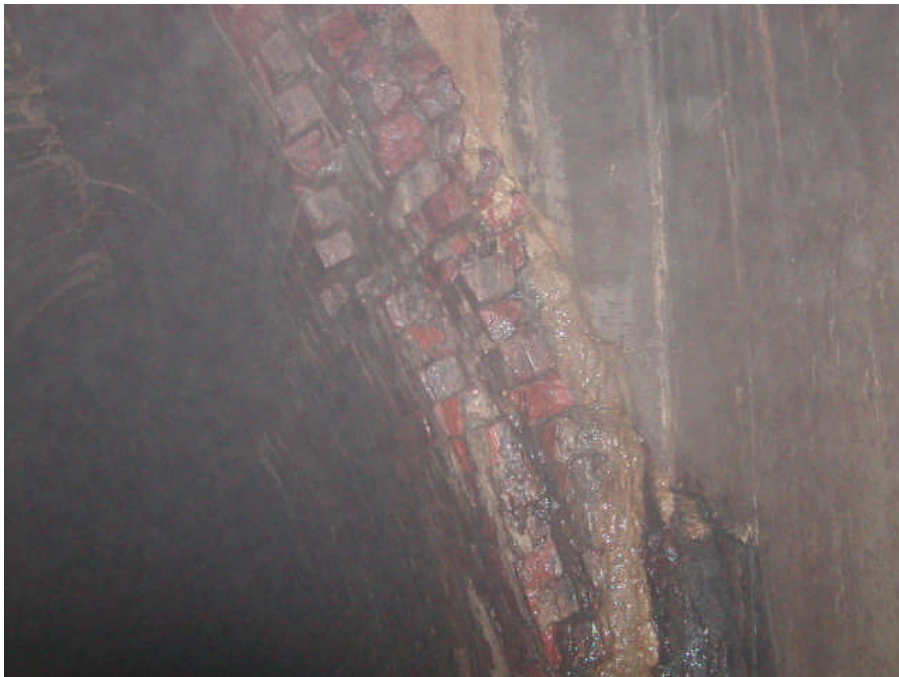
Photo 12. Joint between brick and concrete portion of the culvert.

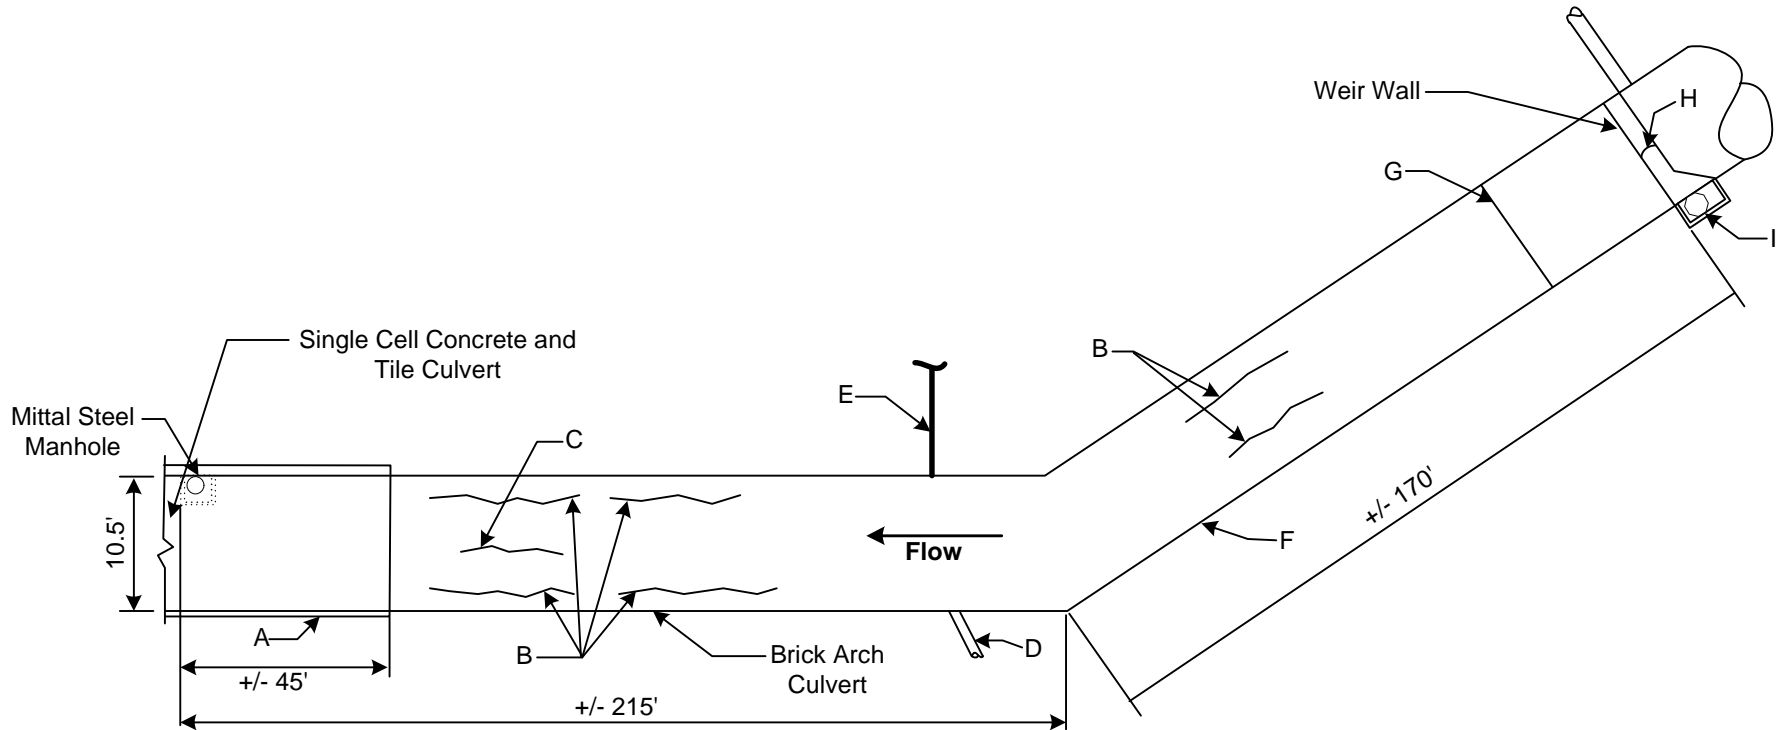
**Substructure Plan View**

- A. Jagged Transition with isolated areas of missing brick.
- B. Horizontal cracking with water infiltration.
- C. Water infiltration near the peak of the arch.
- D. 48" diameter brick inflow pipeline.
- E. 4" diameter clay inflow pipeline.
- F. Area of missing brick ~3 sq.ft.
- G. 6" steel cambering beam.
- H. Weir wall with hairline vertical through crack.
- I. East 49<sup>th</sup> Street Manhole.
