BRIDGE INSPECTION REPORT

BRIDGE NUMBER CUY 00077 1318

Inspection Report for:

Morgana Run Culvert under Interstate Route 77 below Cleveland, Ohio
(Three layer Brick and Reinforced Concrete Culvert)

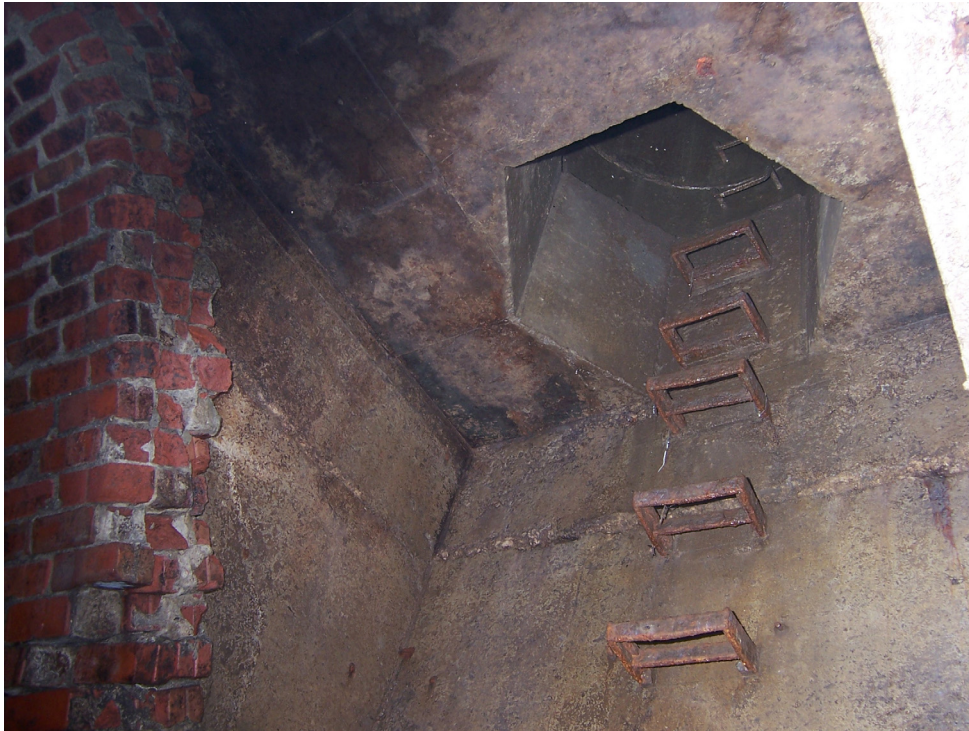
- At 385 feet from the Arcelor Mittal Steel entry manhole is the 49th Street manhole. This six-sided concrete structure has ladder rungs mounted on one side and is located on the south wall of the culvert (see Photo 2).

- The concrete around the 49th Street manhole had up to ½-inch deep scaling.
- The ladder rungs at both manholes were intact but heavily corroded. Photo 2 shows the 49th Street ladder rungs and Photos 14 and 16 show the Arcelor Mittal Steel manhole ladder rungs.

Photo 2 – Facing Southwest. 49th Street Manhole access.

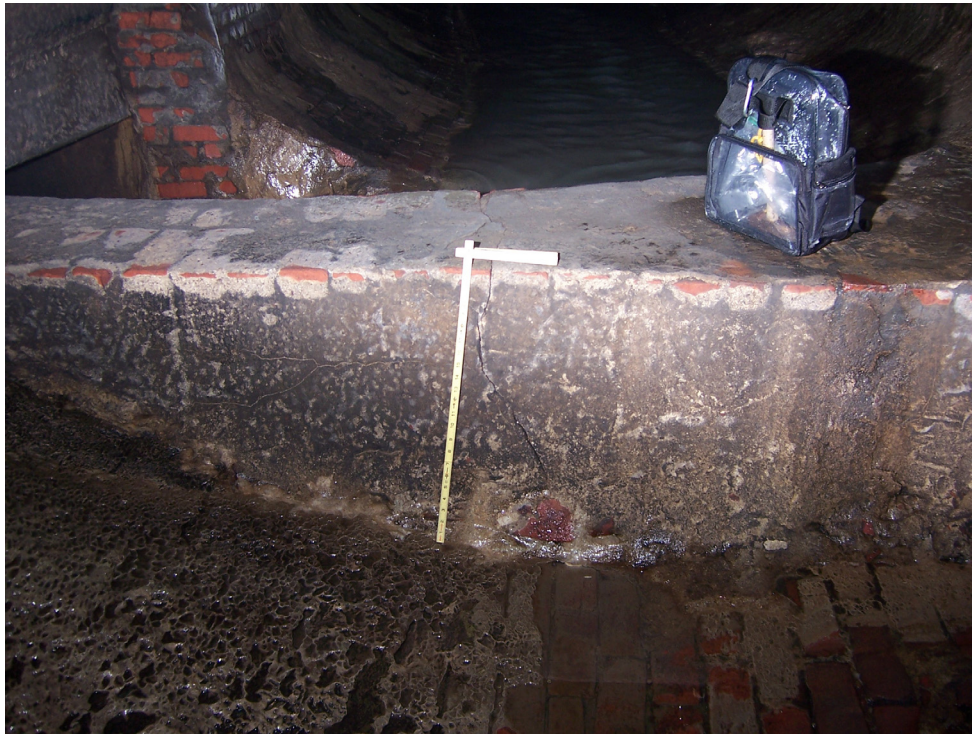
- The diversion weir has a 1/16-inch wide through crack at the center. This is shown in Photo 3.
- The horizontal beam shown in Photos 5, 6 and 7 has heavy corrosion and is deflected approximately 2 inches in the center. The area where the beam penetrates the walls is patched with concrete. Both the beam condition and the surrounding concrete patchwork are similar to the conditions found during the 2006 inspection. The similar beam to the east of the weir wall does not appear to have the deflection.

Photo 3 – Facing East. Weir Wall with 1/16-inch through crack.

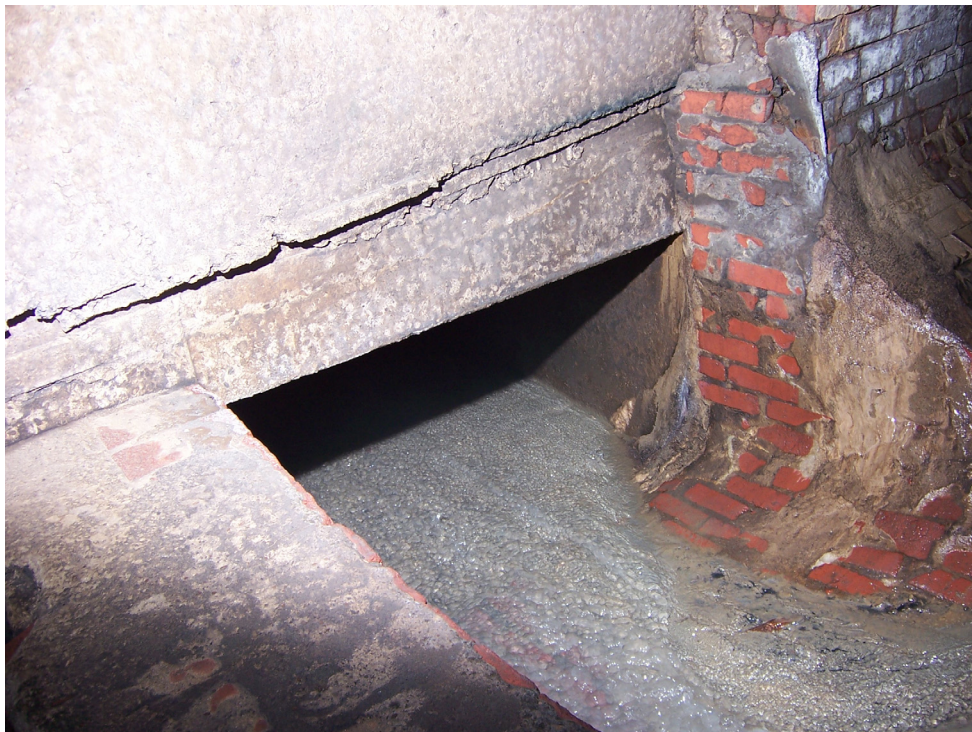
- The 12-inch deep water on the east side of the weir wall makes a 90-degree bend and flows under the north wall. This is shown in Photos 3 and 4. There were only sporadic puddles on the west side.

Photo 4 – Facing Northeast. Diversion Channel at the Weir Wall with water exiting beneath North Wall.

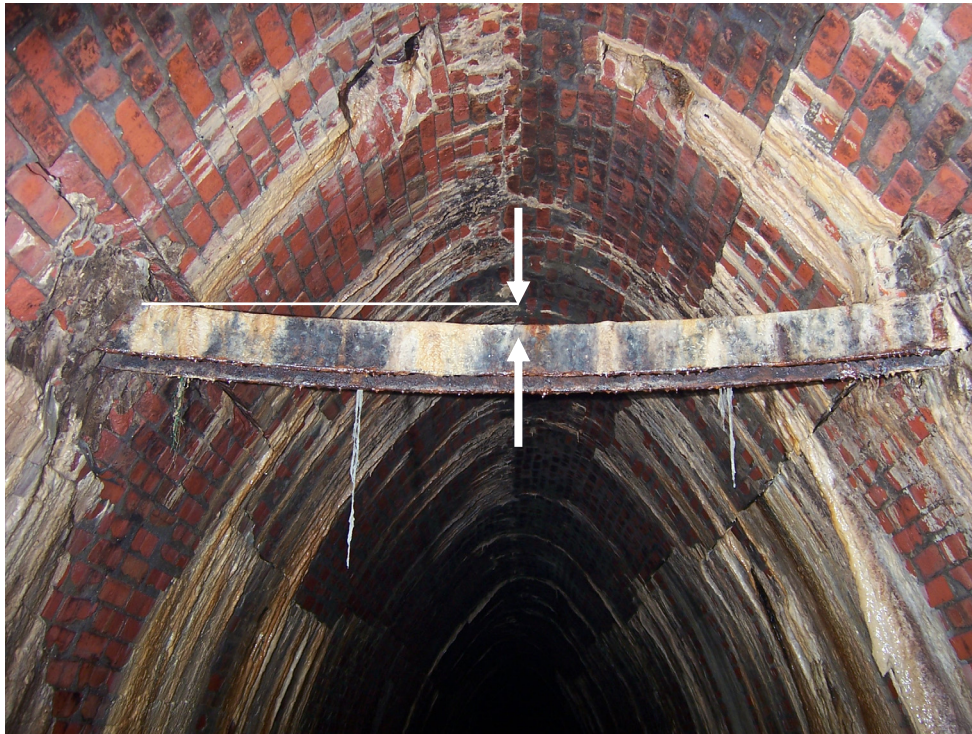
- At 370 feet from the entry point, is a horizontal six inch beam located eight feet above the floor. Photos 5, 6 and 7 show the beam and the brick surrounding it. A similar beam is located 15 feet east of the weir wall at the same elevation.

- Photos 5, 8, 12 and 13 show a ½-inch horizontal crack on both sides of the culvert with water infiltration and heavy efflorescence. This crack jumps mortar joints staying between 7 and 9 feet above the floor on both walls. The crack is not continuous around the culvert's 35-degree bend. There is very little infiltration in this area also.

*Photo 5 – Facing West at 370 feet from the Arcelor Mittal Steel entry point.
Steel Beam with approximate 2-inch deflection.*

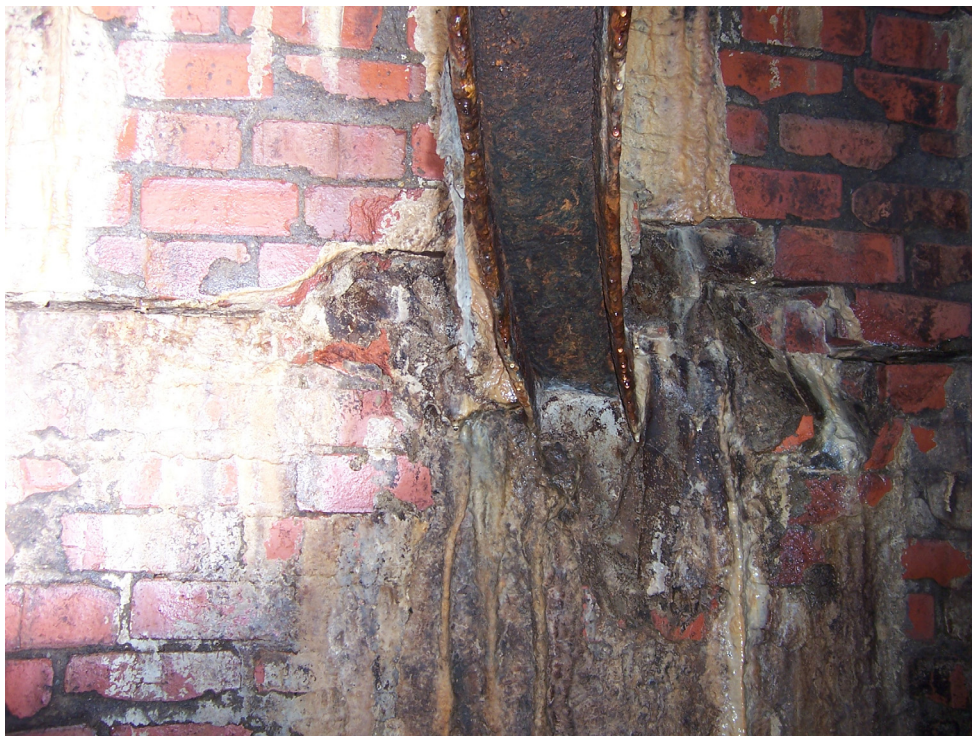
Photo 6 – Facing North. Area where the Steel Beam penetrates the brick wall.

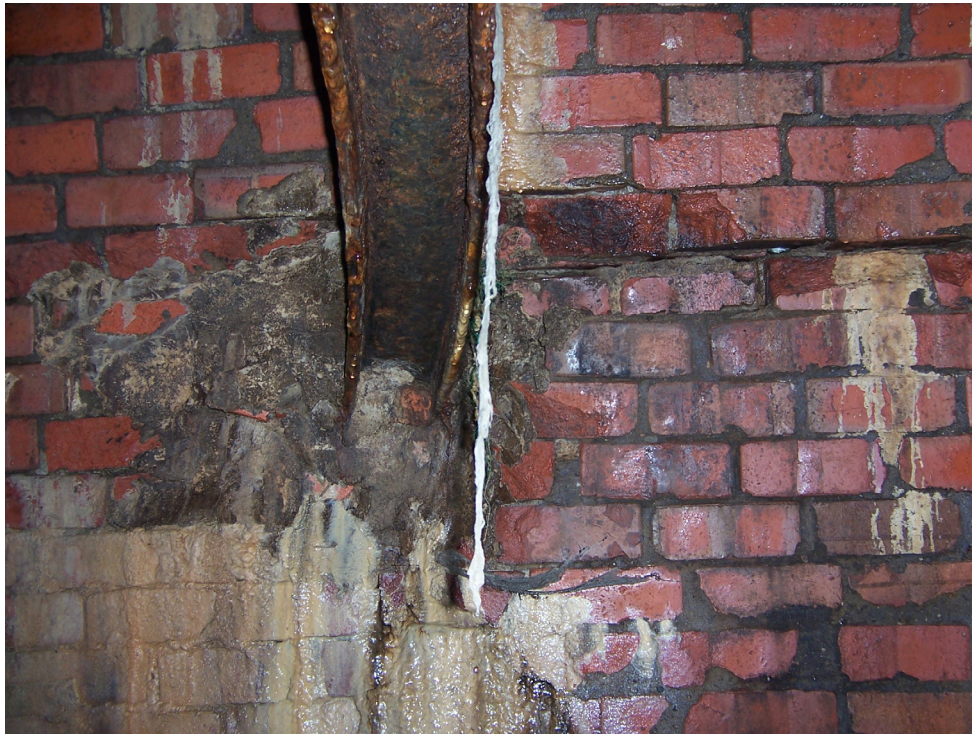
Photo 7 – Facing South. Area where the Steel Beam penetrates the brick wall.

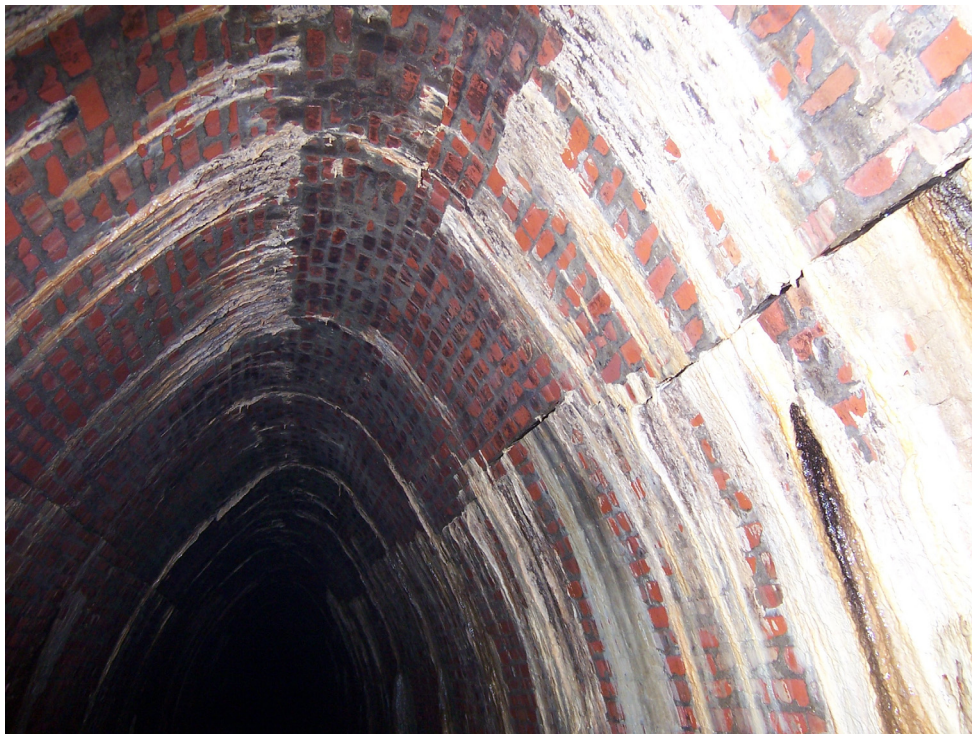
Photo 8 – Facing West at 365 feet from the Arcelor Mittal Steel entry point.
Horizontal Mortar Joint Cracks with infiltration and efflorescence.

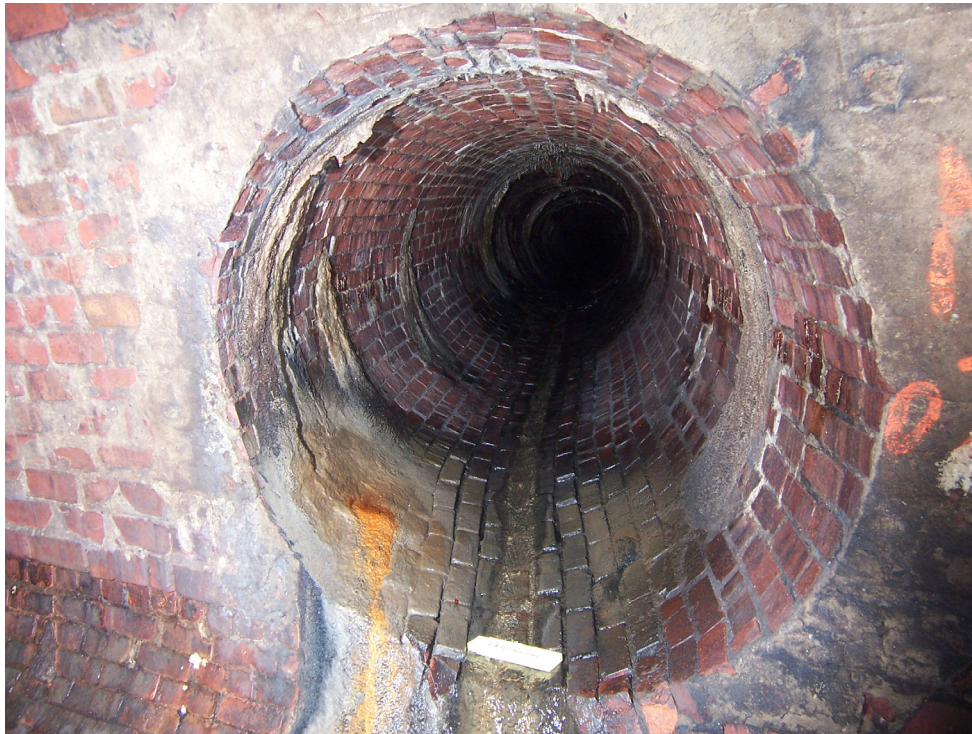
- Facing west at 215 feet from the entry point, the brick culvert makes approximately a 35-degree bend northward (to the right).
- There is a 4-foot diameter brick incoming pipe on the south wall 160 feet from the entry point. Photo 9 shows this incoming pipe with a small amount of flow.

Photo 9 – Facing South at 160 feet from the Arcelor Mittal Steel entry point.
48-inch diameter brick incoming pipe.

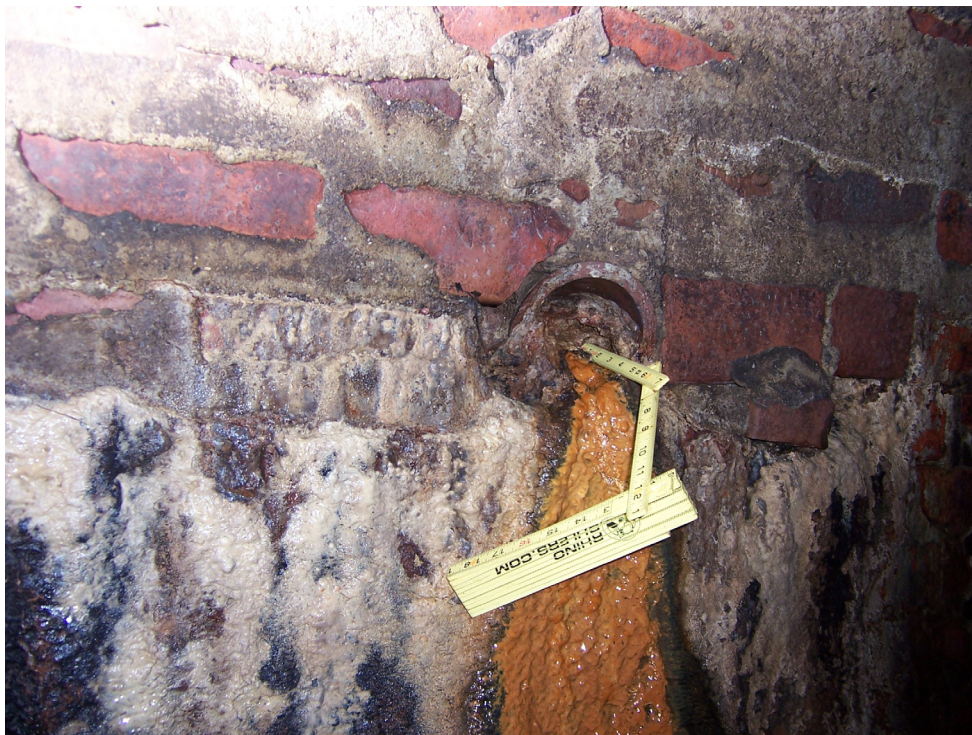
- There is a 4-inch diameter clay tile incoming pipe on the north wall at 160 feet from the entry point. It is located approximately 6 feet above the floor and is partially blocked with sludge and debris (see Photo 10).

Photo 10 – Facing North at 160 feet from the Arcelor Mittal Steel entry point.
4-inch diameter incoming clay tile pipe.

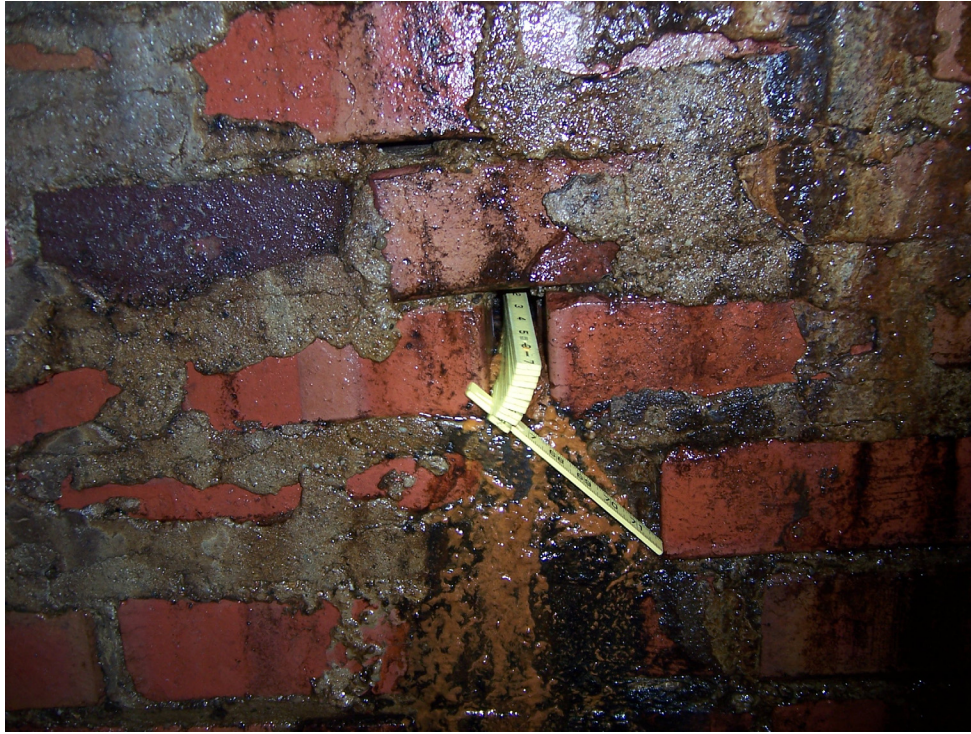
- Photo 11 shows a 2-inch wide x 3-inch high hole in the first layer of brick located 5 feet off of the floor on the north wall at 150 feet east of the entry point. This small area was not noted in the previous inspection.

Photo 11 – Facing North at 150 feet from the Arcelor Mittal Steel entry point.
2-inch wide x 3-inch high hole in first layer of brick.

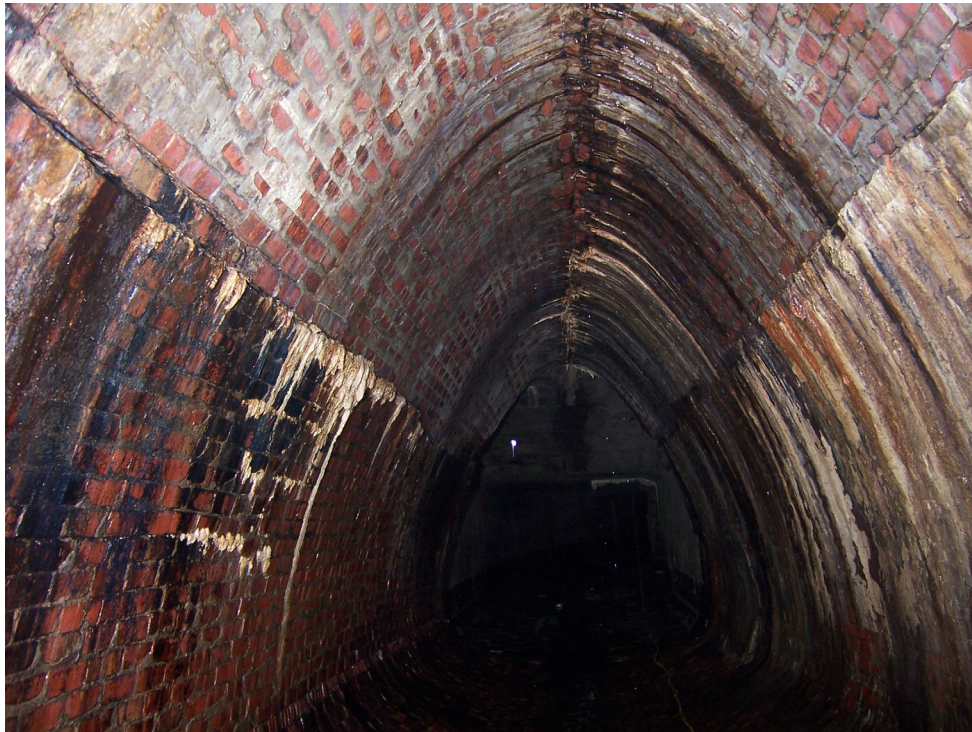
- There is water infiltration in numerous places at the peak for the first 100 feet of the teardrop shaped culvert. Photo 12 shows this well.
- The transition between the two culvert types is not smooth at the west end. This is shown in Photo 13.

Photo 12 – Facing West. Looking out the west end of the Brick Culvert.

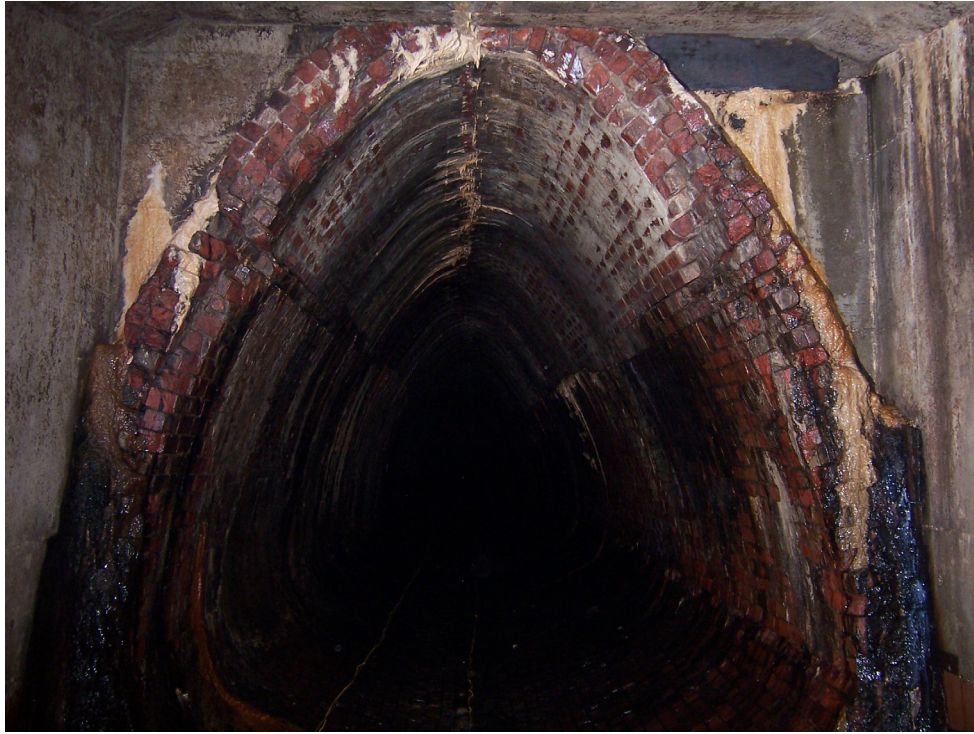
Photo 13 – Facing East. Transition from Concrete to Brick Culvert.

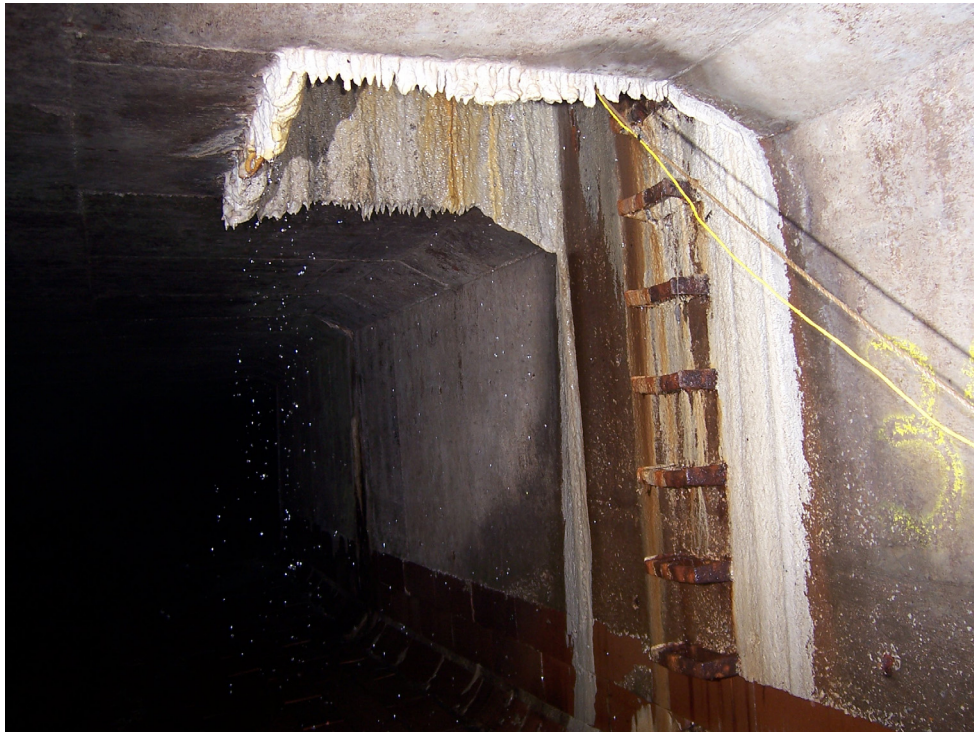
- The concrete culvert below the entry point had up to ¼-inch scaling with heavy efflorescence near the ladder rungs (Photos 14 – 16).
- The entry / exit manhole ladder rungs are offset, corroded and slippery. A tripod, winch and harness are necessary for safe extraction.

Photo 14 – Facing Northwest. Arcelor Mittal Steel manhole (entry point) ladder rungs.

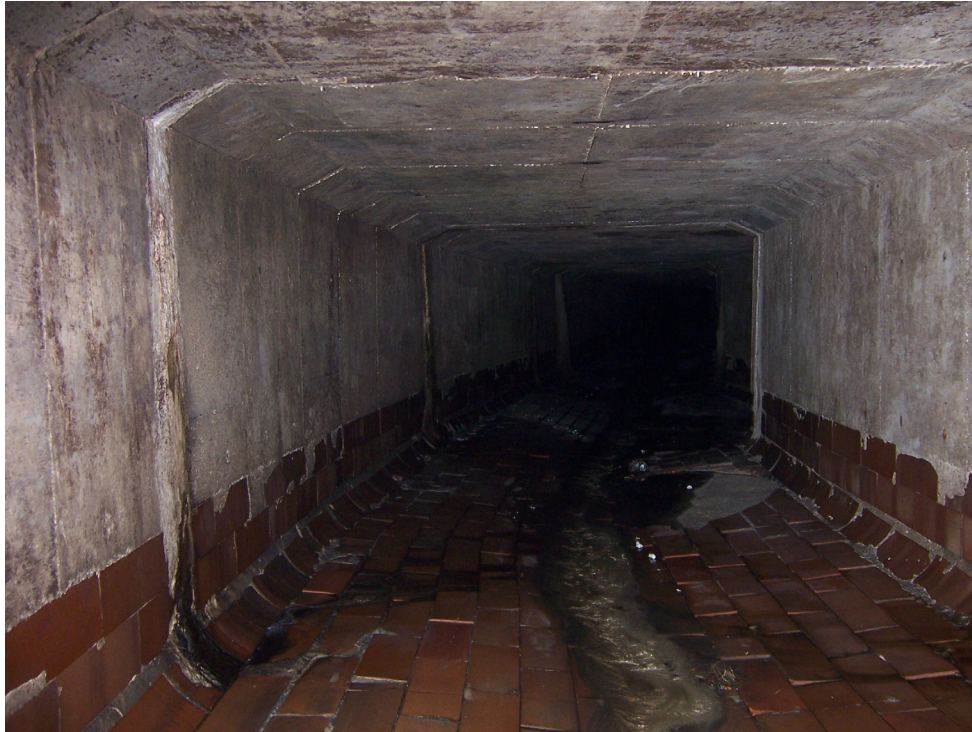
- The culvert transitions from the red brick teardrop shape to a rectangle concrete and tile floor culvert section 45 feet from the entry point. This is shown in Photos 12, 13 and 15.

Photo 15 – Facing West. Concrete and Tile Culvert.

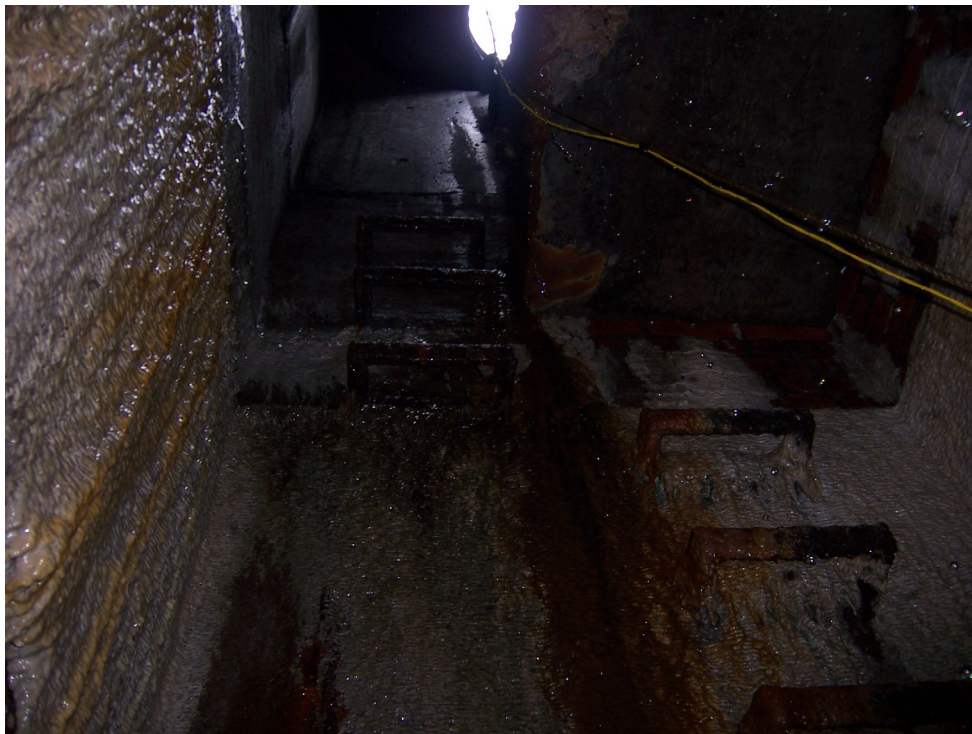
Photo 16 – Facing up at entry point. Note the offset in the ladder rungs.
