BRIDGE INSPECTION REPORT

BRIDGE NUMBER CUY 00077 1318

Inspection Report for:

Morgana Run Culvert under Interstate Route 77 below Cleveland, Ohio
(Three layer Brick and Reinforced Concrete Culvert)

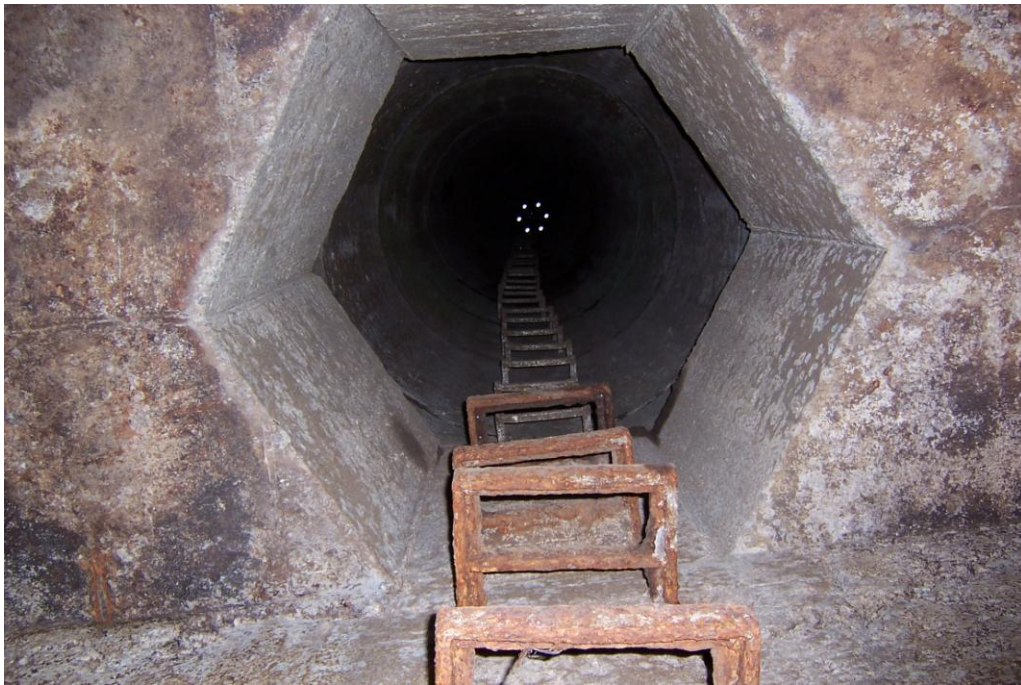
- At 385 feet from the Arcelor Mittal Steel entry manhole is the 49th Street manhole. This six-sided concrete structure has ladder rungs mounted on one side and is located on the south wall of the culvert (see Photo 2).

- The concrete around the 49th Street manhole had up to ½-inch deep scaling.
- The ladder rungs at both manholes were intact but heavily corroded. Photo 2 shows the 49th Street ladder rungs and Photos 14 and 16 show the Arcelor Mittal Steel manhole ladder rungs.

Photo 2 – Facing Upward. 49th Street Manhole access.

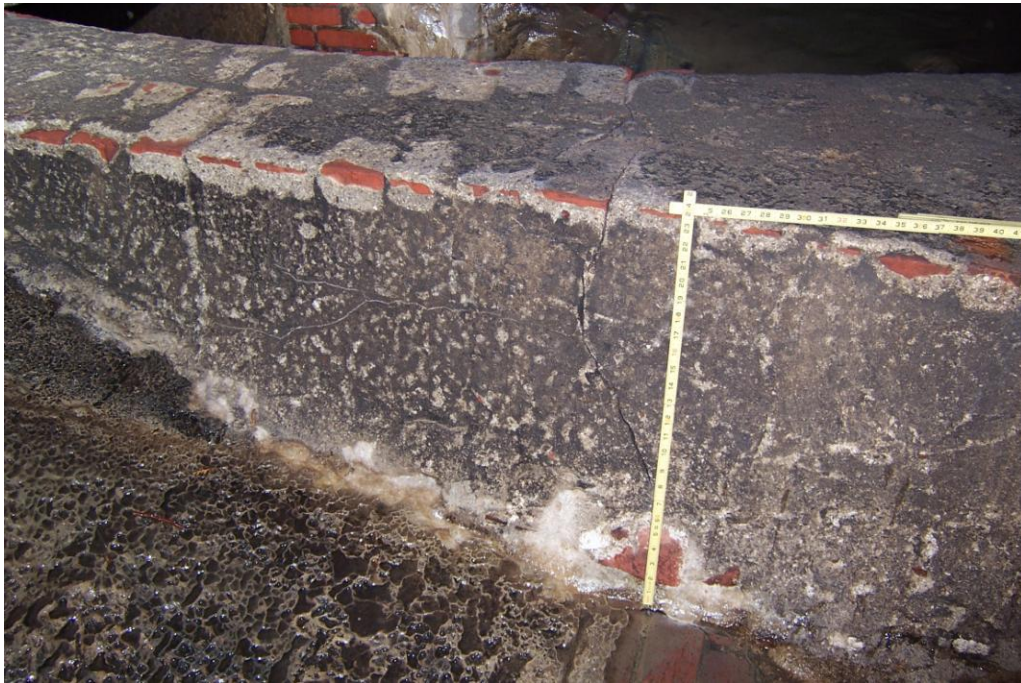
- The 12-inch deep water on the east side of the weir wall makes a 90-degree bend and flows under the north wall. This is shown in Photos 3 and 4. There were only sporadic puddles on the west side.

- The diversion weir has a 1/16-inch wide through crack at the center. This is shown in Photo 3.
- The horizontal beam shown in Photos 5, 6 and 7 has heavy corrosion and is deflected approximately 2 inches in the center. The area where the beam penetrates the walls is patched with concrete. Both the beam condition and the surrounding concrete patchwork are similar to the conditions found during the 2009 inspection. There is minor debris on the beam (see Photos 5-7). The similar beam to the east of the weir wall does not appear to have the deflection.

Photo 3 – Facing East. Weir Wall with 1/16-inch through crack.

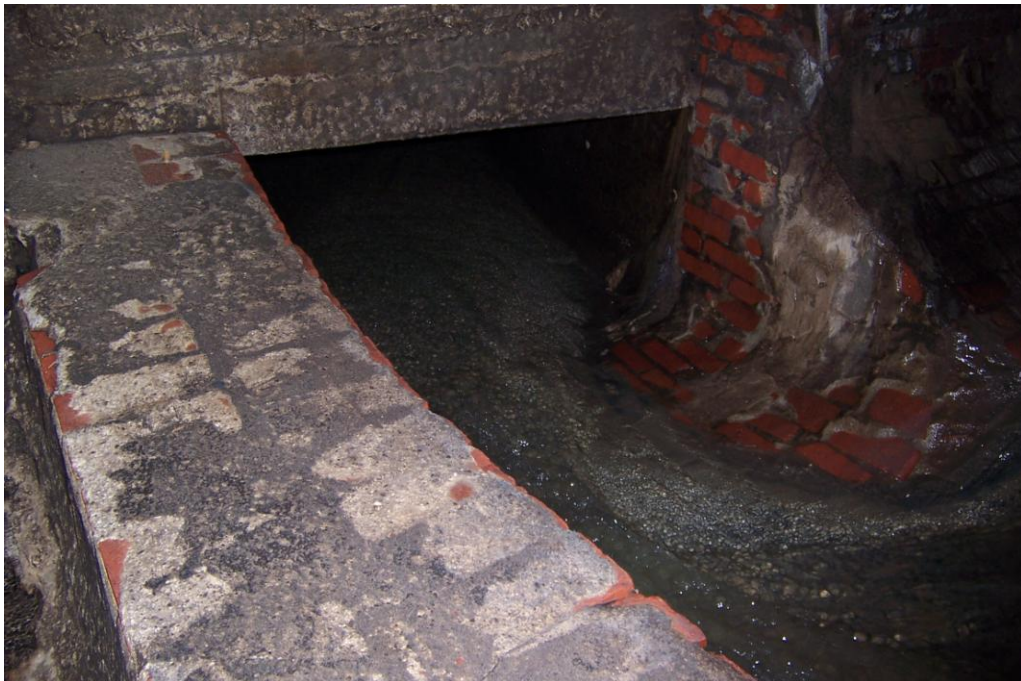
Photo 4 – Facing Northeast. Diversion Channel at the Weir Wall with water exiting beneath North Wall.

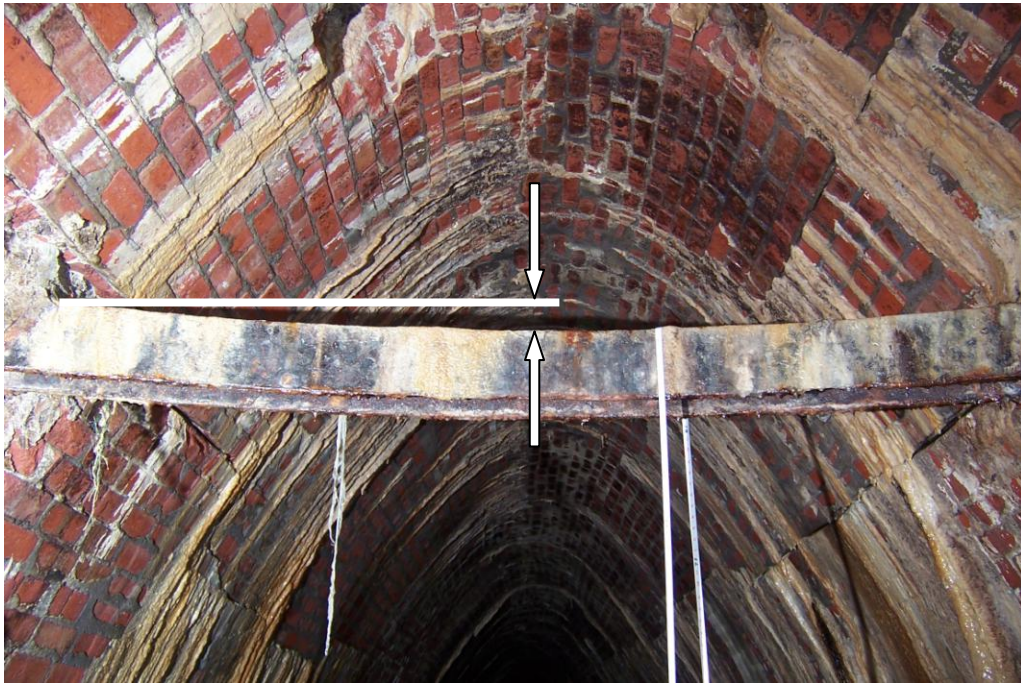
- At 370 feet from the entry point, is a horizontal six inch beam located eight feet above the floor. Photos 5, 6 and 7 show the beam and the brick surrounding it. A similar beam is located 15 feet east of the weir wall at the same elevation.

- Photos 5, 8, 12 and 13 show a ¼ to ½-inch horizontal crack on both sides of the culvert with water infiltration and heavy efflorescence. This crack jumps mortar joints staying between 7 and 9 feet above the floor. The cracking is mostly on the south wall. The crack is not continuous around the culvert's 35-degree bend. There is very little infiltration in this area also.

*Photo 5 – Facing West at 370 feet from the Arcelor Mittal Steel entry point.
Steel Beam with approximate 2-inch deflection and debris.*

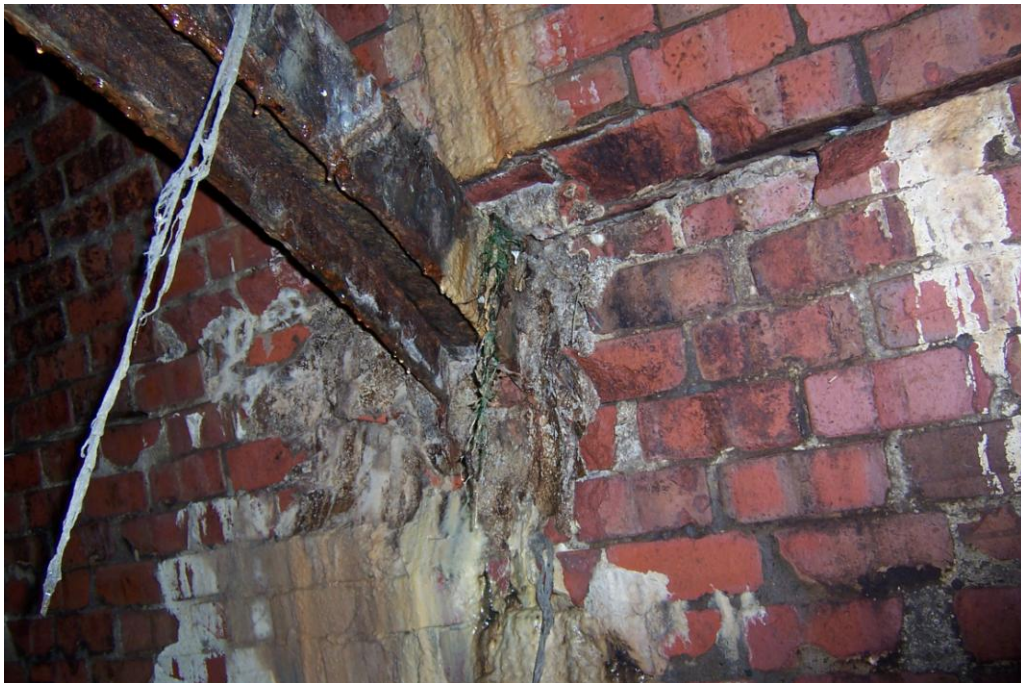
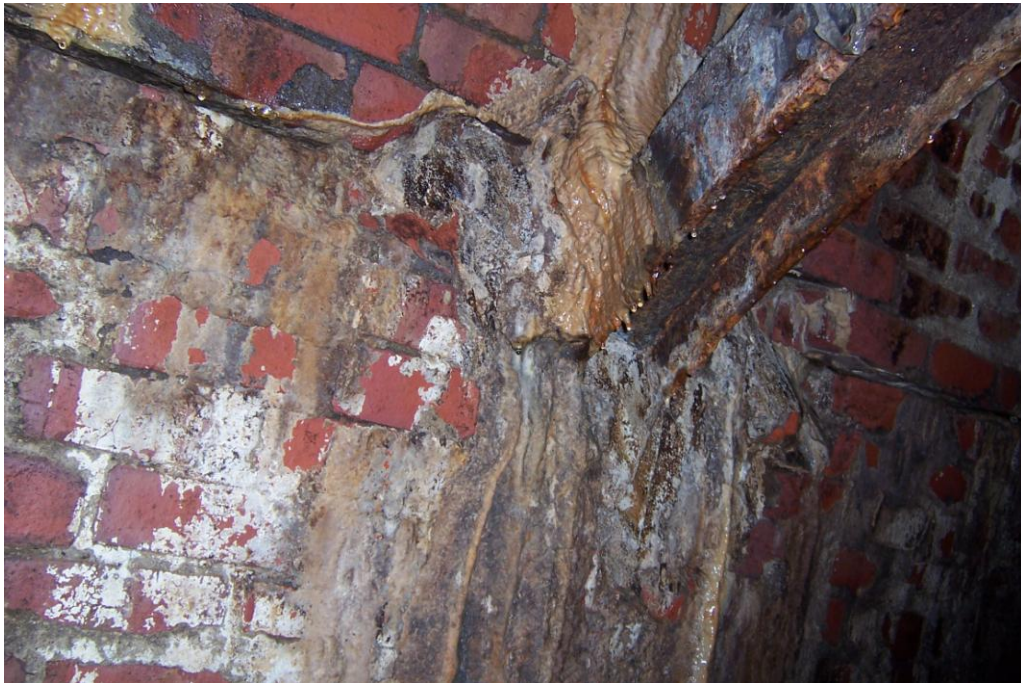
Photo 6 – Facing South. Area where the Steel Beam penetrates the brick wall.

Photo 7 – Facing North. Area where the Steel Beam penetrates the brick wall.

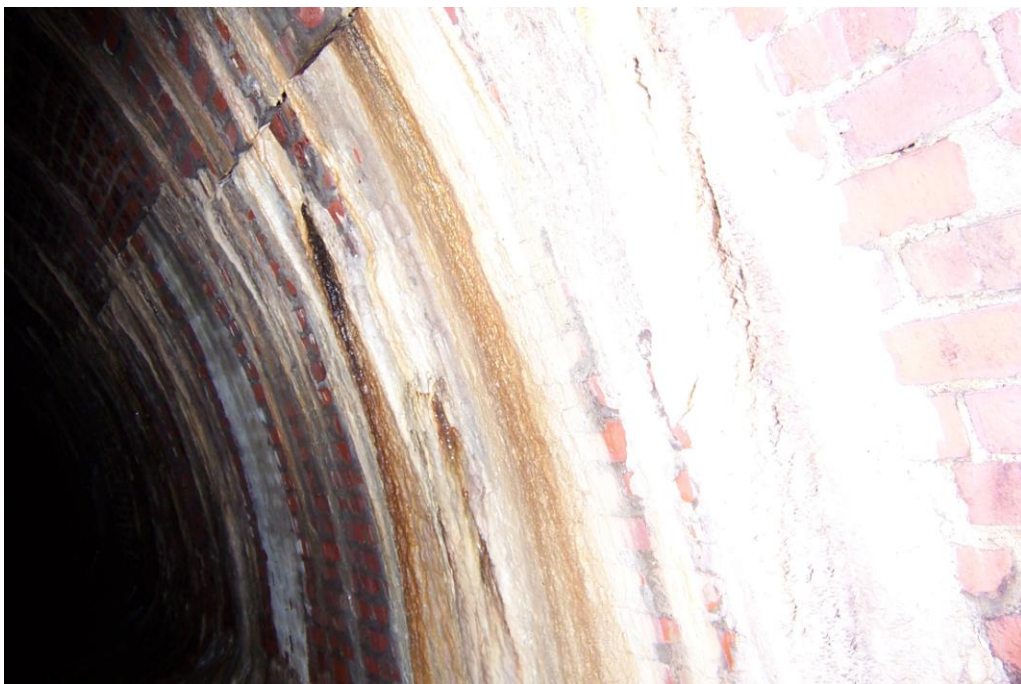
*Photo 8 – Facing West at 365 feet from the Arcelor Mittal Steel entry point.
Horizontal Mortar Joint Cracks with infiltration and efflorescence.*

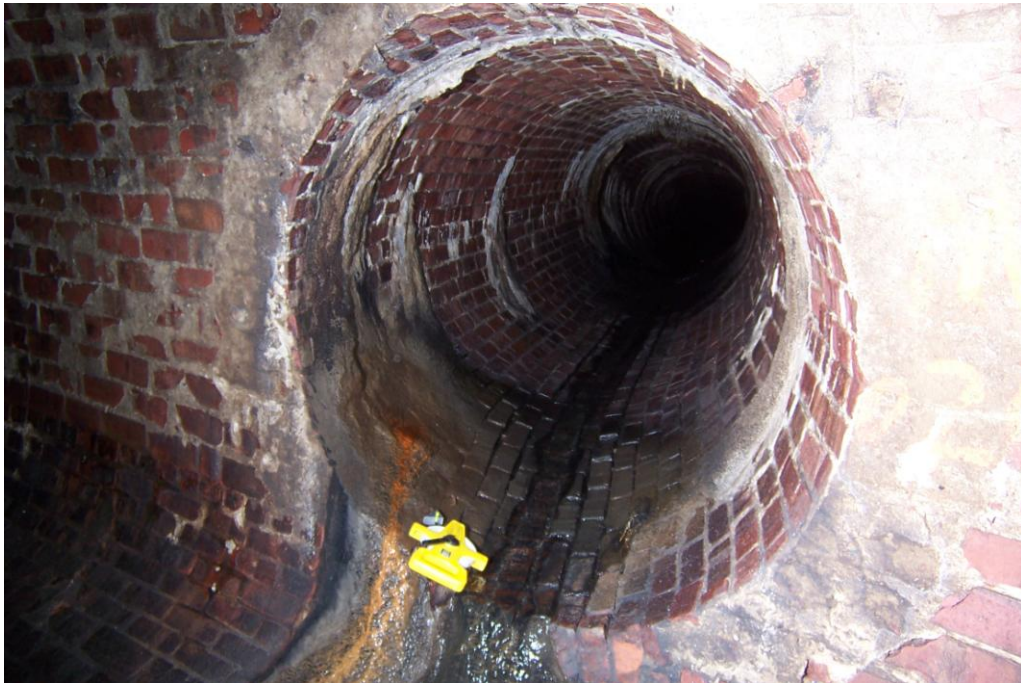
- Facing west at 215 feet from the entry point, the brick culvert makes approximately a 35-degree bend northward (to the right).
- There is a 4-foot diameter brick incoming pipe on the south wall 290 feet from the entry point. Photo 9 shows this incoming pipe with a small amount of flow.

*Photo 9 – Facing South 290 feet from the entry manhole.
48-inch diameter brick incoming pipe.*

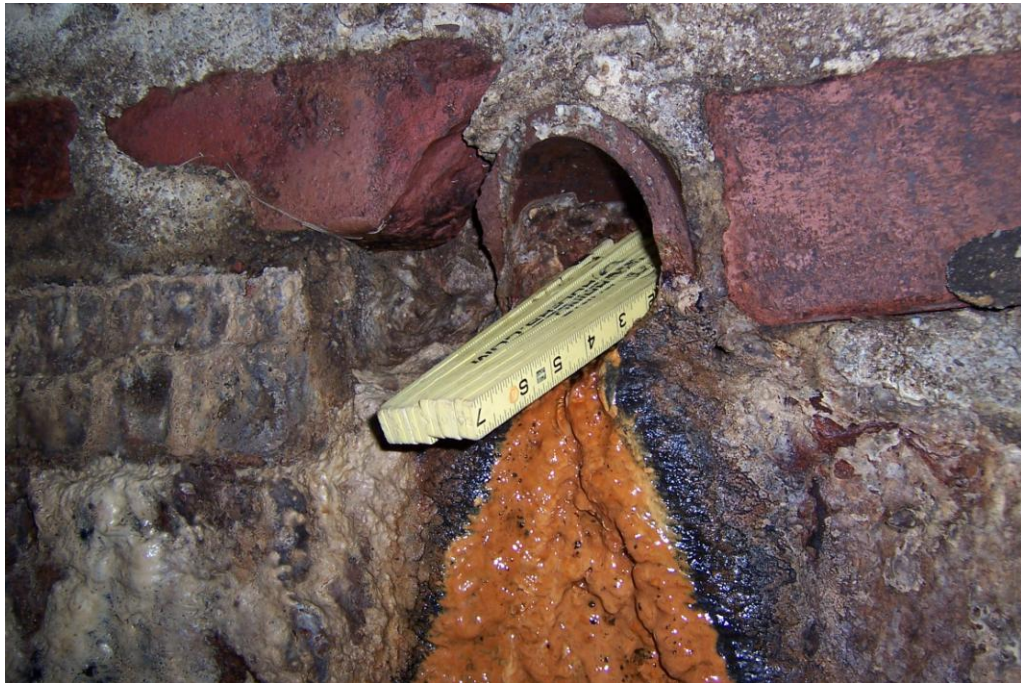
- There is a 4-inch diameter clay tile incoming pipe on the north wall at 160 feet from the Arcelor Mittal Steel entry manhole. It is located approximately 6 feet above the floor and is partially blocked with sludge and debris (see Photo 10).

*Photo 10 – Facing North at 160 feet from the Arcelor Mittal Steel entry point.
4-inch diameter incoming clay tile pipe.*

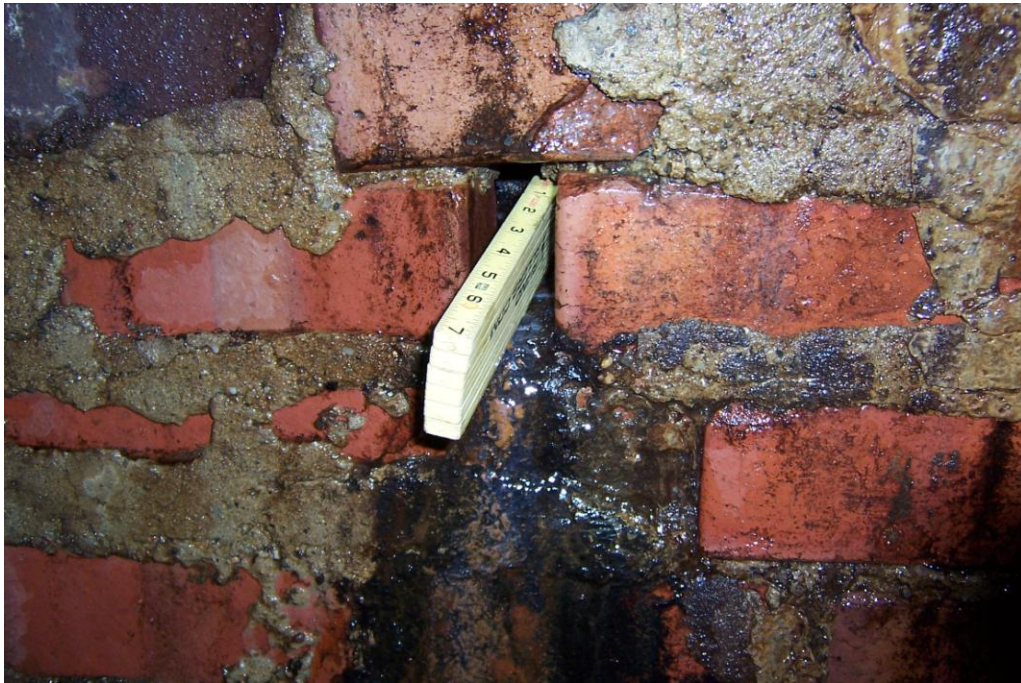
- Photo 11 shows a 2-inch wide x 3-inch high hole in the first layer of brick located 5 feet off of the floor on the north wall at 150 feet east of the entry point.

*Photo 11 – Facing North at 150 feet from the Arcelor Mittal Steel entry point.
2-inch wide x 3-inch high hole in first layer of brick.*

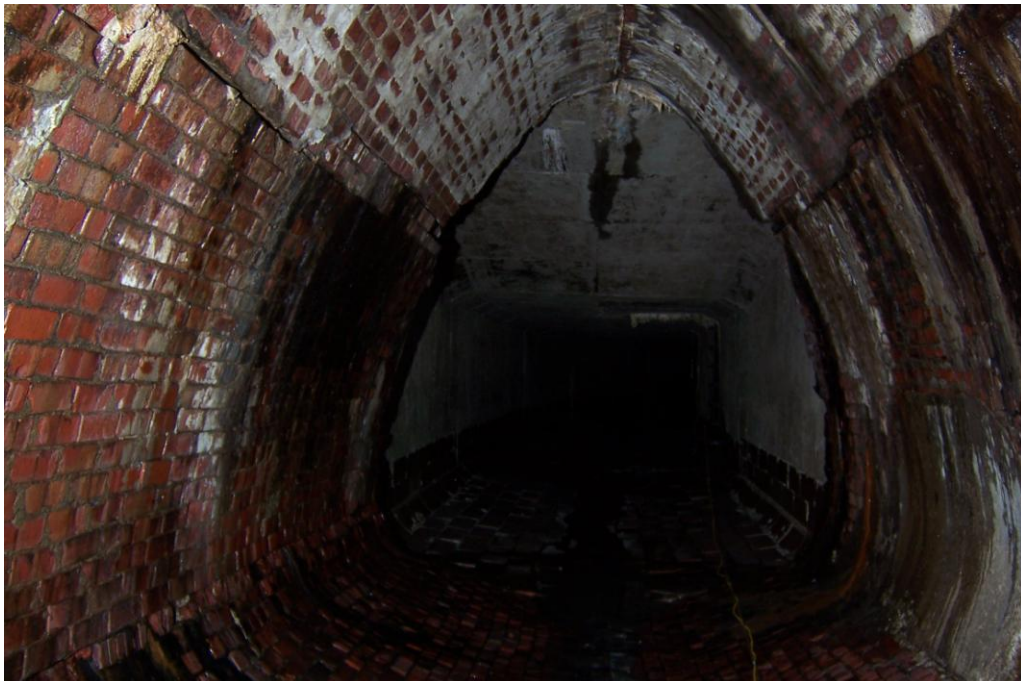
- There is water infiltration in numerous places at the peak for the first 100 feet of the teardrop shaped culvert. Photo 12 shows this well.
- The transition between the two culvert types is not smooth at the west end. This is shown in Photo 13.

Photo 12 – Facing West. Looking out the west end of the Brick Culvert.

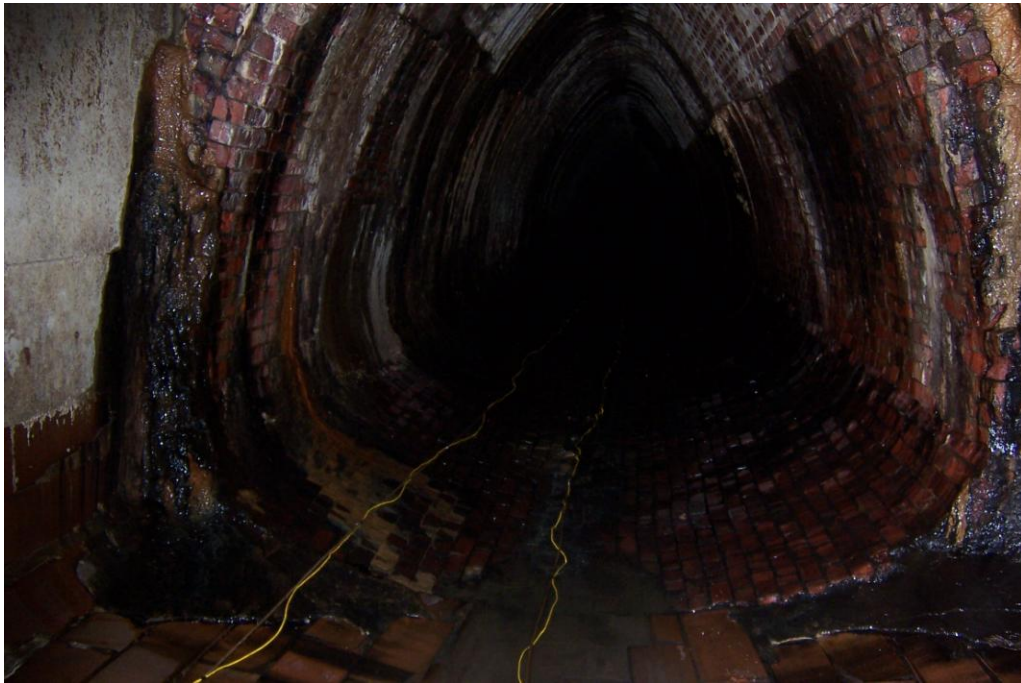
Photo 13 – Facing East. Transition from Concrete to Brick Culvert.

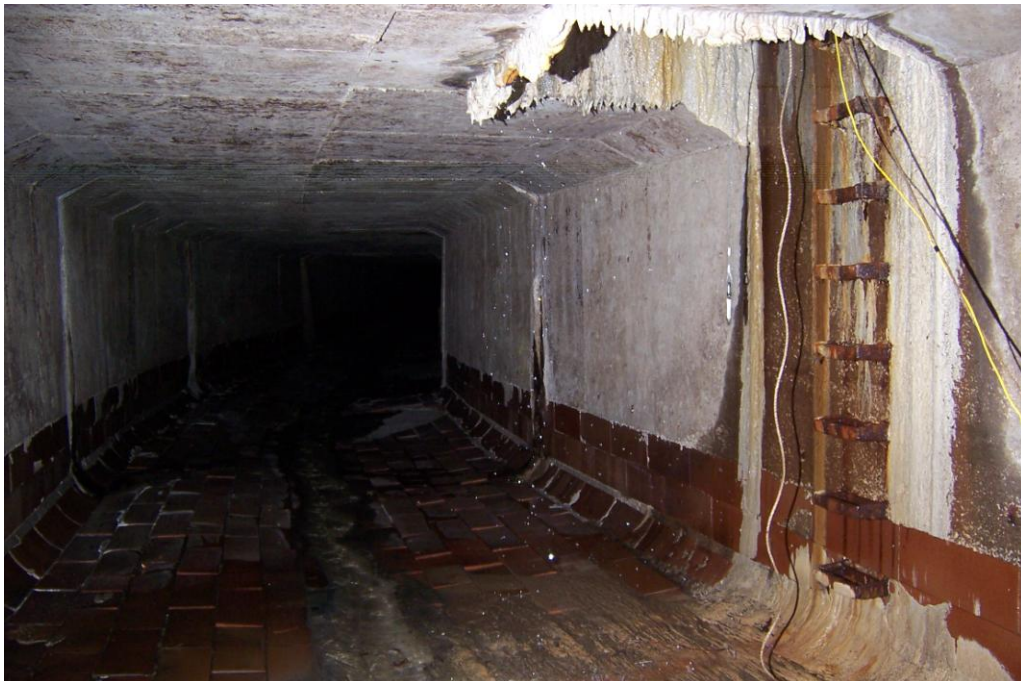
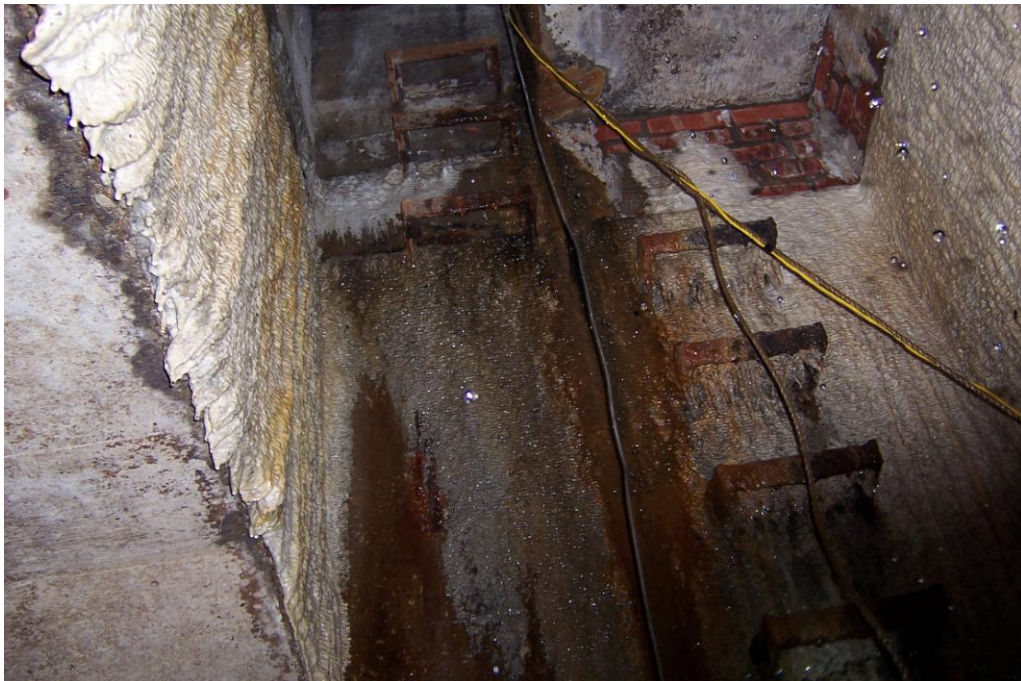
- The concrete culvert below the entry point had up to ¼-inch scaling with heavy efflorescence near the ladder rungs (Photos 14 – 16).
- The entry / exit manhole ladder rungs are offset, corroded and slippery. A tripod, winch and harness are necessary for safe extraction.

Photo 14 – Facing Northwest. Arcelor Mittal Steel manhole (entry point) ladder rungs.

Photo 16 – Facing up at entry point. Note the offset in the ladder rungs.

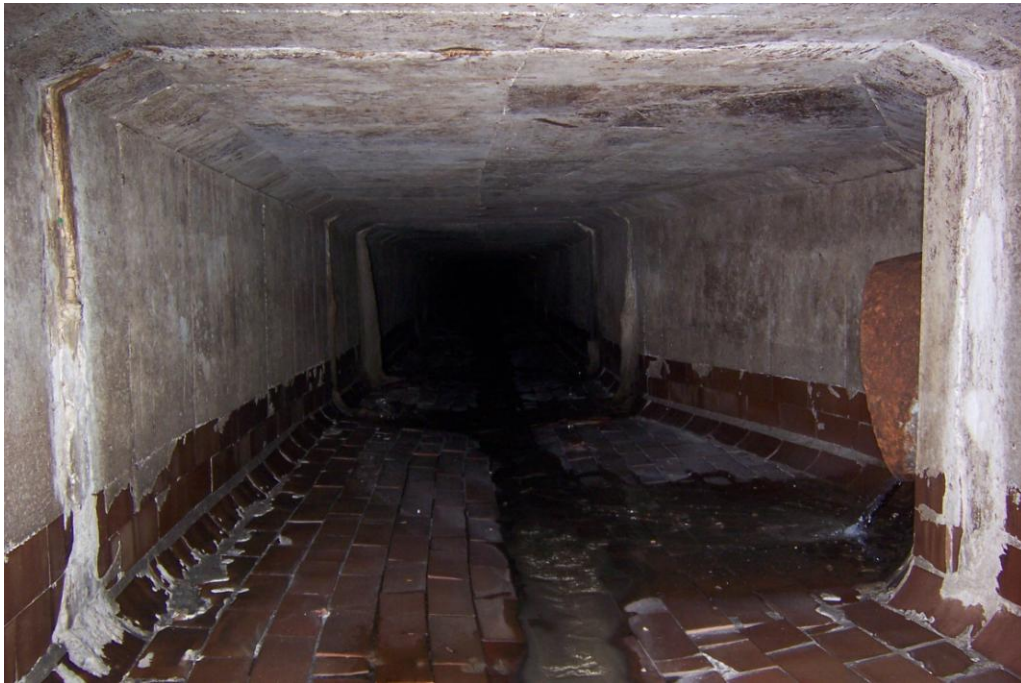
- The culvert transitions from the red brick teardrop shape to a rectangle concrete and tile floor culvert section 45 feet from the entry point. This is shown in Photos 12, 13 and 15.

Photo 15 – Facing West. Concrete and Tile Culvert.

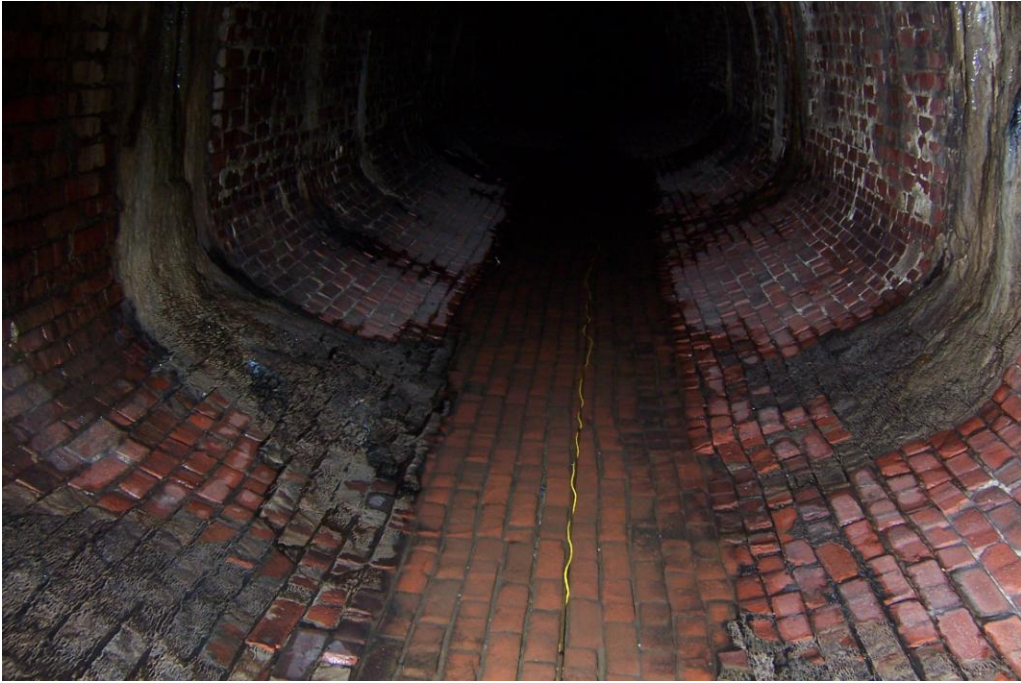
- No loose bricks or concrete debris was found on the floor.
- Photo 17 shows a 60' long x 3' wide area of 4" deep standing water approximately 50' from the East 49th Street manhole.

Photo 17 – Facing West. Standing water along the floor of the culvert at approximately 335 feet from the entry manhole.
