**Underwater Inspection of
SFN - 1806564
Morgana Run Culvert under Interstate 77 and
East 49th Street
(CUY-77-1318)
October 31, 2014
For
Ohio Department of Transportation
District-12**

By
GPI/Greenman-Pedersen, Inc.

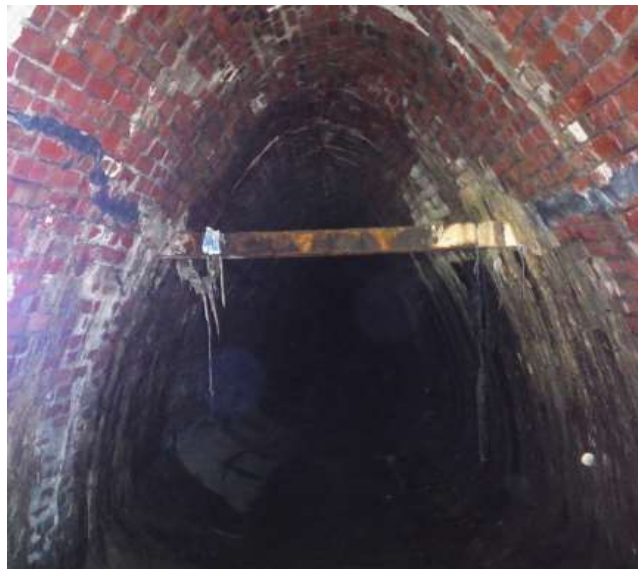
(General View of Brick Arch Structure)

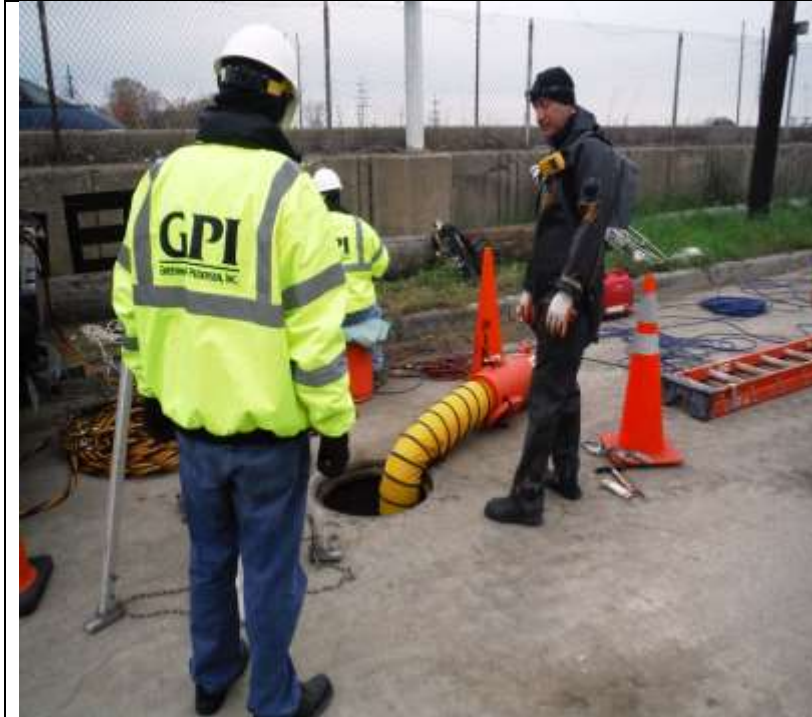
Photograph 1

Culvert Entrance
through manhole on
East 49th Street

Safety Equipment in
place.

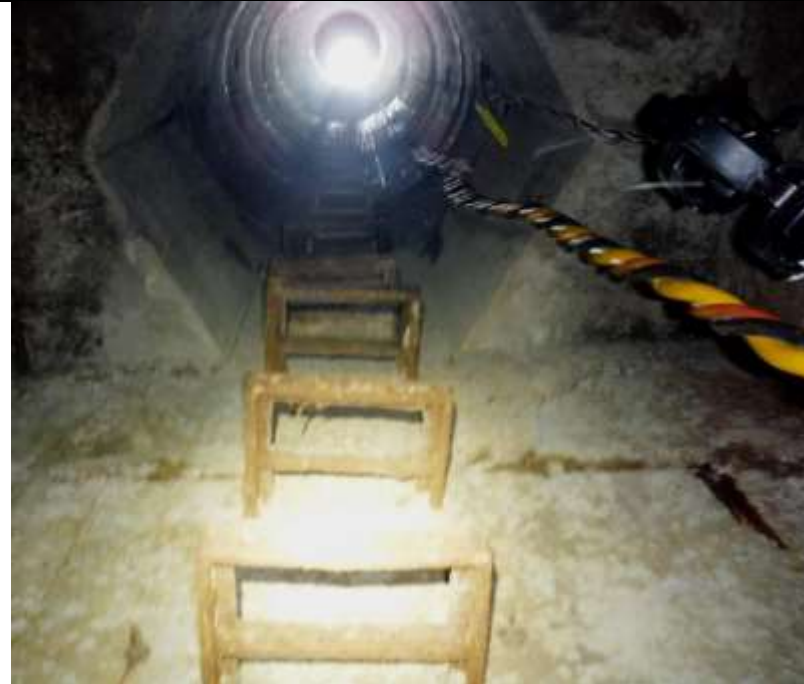
Photograph 2

View of entry manhole
from East 49th Street.
Note tether as manhole
is over 65 feet deep.

Station 0+00

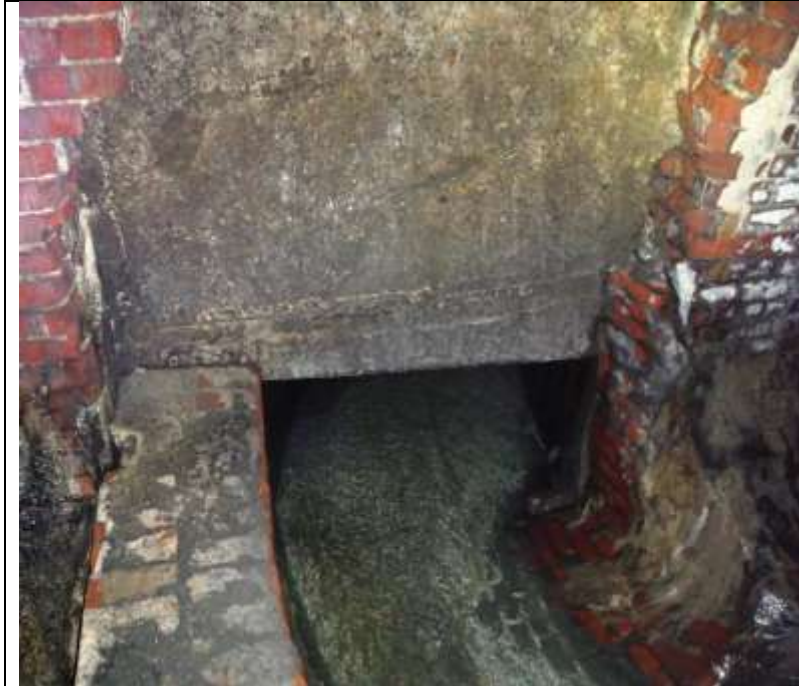
Photograph 3

- Station 0+05: There is a diversion weir which runs in a north-south direction, parallel with I-77 and East 49th Street. This weir intersects the flow coming from the east, under East49th Street and directs it in a northerly direction in a 20"x 24" brick invert. (See Photograph # 3). There is a crack in the weir wall that runs through the entire depth of the wall. It has remained unchanged since the last inspection.(See Photograph #4)

Intercepting invert and weir. Sewer line running parallel with East 49th Street

Station 0+05

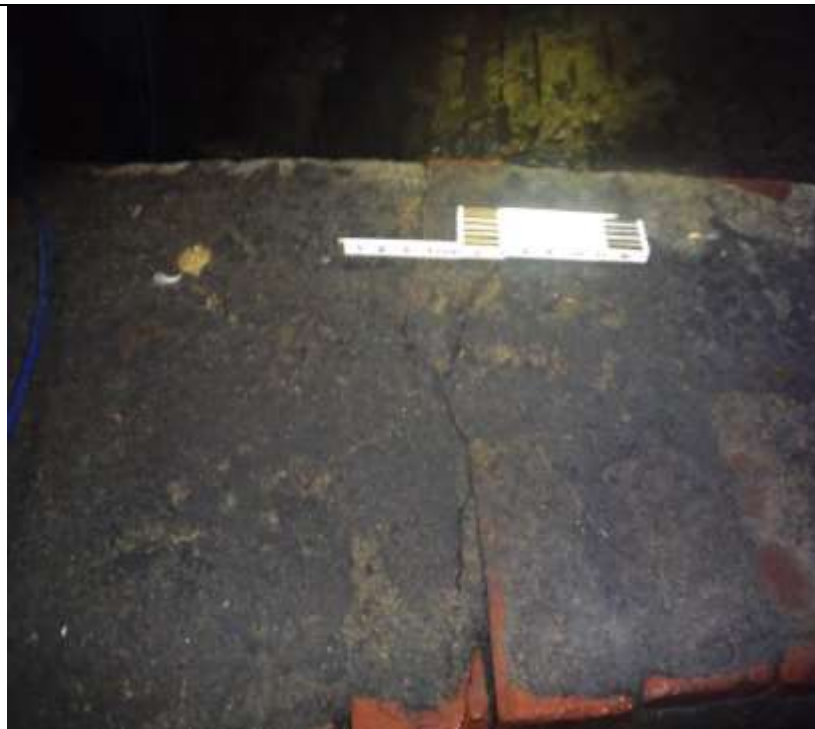
Photograph 4

Crack in Weir Wall

Station 0+05

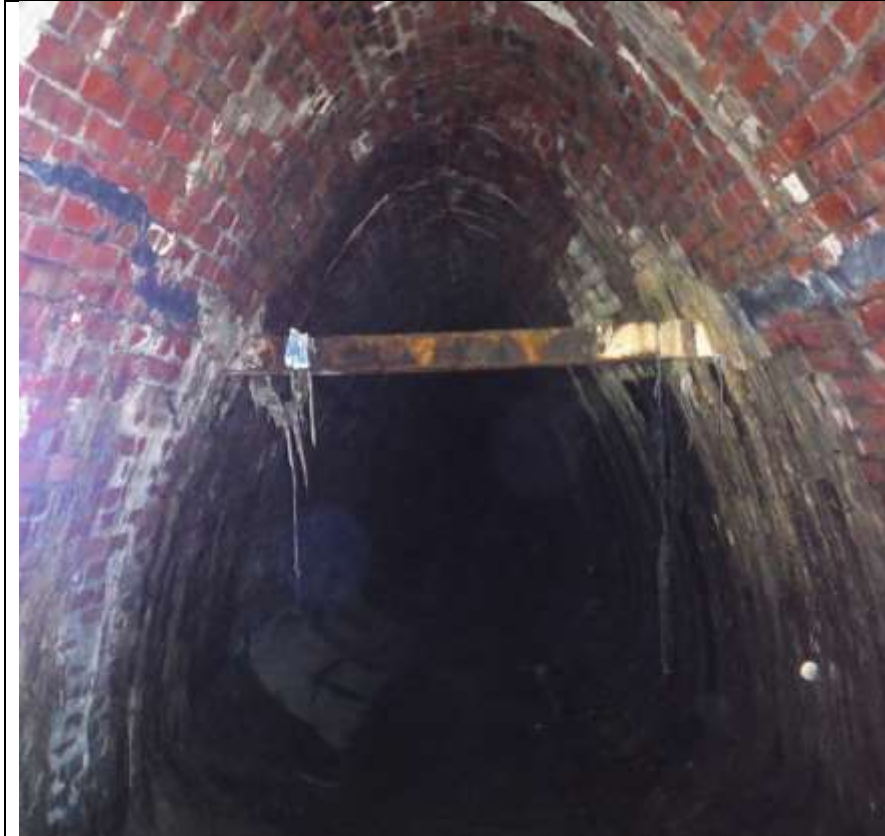
Photograph 5

- Station 0+12: There is a W 8 by 14(estimated) steel beam running perpendicular to the brick culvert at approximately two-thirds of the height of the culvert, from the bottom invert. This beam is deflected in both a horizontal and vertical direction. Horizontal deflection is approximately 2"from level and the vertical deflection (sweep) is approximately 5" to 6". This deflection does not appear to be a recent development as the joint at the brick wall shows little to no change from previous reports. (See Photographs #5 , #6 and #8)

Steel Beam in Brick Arch
Culvert

Station 0+12

- Re-inspect the culvert at the normal maximum recommended interval of five (5) years and after a significant event such as flooding or other phenomenon that could affect the structural integrity of the culvert.
- Continue to monitor the deflection in the steel beam located at Station 0+12 and the large joint separation between stations 0+15 to 0+30.

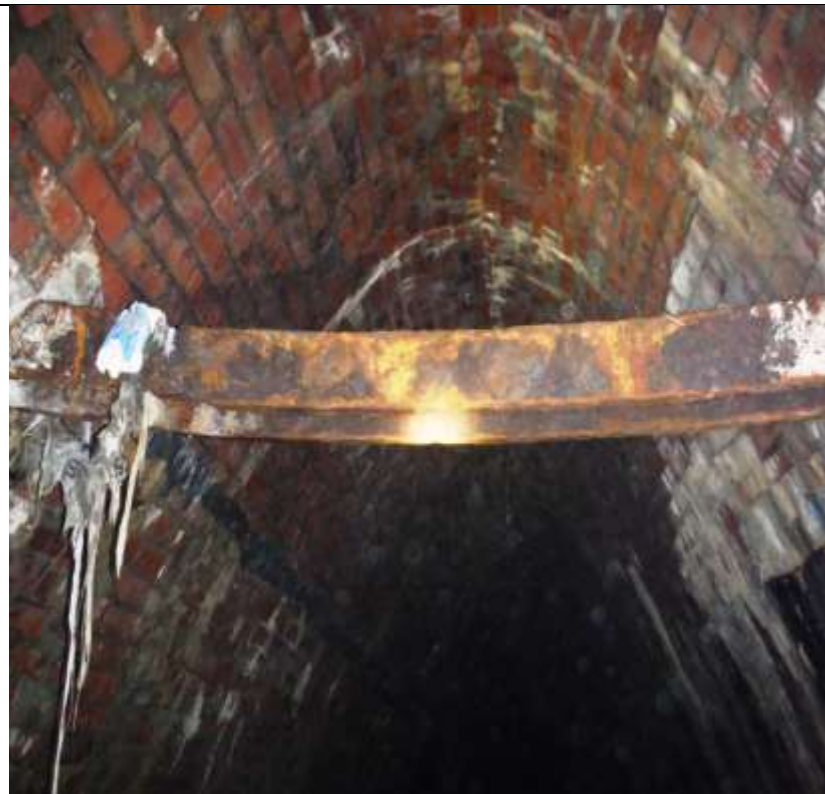
Photograph 6

Steel Beam in Brick Arch
Culvert

Station 0+12

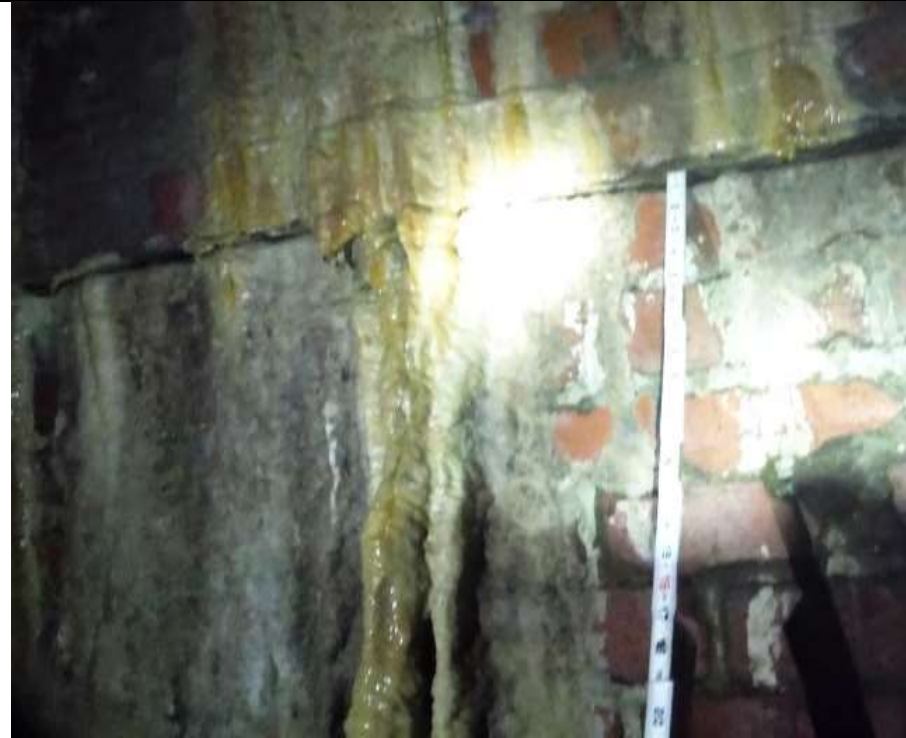
Photograph 7

- Station 0+15 to 0+30: There is a horizontal separation in the brick joint along the North wall with heavy efflorescence. This separation is approximately 15 feet long and is located 7.5 feet above the floor of the culvert (See Photographs # 7 & #8)

Heavy Efflorescence and joint separation

Station 0+15 to 0+30

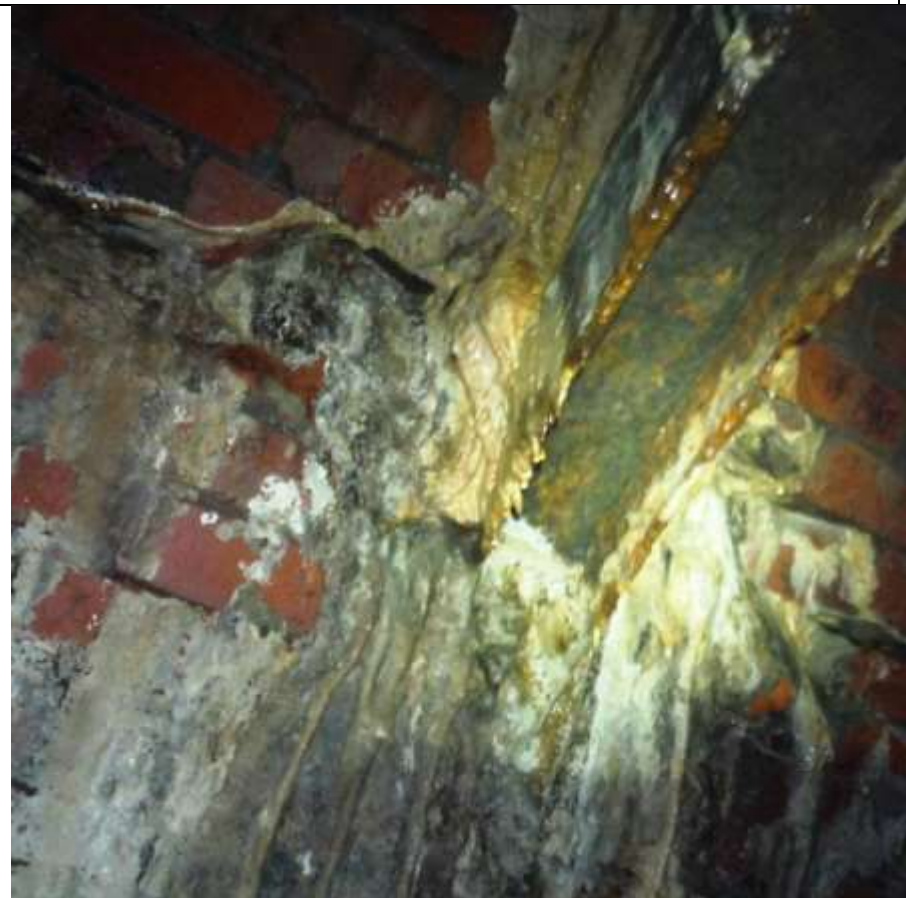
Photograph 8

Detailed View of Steel Beam and Brick Culvert interface.

Station 0+12

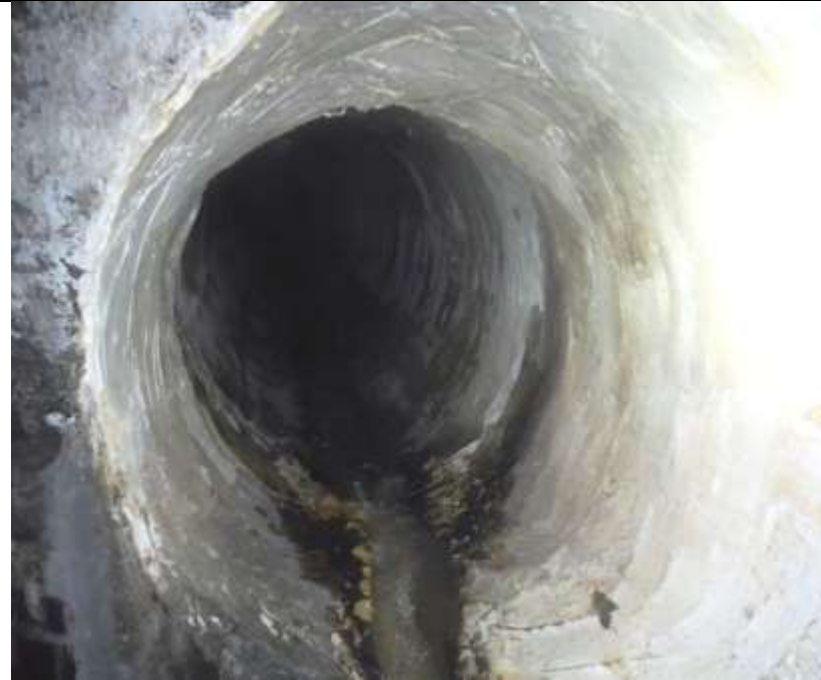
Photograph 9

- Station 97+00: There is a 48 inch diameter pipe entering from the south that has been coated with mortar slurry. The treatment appears to extend into the pipe for at least 40-50 feet, and possibly further. Slurry treatment appears to have been hand applied with a trowel or other tools.(See Photographs #9 & #10)

Mortar Slurry Coated 48"
Diameter Pipe

Station 97+00

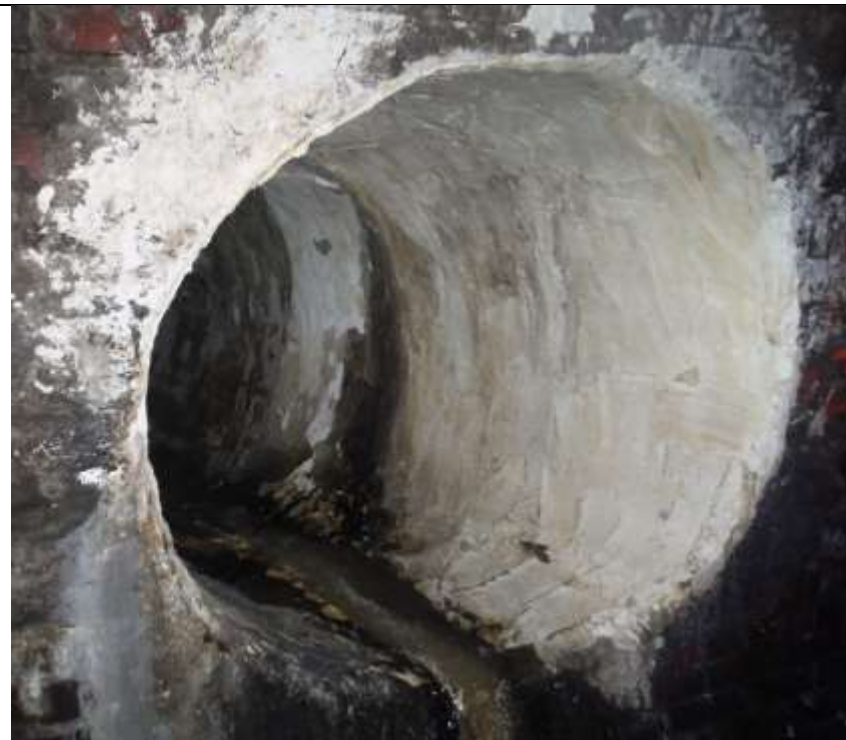
Photograph 10

Mortar Slurry Coated 48"
Diameter Pipe

Station 97+00

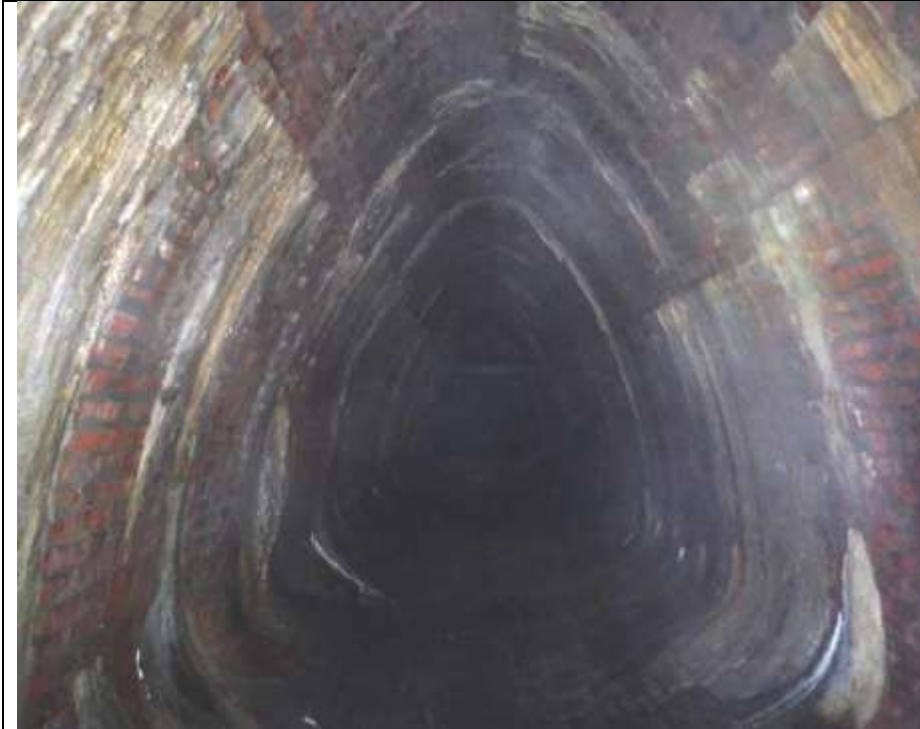
Photograph 11

- Remaining sections of the culvert exhibit minor mortar loss and efflorescence but overall condition is very good. (See Photograph # 11)

Brick Culvert Under Interstate 77

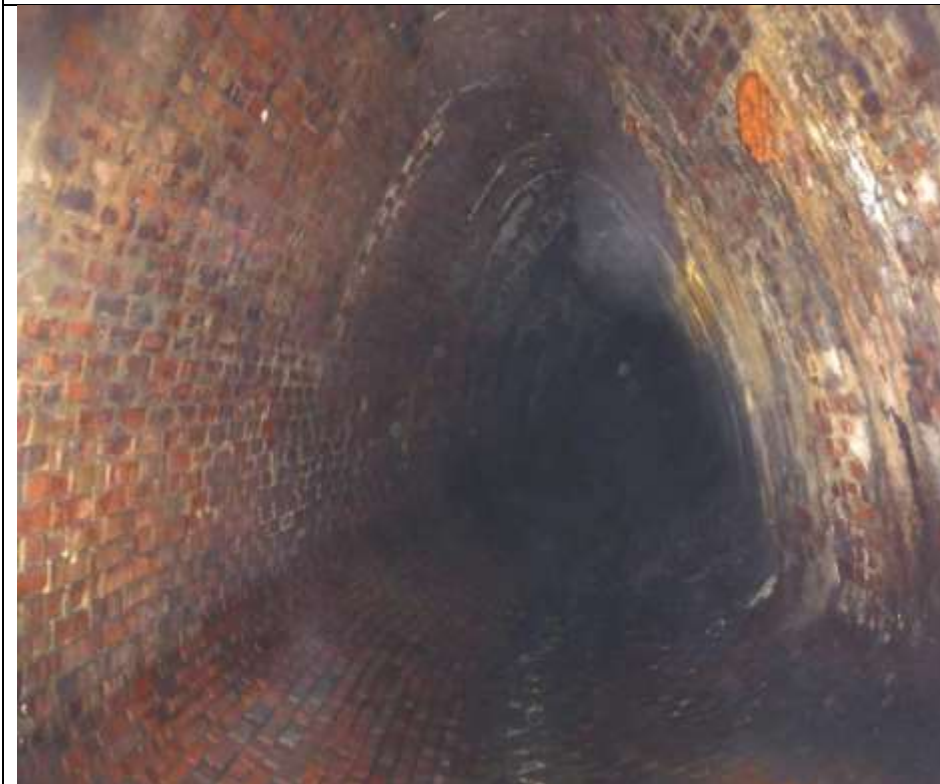
Photograph 12

- The brick culvert under East 49th Street was inspected as a courtesy for the Cuyahoga County Engineer. This section carries water from the east and is intersected by the diversion weir near the entry manhole. At the time of inspection there was little to no water flowing through this section of pipe. The pipe is in good condition, similar to the section under Interstate 77.
- There is minor seepage and efflorescence at the crown of the culvert. There were no conduits or pipes entering the culvert in this section. (See Photograph #12).

Brick Culvert under East 49th Street.
