BRIDGE INSPECTION REPORT

BRIDGE NUMBER CUY 00090 2046 L

Underwater Inspection Report for:

Interstate 90 over C.E.I Outlet
Cuyahoga County, Ohio
(Three Span Steel Beam Bridge)

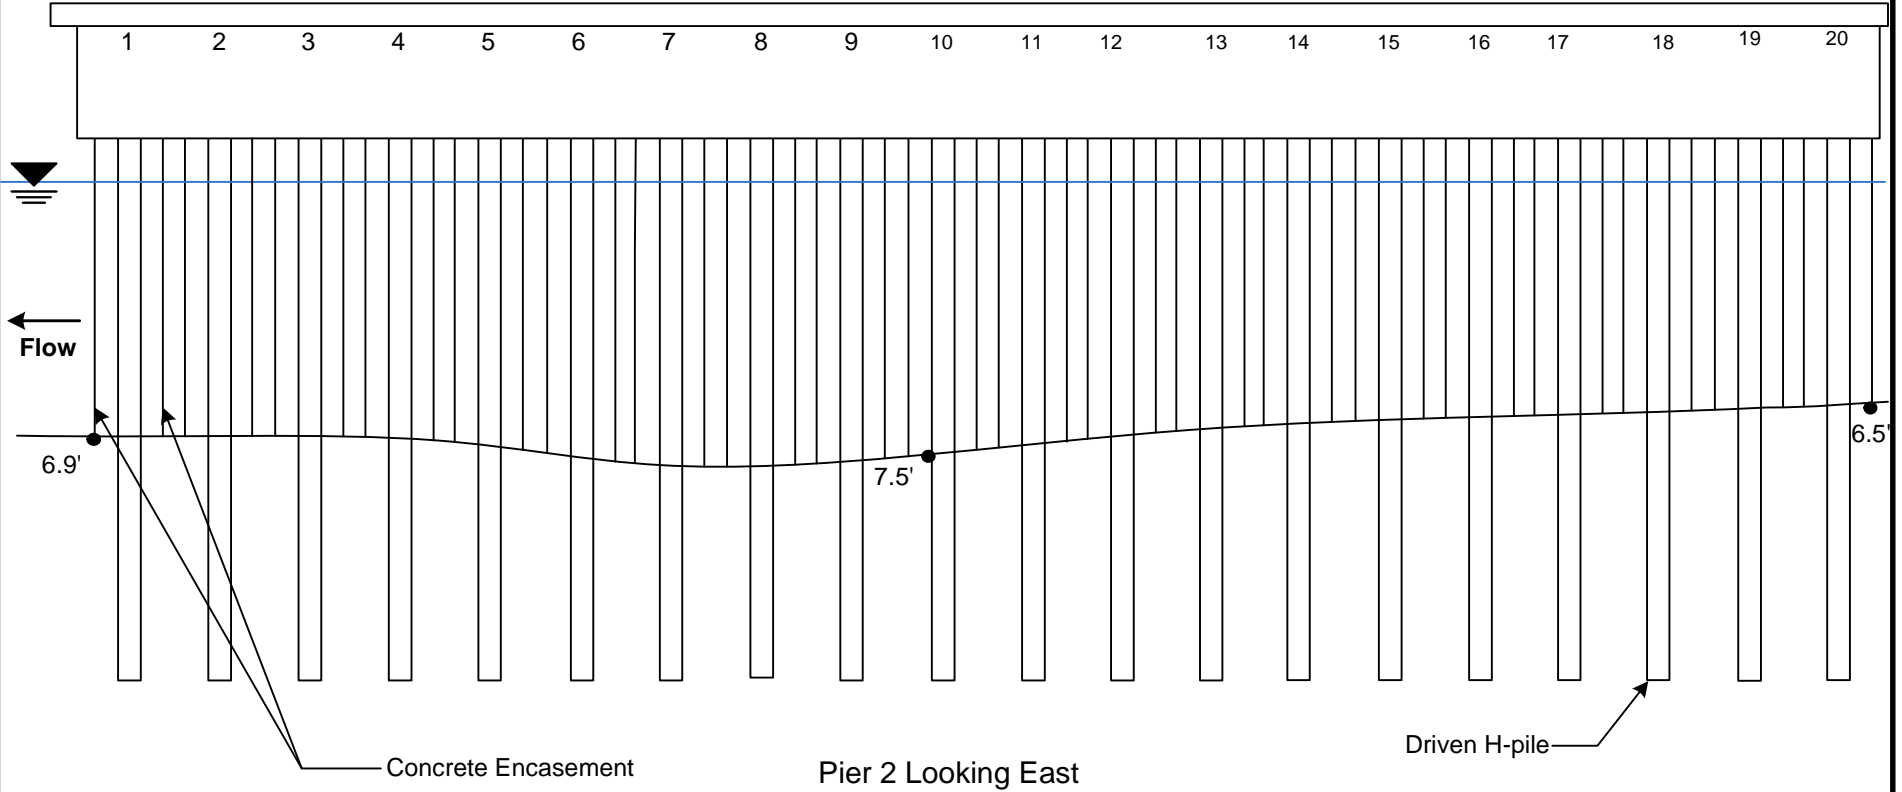
PROJECT: ODOT District 12 2007 Underwater Bridge Inspections	
SHEET: CUY-00090-2046L I90 over C.E.I Outlet City of Cleveland	PAGE NO.: B-4
Pier 2 Looking East	FIG. NO.: 4

- Pile 1, area of section loss up to 4 inch tall with up to 1.5 inches of penetration located at the water surface.
- Pile 19, area of section loss up to 6 inch diameter with up to 1/2 inch of penetration located at the surface on the southeast face.
