BRIDGE INSPECTION REPORT

1808311
Structure File NumberBRIDGE NUMBER **CUY 00090 2043 L**YEAR BUILT **1952**DIST **12** Bridge Type **322** TYPE SERVICE **1 5** **CEI OUTLET CHANNEL**

Underwater Inspection Report for:

Interstate 90 over C.E.I Outlet
Cuyahoga County, Ohio
(Three Span Steel Beam Bridge)

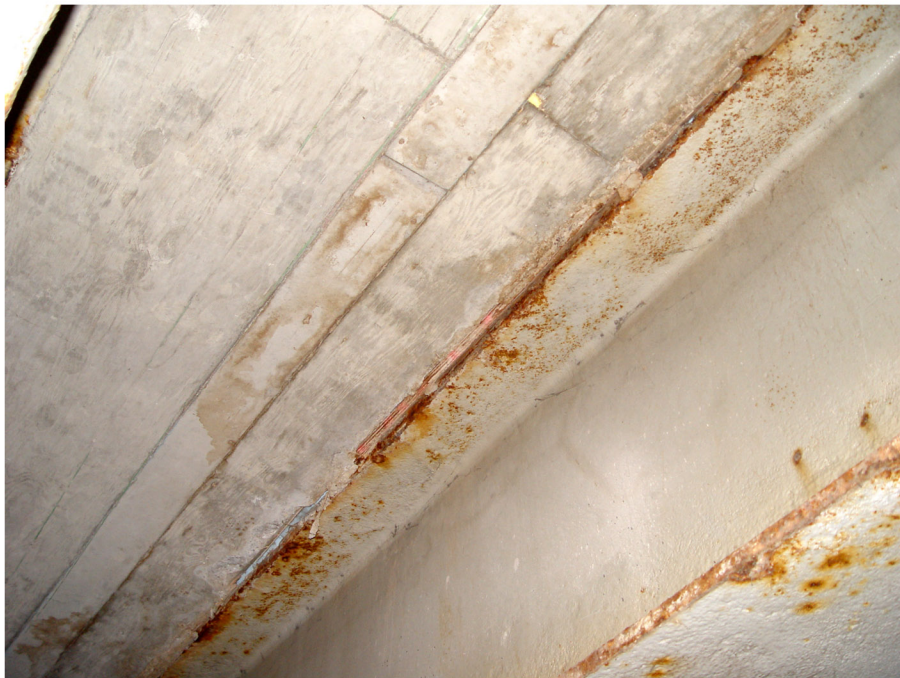
1808311 11_7_05 P3 plywood cast into floor.jpg

INTO FLOOR ALONG LEFT FACE OF TOP FLANGE OF LEFT BEAM
ABOVE FINISH CHANNEL PROTECTION; SEE ATTACHED PHOTOS 3 & 4

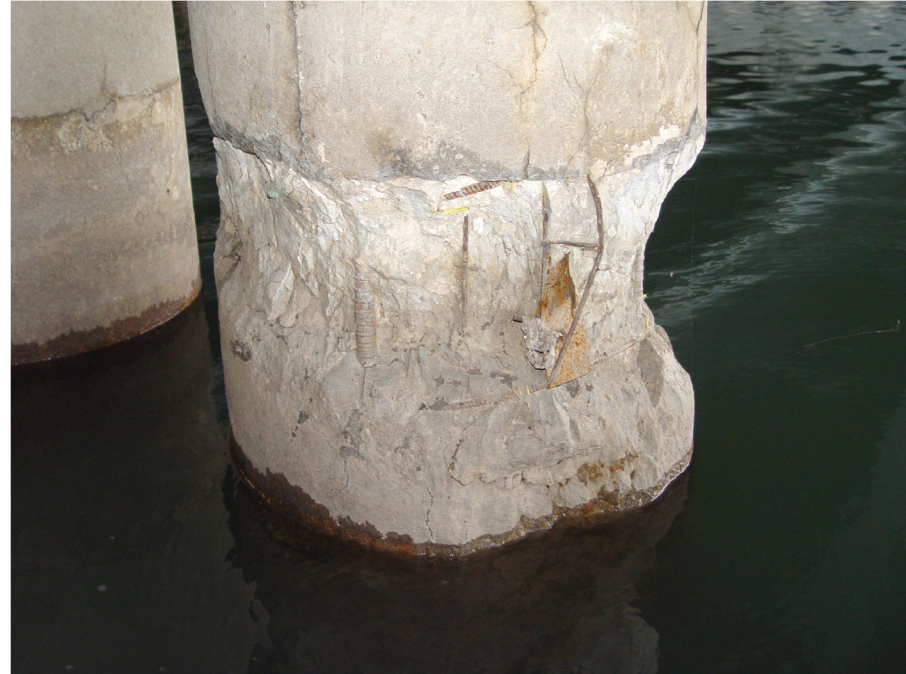
1808311 10_5_05 P7 deep spalling of P1C15.jpg

PIERS: FAILED PATCHES AND SPALLS ON COLUMNS; SEE ATTACHED
PHOTOS 7 & 8 DATED 9/25/07. CAP SPALL ABOVE P2C5R;
SEE ATTACHED PHOTO 9 DATED 10/05/05.

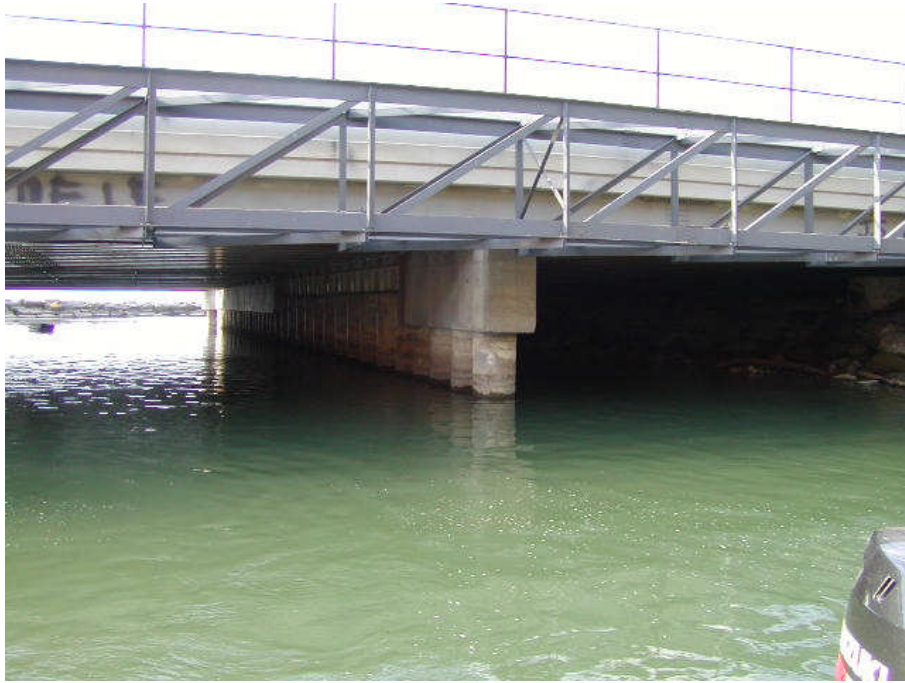
Photo 3. Pier 2L (southwest).

- Pile 1, area of section loss up to 4 inch tall with up to 1.5 inches of penetration located at the water surface.
- Pile 19, area of section loss up to 6 inch diameter with up to 1/2 inch of penetration located at the surface on the southeast face.

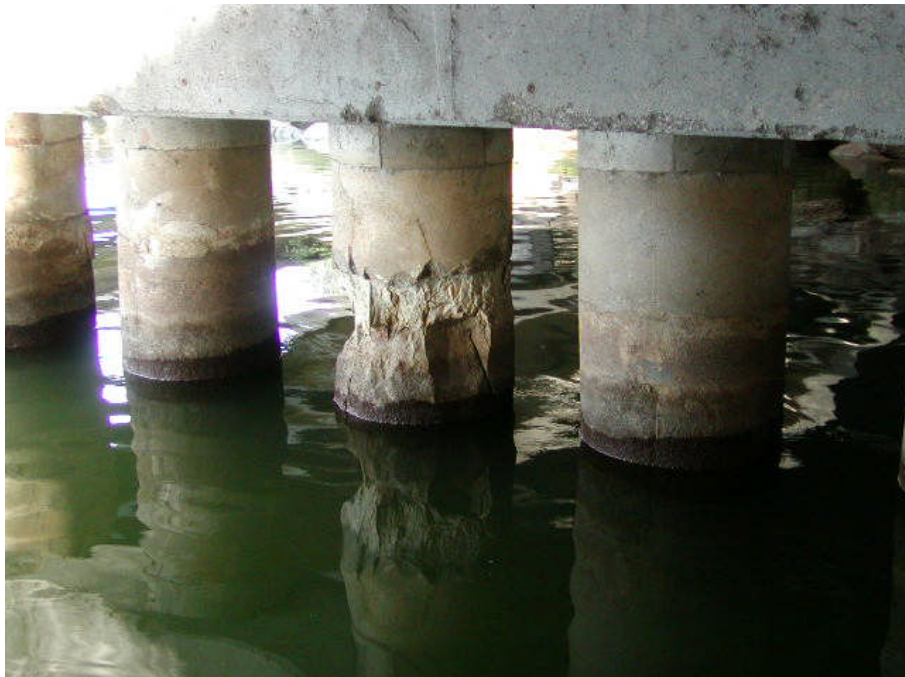
Photo 4. Typical Section Loss.
