BRIDGE INSPECTION REPORT

1808311
Structure File NumberBRIDGE NUMBER **CUY 00090 2043 L**YEAR BUILT **1952**DIST **12** Bridge Type **322** TYPE SERVICE **1 5** **CEI OUTLET CHANNEL**

Underwater Inspection Report for:

Interstate 90 over C.E.I Outlet
Cuyahoga County, Ohio
(Three Span Steel Beam Bridge)

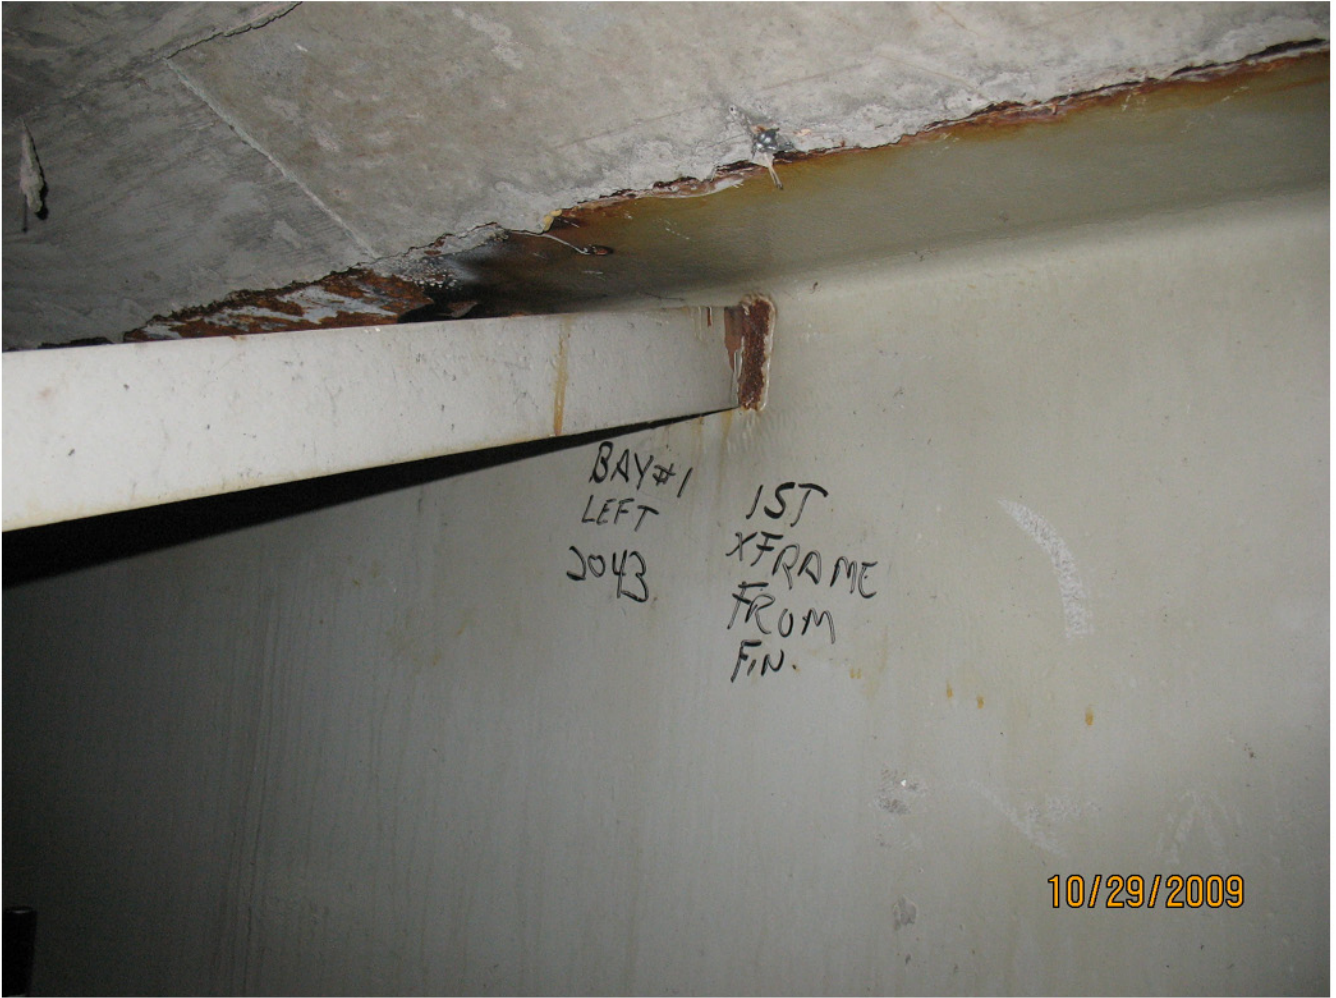
Cracked weld.JPG

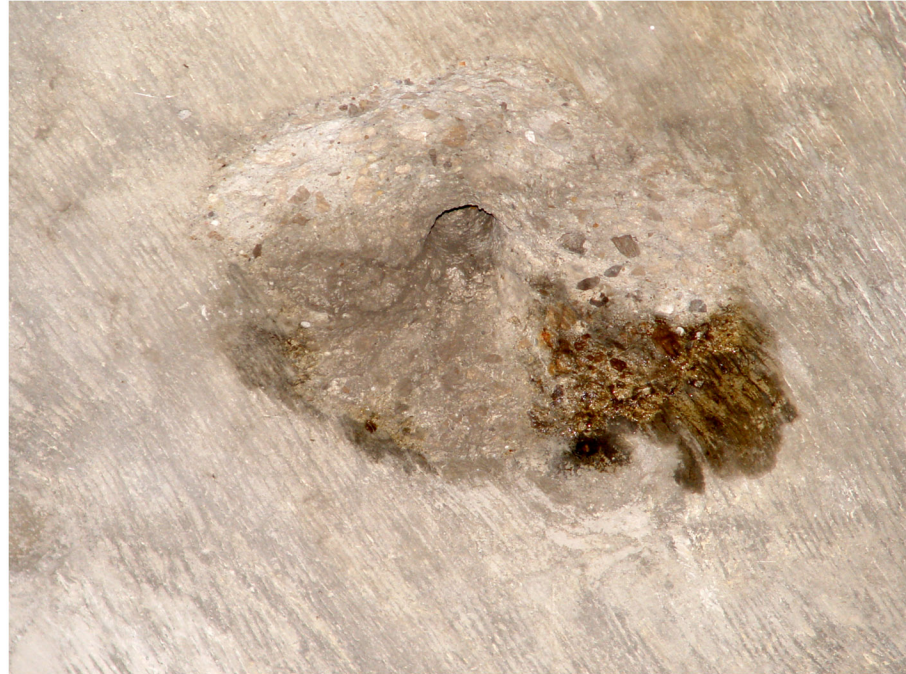
FLOOR: SPALL IN BAY #5 BETWEEN 1ST & 2ND XFRAMES WEST OF PIER #1; SEE ATTACHED PHOTOS 1 & 2 DATED 10/05/05. PLYWOOD CAST INTO FLOOR ALONG LEFT FACE OF TOP FLANGE OF LEFT BEAM ABOVE FINISH CHANNEL PROTECTION; SEE ATTACHED PHOTOS 3 & 4 DATED 11/07/05. A FEW CRACKS. FLOOR <1% DETERIORATED. WEARING SURFACE: A FEW CRACKS. <1% DETERIORATED. DRAINAGE: PARTIALLY PLUGGED SCUPPERS.

1808311 10_5_05 P2 closeup of P1.jpg

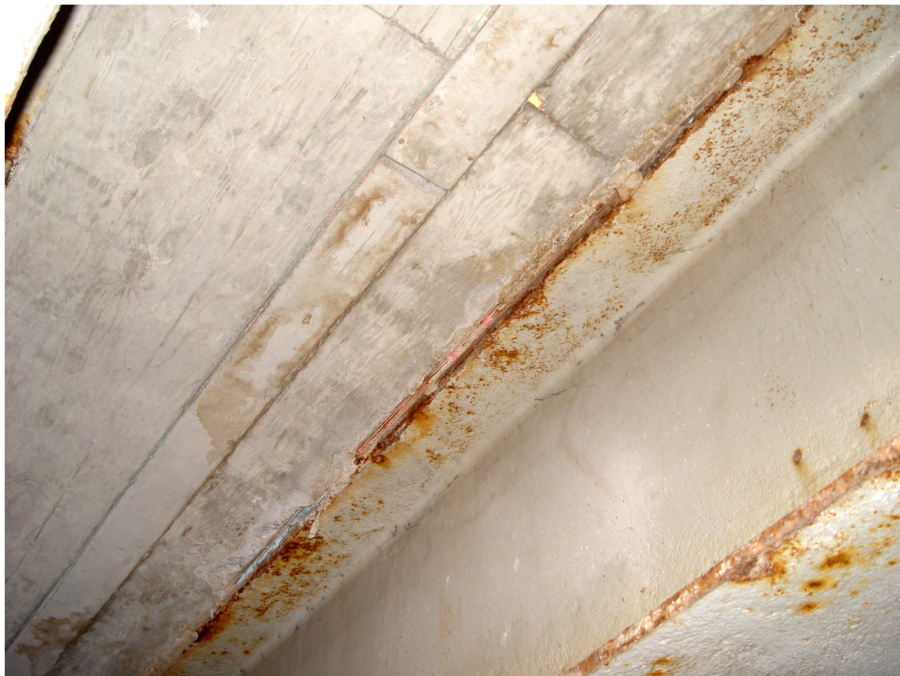
1808311 11_7_05 P3 plywood cast into floor.jpg

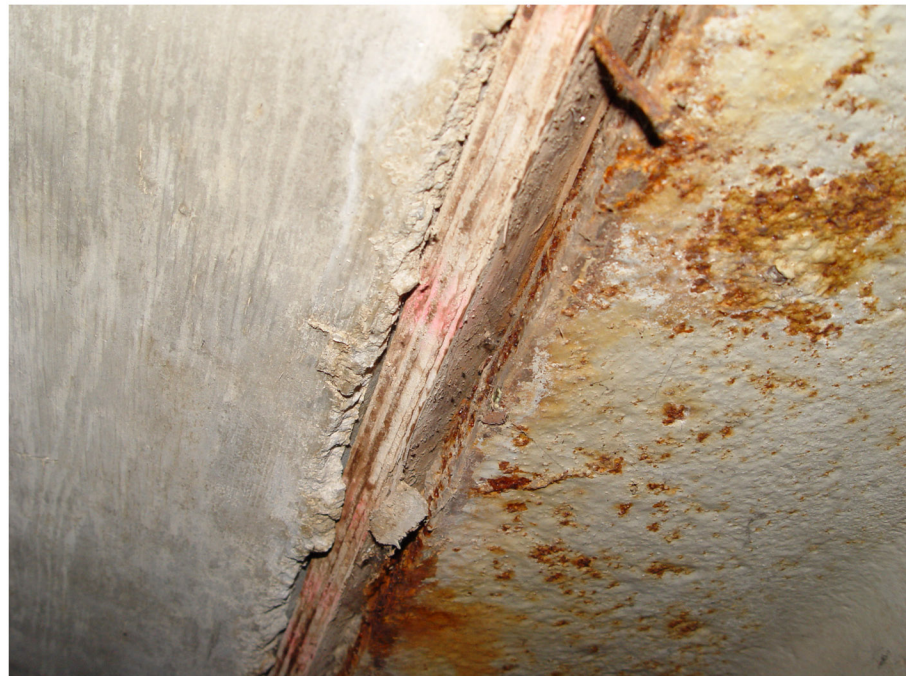
1808311 11_7_05 P4 closeup of P3.jpg

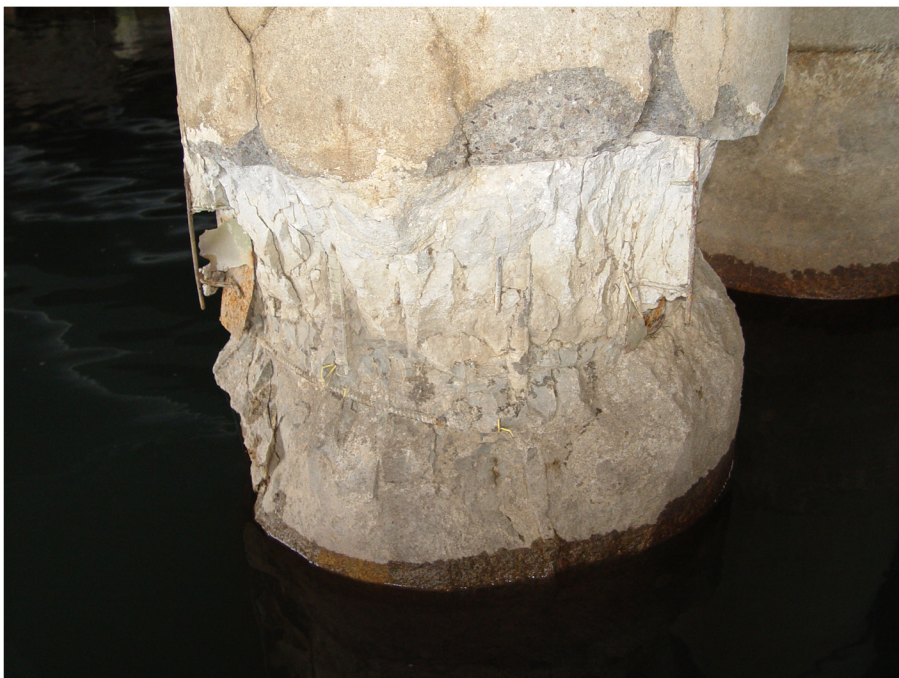
ABUTMENTS: CRACKS. MINOR DELAMINATIONS. PIERS: FAILED PATCHES AND SPALLS ON COLUMNS; SEE ATTACHED PHOTOS 7 & 8 DATED 9/25/07. CAP SPALL ABOVE P2C5R; SEE ATTACHED PHOTO 9 DATED 10/05/05. SCOUR: CONCRETE ENCASEMENTS OF 3 COLUMNS OF PIER #1 ARE UNDERMINED. NO CHANGE FROM LAST DIVE INSPECTION ON 9/25/07 THAT IS ATTACHED WITH THIS REPORT.

1808311 10_5_05 P7 deep spalling of P1C15.jpg

1808311 10_5_05 P8 deep spalling of P1C15.jpg

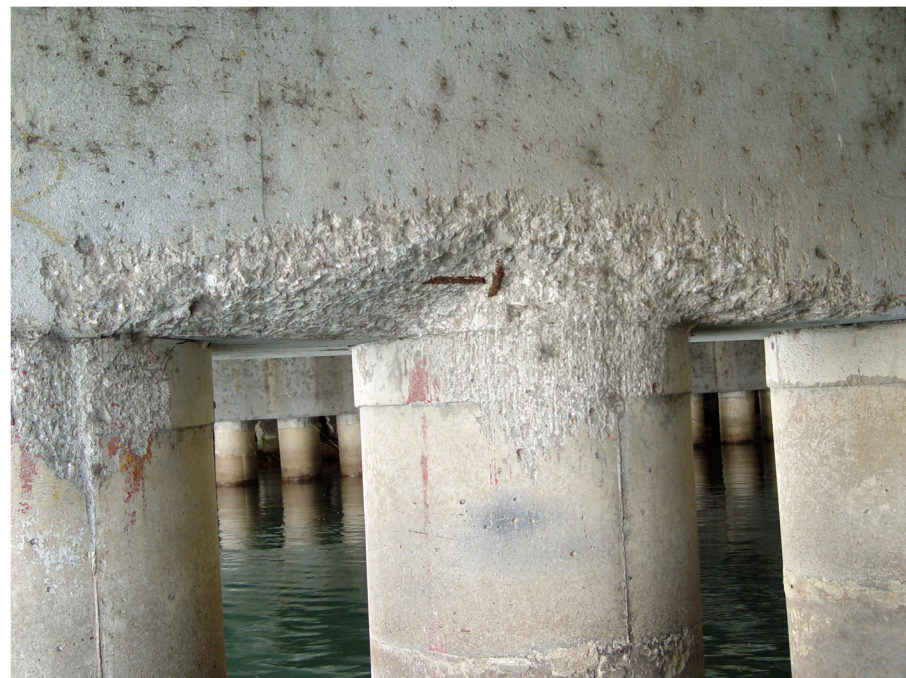
1808311 10_5_05 P9 cap spall above P2C5R.jpg

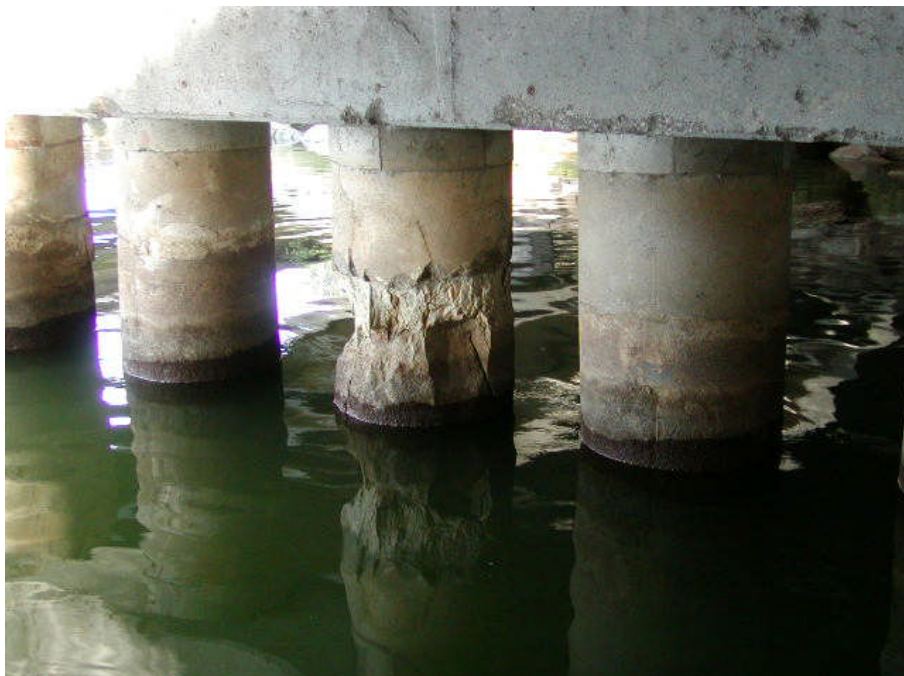
Photo 4. Typical Section Loss.
