## BRIDGE INSPECTION REPORT

BRIDGE NUMBER CUY 00090 2043 L

CUY-90-2043L CEI outlet channel  
SFN 1808311 by acp

**Underwater Inspection Report for:**

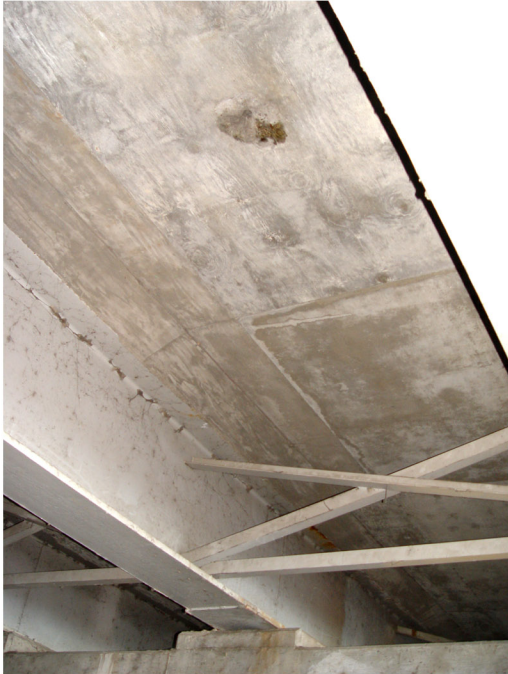
1808311 10\_5\_05 P1 floor spall span 1 bay 5.jpg

FLOOR: SPALL IN BAY #5 BETWEEN 1ST & 2ND XFRAMES WEST OF PIER #1; SEE ATTACHED PHOTOS 1 & 2 DATED 10/05/05. PLYWOOD CAST INTO FLOOR ALONG LEFT FACE OF TOP FLANGE OF LEFT BEAM ABOVE FINISH CHANNEL PROTECTION; SEE ATTACHED PHOTOS 3 & 4 DATED 11/07/05. A FEW CRACKS. FLOOR <1% DETERIORATED. WEARING SURFACE: A FEW CRACKS. <1% DETERIORATED. DRAINAGE: PARTIALLY PLUGGED SCUPPERS.

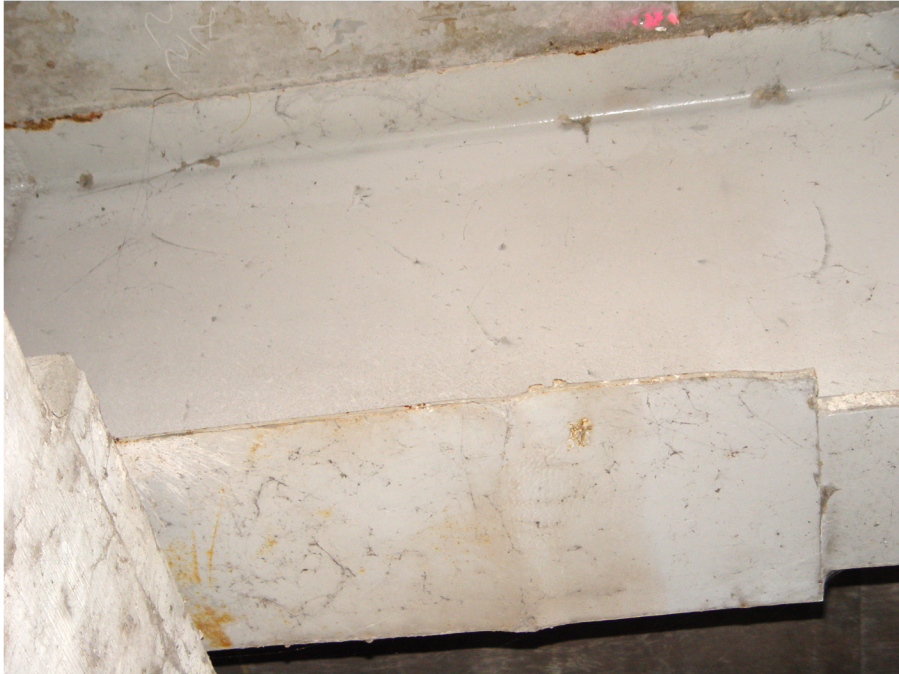
1808311 10\_5\_05 P6 bent beam 5 cover plate.jpg

BEAMS: PACK RUST BETWEEN SOME COVER PLATES & BOTTOM FLANGES. RUSTED SECTION LOSS. RUSTING SECTION LOSS OF LEFT BEAM WITH RUSTED THRU HOLES IN COVER PLATES IN SPAN #2. BOTTOM FLANGE COVER PLATE OF BEAM #5 IS BENT IN SPAN #2 NEAR PIER #2; SEE ATTACHED PHOTO 6 DATED 10/05/05. NO COPE HOLES AT INTERSECTING WELDS WHERE BEAMS ARE JOINED ABOVE PIERS. CROSSFRAMES: SEE PHOTO DATED 10/29/09. PCS: 2% RUST. 1-5% DETERIORATED.

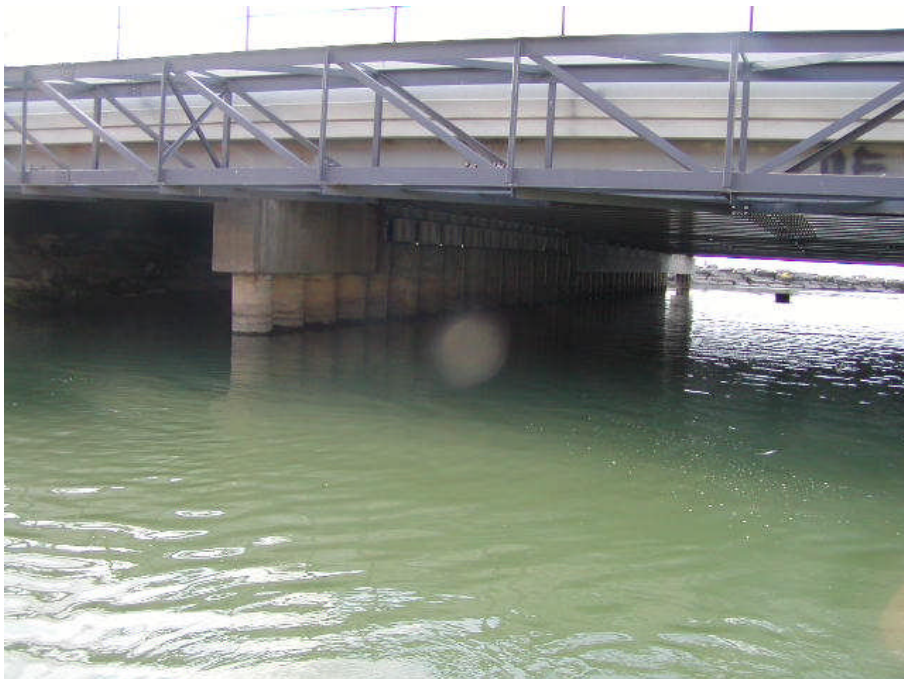
Photo 2. Pier 1L (southeast).

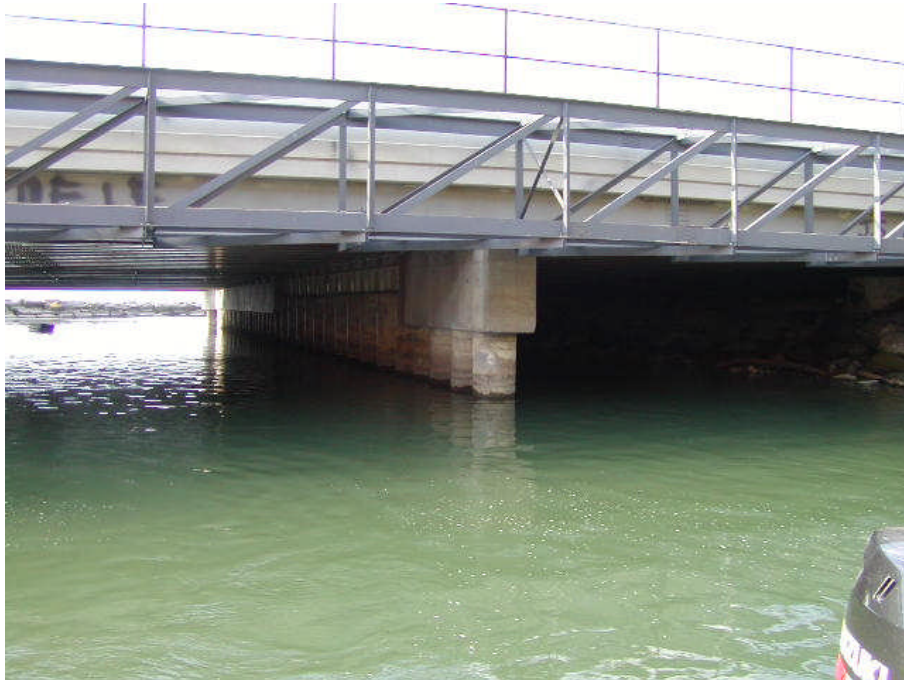
Photo 3. Pier 2L (southwest).

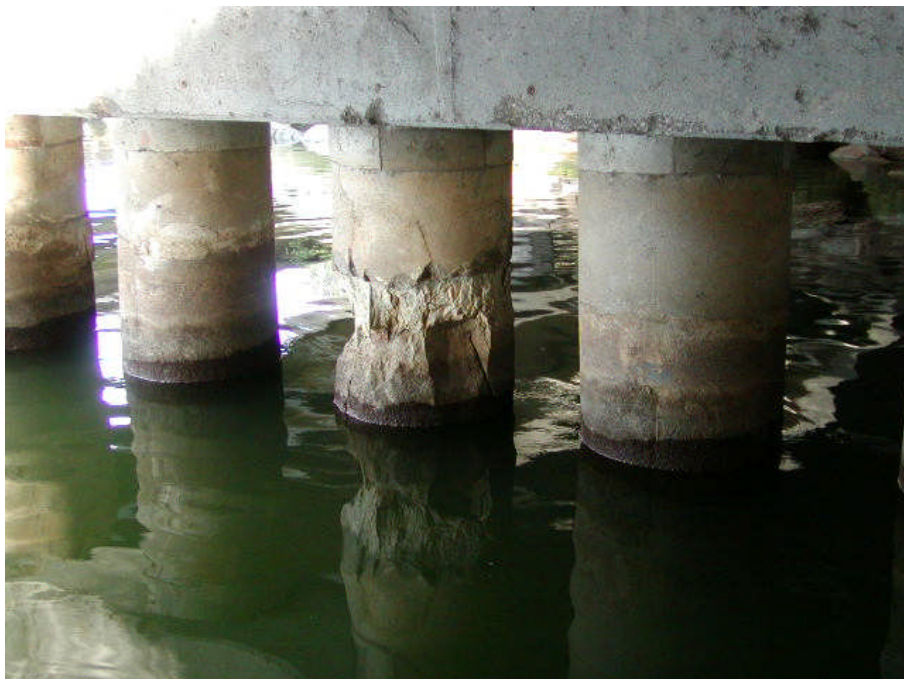
Photo 4. Typical Section Loss.

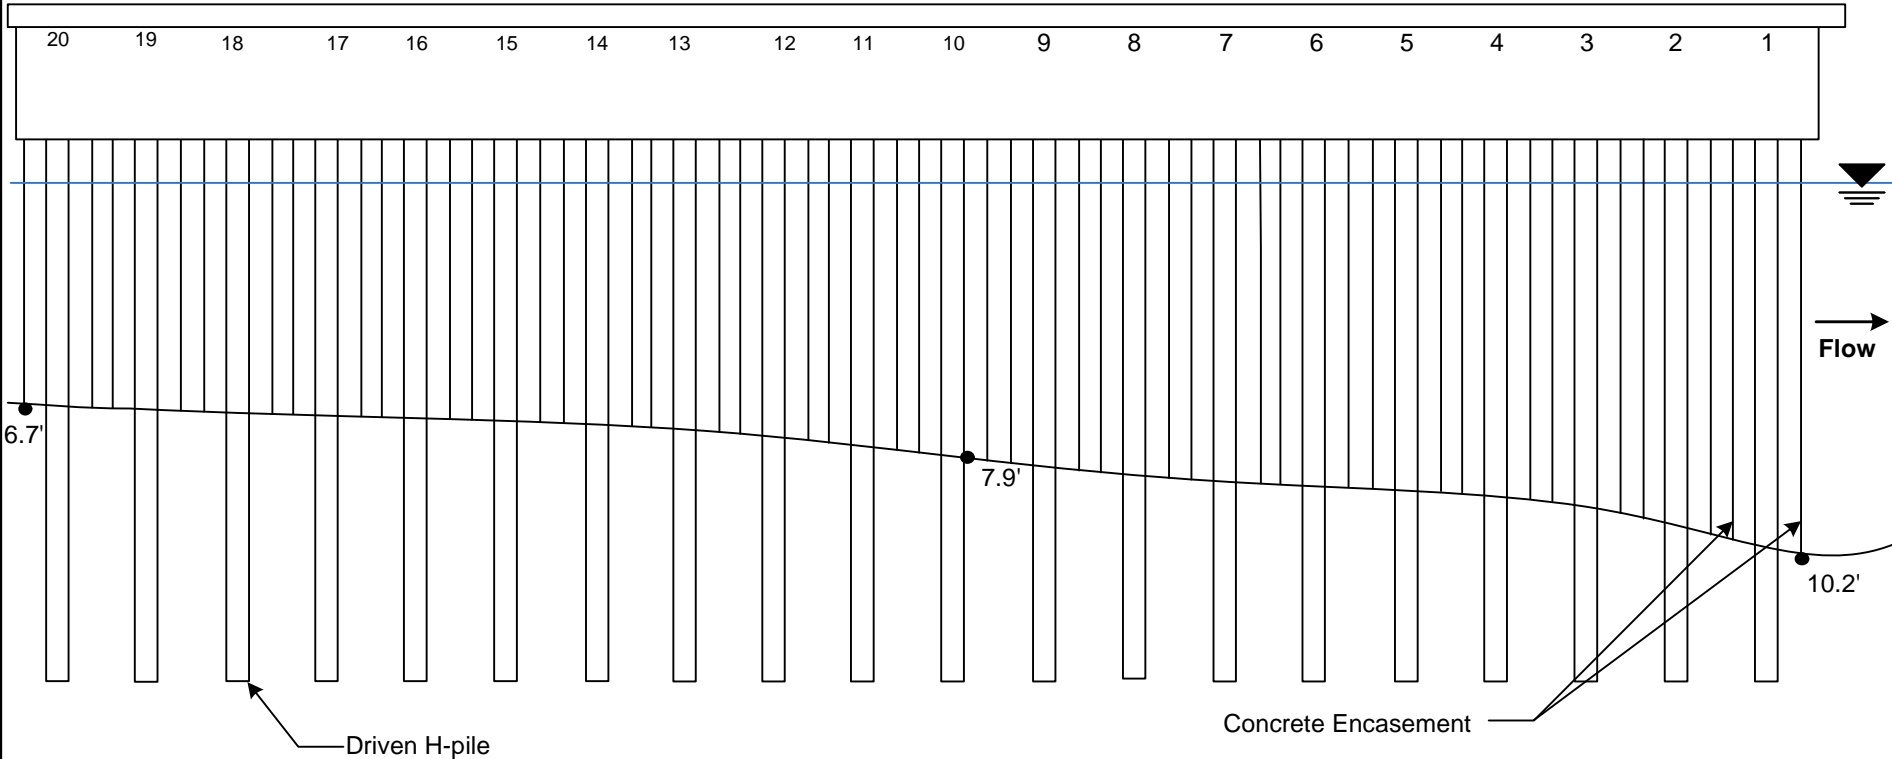
Pier 1 Looking West

- Pile 1, area of section loss up to 1 inch tall by 6 inches wide with up to 2 inches of penetration located on the north face.

- Pile 2, area of section loss up to 6 inches tall by 6 inches wide with up to 4 inches of penetration located on the northwest face.
- Pile 4, area of section loss up to 2 inch tall with up to 2.5 inches of penetration located at the bottom of the north face and extending around to the south face.

- Pile 5, area of section loss up to 4 inch tall with up to 3.5 inches of penetration located at the bottom of the north face and extending around to the south face.

- Pile 6, area of section loss above the water surface with exposed rebar. There are also sand bags around the entire pile at the bottom.
- Pile 7, area of section loss up to 4 inch tall with up to 4 inches of penetration located at the bottom of the north face and extending around to the south face.

- Pile 14, area of section loss up to 10 inch tall with up to 6 inches of penetration located at the bottom of the west face and extending around to the east face.

- Pile 15, area of section loss up to 4 inch tall with up to 6 inches of penetration located at the bottom of the west face and extending around to the south face.

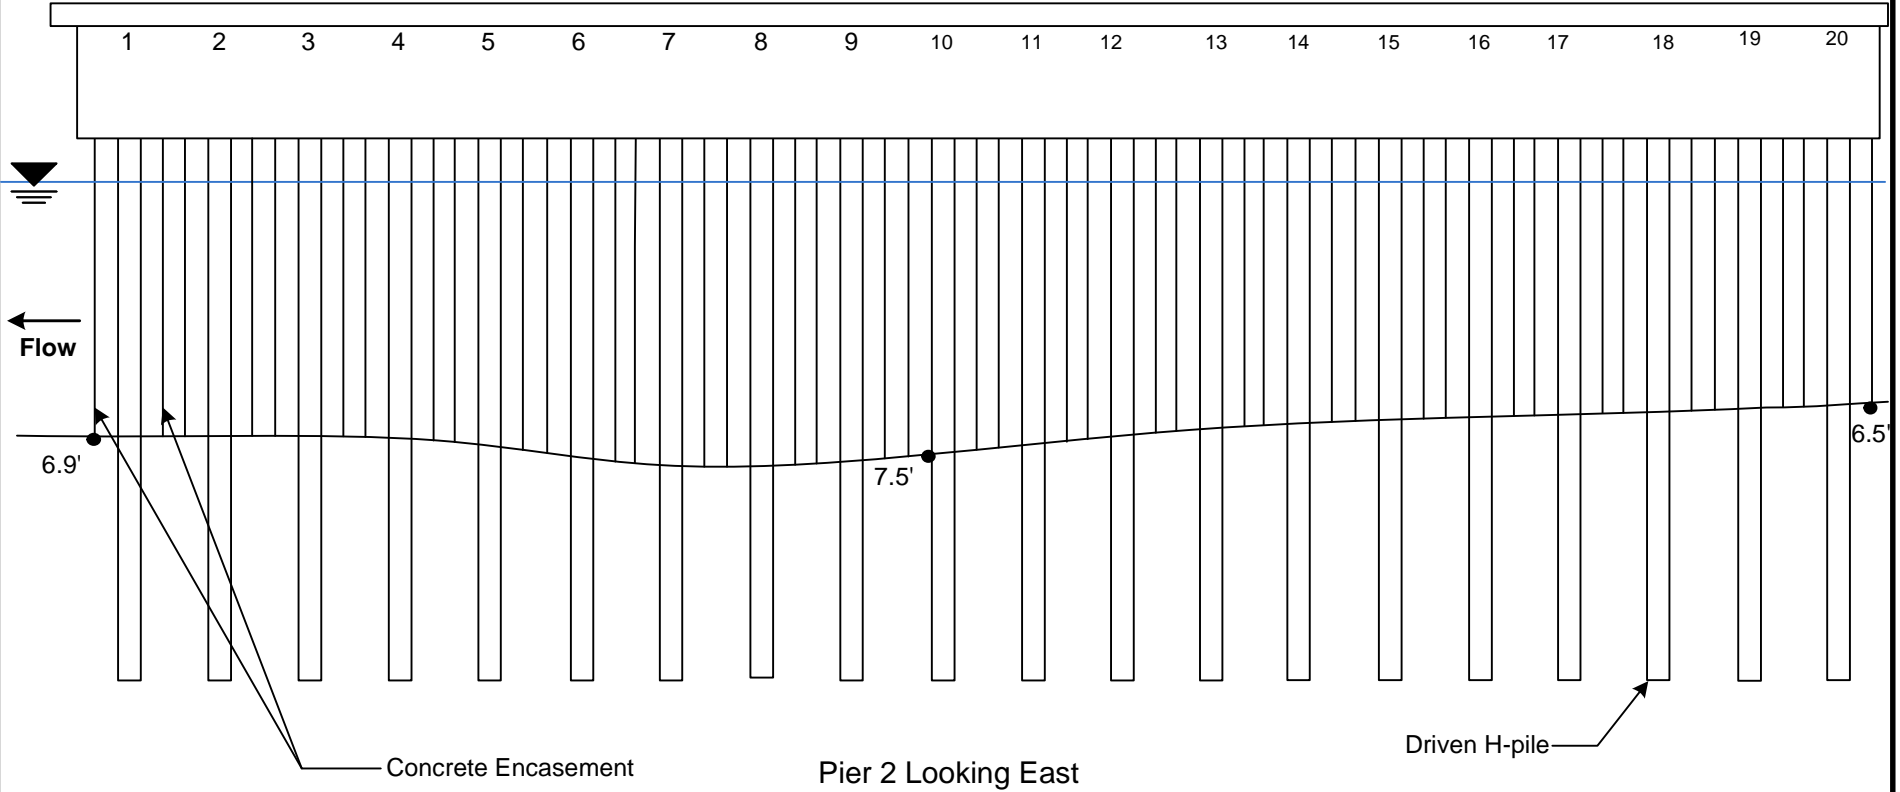
**Pier 2 Looking East**

- Pile 1, area of section loss up to 4 inch tall with up to 1.5 inches of penetration located at the water surface.
- Pile 19, area of section loss up to 6 inch diameter with up to 1/2 inch of penetration located at the surface on the southeast face.
