## BRIDGE INSPECTION REPORT

1808311  
Structure File Number

BRIDGE NUMBER CUY 00090 2043 L

CUY-90-2043L CEI outlet channel  
SFN 1808311 by acp

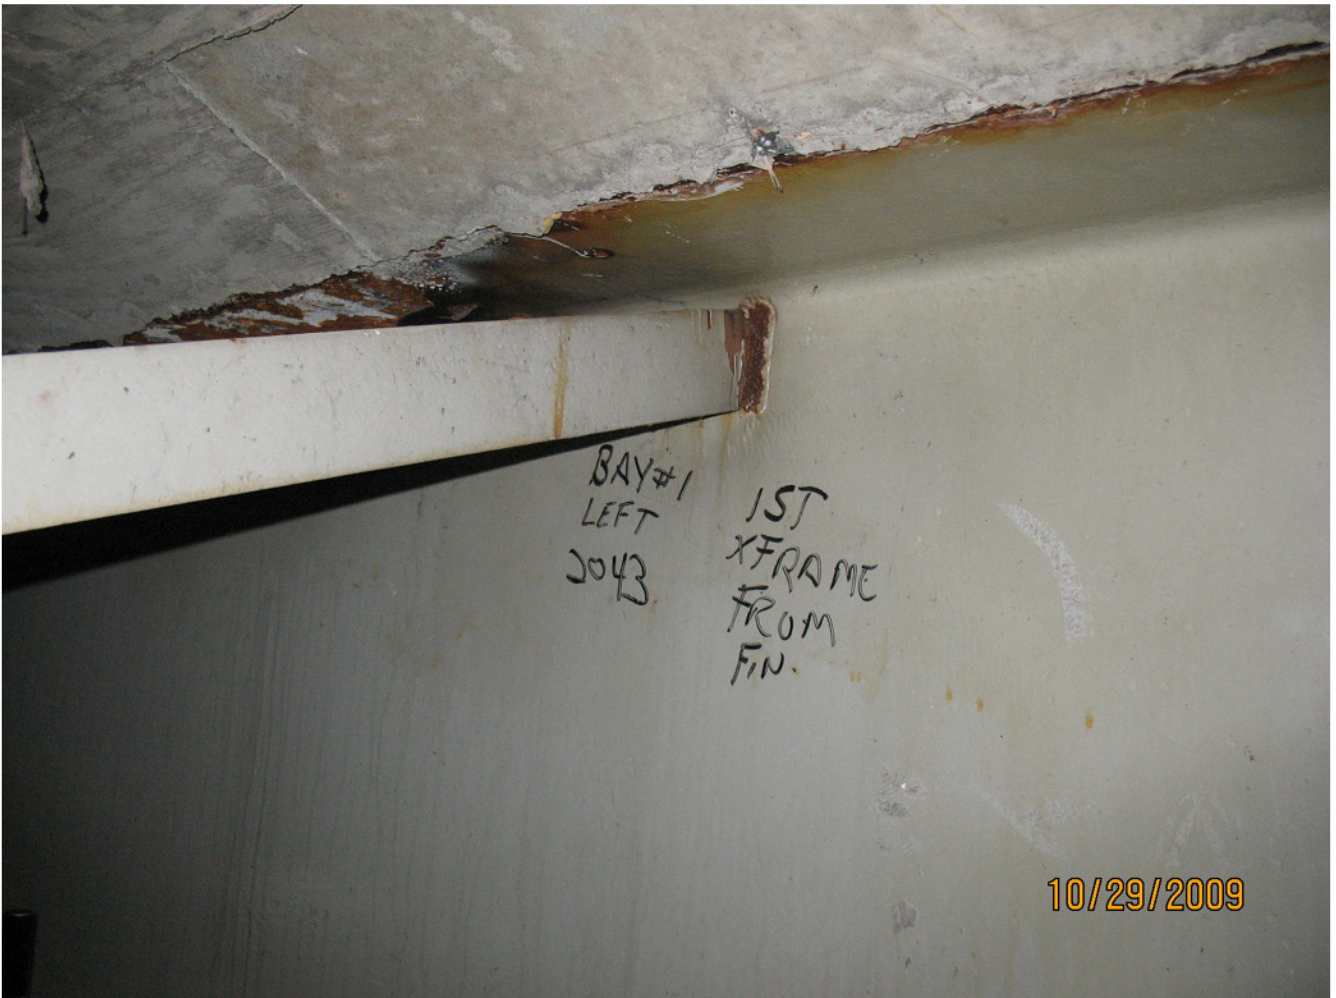
Cracked weld.JPG
