UNDERWATER BRIDGE INSPECTION REPORT

Bridge Number: CUY-00090-2043L
Inspection Date: 12/5/2012
Division: District 12
River: CEI Outlet

Engineer of Record: David Reser
Team Leader: Fred Meek
Substructures Inspected: Bents 1 and 2
Team Members:
KRR, JML

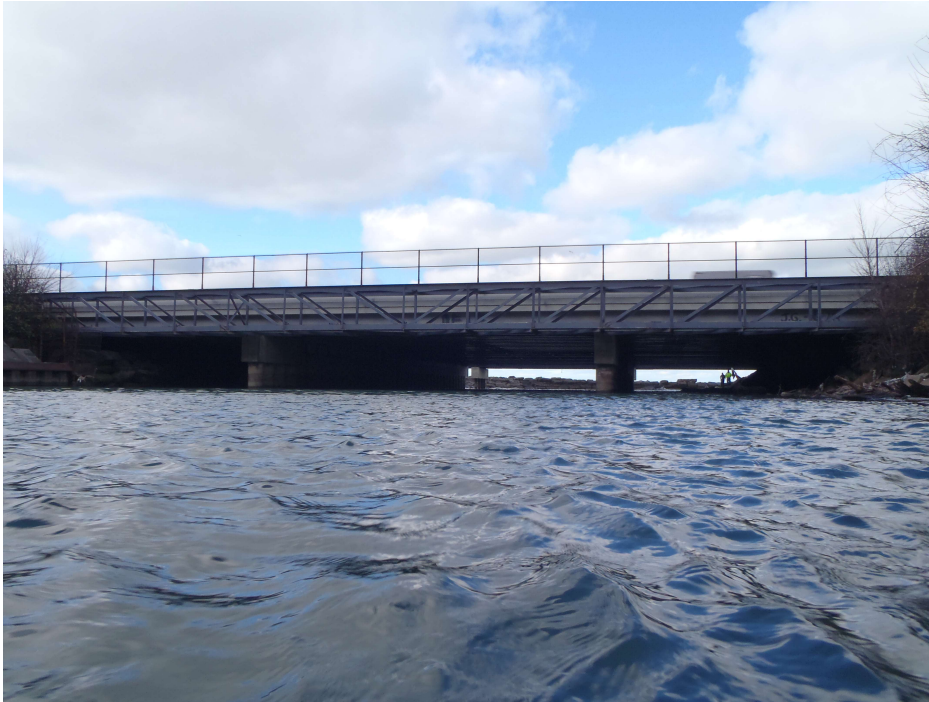
The inspected substructure units are in fair condition. There are several concrete encased piles with spalls and exposed reinforcement. Refer to Photos 1 and 2 for overall views of the bridge and substructure configuration.

Photo 1 - Upstream (South) Fascia Looking North

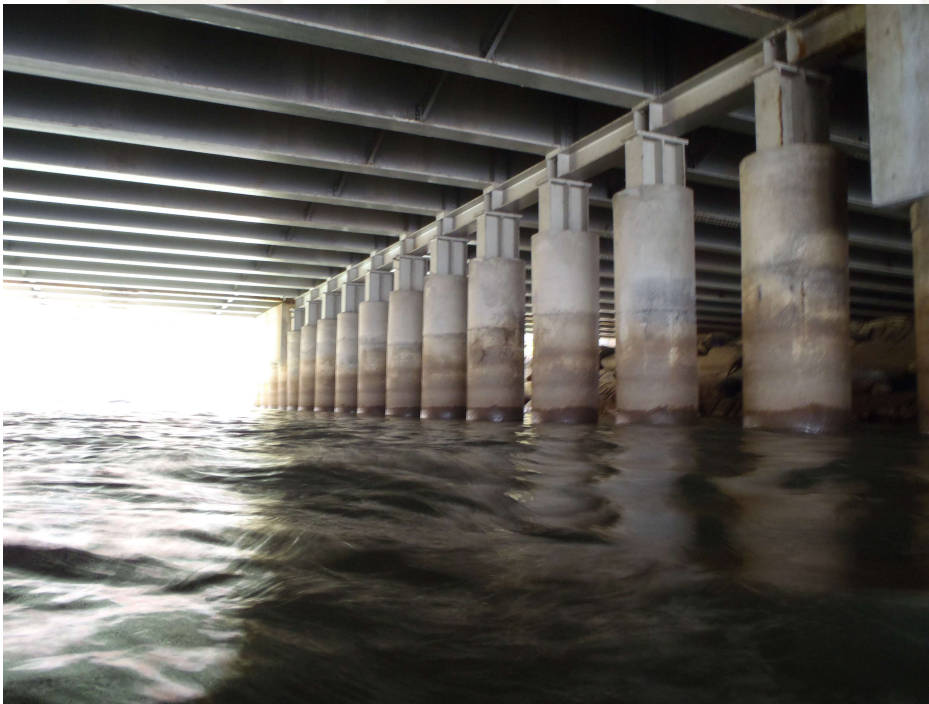
Photo 2 - Typical Bent Configuration, Bent 1

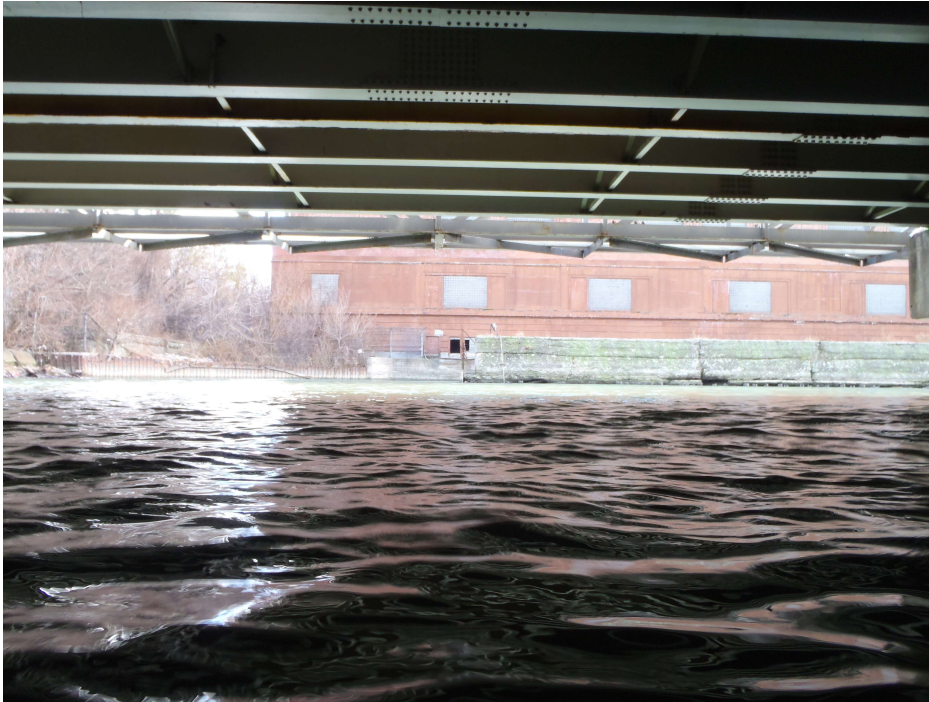
The channel bottom is in good condition and is well aligned with the substructure units. Refer to Photos 3 and 4. The channel is armored with large rock. There is some moderate timber debris along the east shoreline. There is a large log at the channel bottom between Piles 8 and 9 of Bent 2. A jetty north of this structure protects this bridge. The channel bottom material consists of silt, sand, gravel, cobbles and trash debris.

Photo 3 - Channel View Looking Upstream (South)

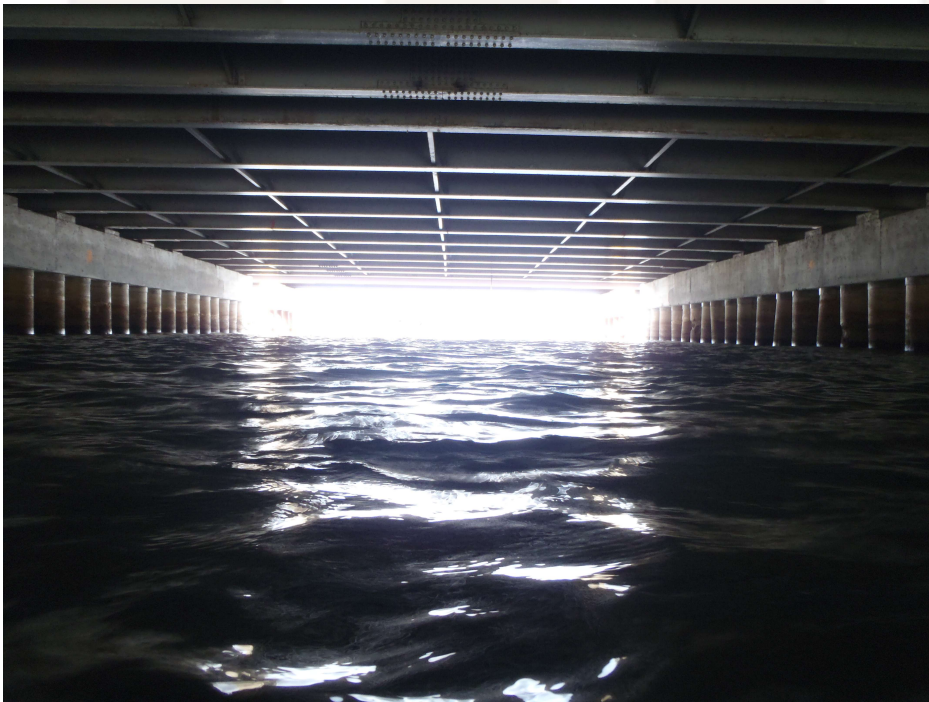
Photo 4 - Channel View Looking Downstream (North)

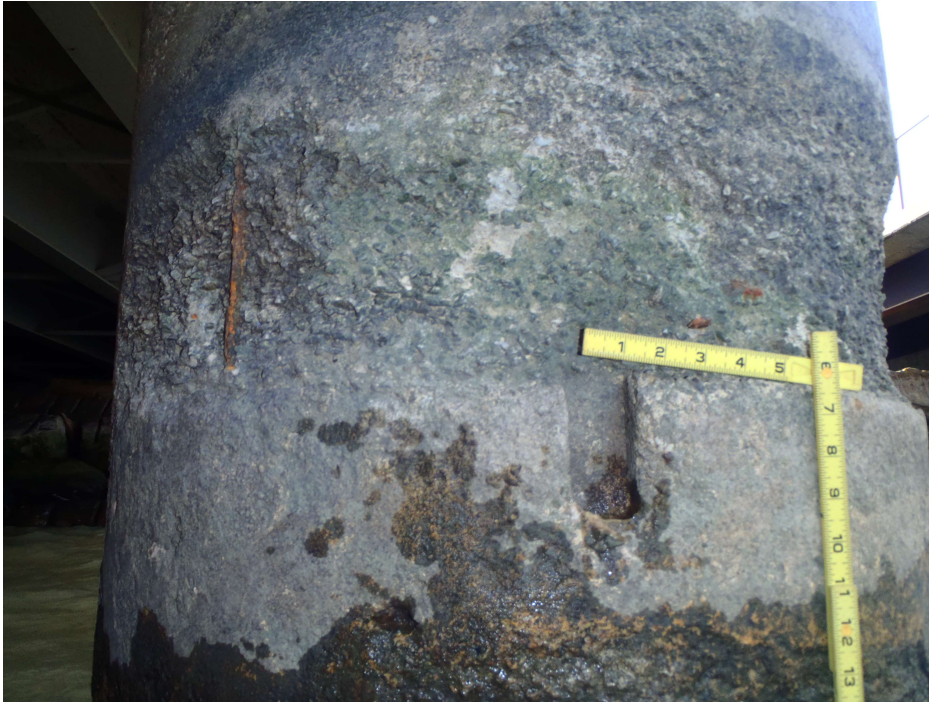
B1P1 has an abrasion/spall up to 11" H x full circumference x 1 1/2" D, located at the waterline, with one (1) piece each of exposed vertical and horizontal reinforcement, 3' below the cap. Refer to Photo 5.

Photo 5 - Bent 1, Pile 1, Abrasion/Spall at the Waterline

Restore concrete cover to the areas of exposed reinforcement at the spalled areas of the concrete encasements. Place fill material, rip rap, or sand bags to abate scour at Bent 2.

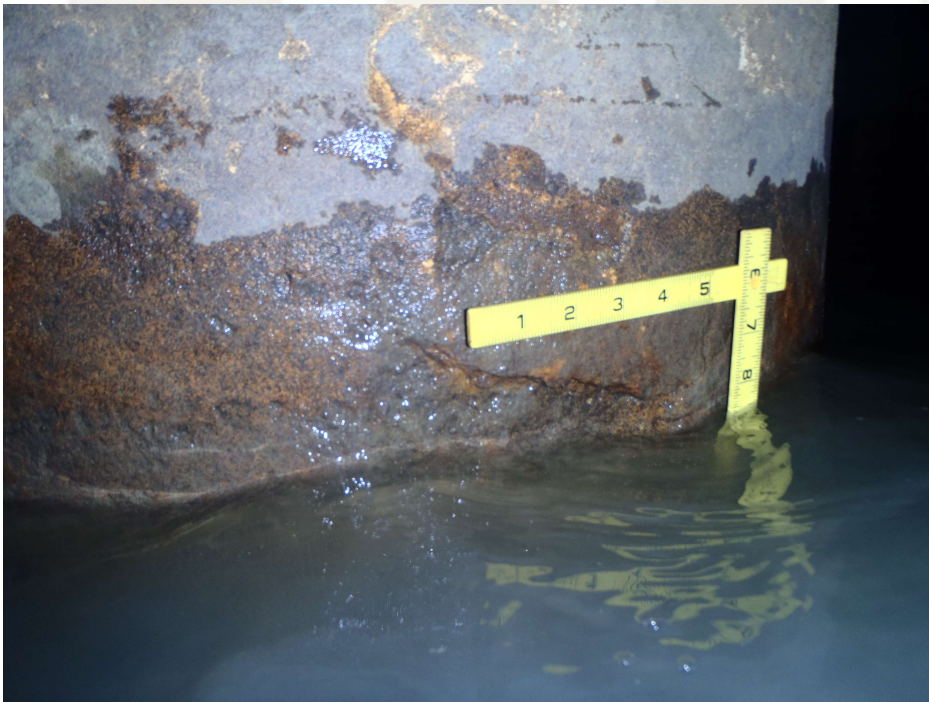
B1P19 has a spall that extends from the southeast to the southwest face, 6" H x 2' W x 1/2" D, 5' below the cap. Refer to Photo 6.

Photo 6 - Bent 1, Pile 19, Spall at South Quadrant, 5' Below the Cap

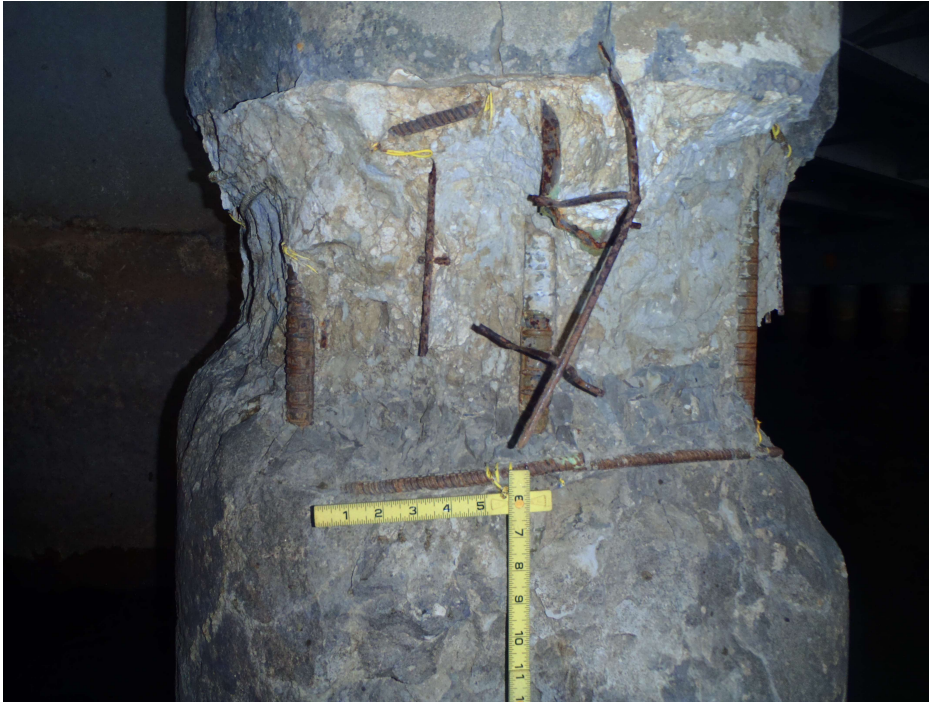
B2P6 has a spall, 3' H x 3 1/2" D, with four (4) pieces of exposed vertical reinforcement on the west, northwest, northeast, and east quadrants, 1'-3" below the cap. Maximum reinforcement exposure is 10" high, with loss of epoxy coating (reinforcement is still in good condition). Secondary horizontal reinforcement is exposed at all quadrants within the spall. Refer to Photo 7. B2P6 has another spall at the south quadrant at the channel bottom, 2" H x 6" W x 3" D with no exposed H-pile or steel. This pile is surrounded by sand bags on the channel bottom.

Photo 7 - Bent 2, Pile 6, Spall with Exposed Reinforcement, 1'-3" Below Cap

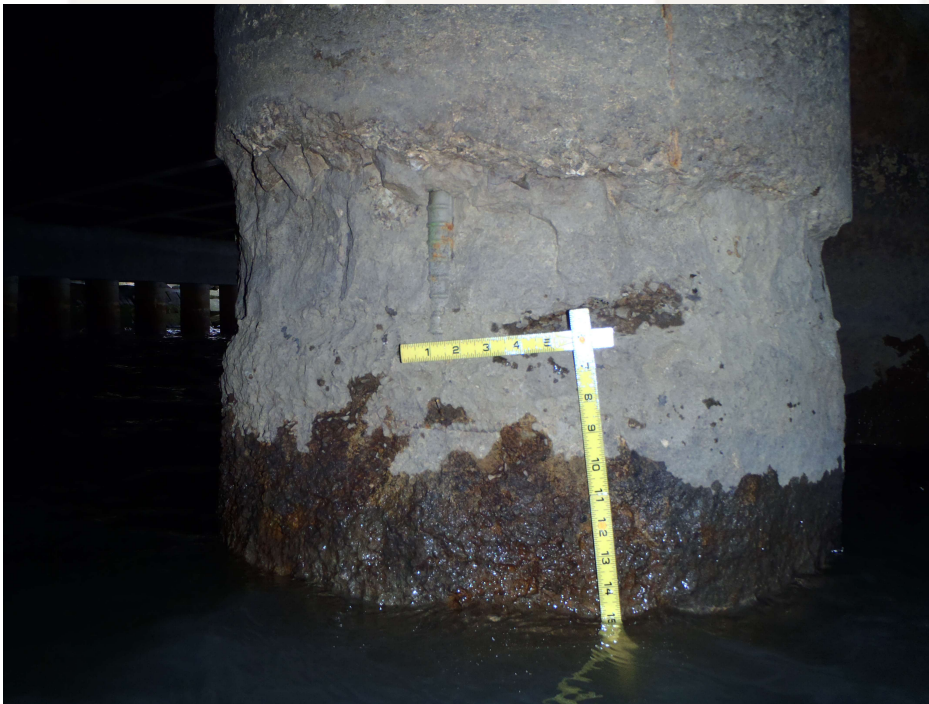
B2P15 has a spall, up to 1'-7" H x full circumference x 3" D, with one (1) piece of exposed primary vertical reinforcement, 6" high, on the east quadrant, and several random pieces of exposed secondary horizontal reinforcement in all quadrants, 3' below the cap. Refer to Photo 8. Another spall, 4" H x 6" D, is at the bottom of the west quadrant and extends around to the south quadrant.

Photo 8 - Bent 2, Pile 15, Spall with Exposed Reinforcement

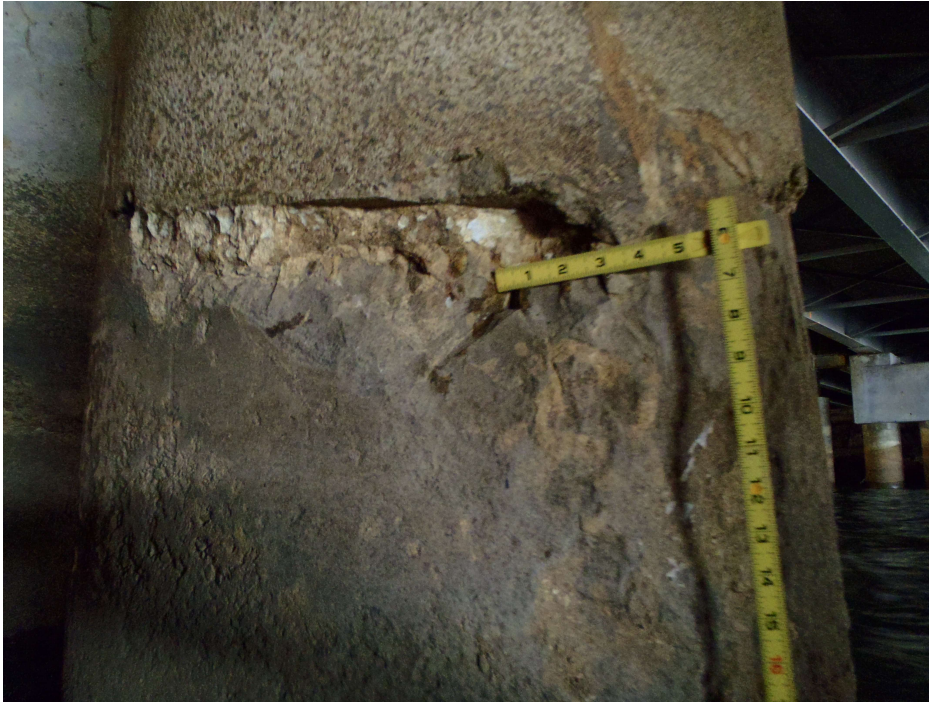
B2P17 has a spall that extends from the east quadrant to the north quadrant, 1'-8" H x 2' W x up to 2 1/2" D with no exposed steel, 3' below the cap. Refer to Photo 9.

Photo 9 - Bent 2, Pile 17, Spall at the East to North Quadrant, 3' Below the Cap

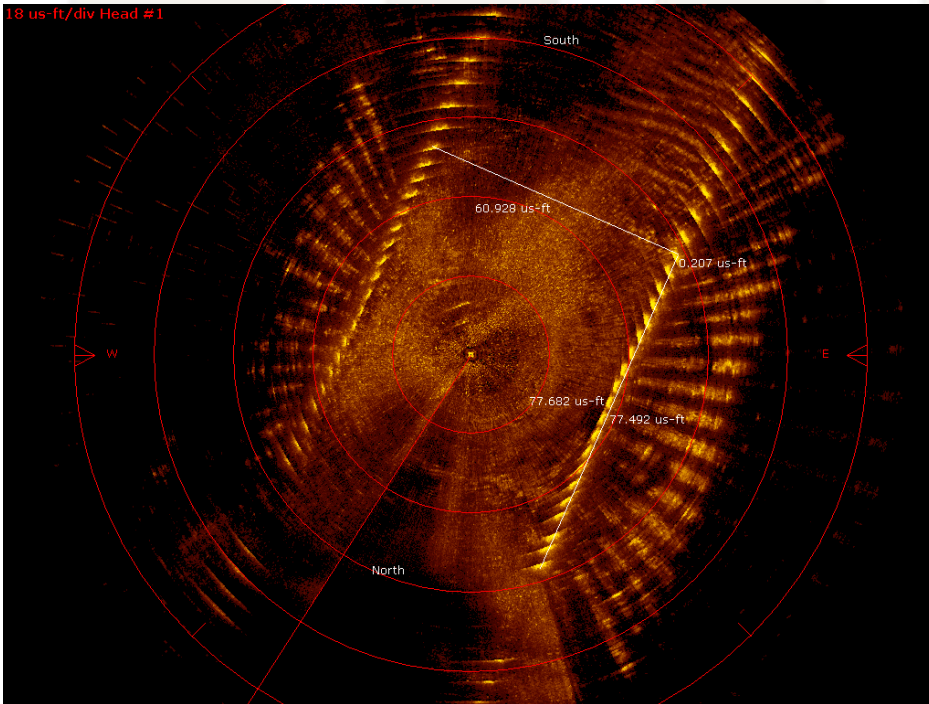
Photo 10 - Span 2, Sonar Image of Channel Bottom at 90' Radius

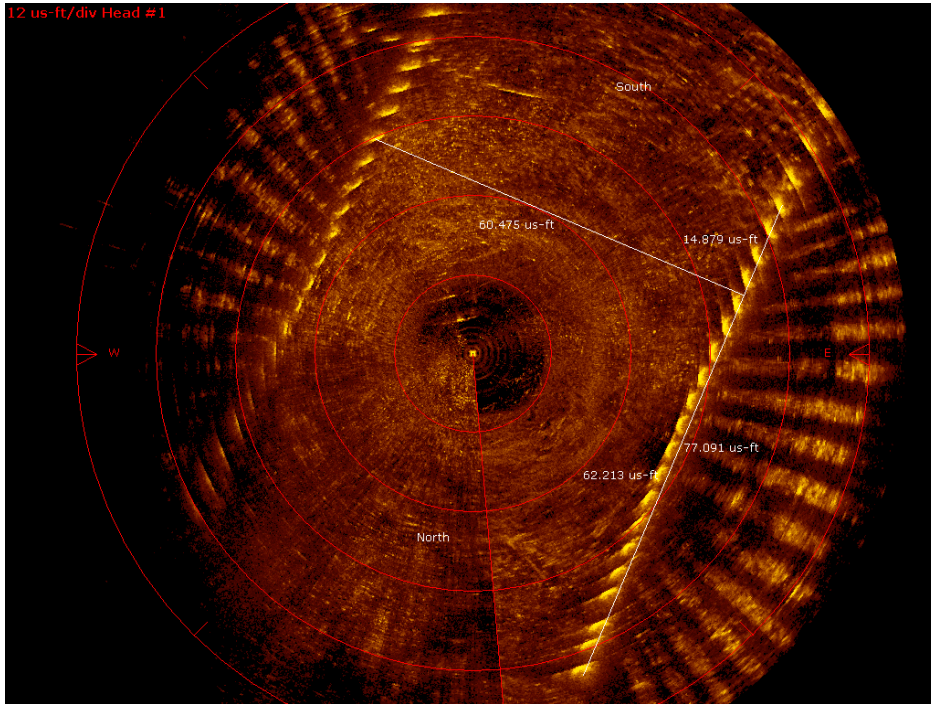
Photo 11 - Span 2, Sonar Image of Channel Bottom at 60' Radius
