# UNDERWATER INSPECTION REPORT

LAKEFRONT WALKWAY  
AND  
CLEVELAND MEMORIAL SHOREWAY  
Job Number 12160OH11.00

**DECEMBER 6, 2012**

OHIO DEPARTMENT OF TRANSPORTATION

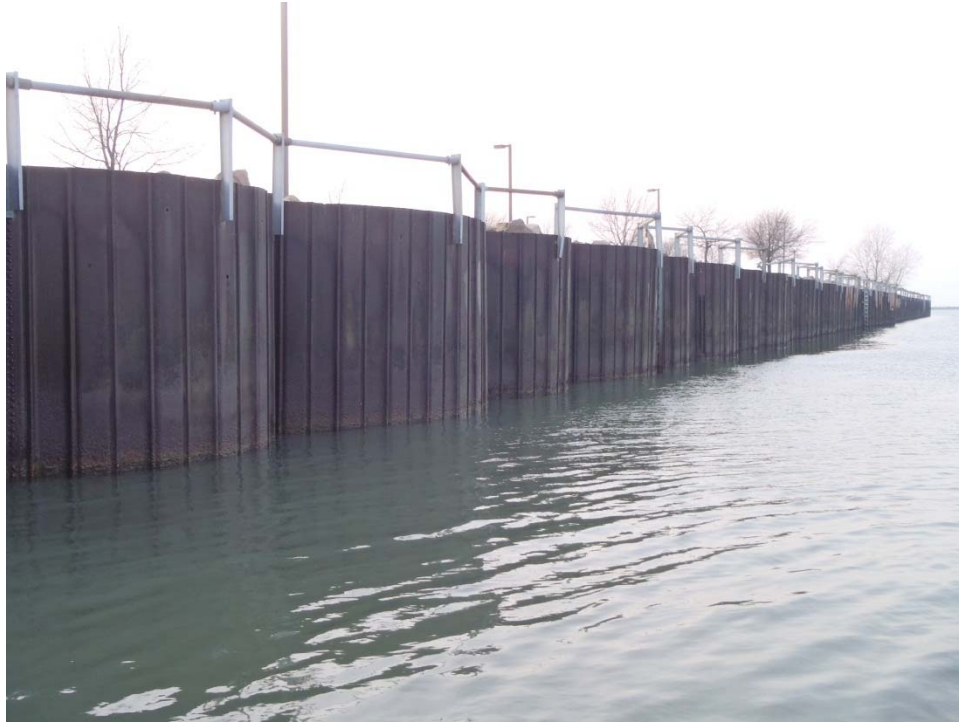
Circular steel sheet pile cells that were backfilled and topped with concrete make up the West and South Bulkheads. Refer to Photograph 1 for a view of the typical bulkhead construction. Refer to Photographs 2 and 3 for views of a typical portion of riprap revetment and concrete jetty, respectively.

Photograph 1: West Bulkhead looking northwest, typical of the West and South Bulkheads.

- Clean and coat the West and South Bulkheads from 3-feet above the waterline to 3-feet below the waterline with a suitable protective system (splash zone A-788 or similar) to prevent further corrosion and section loss.
- There are no repair recommendations for the riprap revetments or concrete jetties at this time.

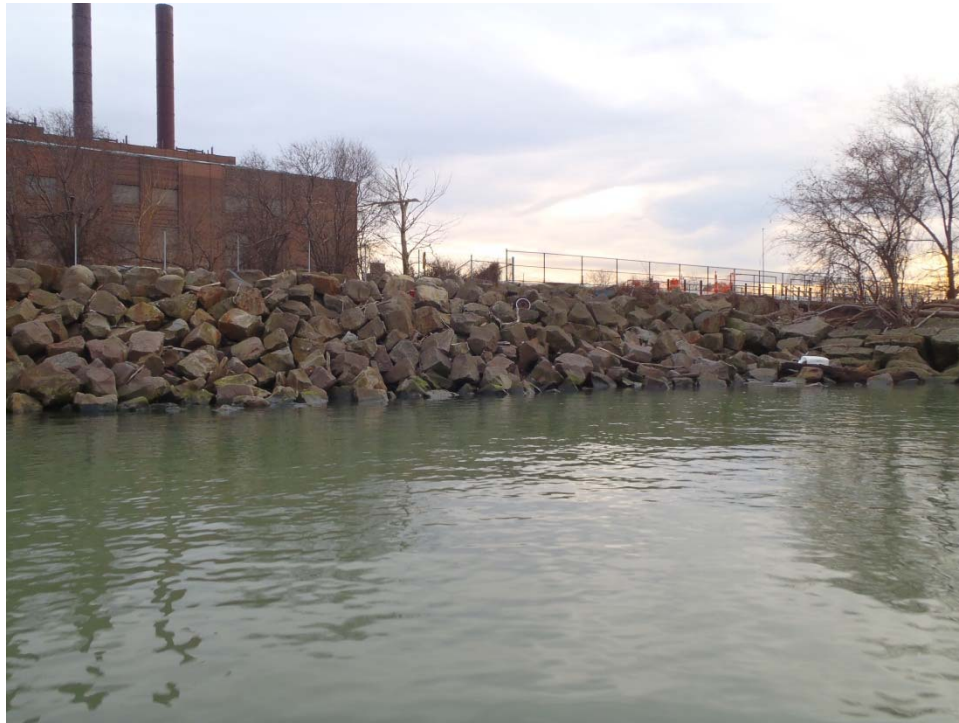
The riprap revetments and concrete jetties are in good condition. There are no noteworthy deficiencies and no significant scour or migration was observed.

Photograph 2: Riprap revetment east of the intake canal, typical of all riprap revetments.

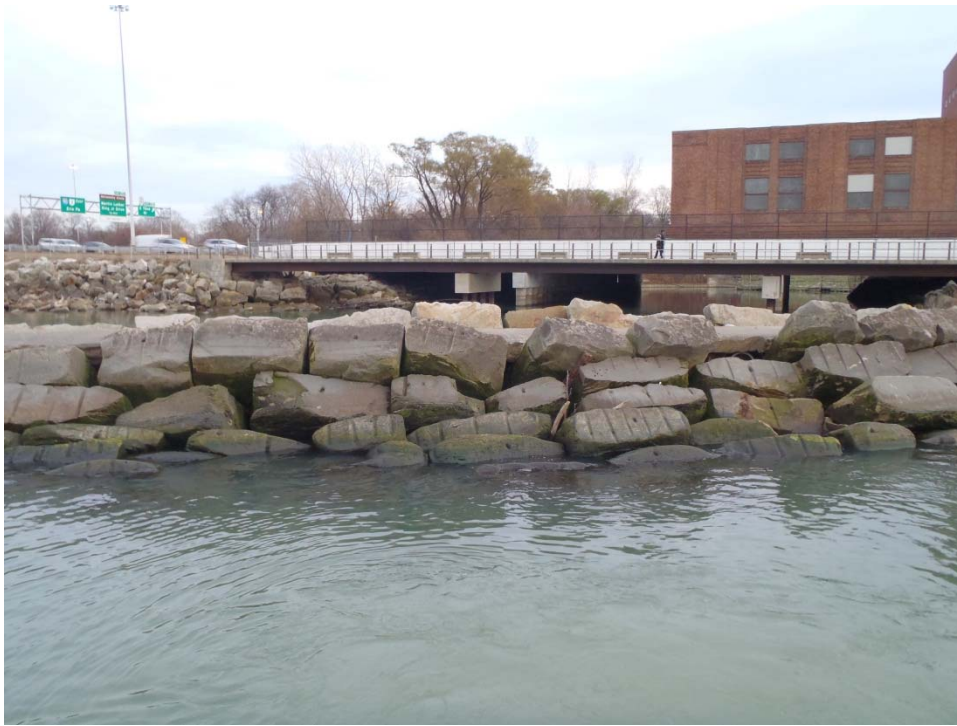
Photograph 3: Concrete jetty at the north end of the intake canal, typical of all concrete jetties.

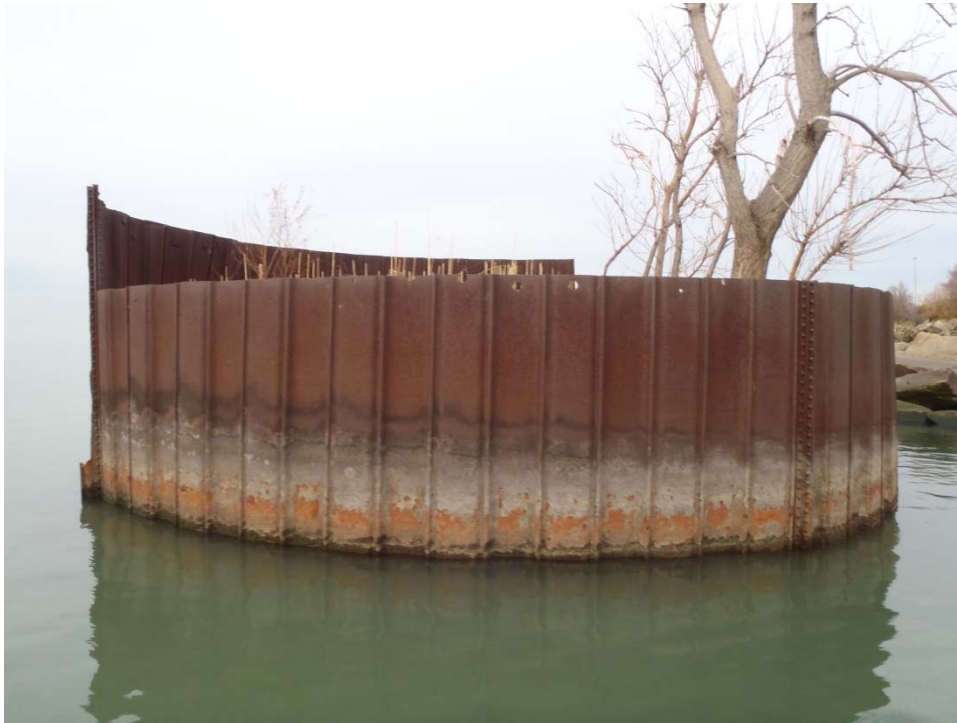
The East and West Dolphins are in good condition. Both dolphins have minor deterioration that does not significantly affect their structural capacity.

Photograph 4: East Dolphin.

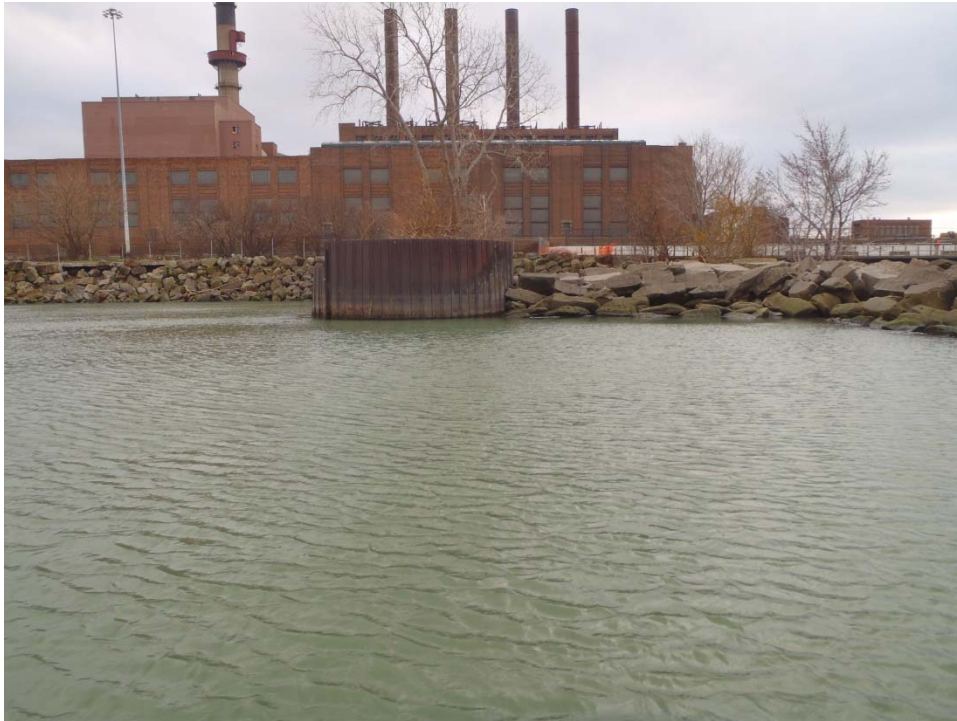
Photograph 5: West Dolphin.

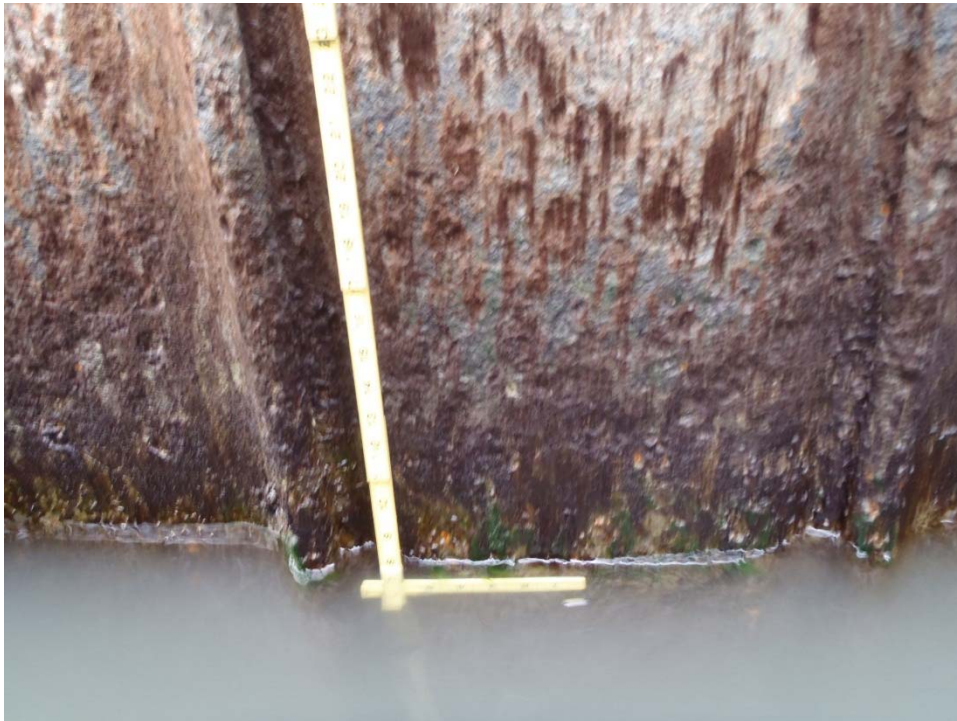
All steel sheet pile joints are tightly interlocked with no evidence of backfill loss. All of the steel sheet piling has light to moderate surface corrosion, pitting, and section loss from 3-feet above the waterline to 2-feet below the waterline. Refer to Photographs 6 through 8 for views of the typical steel sheet pile condition at the waterline and below water.

At the waterline, the West Bulkhead has approximately 72% of its original section remaining on average. At one isolated location, 500-feet from the south end, the West Bulkhead has a minimum of 53% of the original section remaining at the waterline. On average, the South Bulkhead has 75% of its original section remaining at the waterline.

The submerged portions of the West and South Bulkheads are generally in fair condition due to the corrosion and section loss at the waterline. Areas of section loss greater than the average are isolated. Based on the average section loss and the cell type construction of the bulkheads, the deterioration does not likely have a significant effect on the performance of the bulkheads.

Photograph 6: Typical steel sheet pile condition at the waterline.

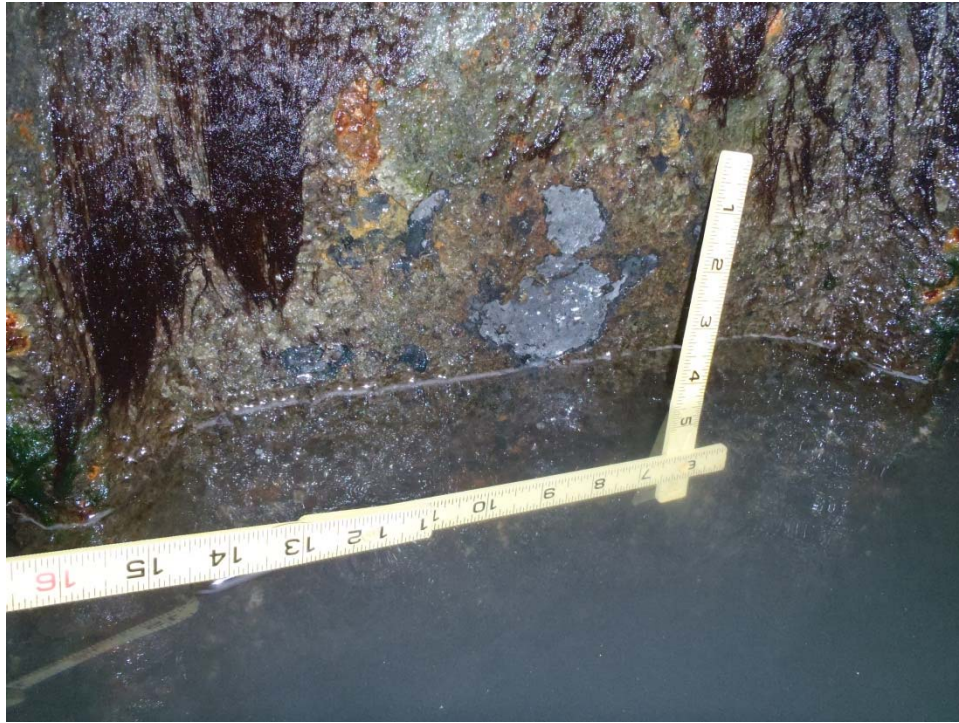
Photograph 7: Typical steel sheet pile condition in a cleaned area at the waterline.

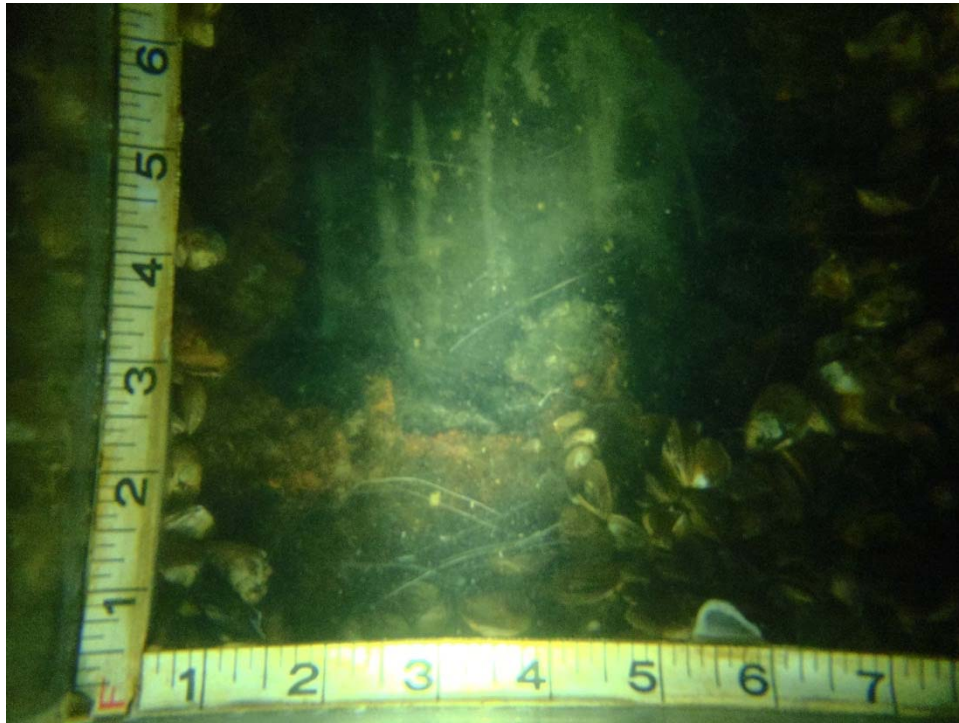
The original thickness of the steel sheet pile is 0.375-inch. At the channel bottom, both bulkheads have more than 80% of their original section remaining on average.

Photograph 8: Typical steel sheet pile condition in a cleaned area below the waterline.

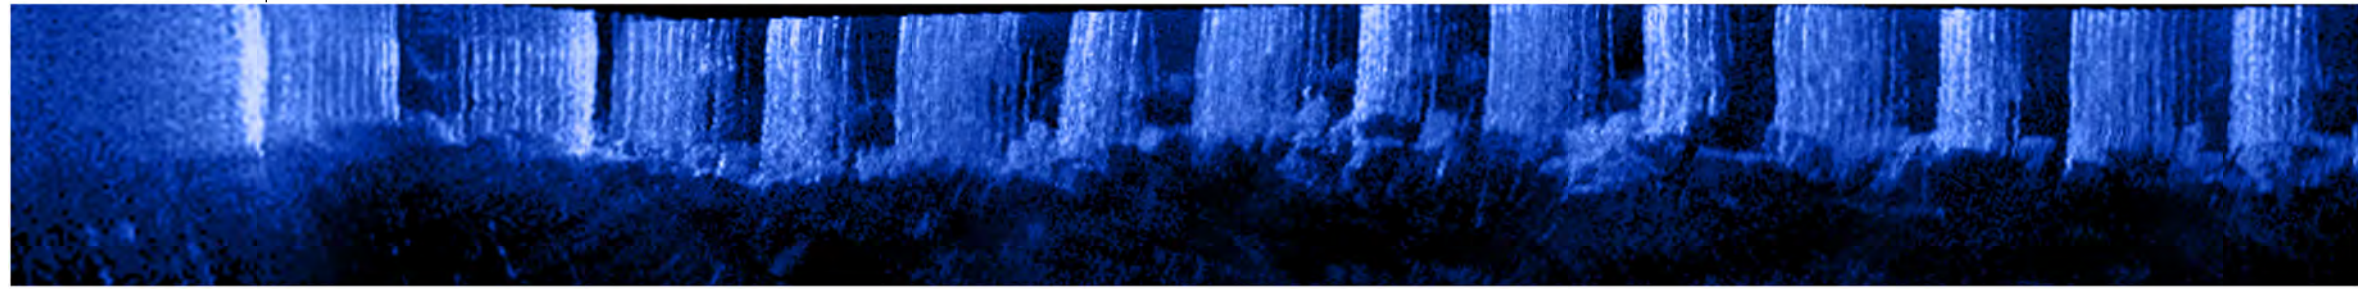
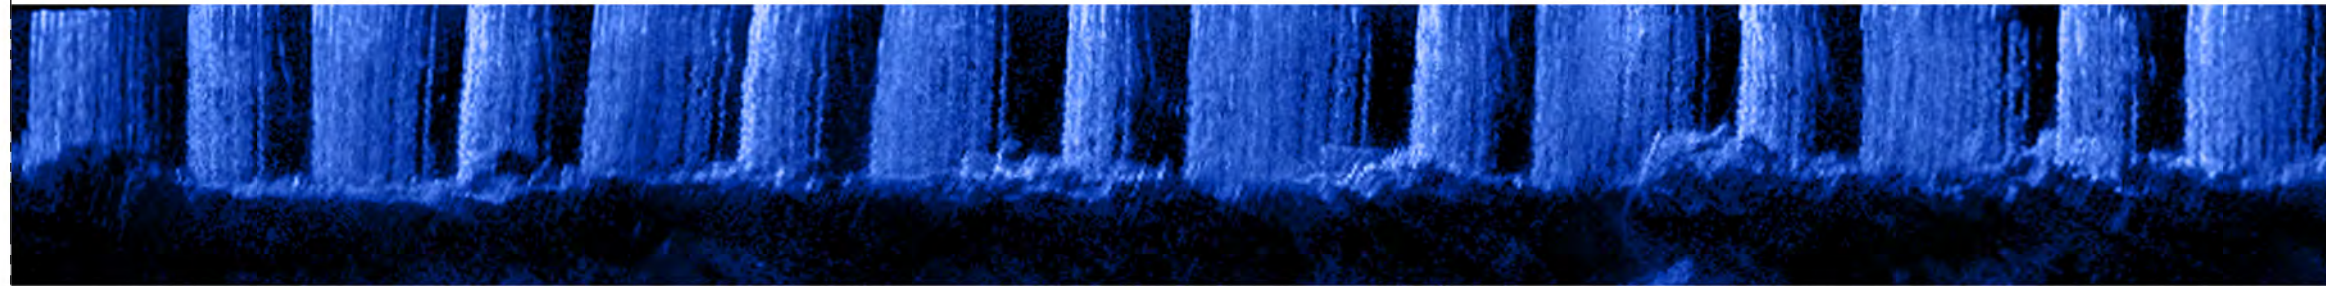
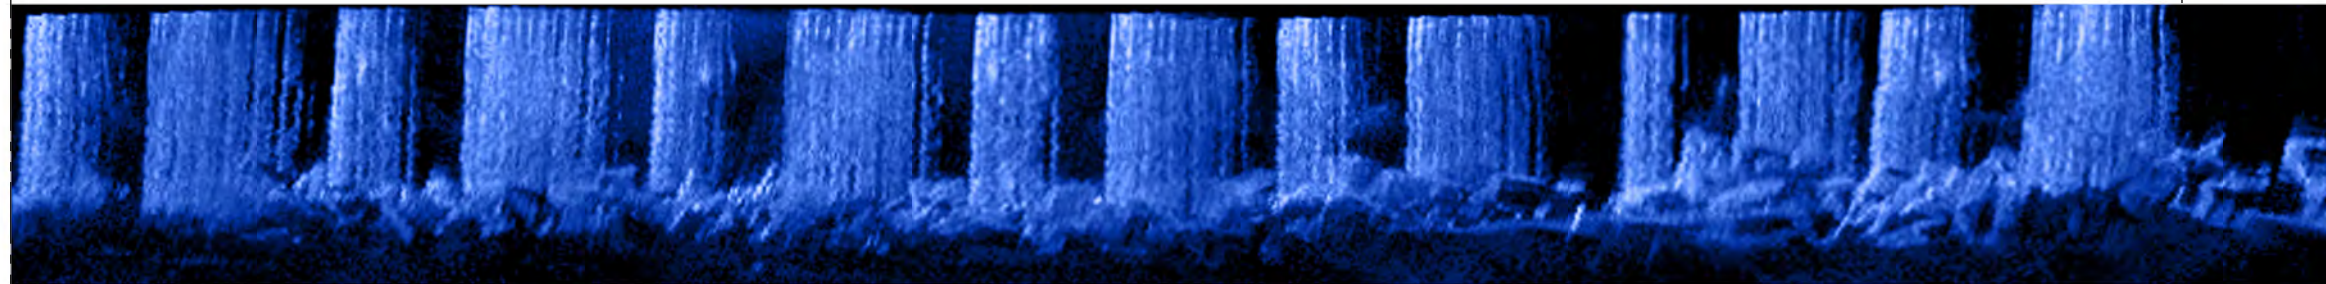
WEST BULKHEAD  
(EAST ELEVATION)

No evidence of significant scour or migration of the riprap revetments or concrete jetties was observed. Refer to Figures 2 through 5 in Appendix B for views of the acoustic images along the bulkheads, revetments, and jetties.
