## BRIDGE INSPECTION REPORT

1808745  
Structure File Number

BRIDGE NUMBER CUY 00090 2046 R

YEAR BUILT 1938

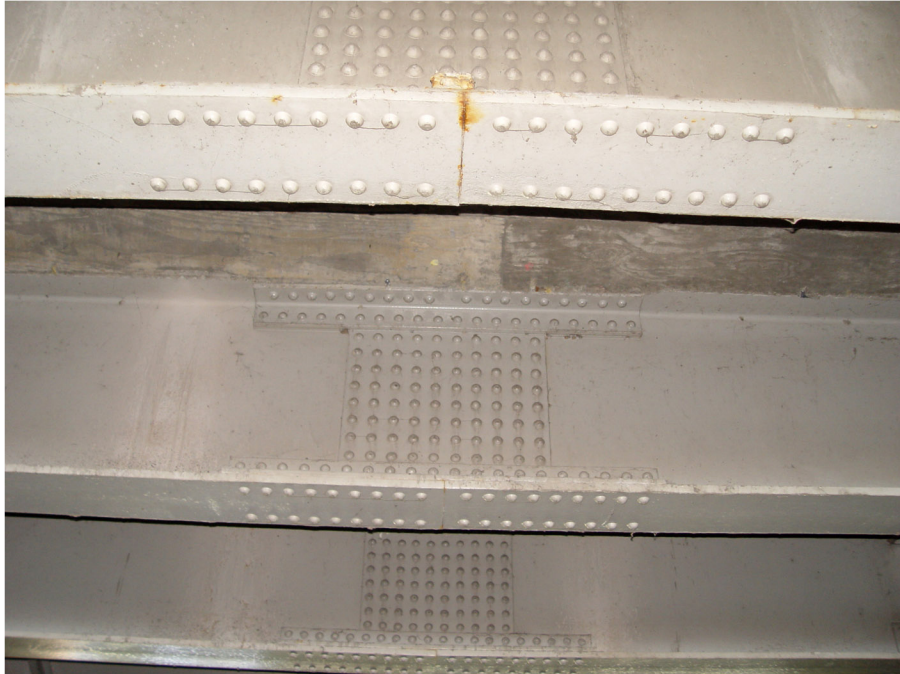
NO SPLICE PLATES ON THE BOTTOMS OF THE LOWER FLANGES  
AT THE FIELD SPLICES IN SPAN #2; SEE ATTACHED PHOTO  
P1 DATED 10/05/05.

1808745 10\_5\_05 P1 no lower splice plates.jpg

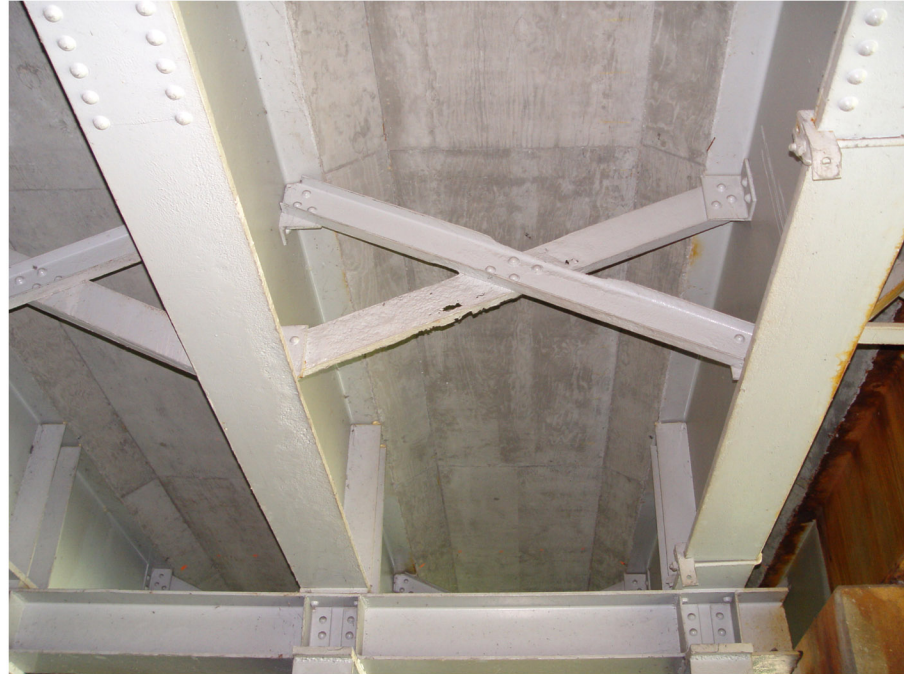
CROSSFRAMES: RUSTED THRU HOLES IN A FEW CROSSFRAMES; SEE  
ATTACHED PHOTOS P2 AND P3 DATED 10/05/05  
(1ST CROSSFRAME START OF PIER #1 IN BAY #5R).  
BENT CHANNEL OF FIRST CROSSFRAME FINISH OF PIER  
#2 IN BAY #3; SEE ATTACHED PHOTO P4 DATED  
10/05/05.

1808745 10\_5\_05 P2 rusted thru holes in xframe.jpg

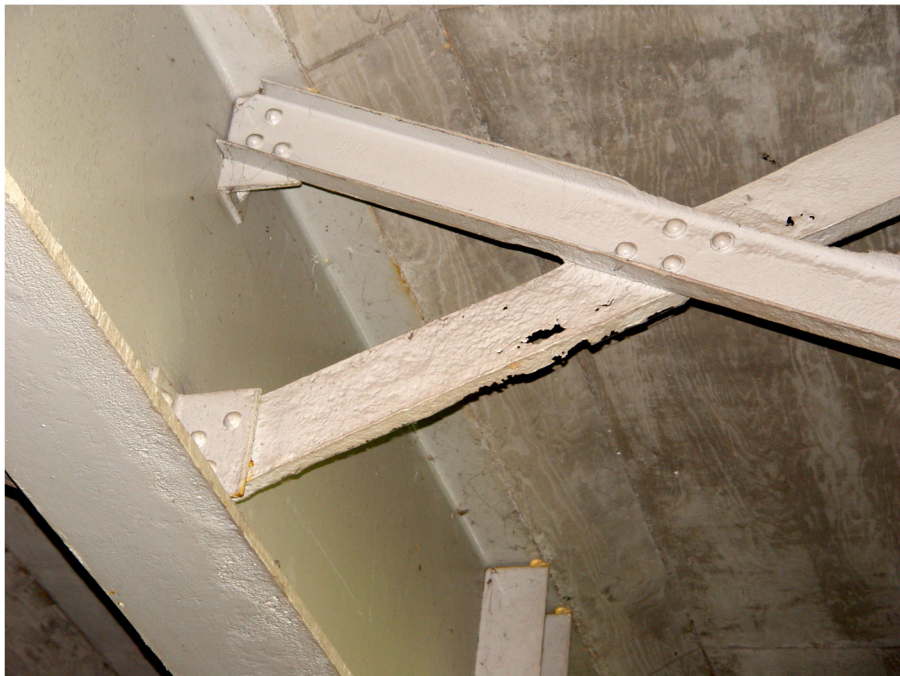
1808745 10\_5\_05 P3 closeup of P2.jpg

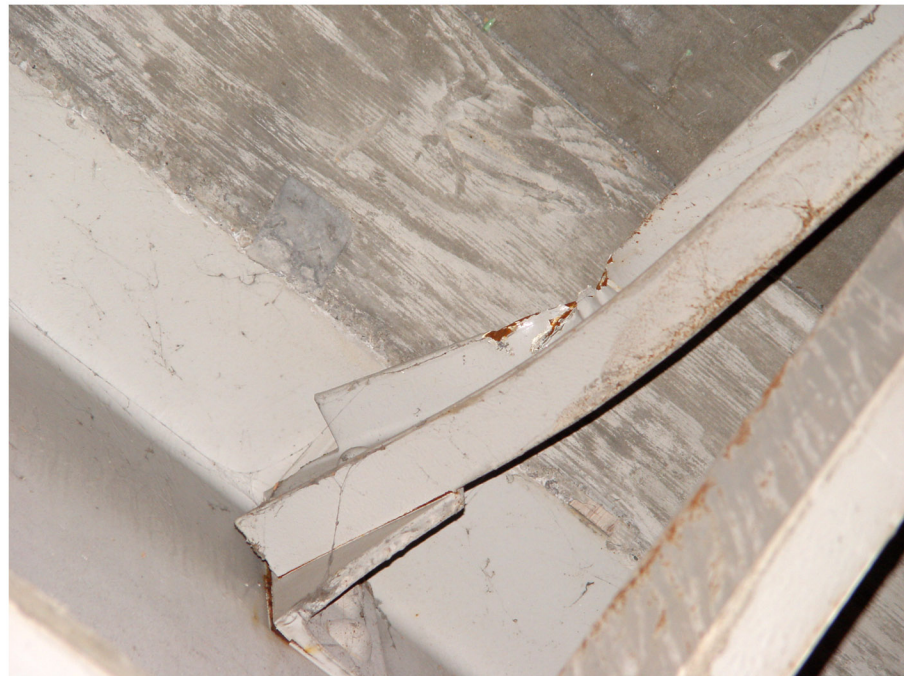
1808745 10\_5\_05 P4 bent crossframe channel.jpg
