BRIDGE INSPECTION REPORT

BRIDGE NUMBER CUY 00090 2046 R

Underwater Inspection Report for:

Interstate 90 over C.E.I Outlet
Cuyahoga County, Ohio
(Three Span Steel Beam Bridge)

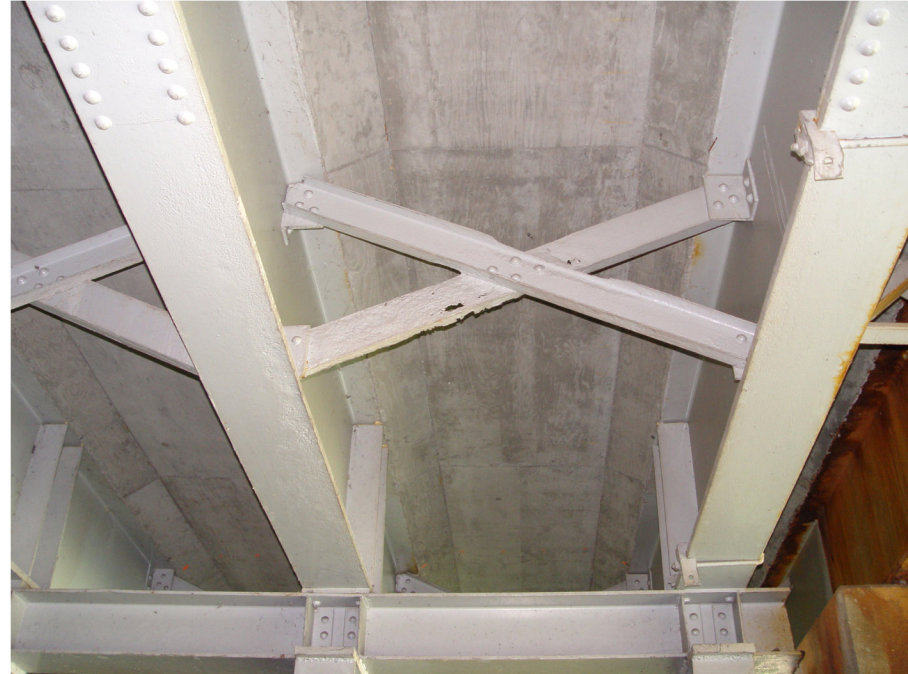
CROSSFRAMES: RUSTED THRU HOLES IN A FEW CROSSFRAMES; SEE ATTACHED PHOTOS P2 AND P3 DATED 10/05/05 (1ST CROSSFRAME WEST OF PIER #1 IN BAY #5R). BENT CHANNEL OF FIRST CROSSFRAME EAST OF PIER #2 IN BAY #3; SEE ATTACHED PHOTO P4 DATED 9/25/07.

1808745 10_5_05 P2 rusted thru holes in xframe.jpg

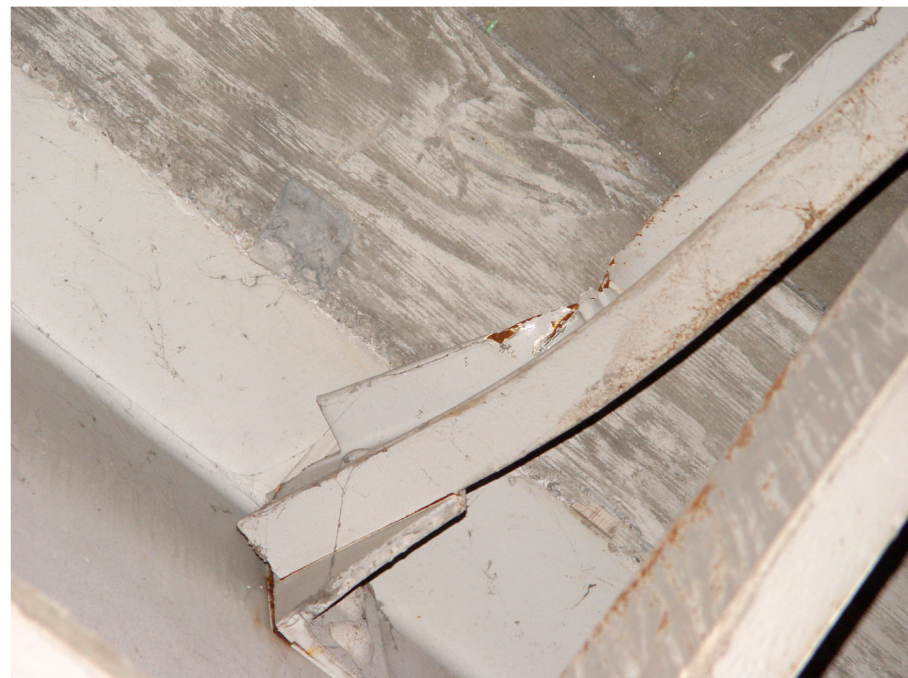
1808745 10_5_05 P4 bent crossframe channel.jpg

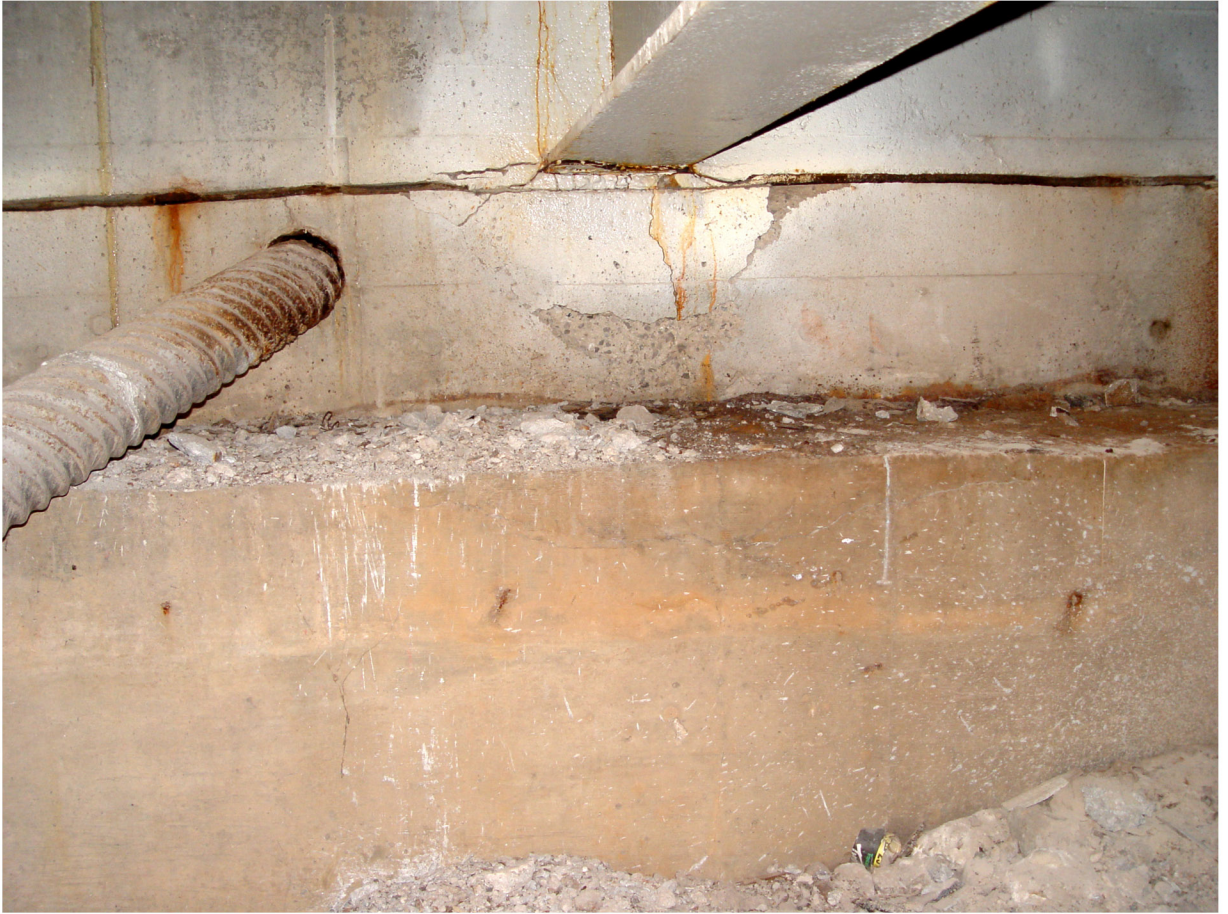
ABUTMENTS: CRACKS. A FEW DELAMINATIONS AND SPALLS; SEE ATTACHED PHOTOS P5 AND P6 DATED 11/07/05 (START ABUTMENT BELOW BEAM #8).

1808745 11_7_05 P5 start abut delamination & spall.jpg
