## BRIDGE INSPECTION REPORT

BRIDGE NUMBER CUY 00090 2043 R

**Underwater Inspection Report for:**

**Interstate 90 over C.E.I Outlet**  
Cuyahoga County, Ohio  
(Three Span Steel Beam Bridge)

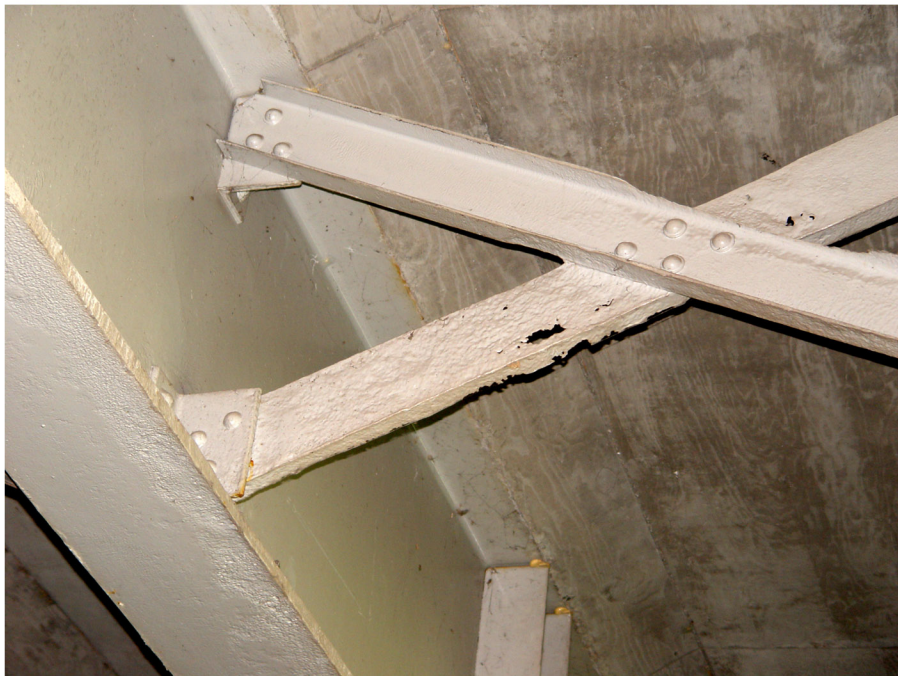
XFRAMES: RUSTED THRU HOLES IN A FEW CROSSFRAMES; SEE ATTACHED PHOTOS 2 & 3 DATED 10/05/05 (1ST XFRAME WEST OF PIER #1 IN BAY #5R). BENT CHANNEL OF FIRST XFRAME EAST OF PIER #2 IN BAY #3; SEE ATTACHED PHOTO 4 DATED 9/25/07.

1808745 10\_5\_05 P3 closeup of P2.jpg

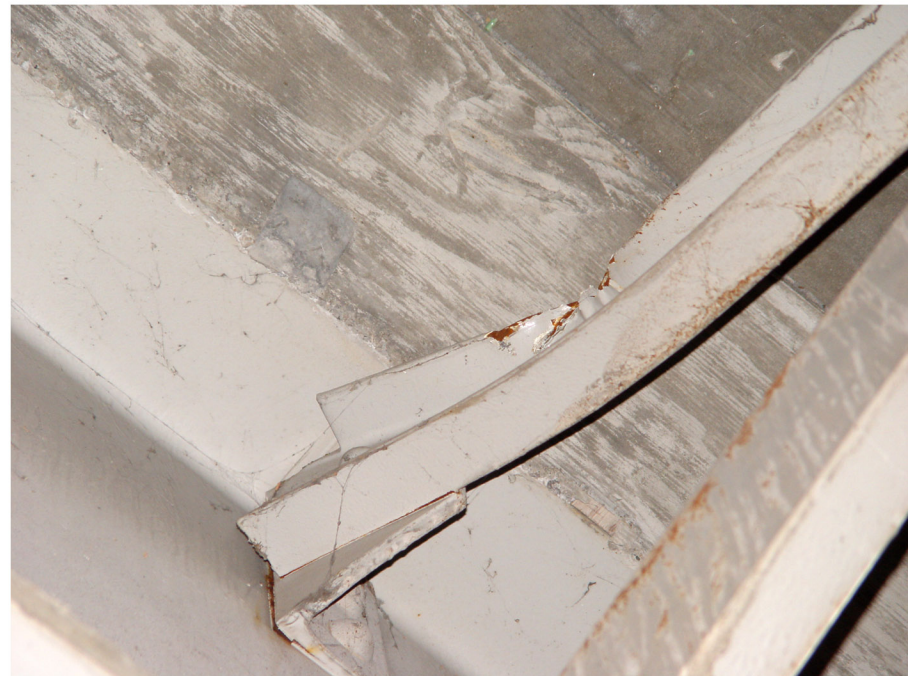
1808745 10\_5\_05 P4 bent crossframe channel.jpg

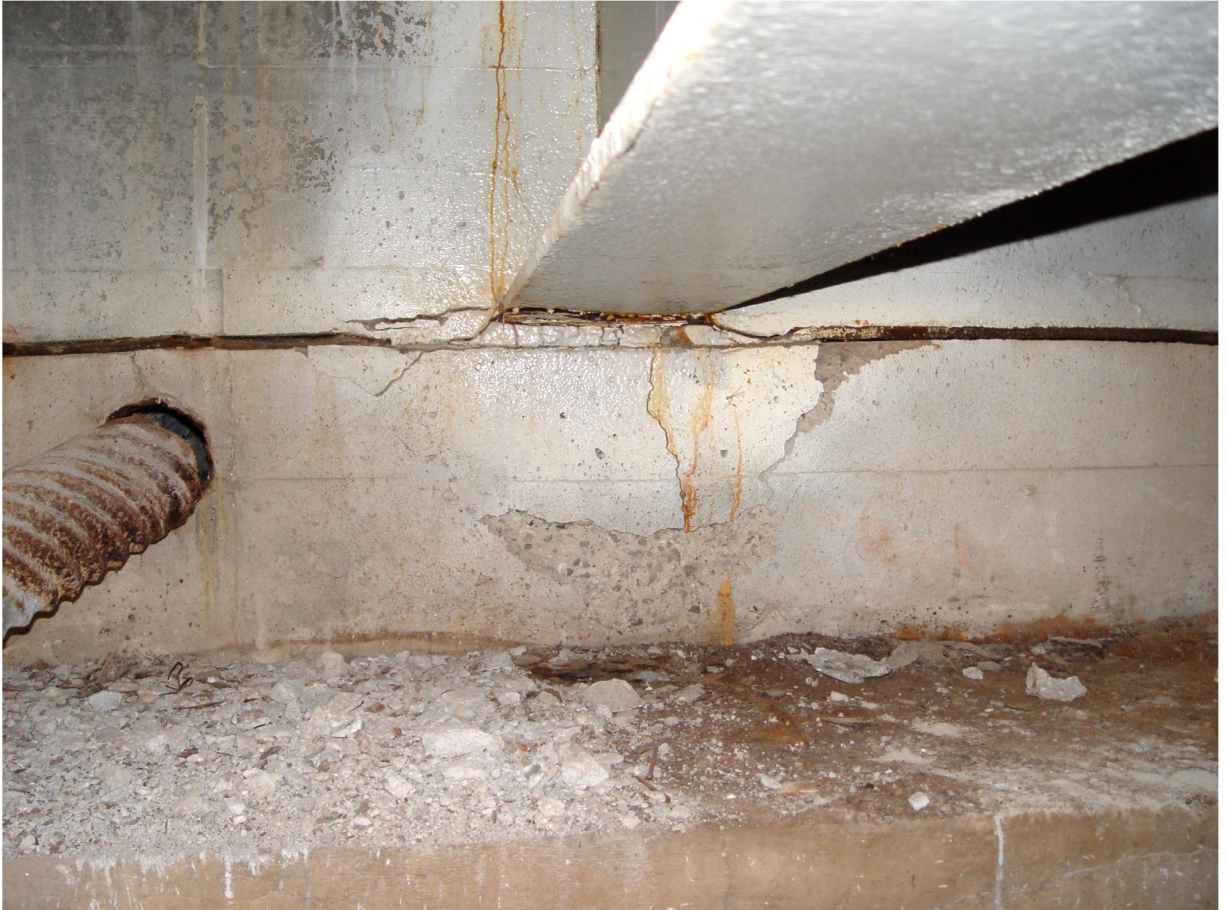
ABUTMENTS: CRACKS. A FEW DELAMINATIONS AND SPALLS; SEE ATTACHED PHOTOS P5 AND P6 DATED 11/07/05 (START ABUTMENT BELOW BEAM #8).

1808745 11\_7\_05 P6 closeup of P5.jpg

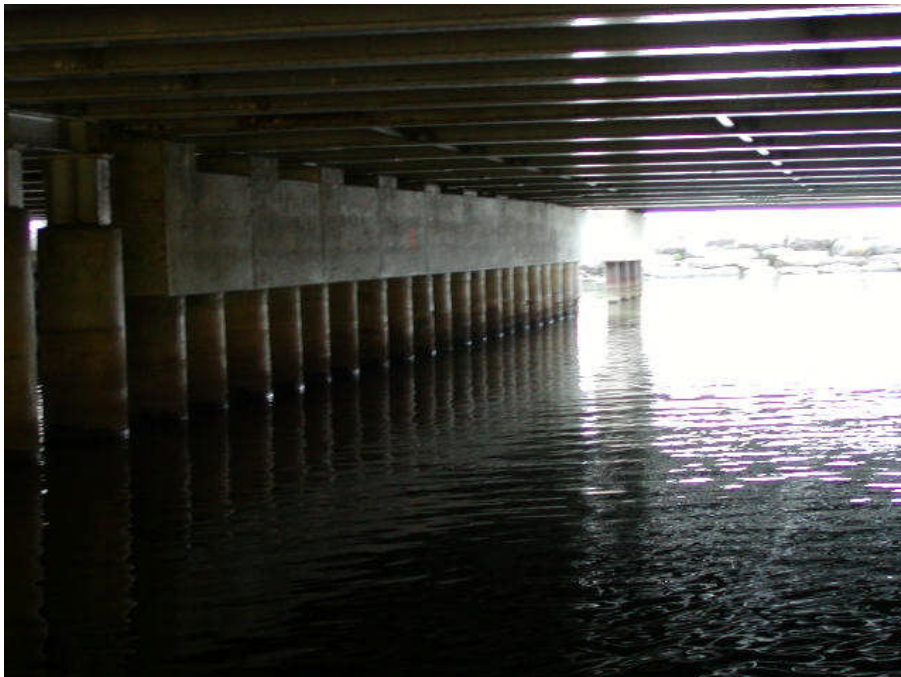
- No section loss of the piles was observed.

Photo 2. Pier 1R (north).

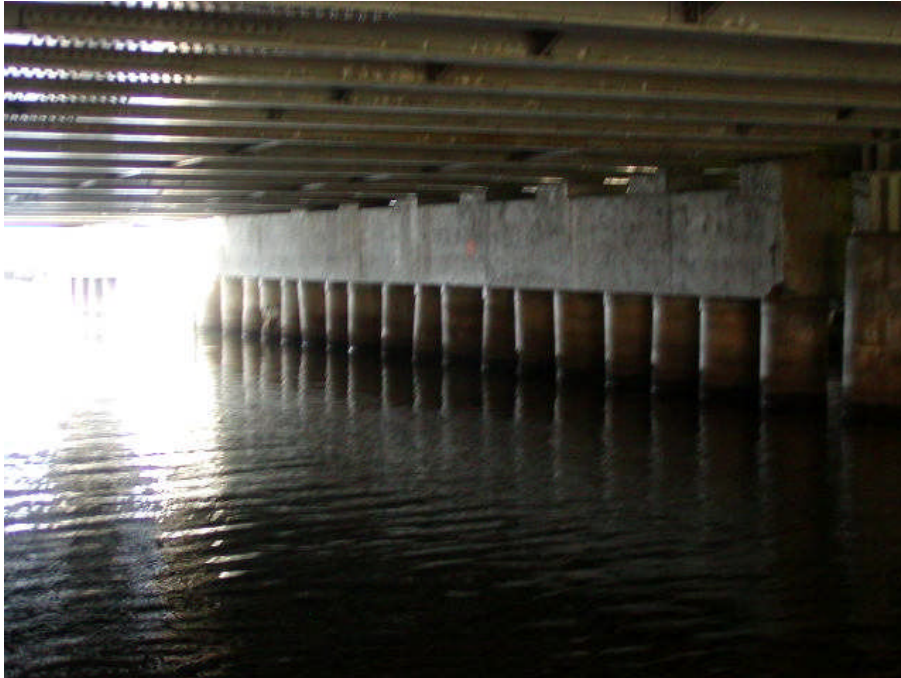
- Pile 14, area of section loss up to 4.5 inch tall with up to 6 inches of penetration located on the bottom on the north, west and south faces.

Photo 3. Pier 2R (southwest).

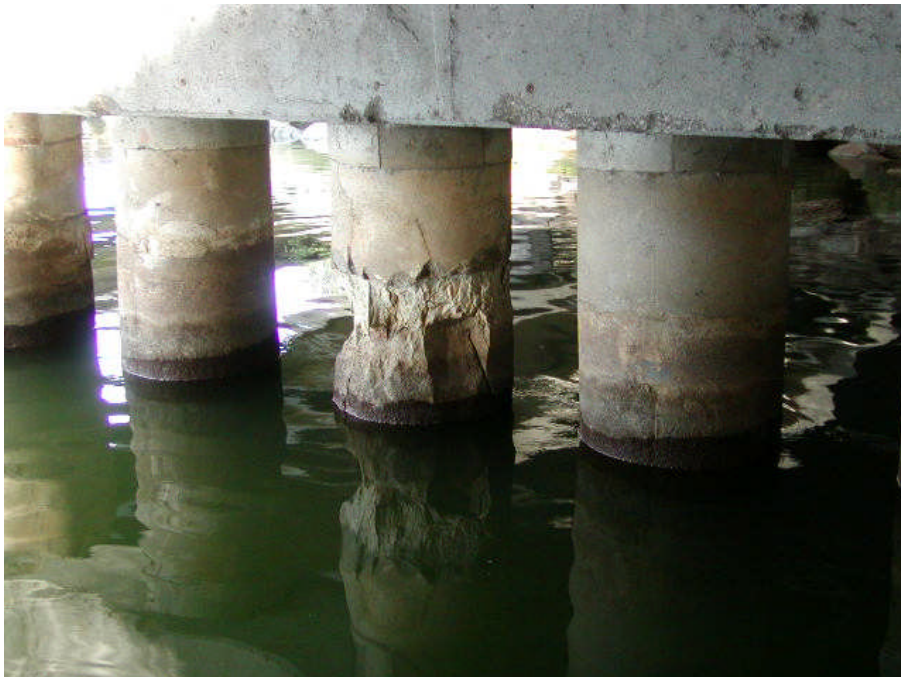
Photo 4. Typical Section Loss.
