BRIDGE INSPECTION REPORT

1808745
Structure File Number

BRIDGE NUMBER CUY 00090 2043 R

Interstate 90 over C.E.I Outlet
Cuyahoga County, Ohio
(Three Span Steel Beam Bridge)

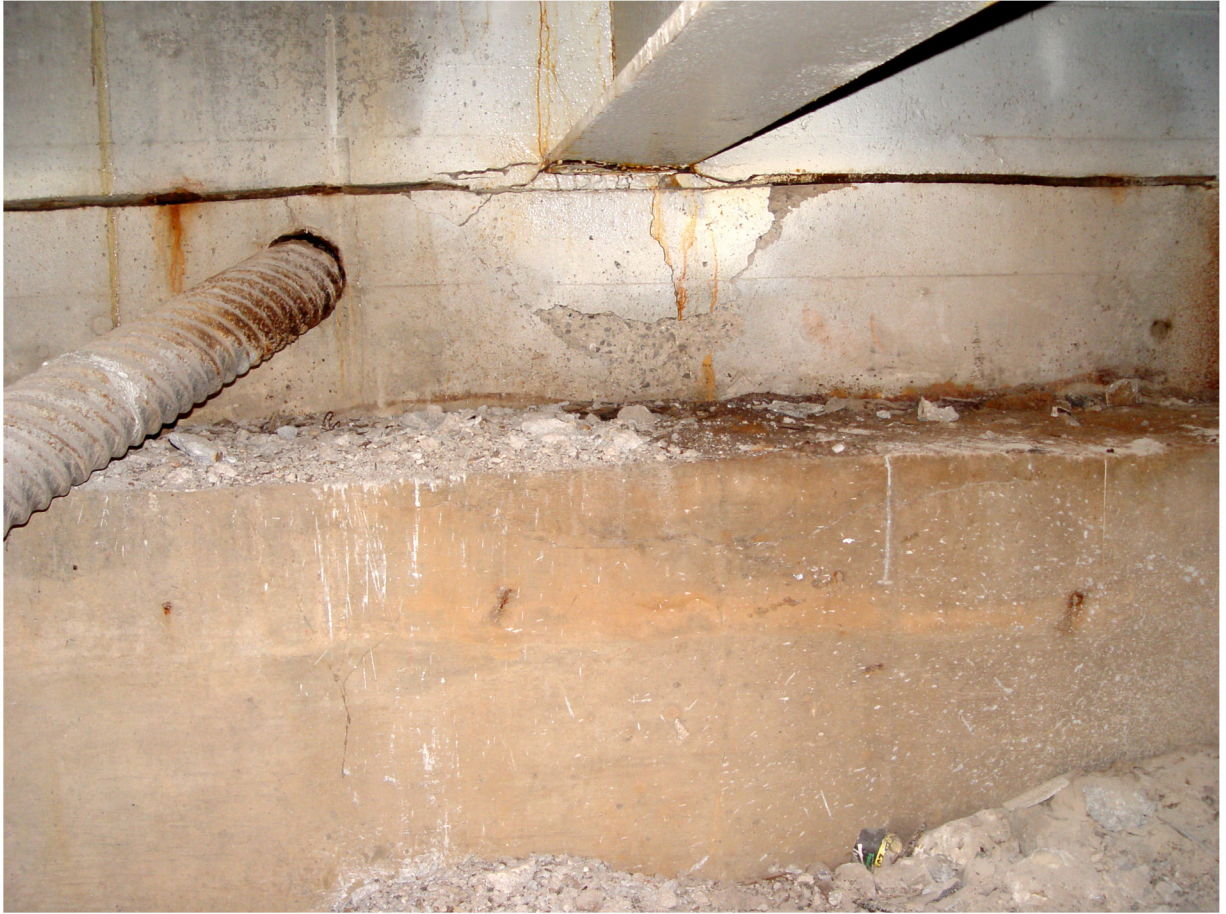
ABUTMENTS: CRACKS. A FEW DELAMINATIONS AND SPALLS; SEE ATTACHED PHOTOS P5 AND P6 DATED 11/07/05 (START ABUTMENT BELOW BEAM #8).

1808745 11_7_05 P5 start abut delamination & spall.jpg

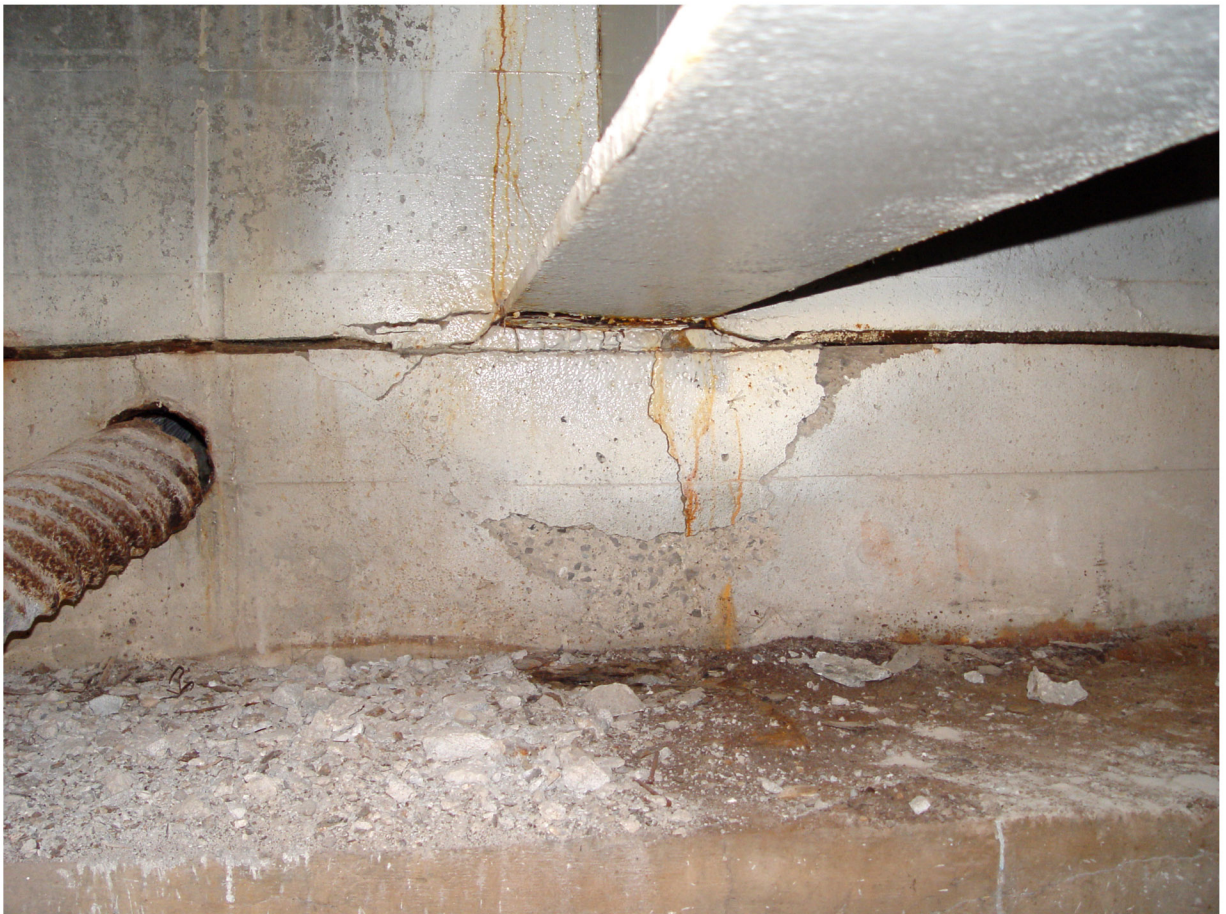
1808745 11_7_05 P6 closeup of P5.jpg
