BRIDGE INSPECTION REPORT

1808745
Structure File Number

BRIDGE NUMBER CUY 00090 2043 R

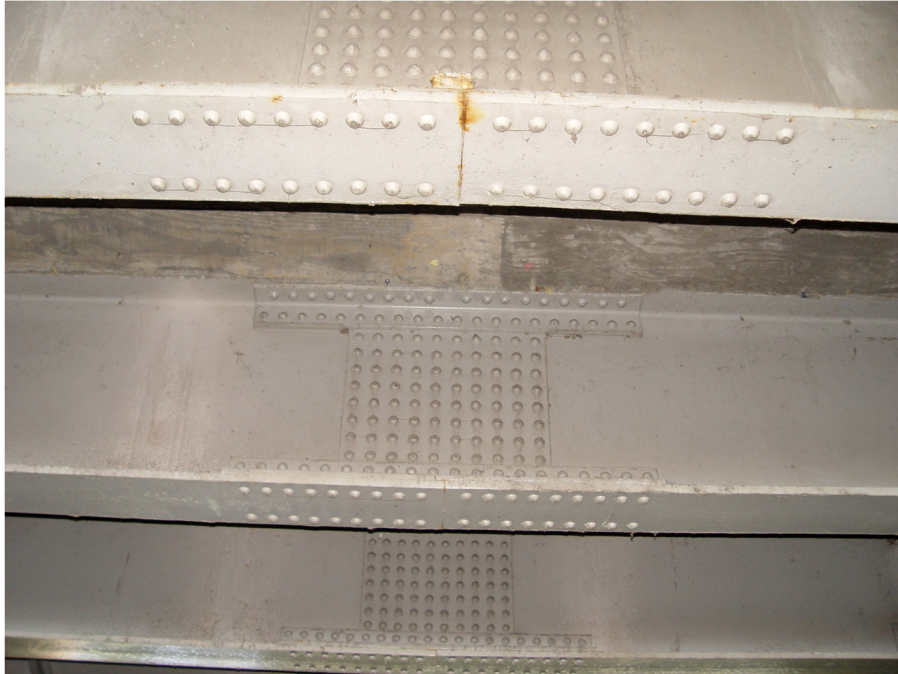
BEAMS: RUSTING & RUSTED SECTION LOSS. NO SPLICE PLATES ON
THE BOTTOMS OF THE LOWER FLANGES AT THE FIELD SPLICES IN
SPAN #2; SEE ATTACHED PHOTO 1 DATED 10/05/05.
XFRAMES: RUSTED THRU HOLES IN A FEW CROSSFRAMES; SEE
ATTACHED PHOTOS 2 & 3 DATED 10/05/05 (1ST XFRAME WEST OF
PIER #1 IN BAY #5R). BENT CHANNEL OF FIRST XFRAME EAST OF
PIER #2 IN BAY #3; SEE ATTACHED PHOTO 4 DATED 9/25/07.
PCS: 2% RUST. 1-5% DETERIORATED.

1808745 10_5_05 P1 no lower splice plates.jpg

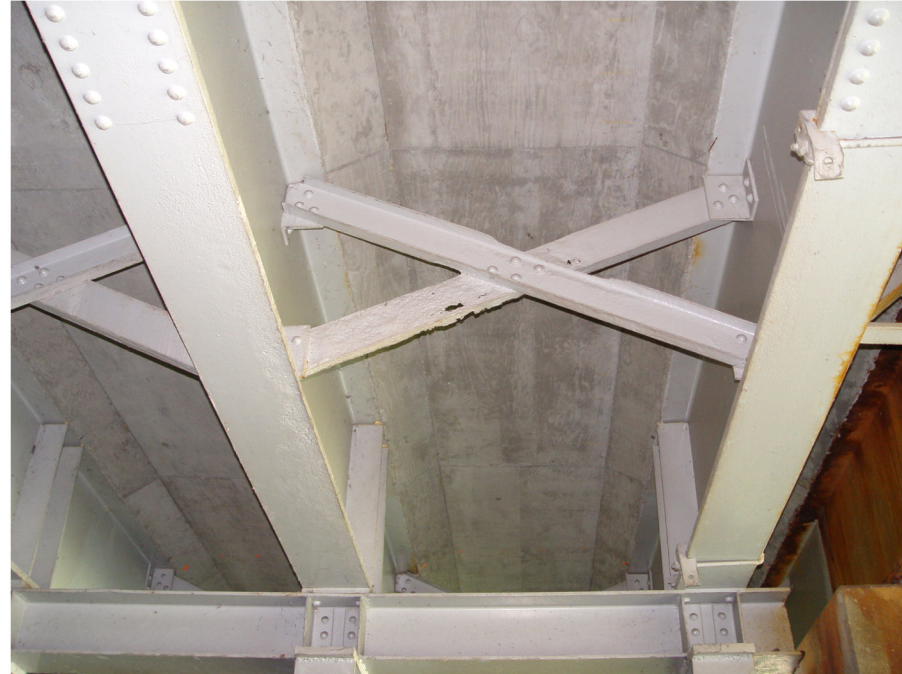
1808745 10_5_05 P2 rusted thru holes in xframe.jpg

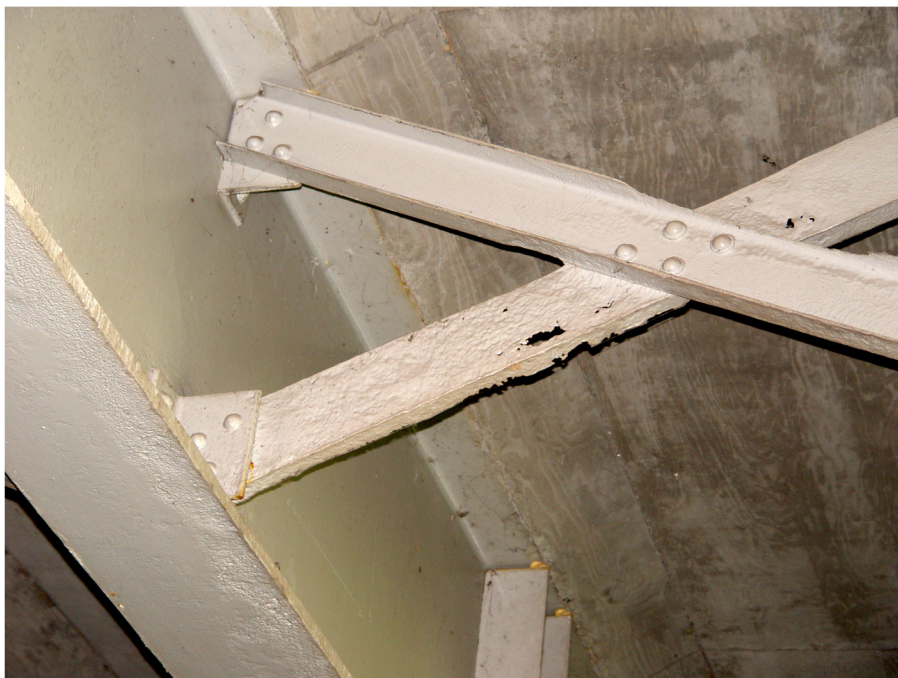
1808745 10_5_05 P3 closeup of P2.jpg

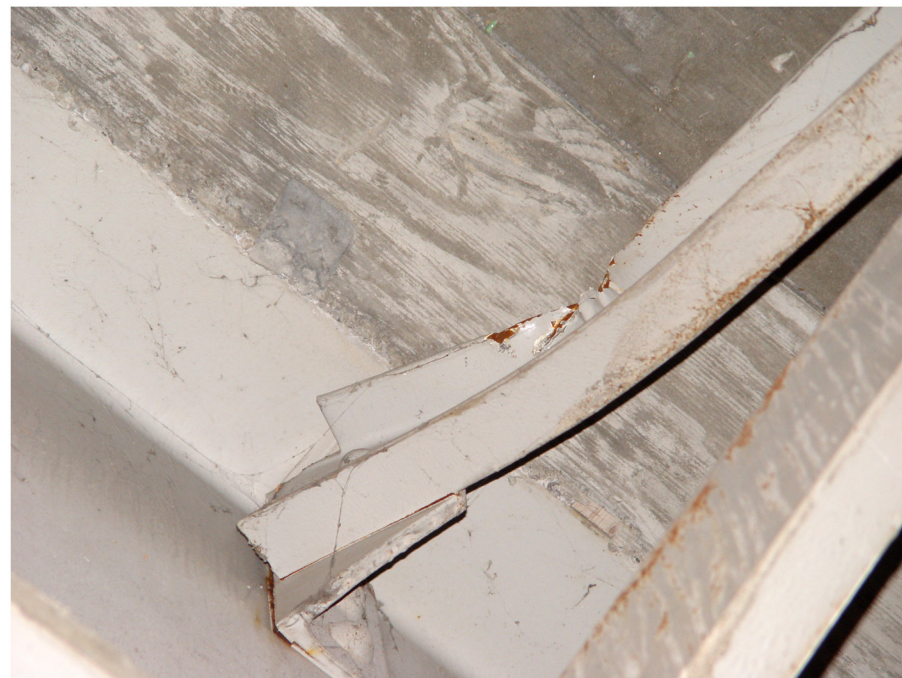
1808745 10_5_05 P4 bent crossframe channel.jpg

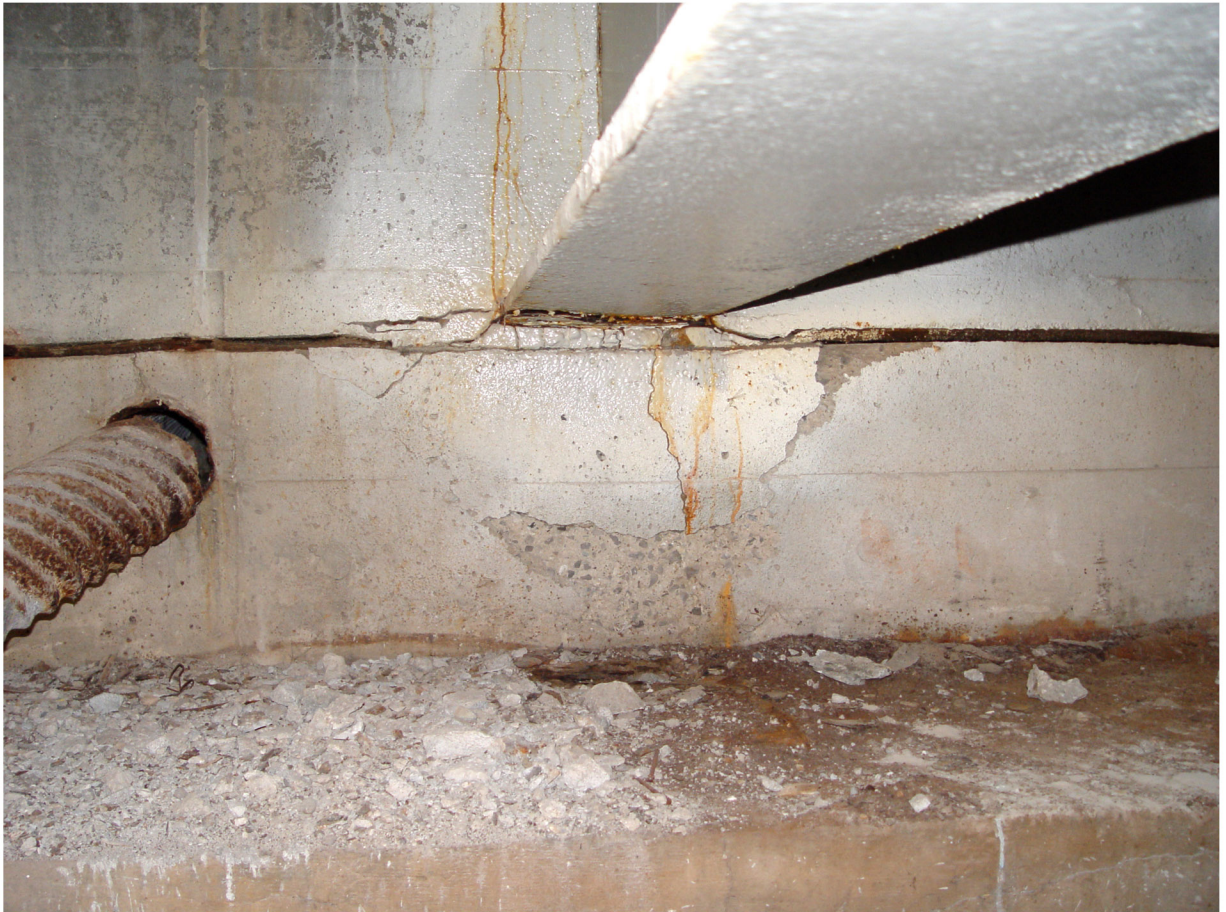
1808745 11_7_05 P6 closeup of P5.jpg
