# UNDERWATER BRIDGE INSPECTION REPORT

Bridge Number: CUY-00090-2043R  
Inspection Date: 12/5/2012  
Division: District 12  
River: Cuyahoga Outlet Channel

Engineer of Record: David Reser  
Team Leader: Fred Meek  
Substructures Inspected: Bents 1 and 2  
Team Members:  
KRR, JML

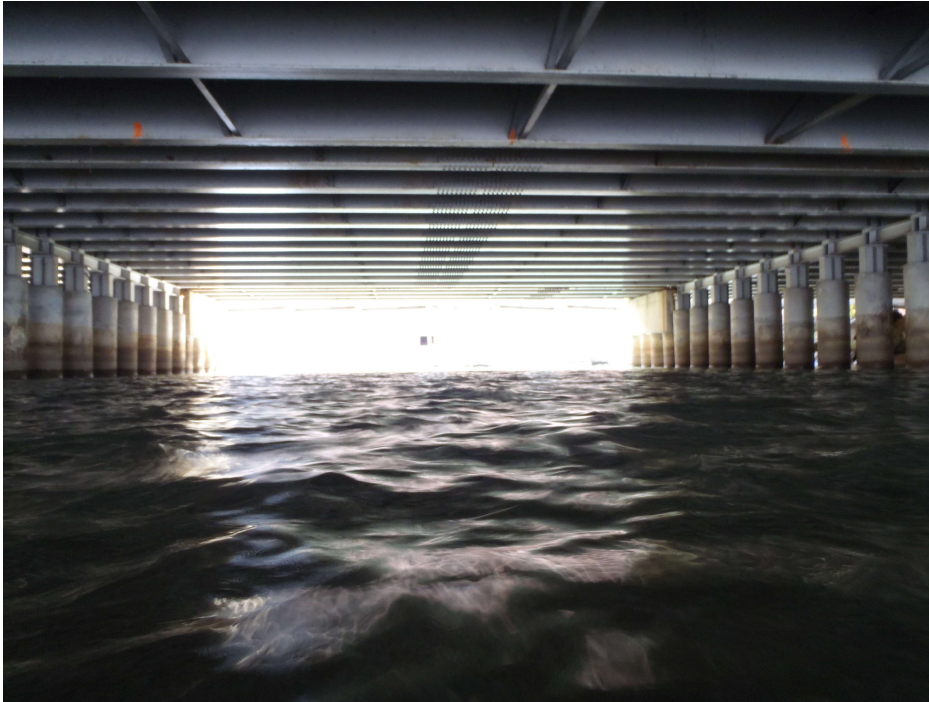
**Photo 3 - Channel View Looking Upstream (South)**

The channel bottom is in good condition and is well aligned with the substructure units. Refer to Photos 3 and 4. The channel is armored with large rock. There is some moderate timber debris along the east shoreline. A jetty north of this structure protects this bridge. The channel bottom material consists of silt, sand, gravel, cobbles and trash debris.

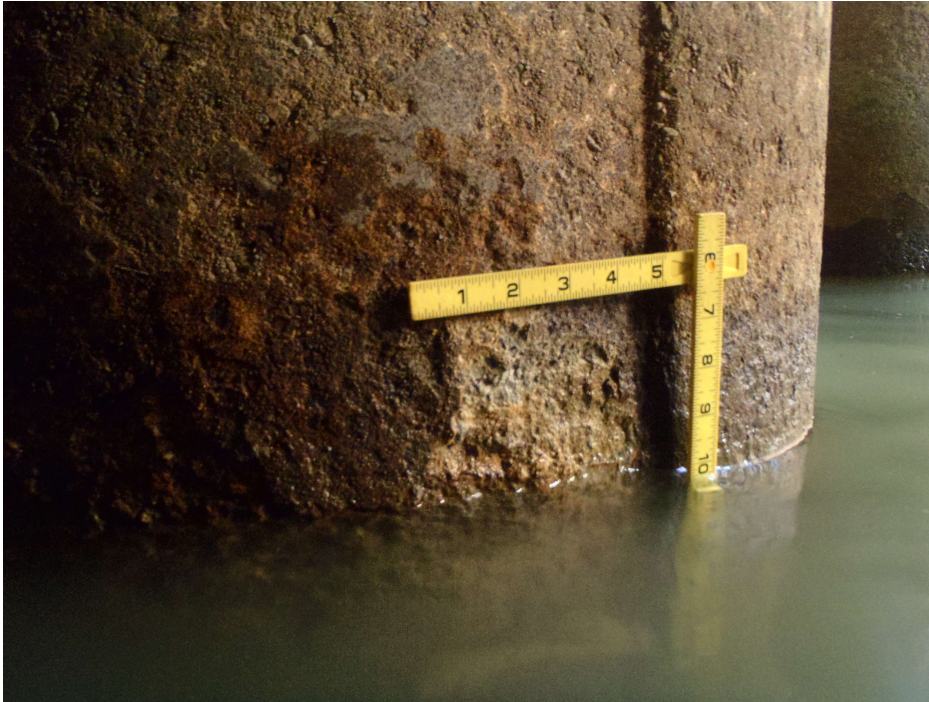
The following piles have hollow sounding, soft, concrete encasements in the splash zone, in the outer inch of the encasement, starting 5' above the channel bottom and extending 1' above the waterline: B1P11 through P14, and B2P4 and B2P7 through B2P15. Refer to Photos 5 and 6.

Photo 5 - Bent 1, Pile 14, Typical Condition of Concrete at Hollow Sounding Area

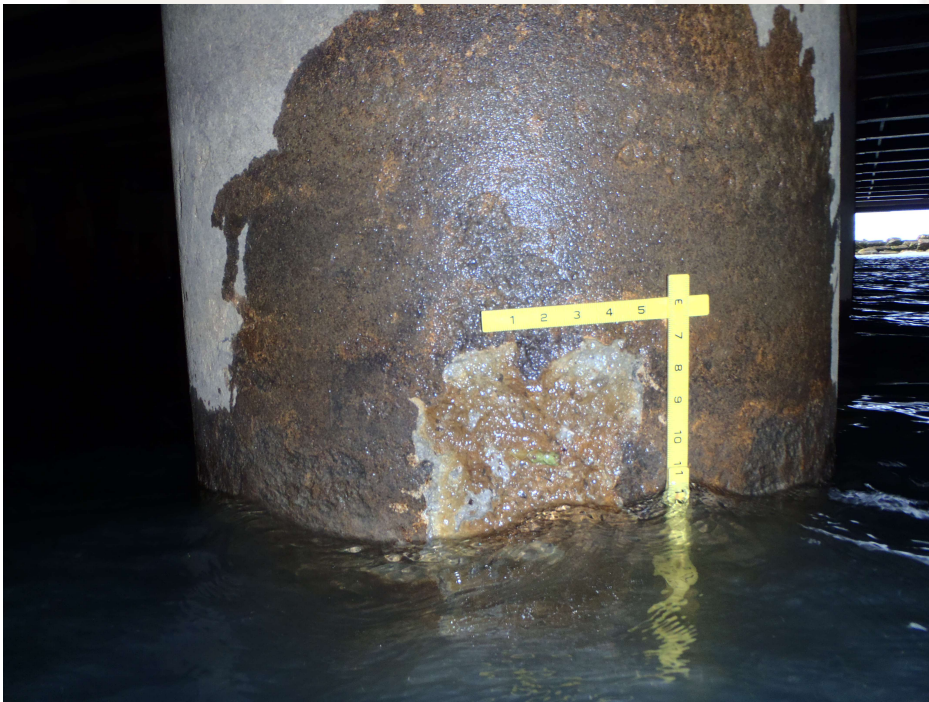
Photo 6 - Bent 2, Pile 9, Typical Area of Hollow Sounding Concrete

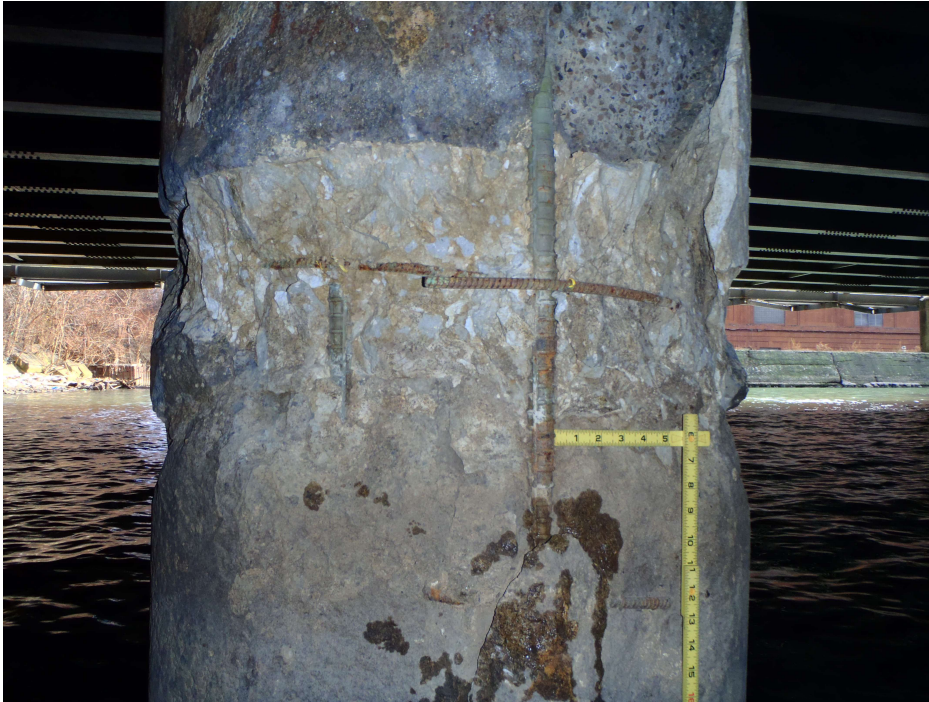
B2P4 has a spall in the concrete encasement at a cold joint, 3' H x full circumference of the concrete encasement x 3" D, with two (2) pieces of exposed vertical and two (2) pieces of horizontal reinforcement in the north quadrant, and one (1) piece of exposed horizontal reinforcement in the south quadrant, starting 4' above the channel bottom. The vertical steel is exposed up to 1'-6" high, and the horizontal piece is exposed up to 1'-8" long. The exposed steel is in good condition, with light surface corrosion. Refer to Photo 7.

Photo 7 - Bent 2, Pile 4, Spall with Exposed Reinforcement in the Concrete Encasement

Restore the deteriorated concrete cover to the areas of exposed reinforcement, at the spalled areas of the concrete encasements for Piles 4 and 11 at Bent 2.

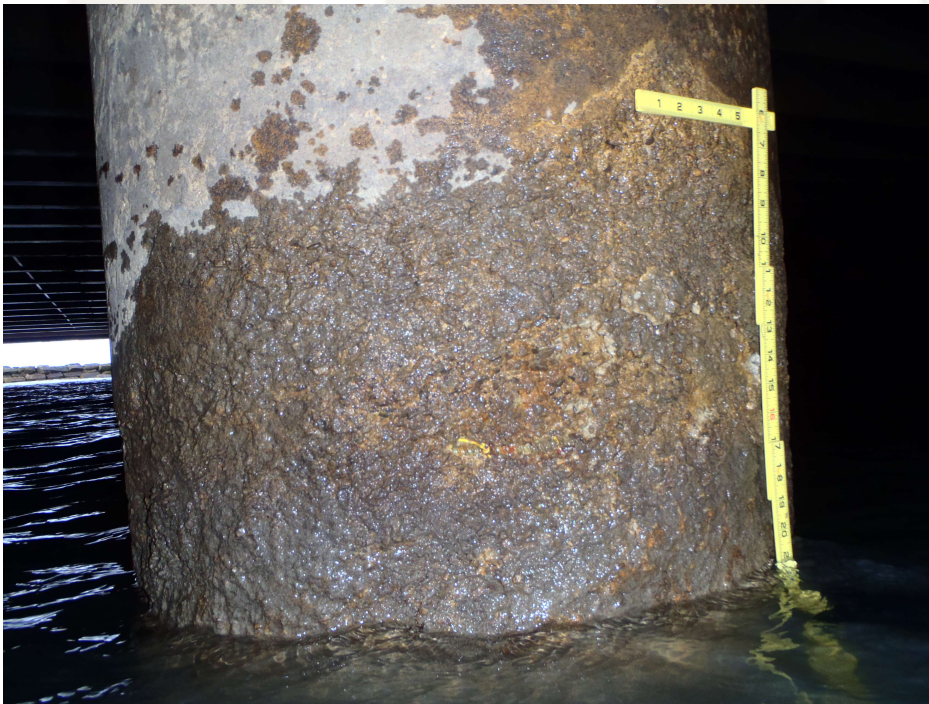
B2P11 has random spalls up to 2"D, with efflorescence, starting 6' below the top of the concrete encasement, extending down to the channel bottom. The largest of these spalls is 3" H x 1' W x 2" D, 1' above the channel bottom at the south quadrant. The concrete encasement has one (1) piece of exposed secondary horizontal reinforcement at the south quadrant, near the waterline. The concrete at the waterline is soft and waterlogged. Refer to Photo 8.

Photo 8 - Bent 2, Pile 11, Condition of Pile
