BRIDGE INSPECTION REPORT

1812246
Structure File Number

BRIDGE NUMBER CUY 00322 1534

U.S. Route 322 (Mayfield Road) over the Chagrin River in Gates Mills, Cuyahoga County
(Two Span Steel Beam Bridge)

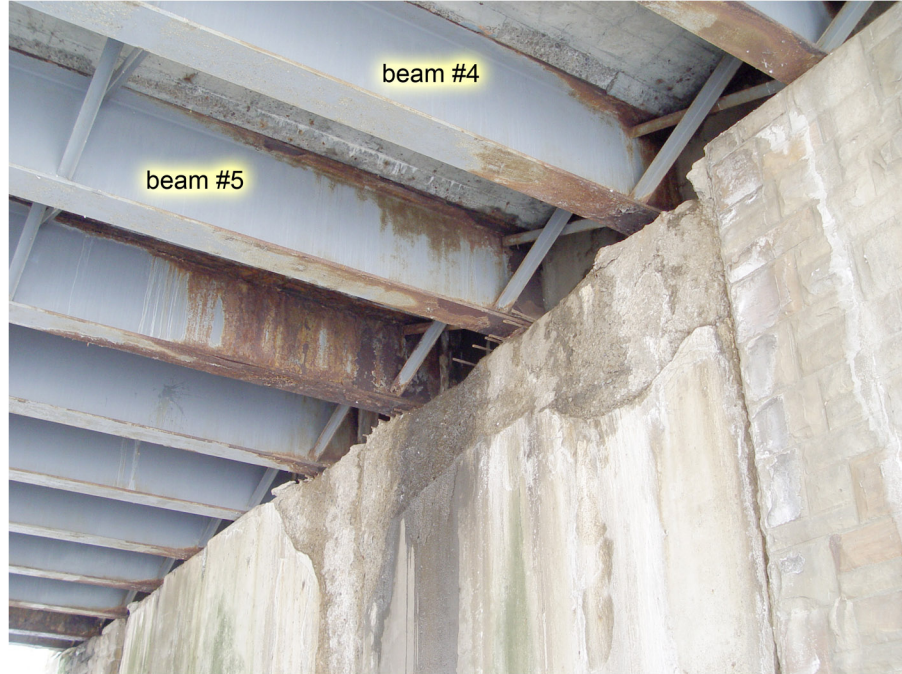
1812246 P1 12_6_05 det of start abut.jpg

ABUTMENTS: DELAMINATIONS. DEEP SPALLS; SEE ATTACHED PHOTO #1 DATED 12/6/05. TWO FULL HEIGHT CRACKS IN FINISH ABUTMENT BELOW BAYS #5 AND #7; SEE ATTACHED PHOTO #4 DATED 12/6/05 (CRACK BELOW BAY #7 IS 1/4 INCH WIDE AT GROUND LEVEL). STONE FACING IS MISSING BELOW RIGHT BAY AT FINISH ABUTMENT; SEE ATTACHED PHOTO #5 DATED 12/6/05.
ABUTMENT SEATS: DEEPS SPALLS AND DETERIORATION. APPROACHING SEAT LOSS AT START ABUTMENT MASONRY PLATE #4. 20 SQUARE INCH SEAT LOSS UNDER START ABUTMENT MASONRY PLATE #5 WITH 5 LF OF NEARBY 360 DEGREE EXPOSURE OF LONGITUDINAL REBARS; SEE ATTACHED PHOTOS #2 AND #3 DATED 5/10/05. 5 SQUARE INCH SEAT LOSS UNDER START ABUTMENT MASONRY PLATE #6; SEE ATTACHED PHOTO #2 DATED 5/10/05. ONE SQUARE INCH SEAT LOSS UNDER START ABUTMENT MASONRY PLATE #7. A TOTAL OF 15 SQUARE INCHES OF SEAT LOSS UNDER MASONRY PLATES #2R, #5R, AND #6R AT FINISH ABUTMENT.
PIER: CRACKS. SCALING.
BACKWALLS: DEEP SPALLS. 2 LF OF 270 DEGREE REBAR EXPOSURE OF START BACKWALL IN BAY #6.

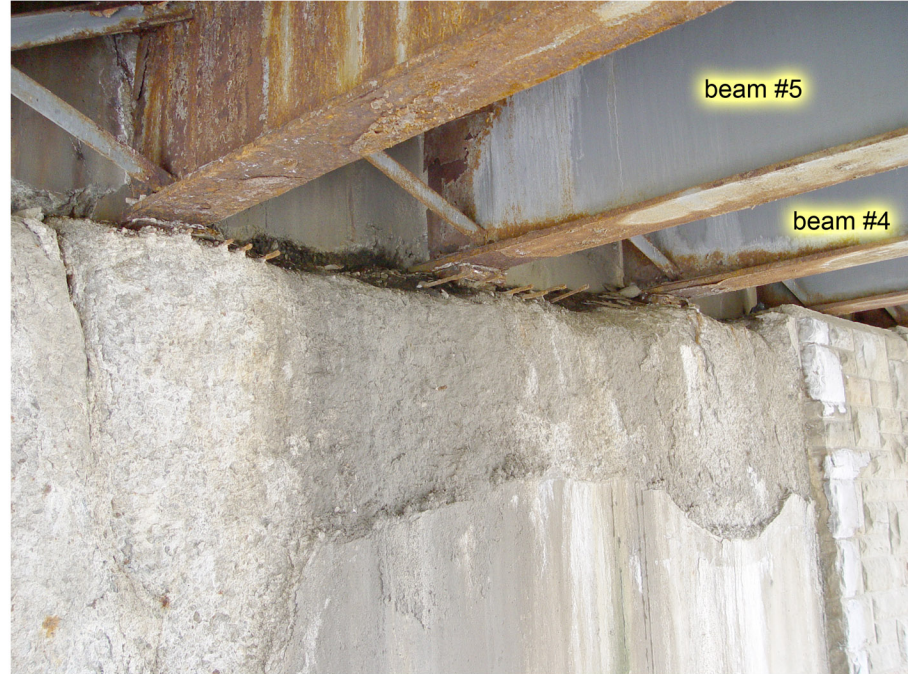
1812246 P2 5_10_05 start abut seat loss.jpg

BEAMS: RUSTING SECTION LOSS; SEE PHOTOS #2 AND #3 DATED 5/10/05. RUSTING THRU HOLES IN BOTH FLANGES OF LEFT BEAM NEAR START ABUTMENT, AND IN LOWER FLANGE OF RIGHT BEAM NEAR MIDDLE OF SPAN #2 AND FROM MIDDLE OF SPAN #2 TO FINISH ABUTMENT; SEE PHOTO #5 DATED 12/6/05.
CROSSFRAMES: ENDFRAME RUSTING SECTION LOSS WITH RUSTING THRU HOLES; SEE PHOTO #5 DATED 12/6/05.
BEARINGS: HEAVY RUSTING.
PAINT: 5-10% RUST. RUSTING IN STRUCTURALLY CRITICAL AREAS; SEE ITEM #10 (BEAMS). PAINT IS 5-10% DET.

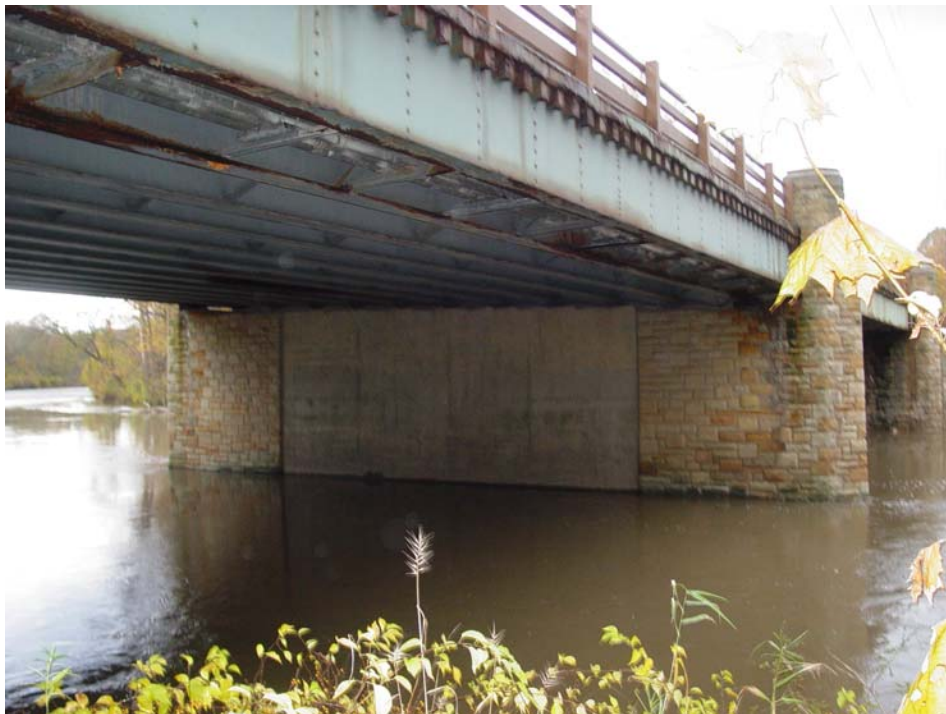
Photo 2 - Facing East. View of start side face (western face) of Pier.

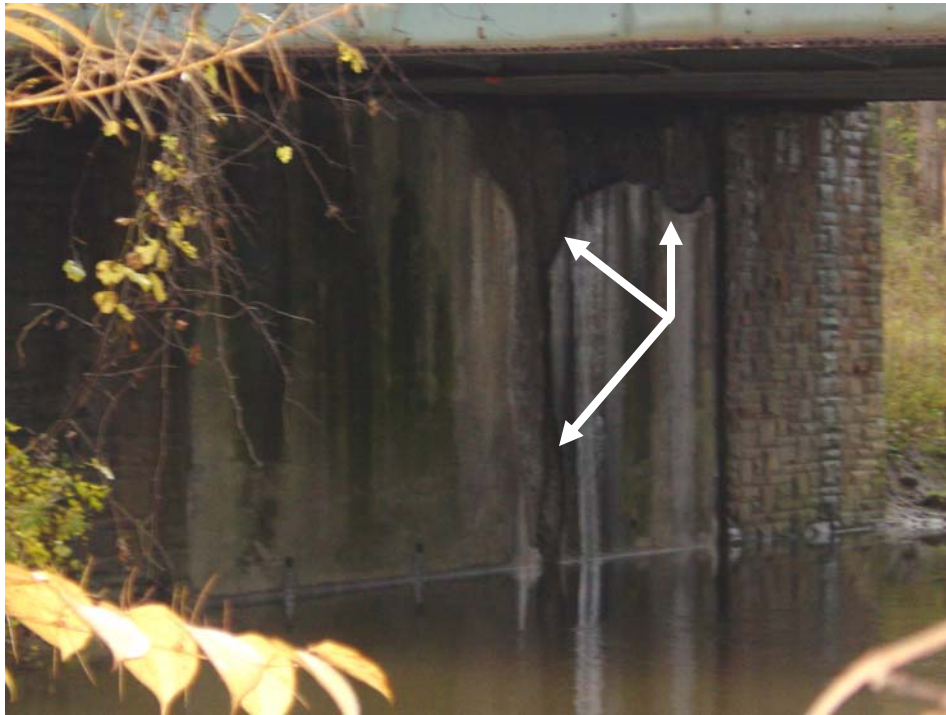
- The exposed concrete surfaces have up to 1/2" deep scaling throughout. Scaling was worst at the water line.
- There is a 1.5' wide area of spalling and delamination of the concrete below an overhead drainpipe all the way to the mudline. This defect was up to 4" deep. No exposed rebar was noted. (See Photo 3).

*Photo 3 - Facing West. View of Start (west) Abutment.
Note large spalled area below drain.*

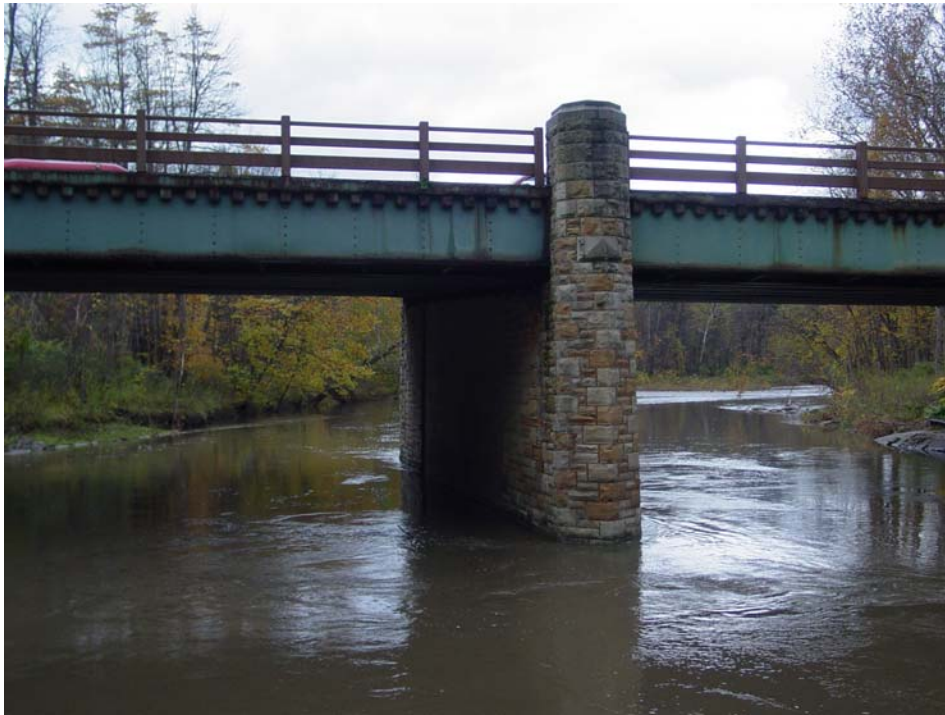
*Photo 5 - Facing North and looking downstream.
View of center pier and pier nose.*

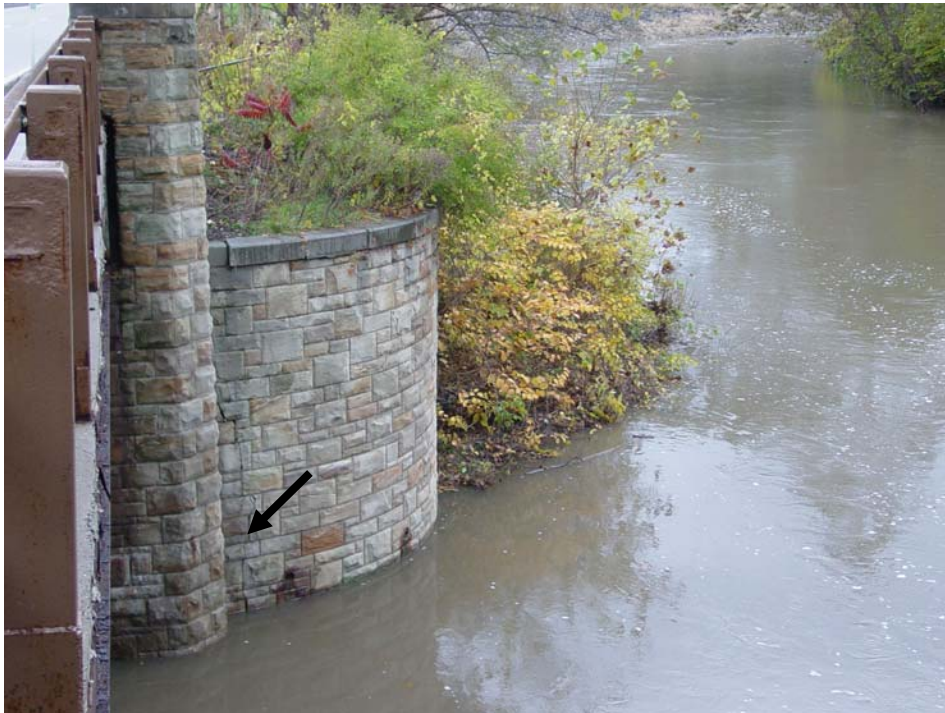
- The channel alignment is from the upstream side towards the start abutment and towards the finish face of Pier #1. It approaches at approximately a 45-degree angle. This can be seen on Photo #6.
- There was approximately a 3-knot current at the time of inspection.
- The bottom composition on the start side of Pier #1 consisted of sand, silt and mud along the entire length of the pier.
- The bottom composition on the finish side of Pier #1 consisted of large diameter riprap and hard clay along the entire length of the pier. The soundings were deeper on the finish side of the pier showing localized scour at the finish left end.

- The finish right wingwall (southeast) had a large, 3/8" wide crack through the sandstone facing from below the mudline up to the top of the wing wall (see Photo 6).

*Photo 6 - Facing East and looking upstream. View of Finish Right
(southeast)Wingwall. Note full height crack (3/8" wide).*

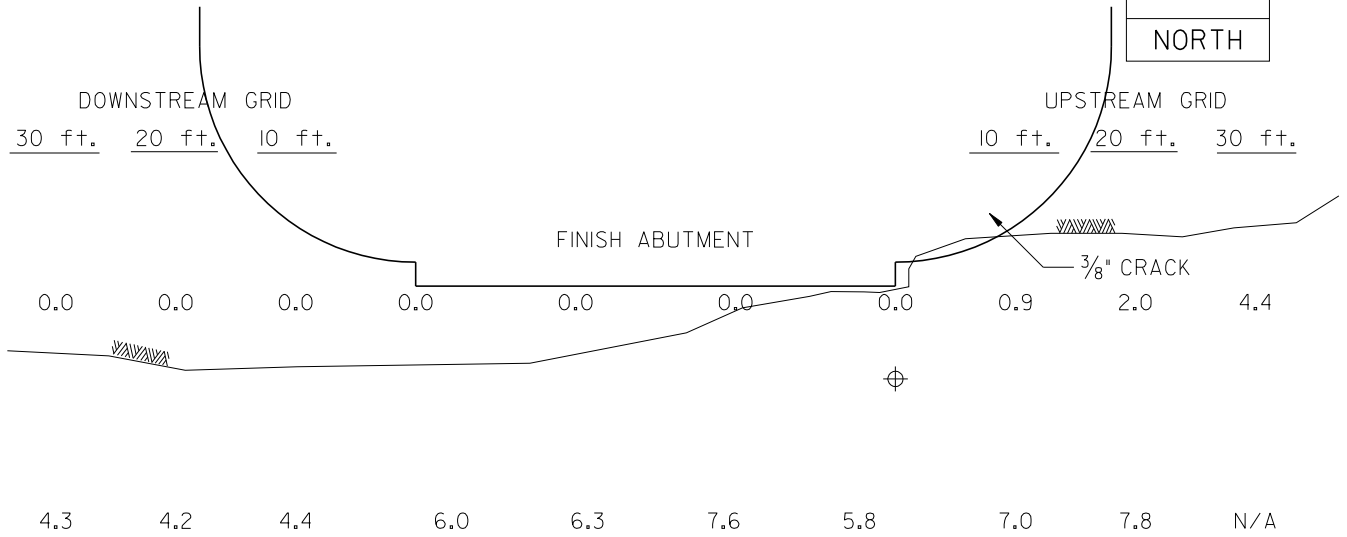
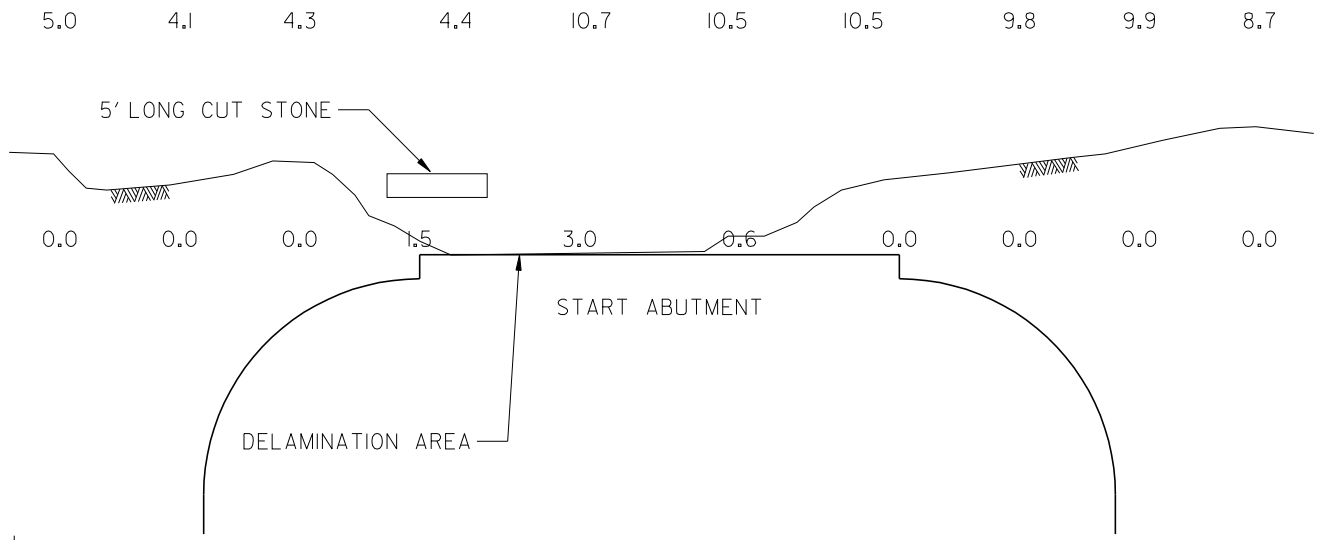
A comparison of the current soundings with the previous soundings indicates some changes in the stream channel at different locations. The differences in these locations, of up to 2 feet, are possibly the result of shifting riprap and/or debris rather than scouring of the stream bottom. Monitoring a trend in these soundings at consistent locations on the sounding grid will be helpful in supporting this conclusion.

RIPRAP ALONG ENTIRE FINISH (EAST) SIDE OF EXPOSED FOOTER

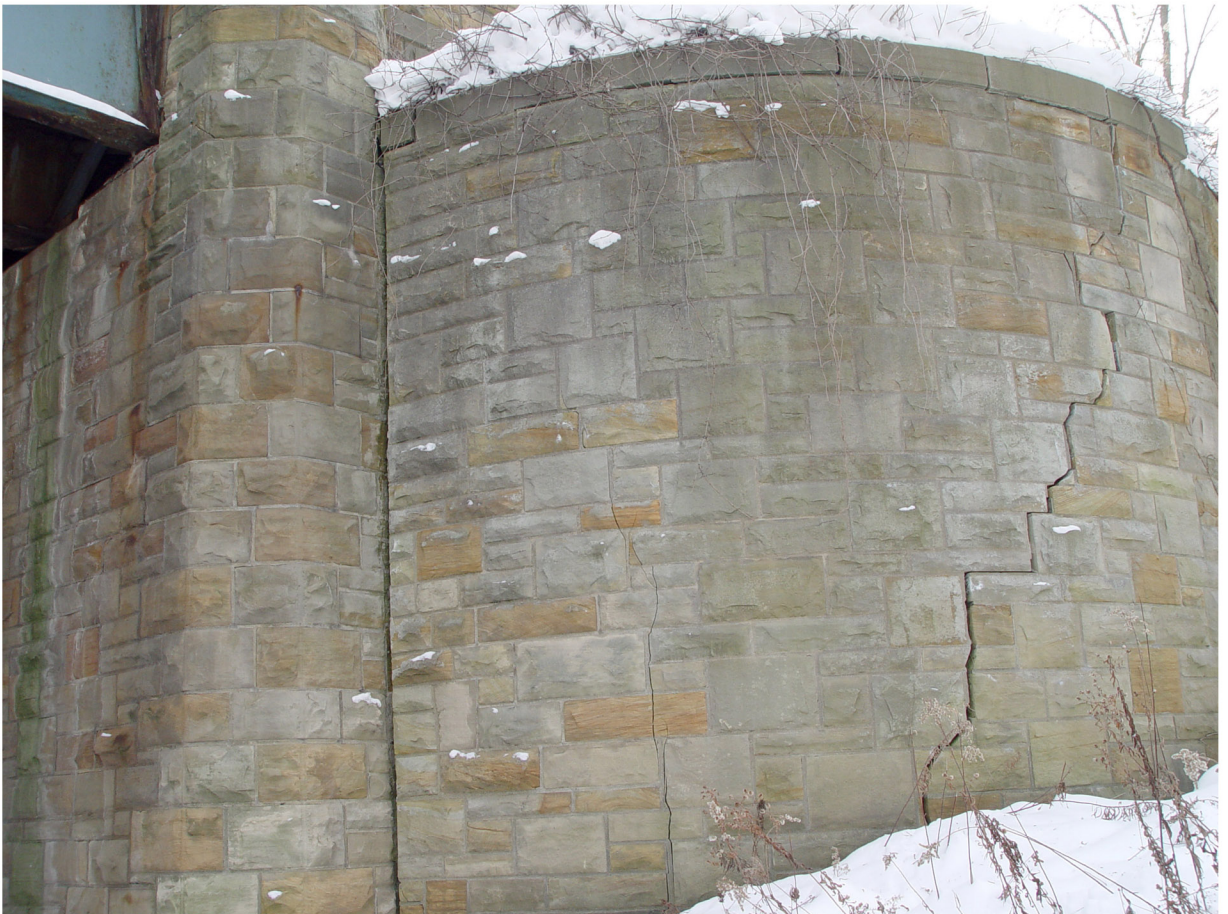
1812246 P6 12_6_05 crack in start left wing wall.jpg

WINGWALLS: FULL HEIGHT CRACKS IN START-LEFT AND FINISH-RIGHT WINGWALLS. CRACK IN START-LEFT WINGWALL IS ONE INCH WIDE AT GROUND LEVEL; SEE ATTACHED PHOTO #6 DATED 12/6/05.
SCOUR: PARTS OF THE PIER FOOTER ARE EXPOSED; SEE ATTACHED SPECIALITY DIVING'S REPORT DATED 10/11/05.
