BRIDGE INSPECTION REPORT

1812246
Structure File Number

BRIDGE NUMBER CUY 00322 1534

CUY-322-1534
SFN-1812246

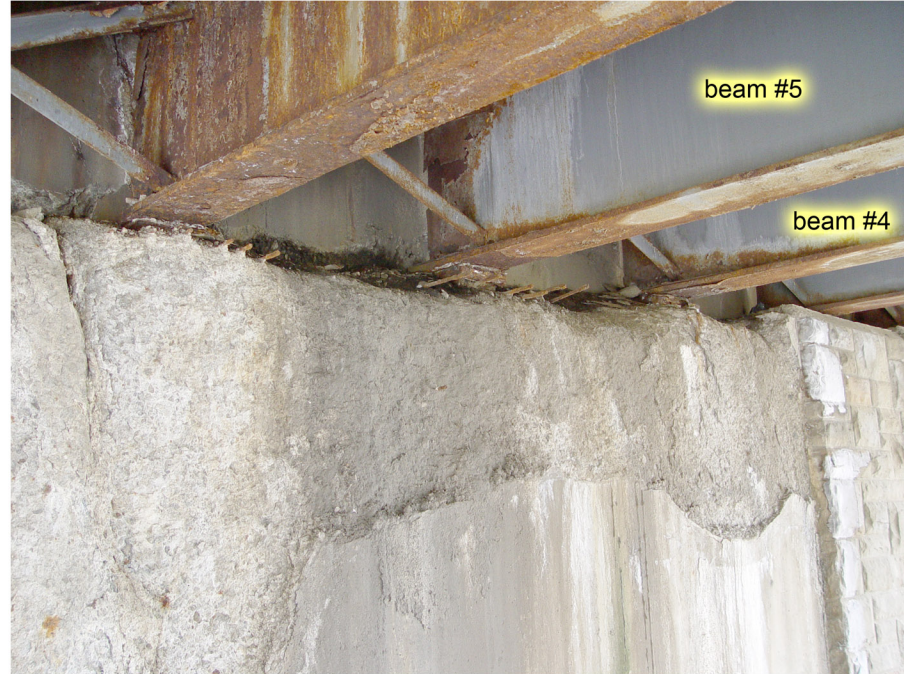
#6; SEE ATTACHED PHOTO #2 DATED 5/10/05. 1 SQUARE INCH
SEAT LOSS UNDER START ABUT MASONRY PLATE #7. A TOTAL OF
15 SQUARE INCHES OF SEAT LOSS UNDER MASONRY PLATES #2R,

1812246 P2 5_10_05 start abut seat loss.jpg

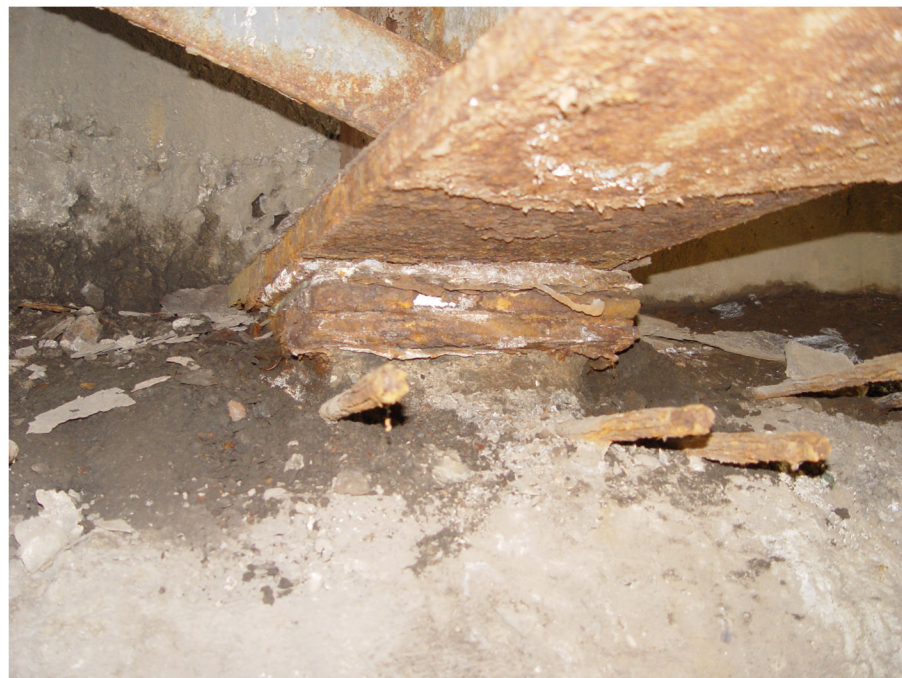
1812246 P3 5_10_05 start abut seat loss at beam 5.jpg

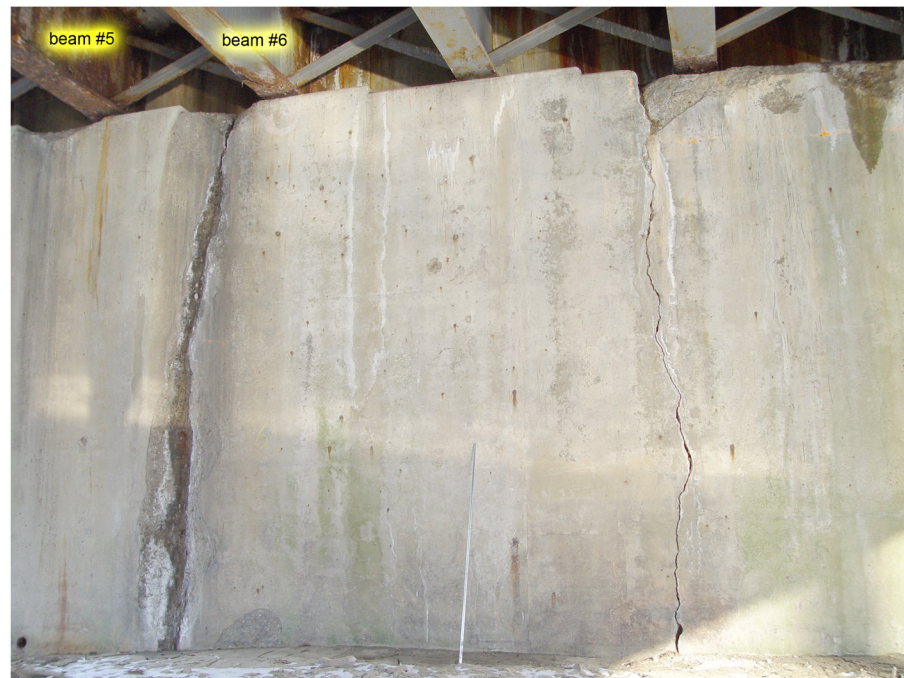
1812246 P4 12_6_05 finish abut cracks.jpg

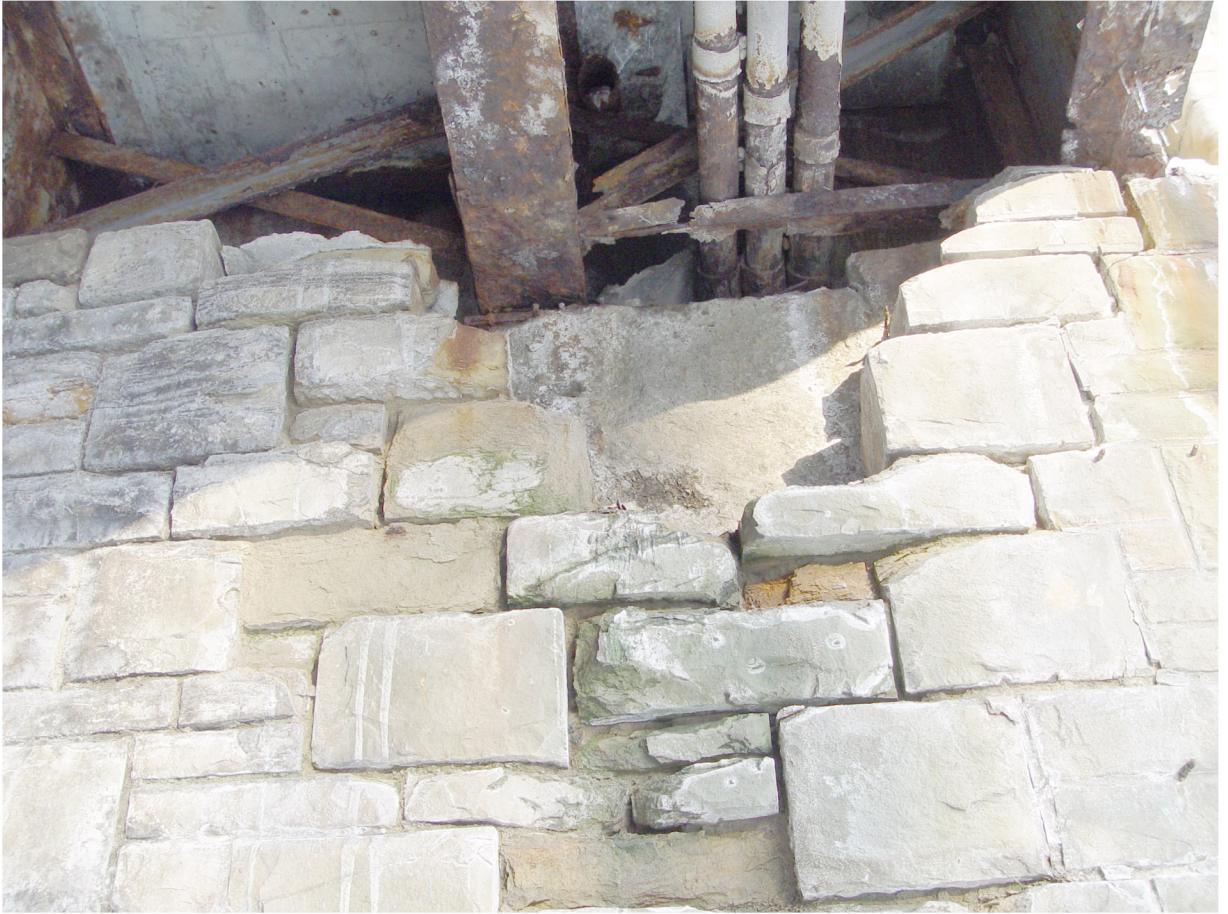
1812246 P5 12_6_05 finish abut missing stone facing.jpg

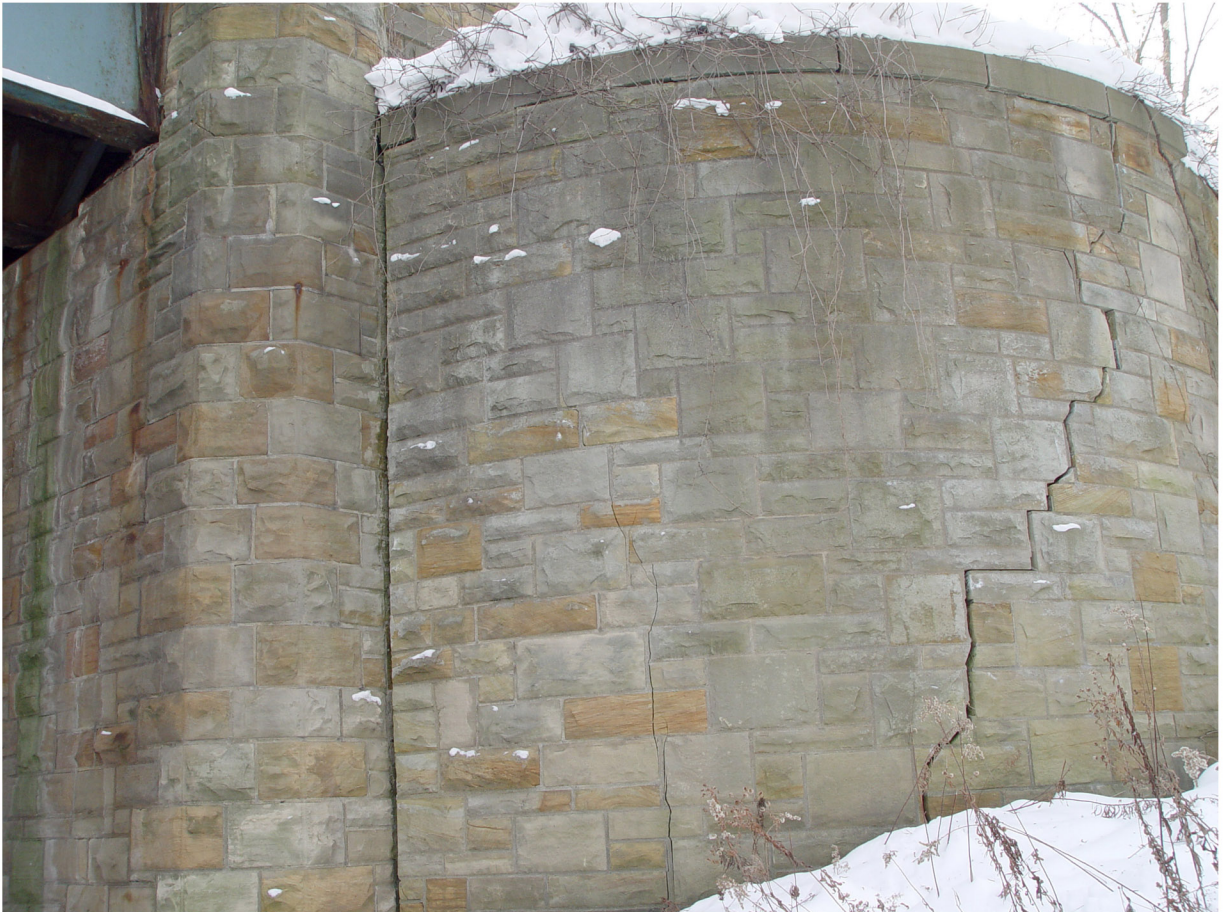
#5R, & #6R AT FINISH ABUT.
PIER: CRACKS. SCALING.
BACKWALLS: DEEP SPALLS. 2 LF OF 270 DEGREE REBAR EXPOSURE
OF START BACKWALL IN BAY #6.
WINGWALLS: FULL HEIGHT CRACKS IN START-LEFT AND FINISH-RIGHT
WINGWALLS. CRACK IN START-LEFT WINGWALL IS 1"
WIDE AT GROUND LEVEL; SEE ATTACHED PHOTO #6 DATED
12/6/05.
SCOUR: PARTS OF THE PIER FOOTER ARE EXPOSED; SEE ATTACHED
DIVING REPORT DATED 9/24/07.

1812246 P6 12_6_05 crack in startleft wingwall.jpg
