BRIDGE INSPECTION REPORT

1812246
Structure File Number

BRIDGE NUMBER CUY 00322 1534

CUY-322-1534

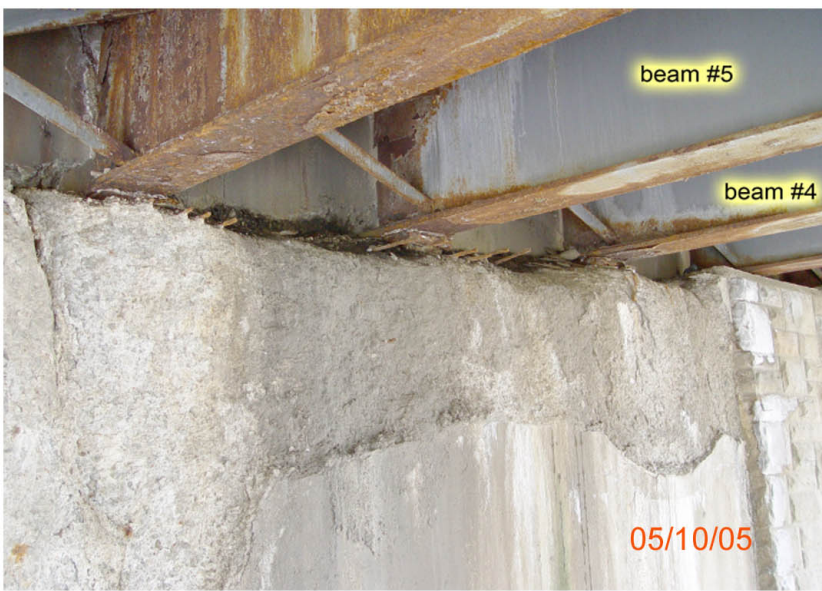
ABUTS: DELAMINATIONS. DEEP SPALLS; SEE ATTACHED PHOTOS 8, &
11 DATED 5/10/05 & 12/6/05. 2 FULL HEIGHT CRACKS IN
FINISH ABUT; SEE ATTACHED PHOTO 10 DATED 12/6/05 (CRACK
BELOW BAY #7 IS 1/4" WIDE AT GROUND LEVEL). STONE FACING
IS MISSING BELOW RIGHT BAY AT FINISH ABUT; SEE ATTACHED
PHOTO 11 DATED 12/6/05.
ABUT SEATS: DEEPS SPALLS AND DETERIORATION. APPROACHING
SEAT LOSS @ START ABUT MASONRY PLATE #4. 20" SQUARE SEAT
SEAT LOSS UNDER START ABUT MASONRY PLATE #5 WITH 5 LF OF
NEARBY 360 DEGREE EXPOSURE OF LONGITUDINAL REBARS; SEE
ATTACHED PHOTOS 9 DATED 5/10/05. 5" SQUARE SEAT LOSS
UNDER START ABUT MASONRY PLATE #6; SEE ATTACHED PHOTO 9
DATED 5/10/05. 1" SQUARE SEAT LOSS UNDER START ABUT
MASONRY PLATE #7. A TOTAL OF 15" SQUARE OF SEAT LOSS
UNDER MASONRY PLATES #2R, #5R, & #6R AT FINISH.

P8: START ABUTMENT SPALLED WITH ABUTMENT SEAT LOSS.

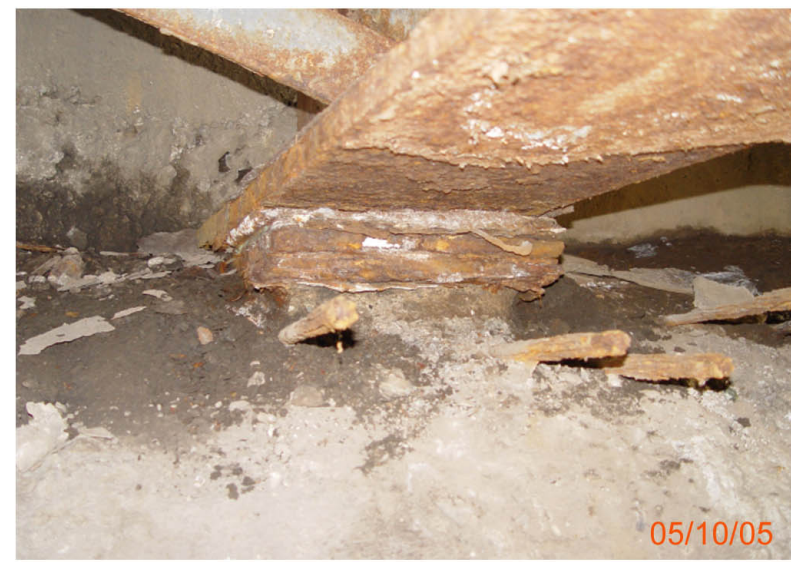
P9: CLOSE-UP OF SEAT LOSS AT BEAM #5 FROM P8.

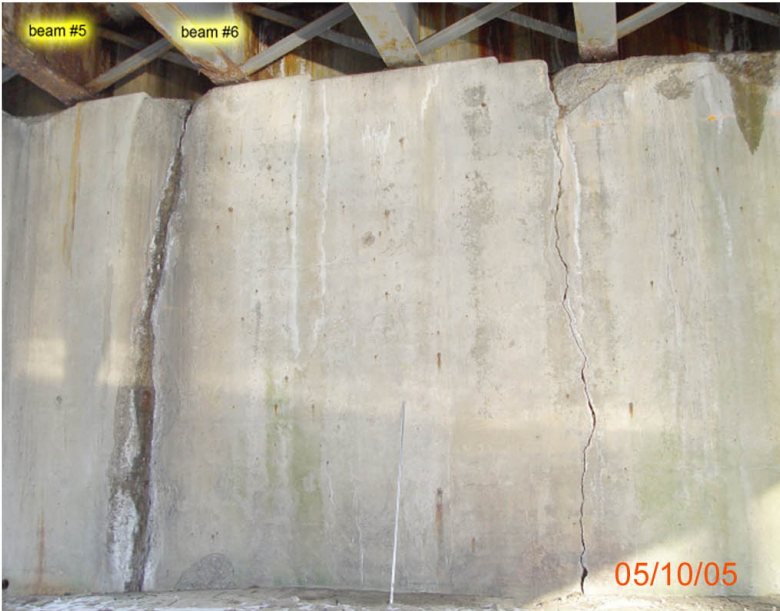
P10: FINISH ABUTMENT CRACKS.

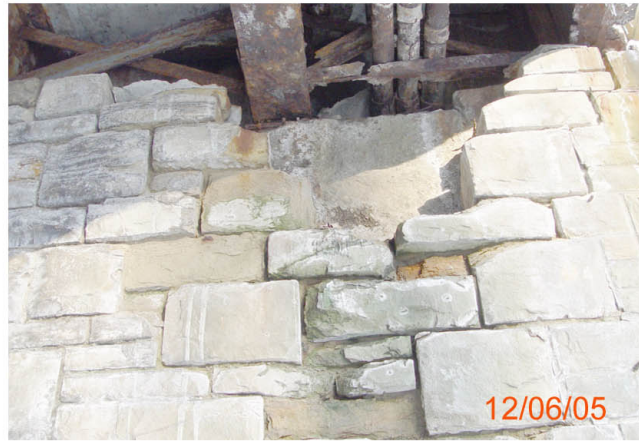
P11: FINISH ABUT UNDER BAY 1R MISSING DECORATIVE STONE.

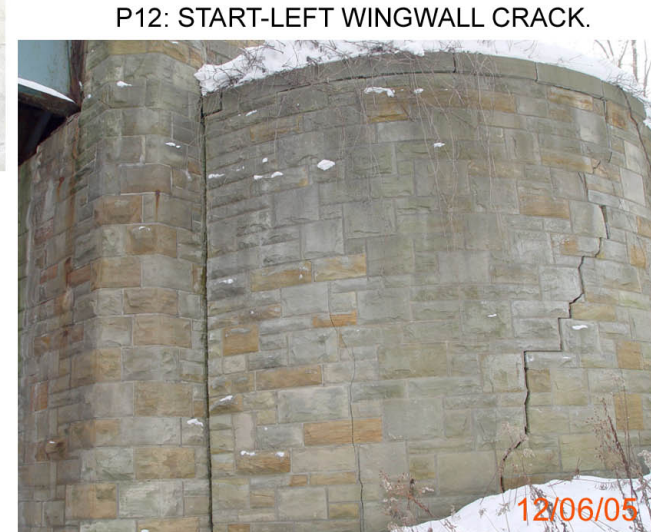
PIER: CRACKS. SCALING.
BACKWALLS: DEEP SPALLS. 2 LF OF 360 DEGREE REBAR EXPOSURE
OF START BACKWALL IN BAY #6.
WINGWALLS: FULL HEIGHT CRACKS IN START-LEFT AND FINISH-RIGHT
WINGWALLS. CRACK IN START-LEFT WINGWALL IS 1" WIDE @
GROUND LEVEL; SEE ATTACHED PHOTO 12 DATED 12/6/05.

P12: START-LEFT WINGWALL CRACK.

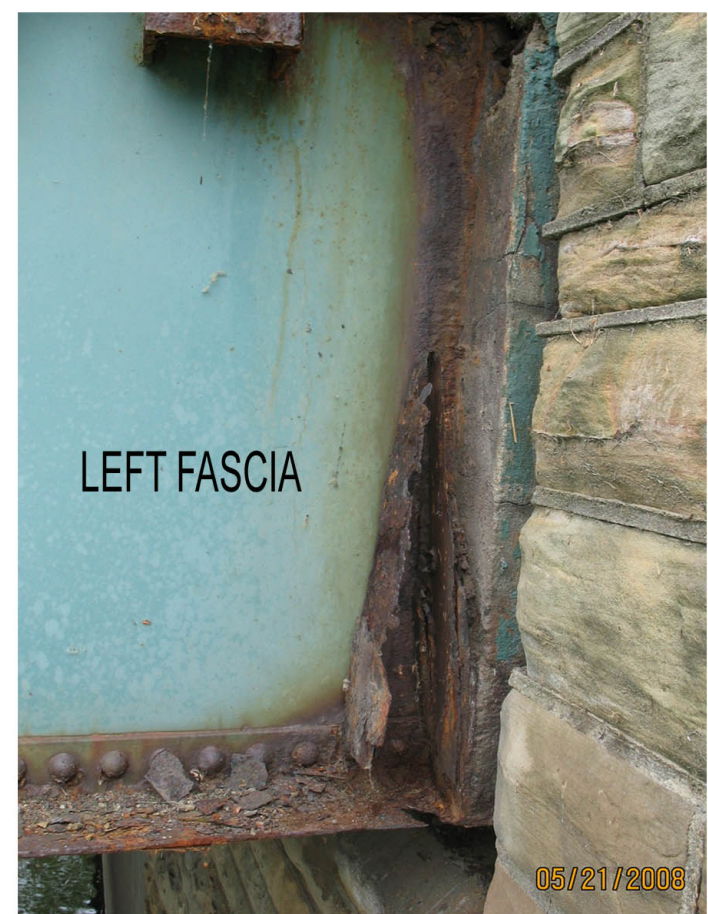
LEFT FASCIA

P7: RUSTED AWAY STIFFENER. RUST THRU HOLE TO LOWER FLANGE. THIS IS THE FINISH SIDE OF THE PIER.

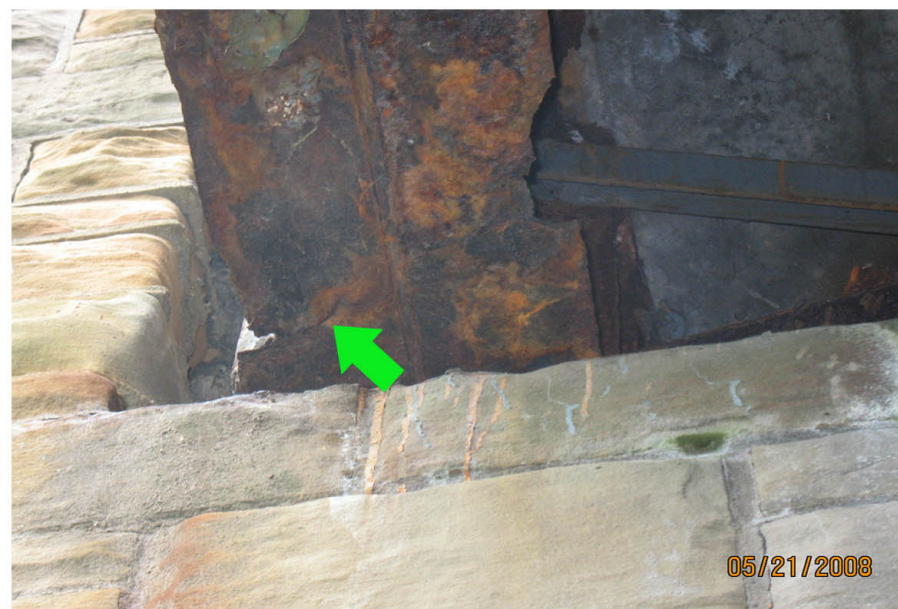
P6: ARROW POINTS TO CRACKED LOWER FLANGE OF RIGHT FASCIA AT THE START ABUT. NOTE SECTION LOSS TO FLANGE.

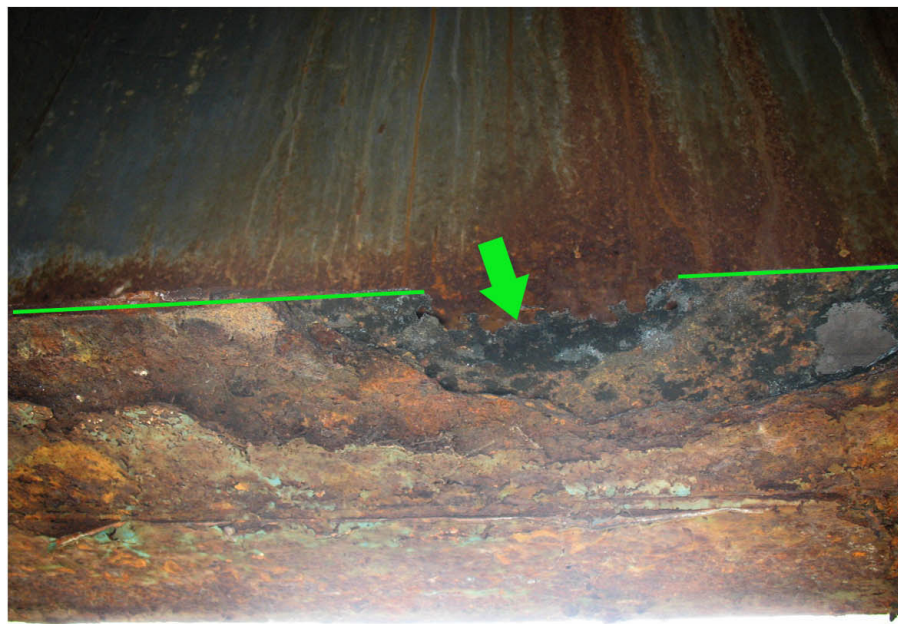
P1: ARROW POINTS TO RUSTING SECTION LOSS TO LOWER FLANGE OF LEFT FASCIA 3' FROM FINISH ABUTMENT. LINES SHOW EDGE OF LOWER FLANGE. THIS IS TYPICAL TO SEVERAL AREAS OF BOTH FASCIAS.

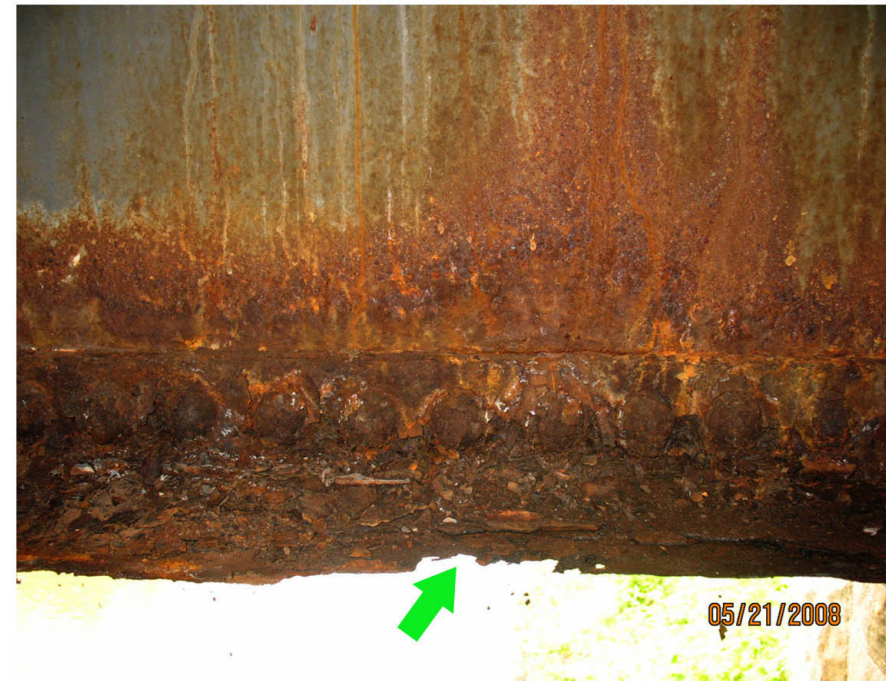
P2: LOOKING AT WEB OF THE SAME LOCATION AS P1. NOTE THE HEAVY SECTION LOSS AT LOWER FLANGE RIVETS.

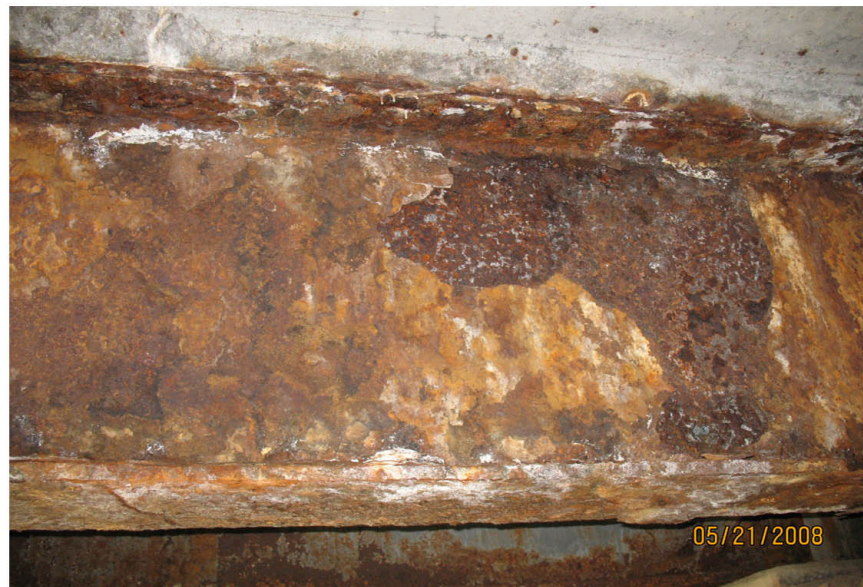
P3: HEAVY SECTION LOSS TO BEAM #5 AT FINISH. THIS IS TYPICAL TO OTHER BEAMS AT FINISH AND OTHER AREAS.

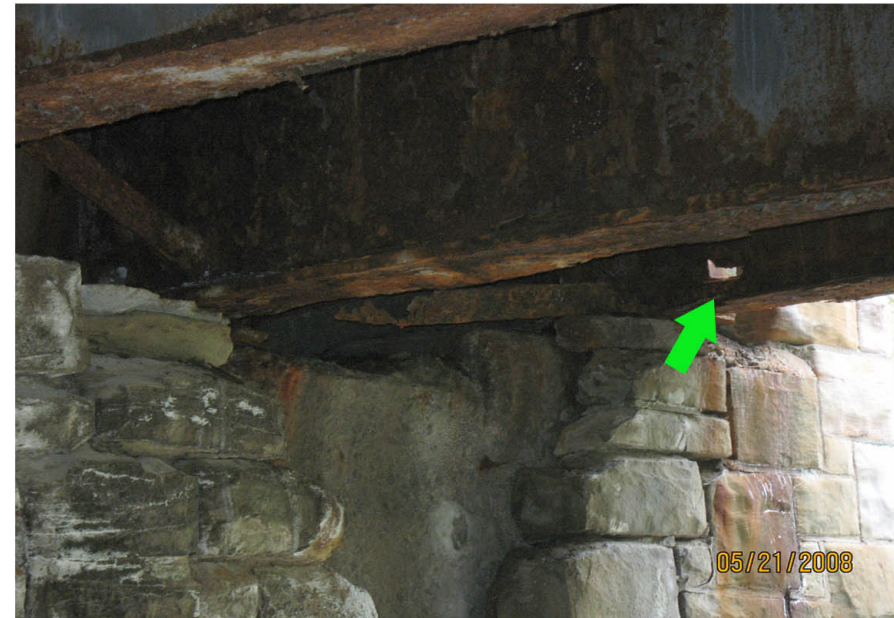
P4: ARROW POINTS TO 4" DIAMETER RUSTING THRU HOLE IN RIGHT FASCIA AT FINISH ABUTMENT.

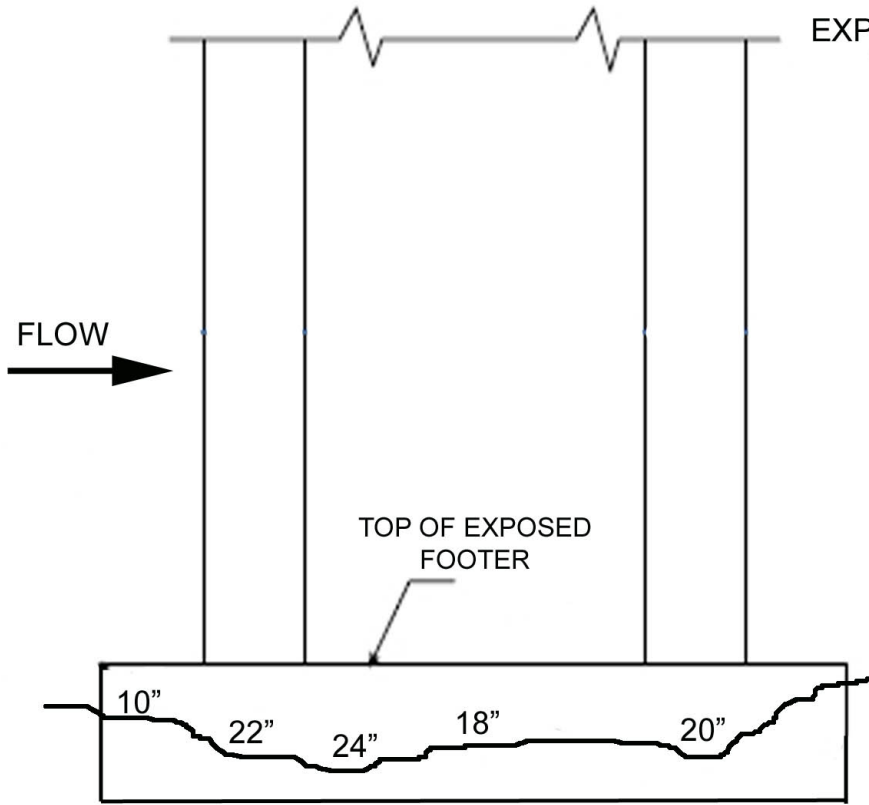
LOOKING WEST TOWARDS
START ABUTMENT

SCOUR: PARTS OF THE PIER FOOTER ARE EXPOSED; SEE ATTACHED
PLAN SHEET DATED 8/27/08.

CUY-322-1534
SFN 1812246
EXPOSED PIER FOOTER
TAKEN ON 8/27/2008
