BRIDGE INSPECTION REPORT

1812246
Structure File Number

BRIDGE NUMBER CUY 00322 1534

YEAR BUILT 1939

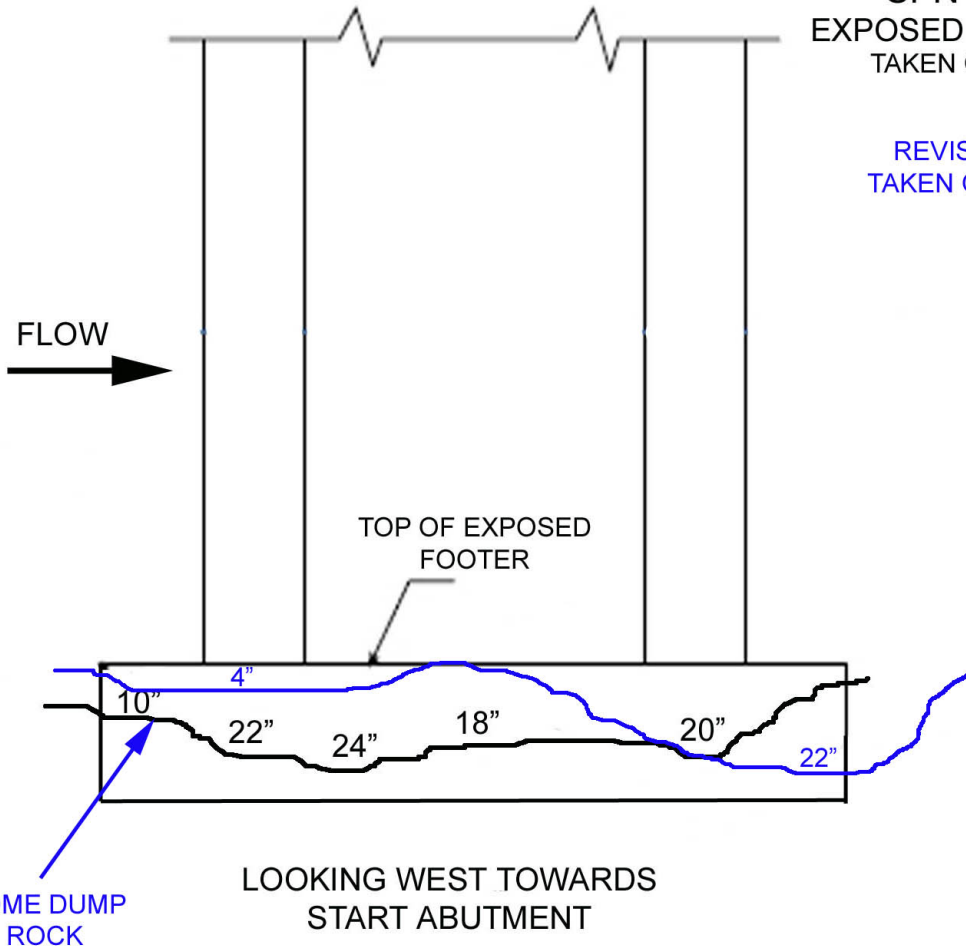
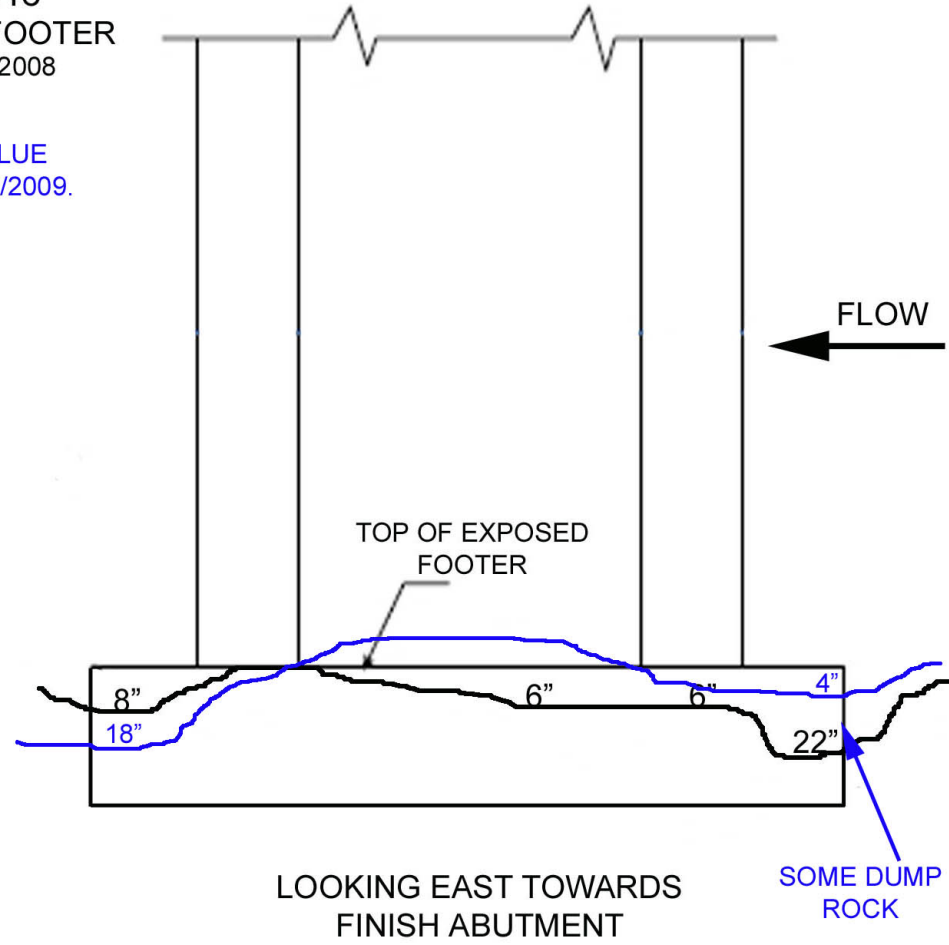
CUY-322-1534
SFN 1812246
EXPOSED PIER FOOTER
TAKEN ON 8/27/2008

SCOUR: SOME DUMP ROCK WAS ADDED TO ABUTS AND PIER IN 2009.

PIER STILL HAS FOOTER EXPOSURE; SEE ATTACHED DIAGRAM FOR MEASUREMENTS.

REVISED IN BLUE
TAKEN ON 11/17/2009.
