BRIDGE INSPECTION REPORT

BRIDGE NUMBER CUY 00322 1534

Underwater Inspection Report for:

U.S. Route 322 (Mayfield Road) over the Chagrin River in Gates Mills, Cuyahoga County
(Two Span Steel Beam Bridge)

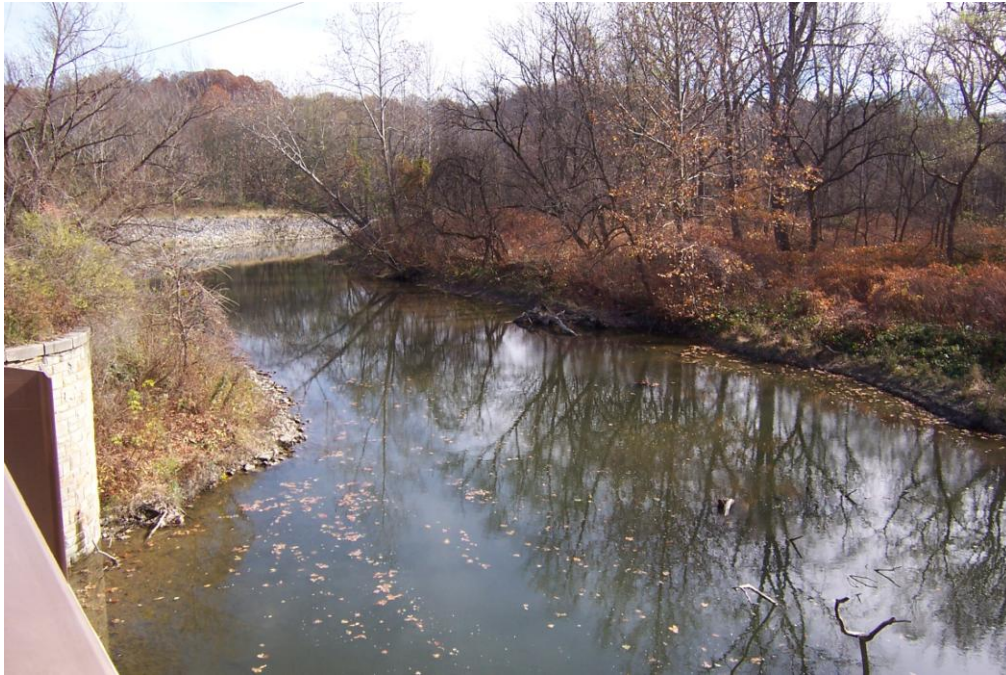
Photo 3 - Facing Southeast, Upstream.

- The channel alignment is poor. It approaches from the southeast at approximately a 45-degree angle (see Photo 3).
- There was low flow at the time of inspection.
- The stream bed consisted of sand, silt and mud and there is large riprap along the entire length of the pier.

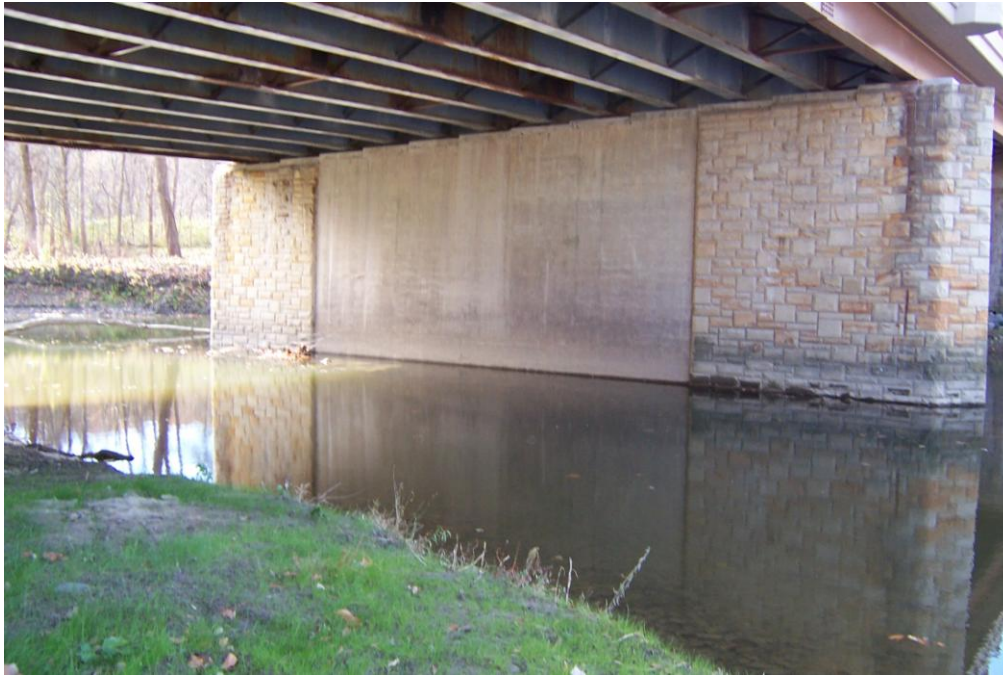
Photo 5 - Facing West. East Elevation of the Pier.

- The bridge had been rehabilitated since the last inspection.
- The entire width of the pier and a section of the southeast wingwall were submerged and inspected (see Photos 5, 6, and 8). Because of the depth of the water and the recently placed riprap, only a dry suit was used during the inspection. The max depth along the pier was 4.8'.
- Large riprap had been placed along the pier since the last inspection (see Photo 11).

- Minor scaling is present in the east and west faces of the pier along the waterline. No other deficiencies were noted during this inspection.

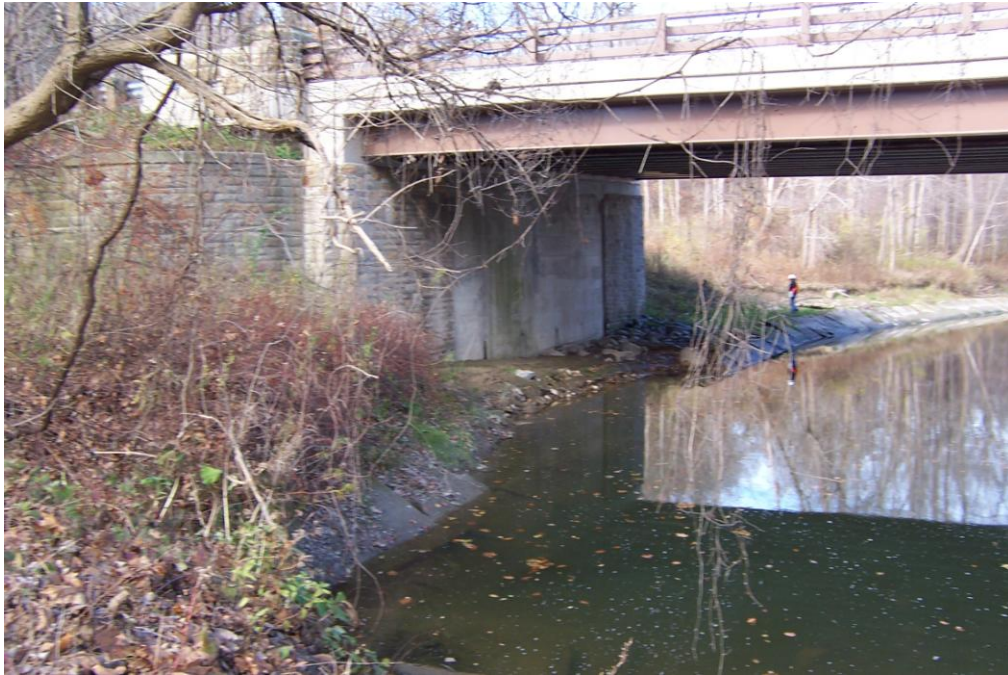
The bridge had been rehabilitated since the last inspection. The cracks in both abutments and the southeast wingwall were patched (see Photo 12). Large riprap was placed along the pier to repair the previously noted exposed footing and to prevent any further scour issues (see Photo 11). Sections of the large cut stone bank protection on the west bank are missing and need replaced. This is shown in Photo 7. There are no other recommendations at this time.

Photo 7 - Facing Northwest. West Abutment and missing shore protection.

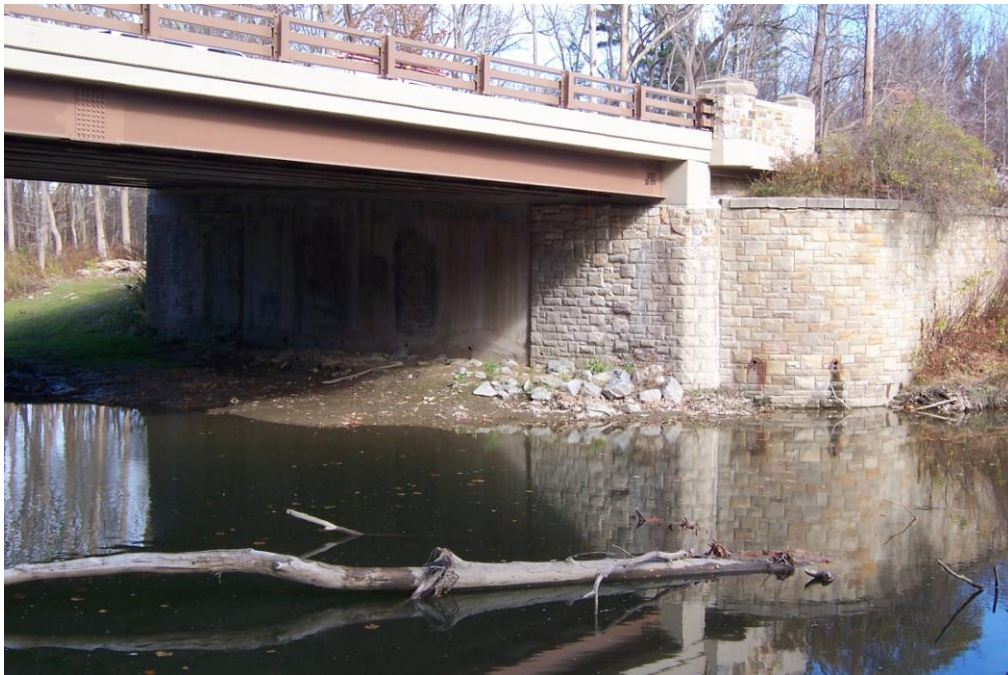
- The mortar of the sandstone masonry facing appeared to be in good condition.
- Both abutments were not inundated by the river and therefore were not considered part of this inspection.
- Large stones are in place along the west embankment serving as scour control (see Photo 9).
- No undermining of the pier footing was found along the entire pier perimeter.
- There is a submerged 10" diameter tree in the upstream channel, 10' from the pier (see Photos 8 and 10).

Photo 8 - Facing East. East Abutment. Note timber debris in foreground.

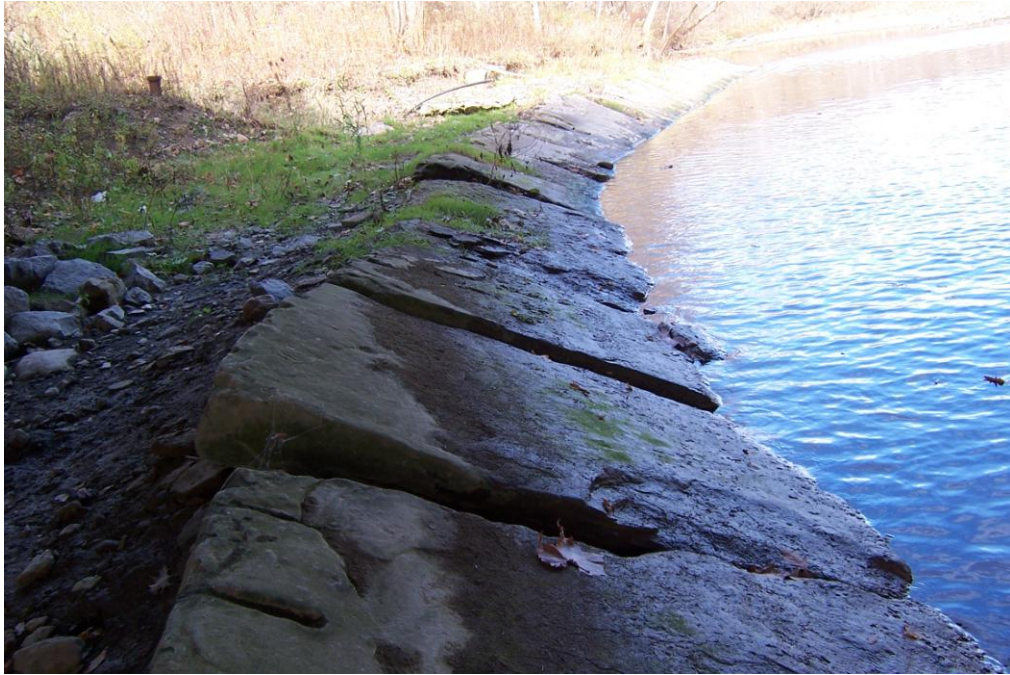
Photo 9 - Facing North. Large stones along the West Embankment for Scour Protection.

The underwater inspection found the pier to be completely surrounded and protected with large diameter riprap for approximately 15 feet in all directions. This riprap placement was part of a recent rehabilitation project. The riprap along with the cut stone shore protection on the west bank should be monitored after future large flood events.

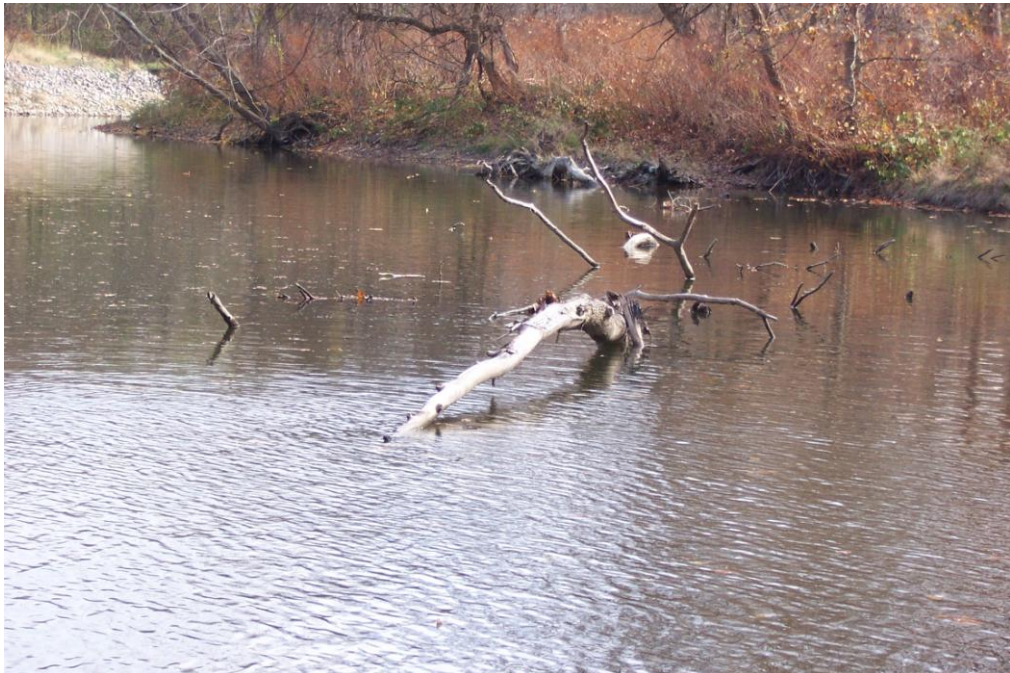
Photo 10 - Facing Southeast. Tree Debris in the Upstream Channel.

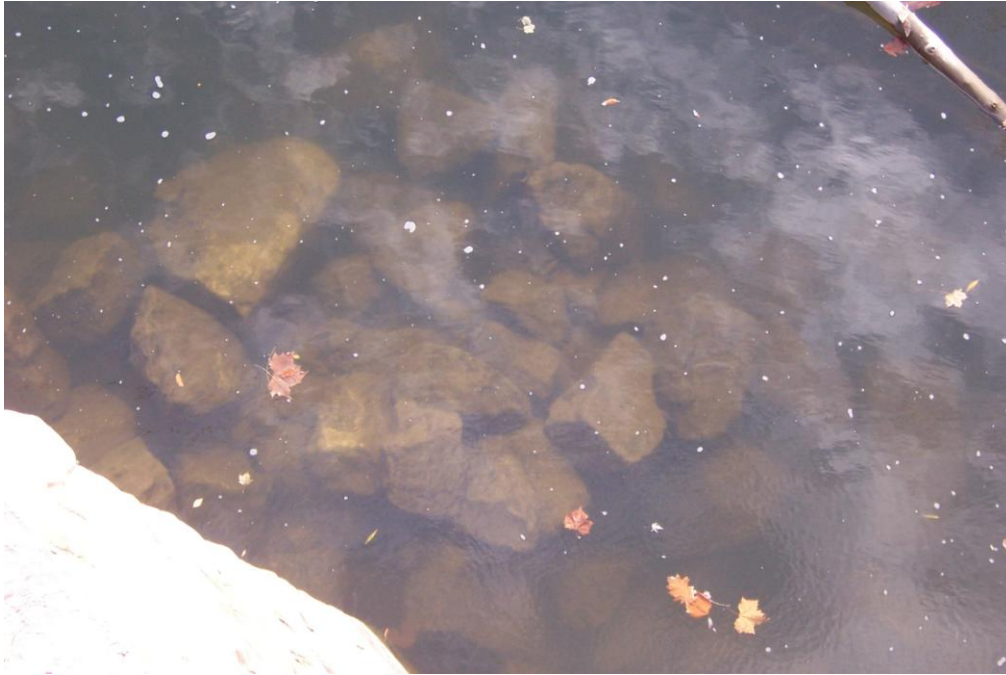
Photo 11 - Facing Downward. Riprap along the Pier (south end shown).

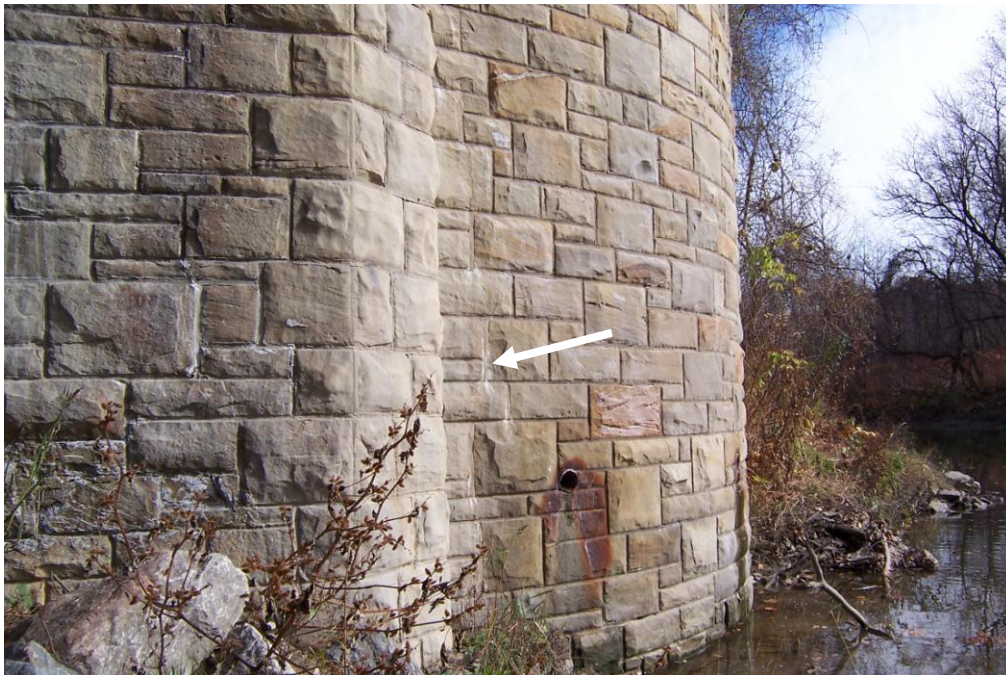
Photo 12 - Facing Southeast. Repaired Crack in the Southeast Wingwall.
