BRIDGE INSPECTION REPORT

2800152
Structure File NumberBRIDGE NUMBER **GEA 00044 0135**YEAR BUILT **1960**DIST **12**Bridge Type **112**TYPE SERVICE **5 5****LA DUE RES. 1.23 MIS 422**

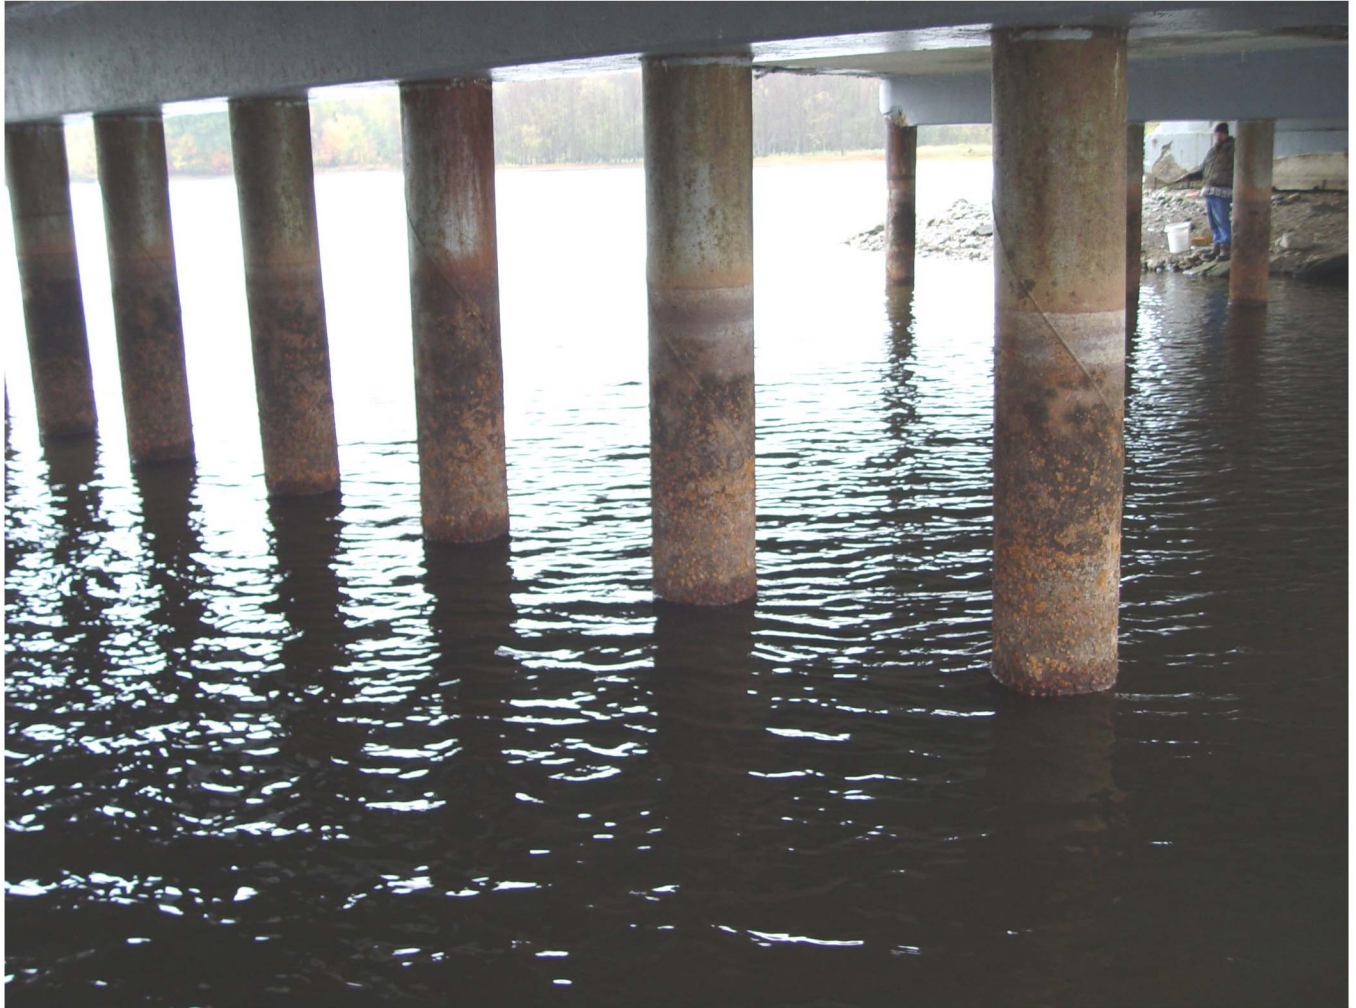
Photo 2. *Facing north looking at the steel pile columns of Pier 1.
Note the rusting section loss occurring at the waterline.*
