BRIDGE INSPECTION REPORT

2800152
Structure File NumberBRIDGE NUMBER **GEA 00044 0135**YEAR BUILT **1960**DIST **12**Bridge Type **112**TYPE SERVICE **5 5****LA DUE RES. 1.23 MIS 422**

SFN 2800152 Bridge GEA-44-0135

USR 44 over La Due Reservoir

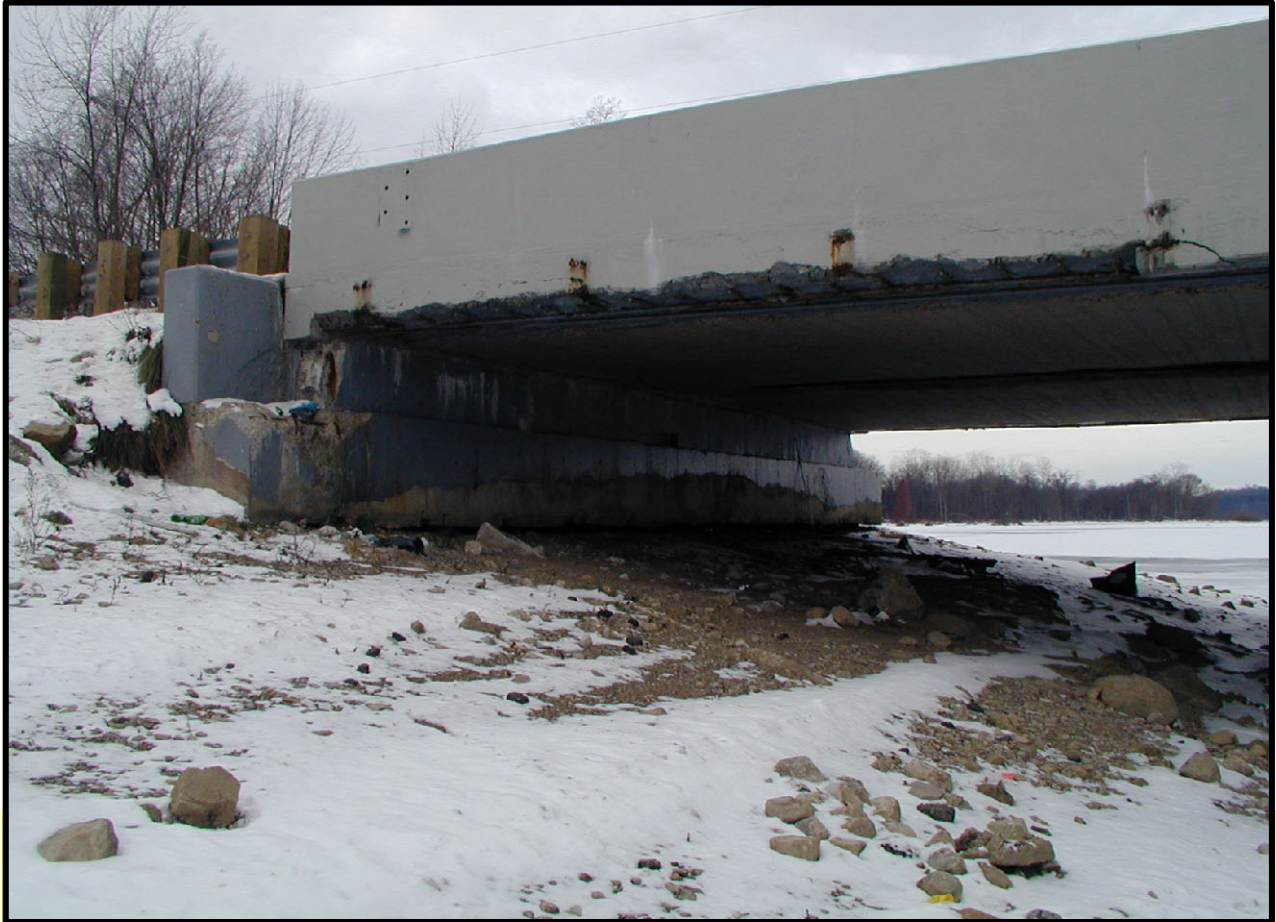
SLOPE PROTECTION: UNDERMINING OF START ABUTMENT EXPOSES PARTS OF SOME PILES TO WATER/AIR. ULTV IS (42", 44', 1'); SEE ATTACHED PHOTOS #1 AND #2 DATED 12/5/02. FINISH ABUTMENT IS SLIGHTLY UNDERMINED NEAR LEFT END AND BELOW CENTERLINE OF SR 44.

▲ Photo #1. Facing southwest. Note the undermining of the start (south) abutment. ULTV is (3 LF, 44 LF, 7 inches).

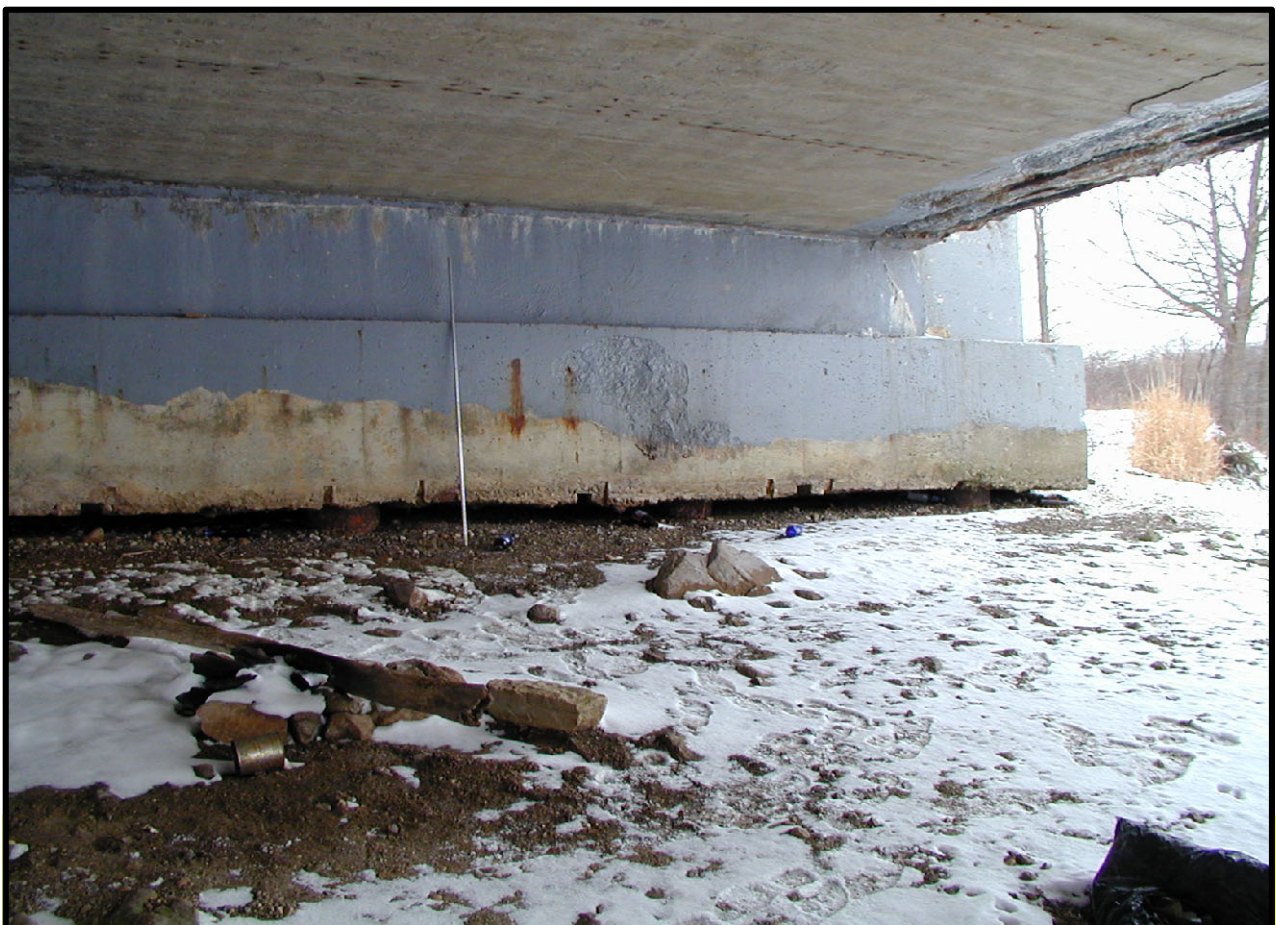
▲ Photo #2. Close-up of photo #1.

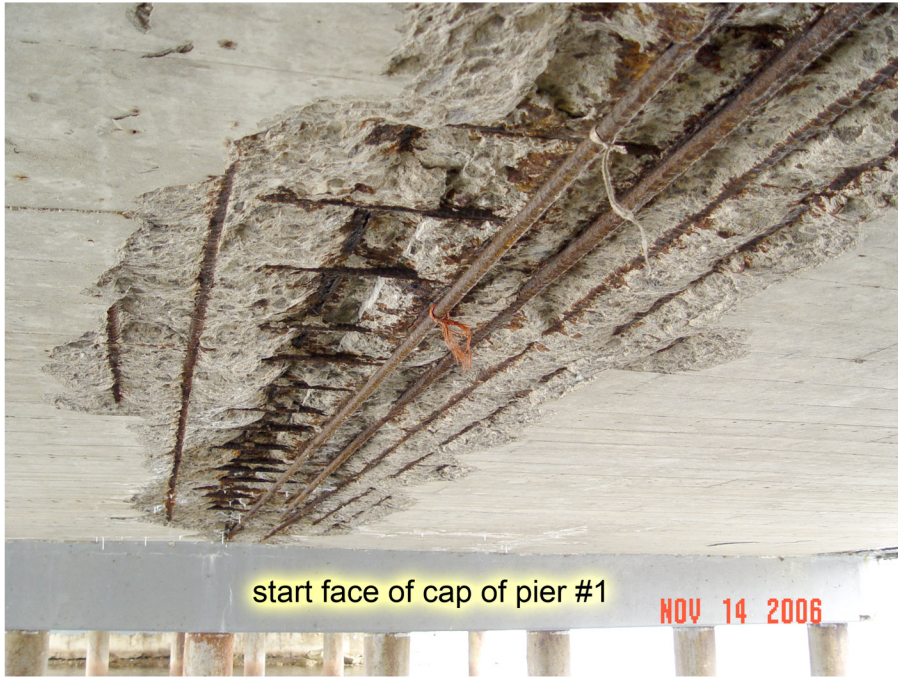
start face of cap of pier #1
NOV 14 2006

SLAB: 380 SF OF FLOOR SPALLS ALONG CONSTRUCTION JOINT AT CENTERLINE OF USR 44 REVEAL 110' OF 360 DEGREE EXPOSURE OF LONGITUDINAL REBARS; SEE ATTACHED PHOTOS #1 THRU #5 DATED 8/30/06 AND 11/14/06. 375 SF OF FLOOR SPALLS ALONG LEFT EDGE OF SLAB REVEAL 210' OF 360 DEGREE EXPOSED REBAR. 370 SF OF FLOOR SPALLS ALONG RIGHT EDGE OF SLAB REVEAL 130' OF 360 DEGREE REBAR EXPOSURE. SOME MISSING LONGITUDINAL REBAR. THE MAJORITY OF THE FLOOR SPALLS ALONG BOTH SLAB EDGES ARE OUTSIDE THE INSIDE RAILINGS.

P1 360 degree exposure of slab rebars in span #1.psd

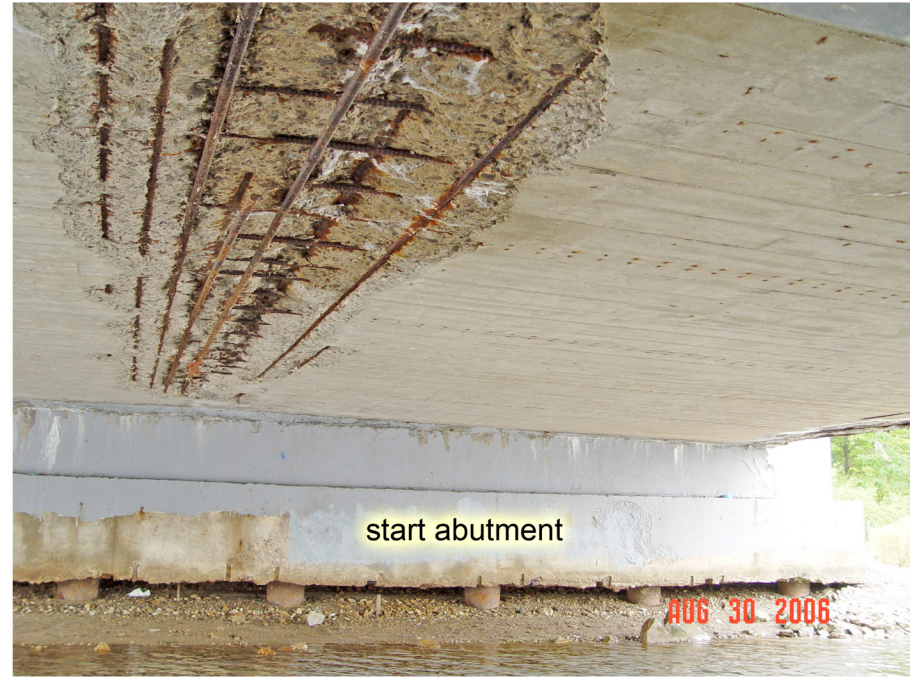
start abutment
AUG 30 2006

P2 360 degree exposure of slab rebars in span #1.psd

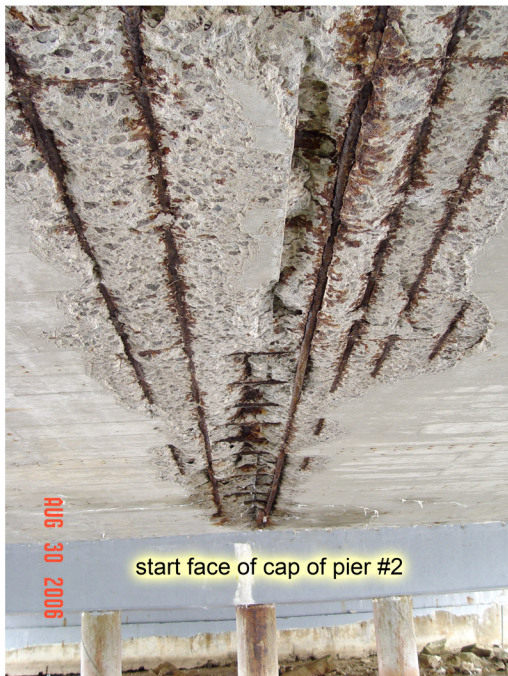
start face of cap of pier #2
AUG 30 2006

P3 360 degree exposure of slab rebars in span #2.psd

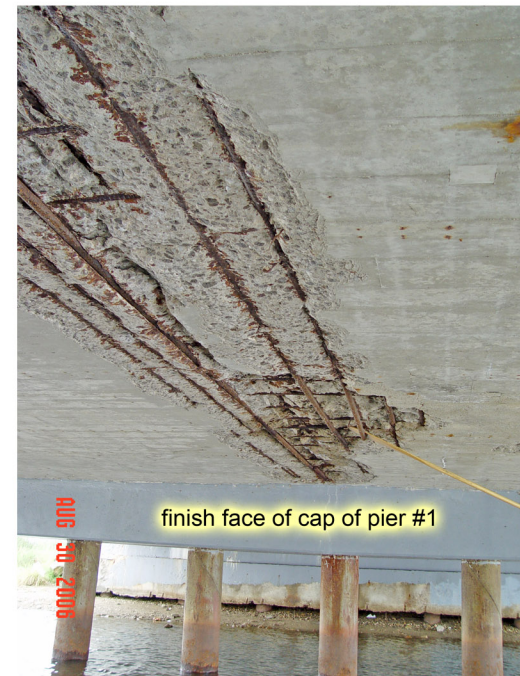
finish face of cap of pier #1
AUG 30 2006

P4 360 degree exposure of slab rebars in span #2.psd

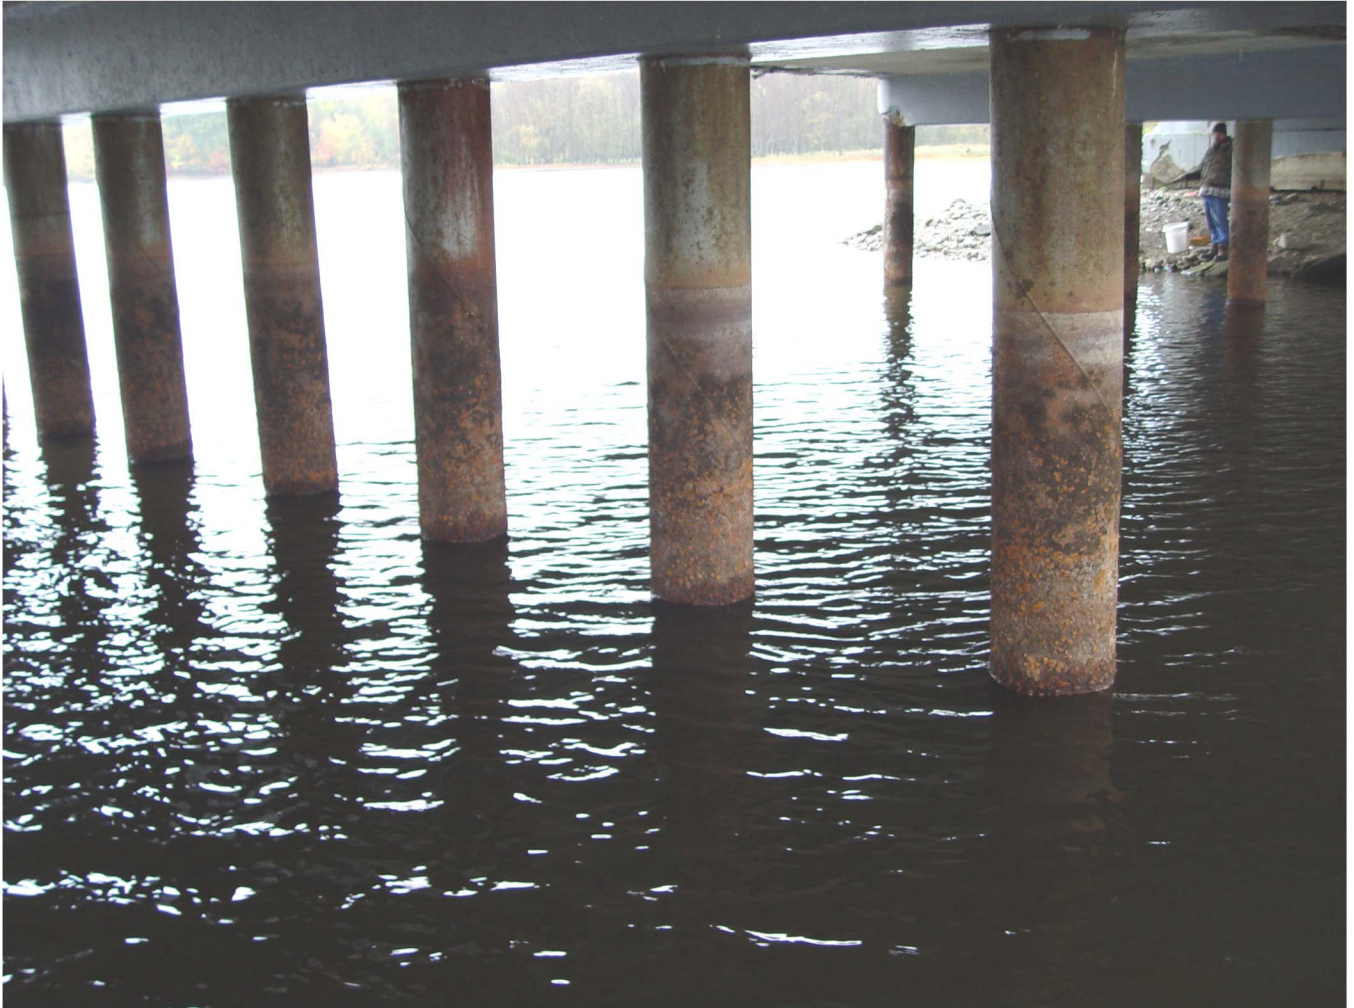
PIERS: MINOR DELAMINATIONS AND SPALLS OF CAPS. RUSTING SECTION LOSS OF STEEL PIER COLUMNS NEAR WATERLINE. SEE ATTACHED PHOTO #2 DATED 10/25/05.

Photo 2. *Facing north looking at the steel pile columns of Pier 1.
Note the rusting section loss occurring at the waterline.*
