BRIDGE INSPECTION REPORT

GEA-44-0135
SFN 2800152

Underwater Inspection Report for:

State Route 44 over La Due Reservoir Geauga County, Ohio
(Three Span, Continuous Reinforced Concrete Slab Bridge)

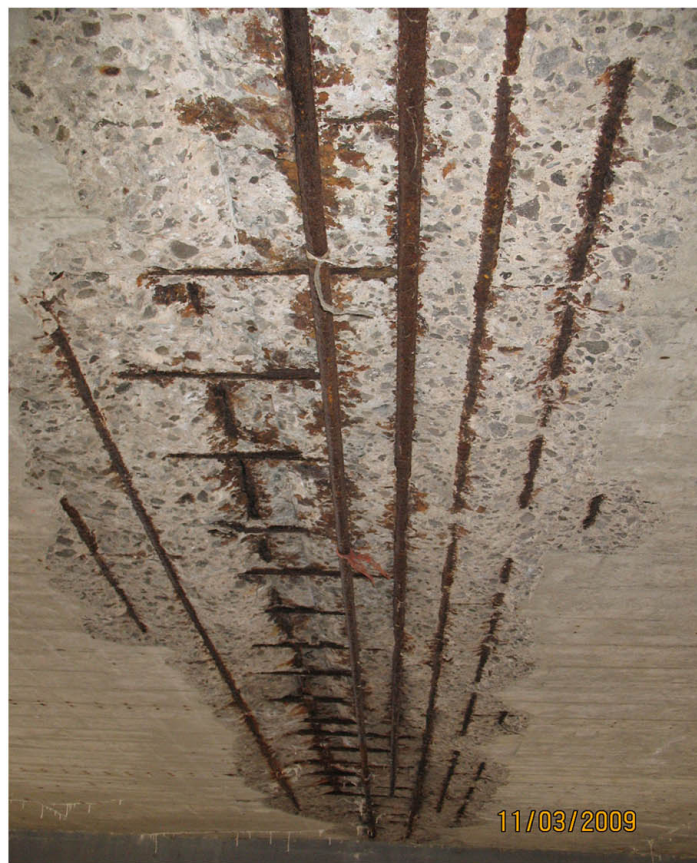
SLAB: 400 SF OF FLOOR SPALLS AND 40 SF OF DELAMS ALONG
CONSTRUCTION JOINT AT CENTERLINE OF USR 44 REVEAL 125' OF
360 DEGREE EXPOSURE OF LONGITUDINAL REBARS; SEE ATTACHED
PHOTOS 1 - 3 DATED 11/3/09. 375 SF OF FLOOR SPALLS ALONG
LEFT EDGE OF SLAB REVEAL 210' OF 360 DEGREE EXPOSED REBAR.
370 SF OF FLOOR SPALLS ALONG RIGHT EDGE OF SLAB REVEAL
130' OF 360 DEGREE REBAR EXPOSURE. SOME MISSING
LONGITUDINAL REBAR. THE MAJORITY OF THE FLOOR SPALLS ALONG
BOTH SLAB EDGES ARE OUTSIDE THE INSIDE RAILINGS.

P1: SPAN #1 UNDER CENTERLINE OF BRIDGE.

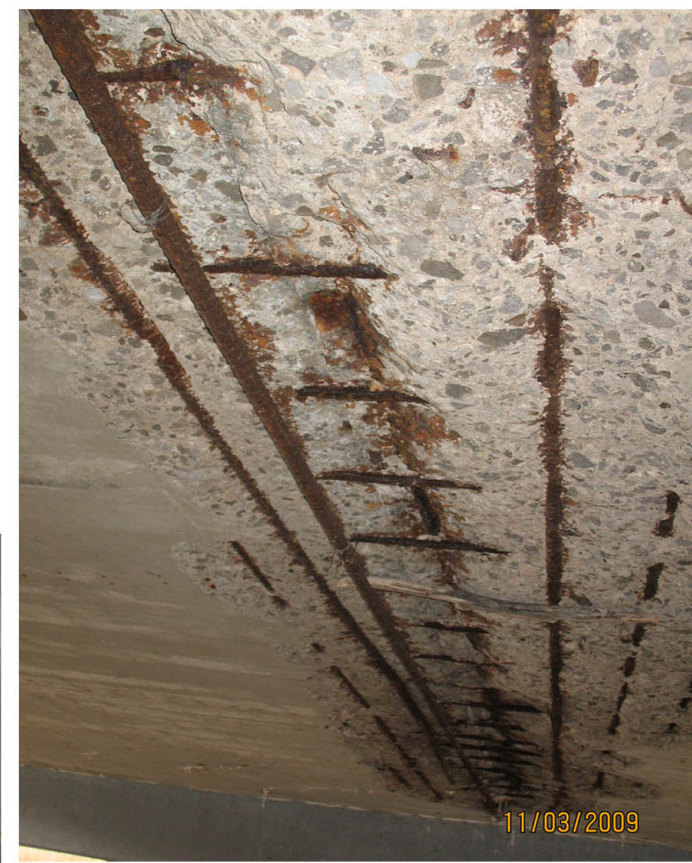
P3: SPAN #3 UNDER CENTERLINE.

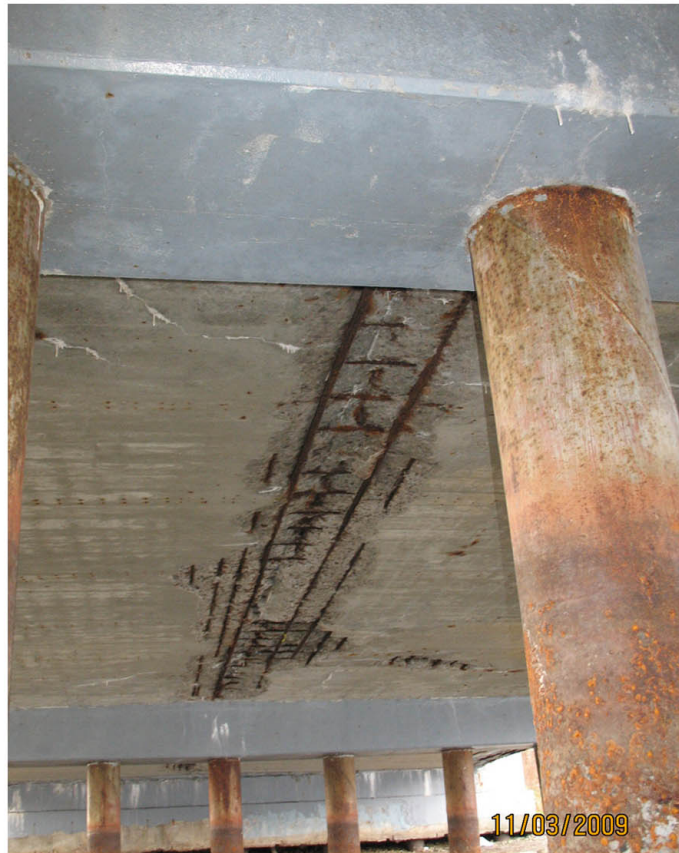
P2: SPAN #2 (MID) UNDER CENTERLINE.

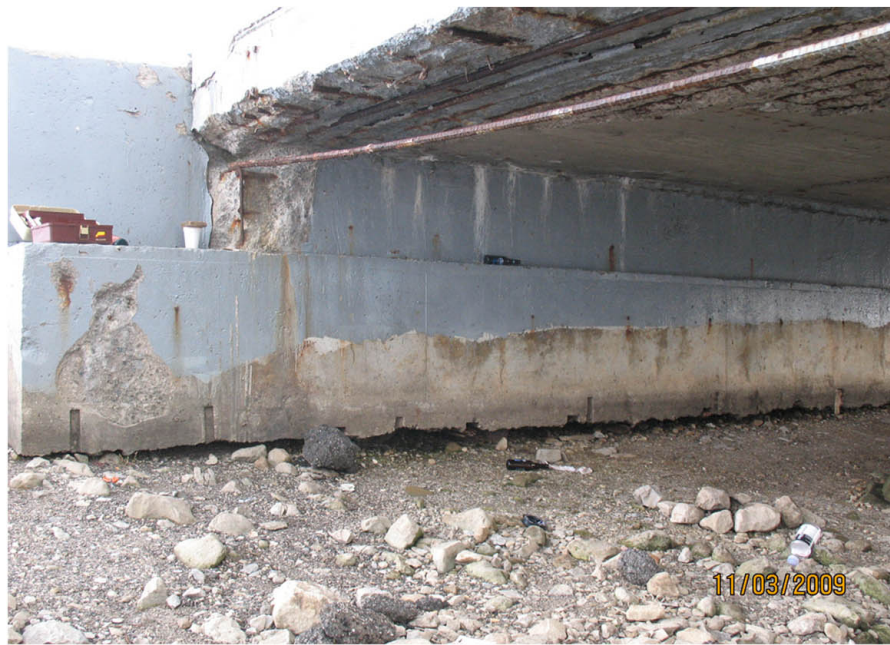
ABUTMENTS: SPALLS.
ABUTMENT SEATS: 4 SF OF SEAT LOSS AT ENDS OF ABUTMENTS.
PIERS: MINOR DELAMINATIONS AND SPALLS OF CAPS. RUSTING
SECTION LOSS OF STEEL PIER COLUMNS NEAR WATERLINE.
SCOUR: SOME EROSION IS HAPPENING BEHIND START ABUTMENT NEAR
CENTERLINE OF BRIDGE; SEE ATTACHED PHOTOS 6 & 7 DATED
11/3/09.
BACKWALLS: SPALLS. SOME DETERIORATED AREAS; SEE ATTACHED
PHOTOS 4 & 5 DATED 11/3/09.
WINGWALLS: CRACKS. SPALLS. DETERIORATING CONCRETE.
SLOPE PROTECT: UNDERMINING OF BOTH ABUTMENTS EXPOSE SOME
PILES AT FINISH ABUT AND ALL PILES AT START ABUT TO AIR

AND WATER WHEN LAKE IS HIGH; SEE ATTACHED PHOTOS 4 - 7
DATED 11/3/09.

P4: FINISH (N) ABUTMENT. NOTE MOST OF DECK EDGE SPALLS ARE UNDER OLD RAILING. NEW RAIL WAS ADDED TO THE INSIDE OF OLD.

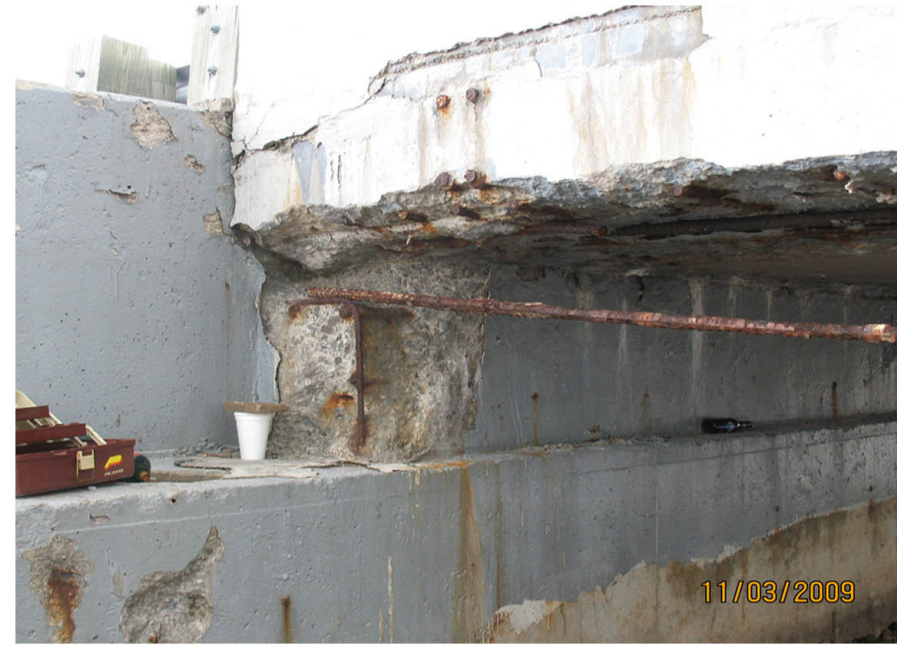
P5: DETERIORATED FINISH-LEFT (NW) ABUTMENT. NOTE REBAR HANGING WAS REMOVED ON 11/6/09.

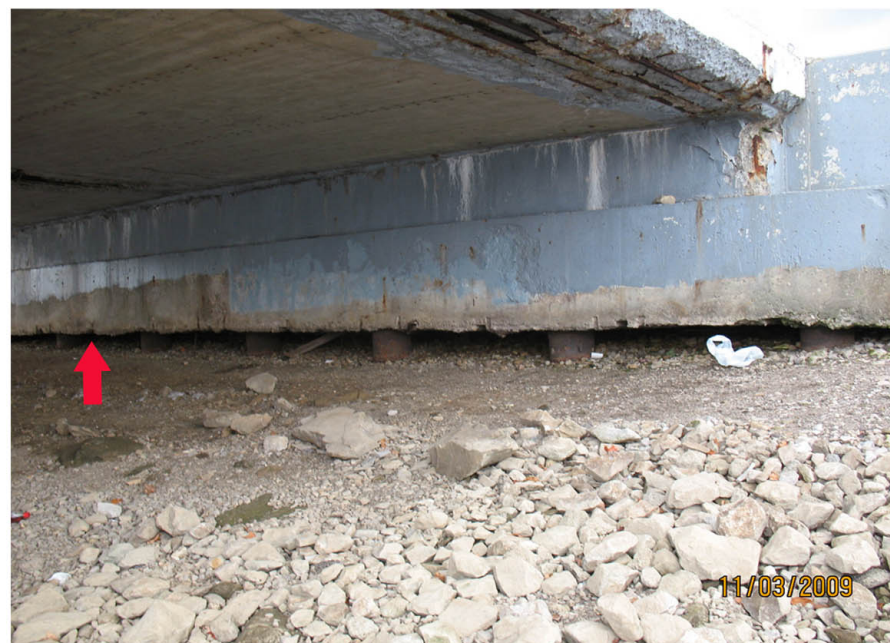
P6: START (S) ABUTMENT. NOTE PILE EXPOSURE. ARROW IS NEAR CENTERLINE OF BRIDGE.

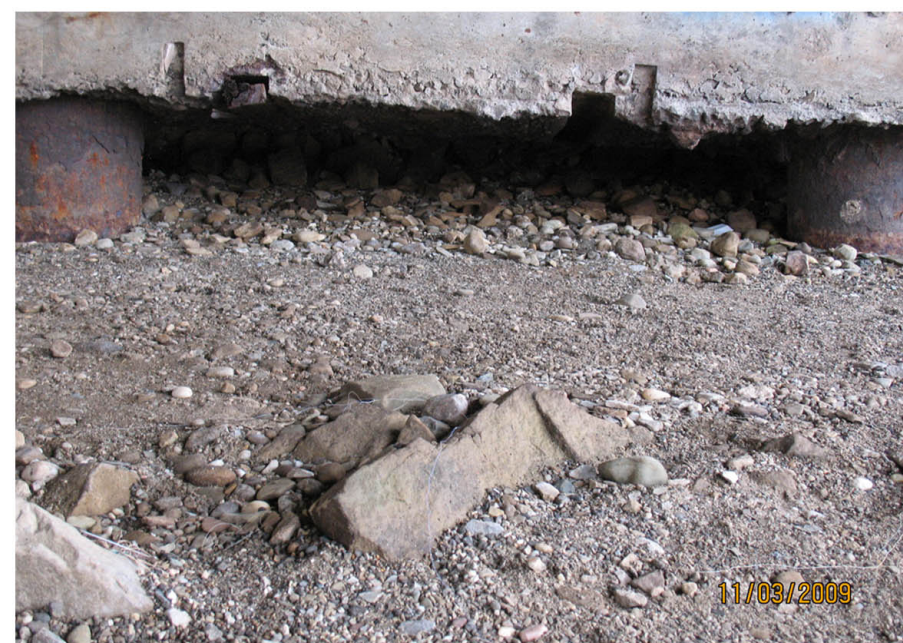
P7: CLOSE-UP OF ARROW IN P6. EROSION IS STARTING TO GET BEHIND ABUTMENT.

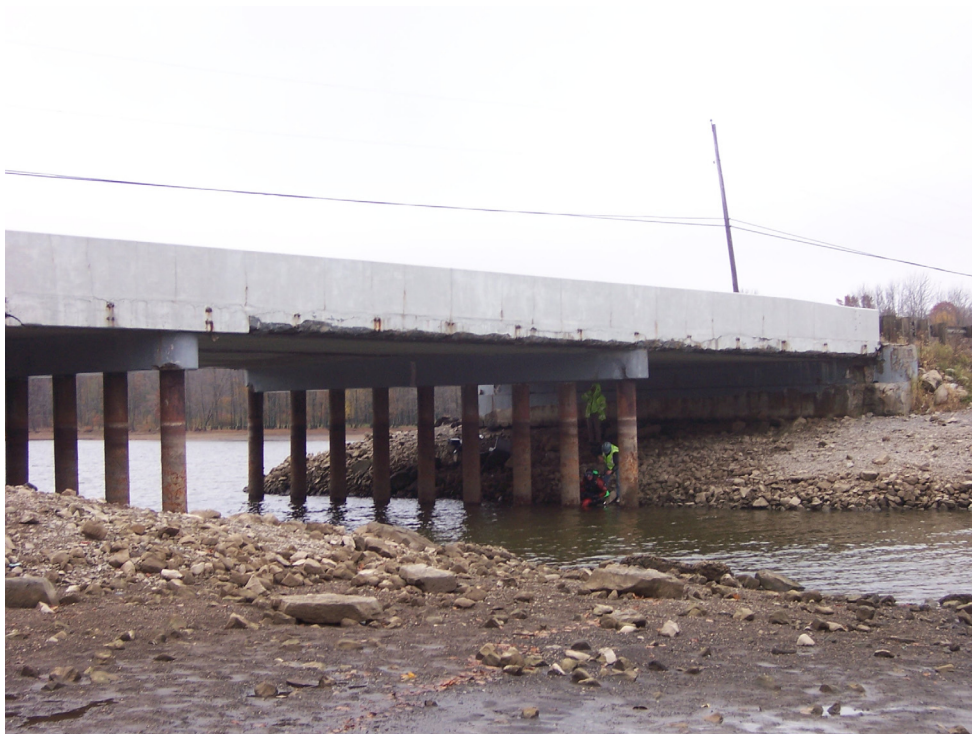
Photo by J. Clower, 10/28/09

- All 9 of the steel piles for this pier have up to a 1/8-inch layer of rust on the surface. Each of these piles was sounded with a hammer from the waterline to the bottom and no through holes were found. Photo 7 of Pier 2 shows this typical rust layer. The condition of the piles remains constant from the waterline to the riprap stone.
- All of the steel piles are surrounded with slope protection riprap stone. This stone slopes downward steeply toward the midspan.
- Although Pier 1's Cap is beyond the scope of this Underwater Inspection Report, it is worth noting the 1-foot diameter x 3-inch deep spalls located on the bottom edges at both the east and west ends. Photo 2 shows the east end spall.

Photo 2 – Facing Northwest. East Elevation of the Bridge.

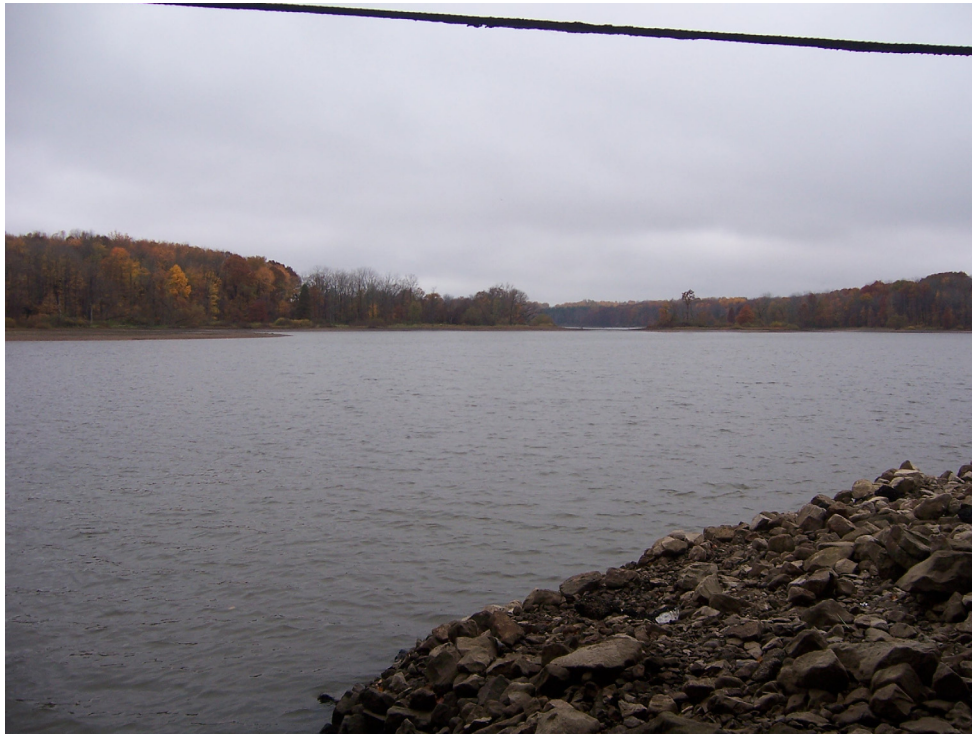
Photo by T. Clower, 10/28/09

- The bottom composition surrounding the steel piles is the slope protection riprap stone shown in Photos 1 – 6. The slope of the stone is steep around the piles and gives way with any contact.
- The bottom composition at the midspan was flat mud. The soundings at the midspan are relatively constant.

Photo 3 – Facing West. View from Bridge also showing North Shore sloping Riprap.

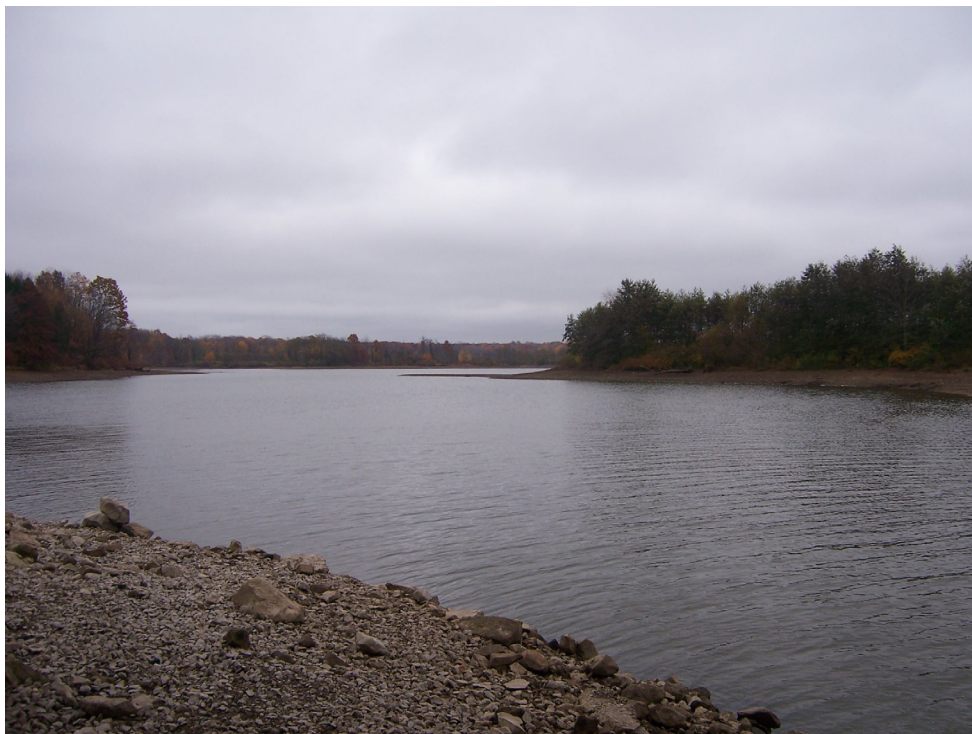
Photo by T. Clower, 10/28/09

Photo 4 – Facing East. View from Bridge also showing North Shore sloping Riprap.

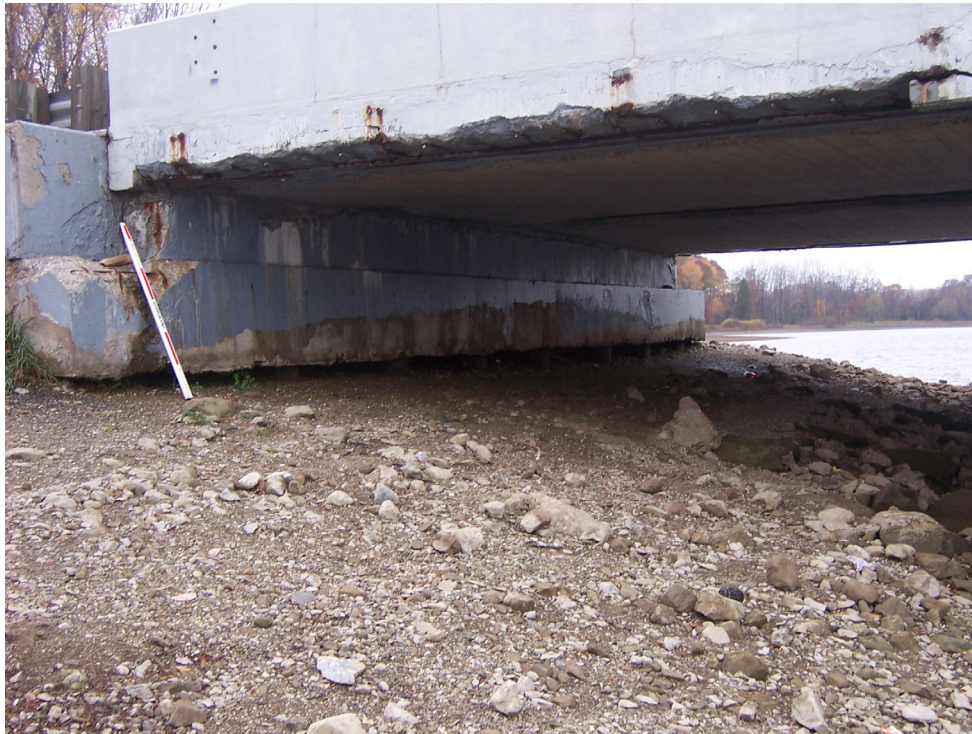
Photo by J. Clower, 10/28/09

- The abutment concrete has less than ¼-inch scaling and is partially painted with an epoxy coating. The epoxy paint stops at the level of where the previous slope protection riprap stone was.
- Using this epoxy paint edge, we can see that the previous slope protection was up to three feet higher in some locations.
- Photo 5 of the abutment east end shows a corner area of spalled concrete 2 feet high x 6 feet wide x 8 inches deep with exposed reinforcing steel. The west end of this abutment also has a corner spall 13 inches in diameter x 5 inches deep with exposed reinforcing steel.
- The South Abutment is undermined across the entire width (44 feet) exposing the supporting piles. The worst undermining occurred ten feet from the west end and has dimensions of 12 inches high x 43 inches deep.

The 11/13/2008 ODOT Topside Inspection Report with photos and dimensions of the South Abutment undermining was provided. The South Abutment undermining dimensions taken during the 2008 inspection were almost identical to those taken during this inspection. The 2008 report mentions the North Abutment undermining also but does not give dimensions. Subsequent inspections can compare the North Abutment undermining dimensions to those provided in this report.

Photo 5 – Facing West. South Abutment with full width Undermining and Exposed Piles.

As stated above, several feet of slope protection stone has washed away from the abutments undermining them and exposing their supporting piles. Now that both abutment faces are exposed, the epoxy painting should be completed and larger slope protection riprap be installed. This will prevent further undermining of the abutments.

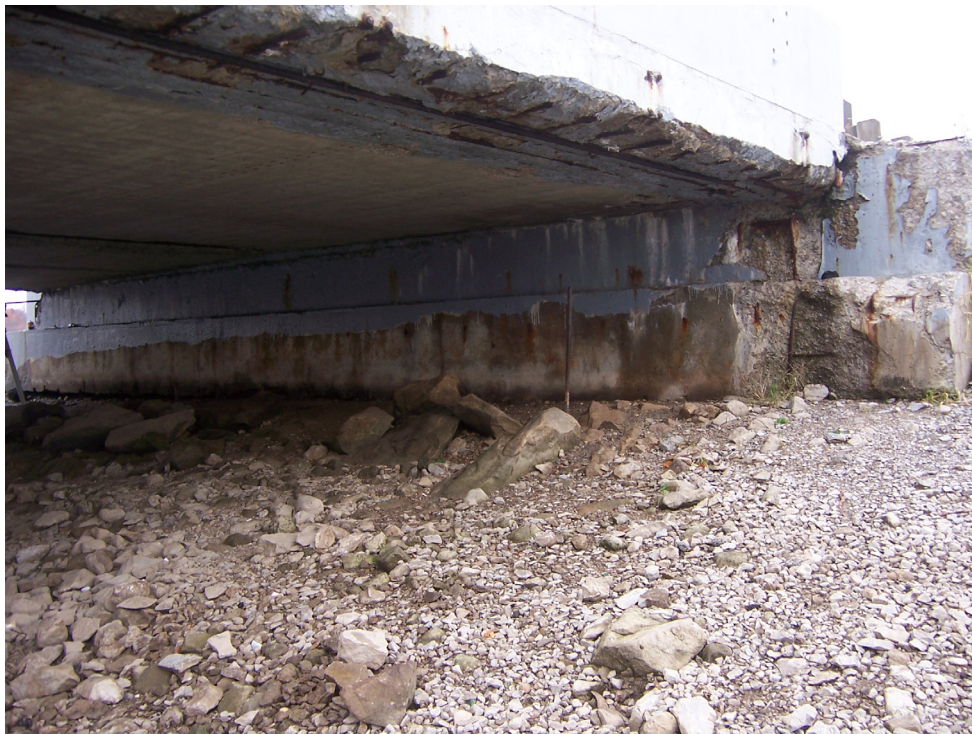
Photo by T. Clower, 10/28/09

- The abutment concrete has less than ¼-inch scaling and is partially painted with an epoxy coating. The epoxy paint stops at the level of where the previous slope protection riprap stone was.
- Using this epoxy paint edge, we can see that the previous slope protection was up to three feet higher in some locations.
- Photo 6 of the abutment east end shows an area of spalled concrete 6 feet high x 4 feet wide x 7 inches deep with exposed reinforcing steel.
- There is 22 feet of concrete undermining at the west end of this abutment with exposed supporting piles. The worst undermining occurred ten feet from the west end and has dimensions of 4 inches high x 33 inches deep.

Photo 6 – Facing Northwest. North Abutment with West Corner Undermining.

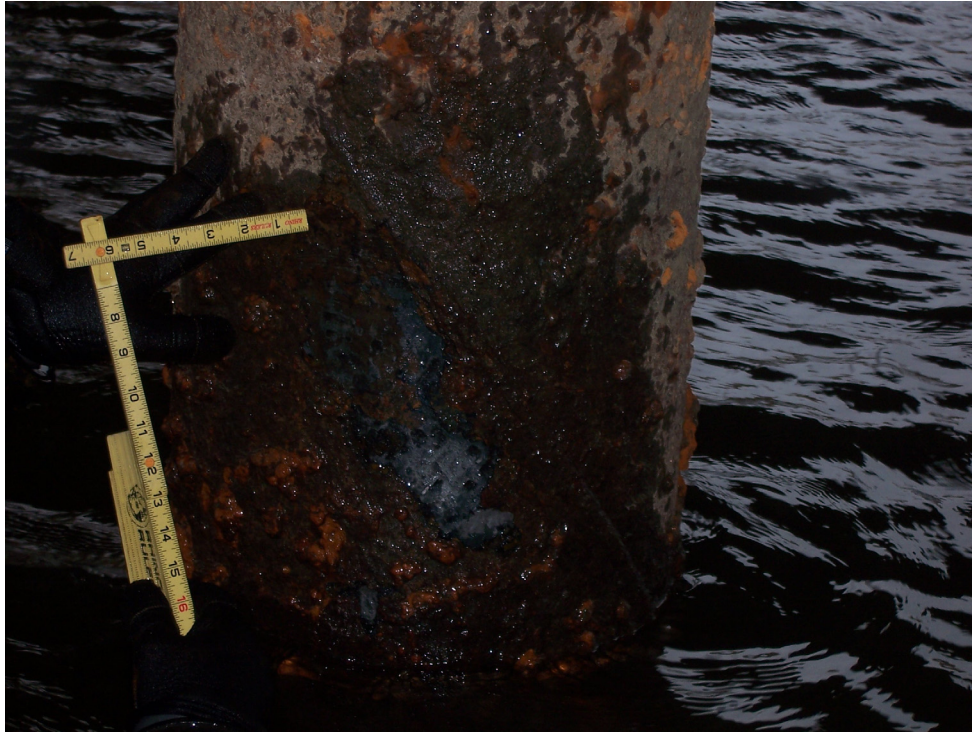
Photo by J. Clower, 10/28/09

- All 9 of the steel piles for this pier have up to a 1/8-inch layer of rust on the surface. Each of these piles was sounded with a hammer from the waterline to the bottom and no through holes were found. Photo 7 shows this typical rust layer. The condition of the piles remains constant from the waterline to the riprap stone.
- All of the steel piles are surrounded with slope protection riprap stone. This stone slopes downward steeply toward the midspan.
- Although Pier 2's Cap is beyond the scope of this Underwater Inspection Report, it is worth noting the spalls located on the bottom edges at both the east and west ends. Photo 8 shows the missing and damaged concrete around the west end pile cap. The area of missing concrete is 1 foot high x 2 feet wide x 6 inches deep.

Without ultrasonically checking the remaining thickness of the steel piles, it is impossible to give an estimate of the section loss in the steel. Hence we are recommending this be done during the next underwater inspection.

Photo 7 – Facing South. Pier 2 (North Pier), 4th Steel Pile from the East. Typical 1/8-inch thick corrosion of the Steel with section loss. No through holes.

The ultrasonic thickness check of the steel piles mentioned above will establish a baseline for future underwater inspections and show the extent of section loss within the piles. KCI's Diving Division owns this equipment and their divers are able to perform this non-destructive test both above and below the water.

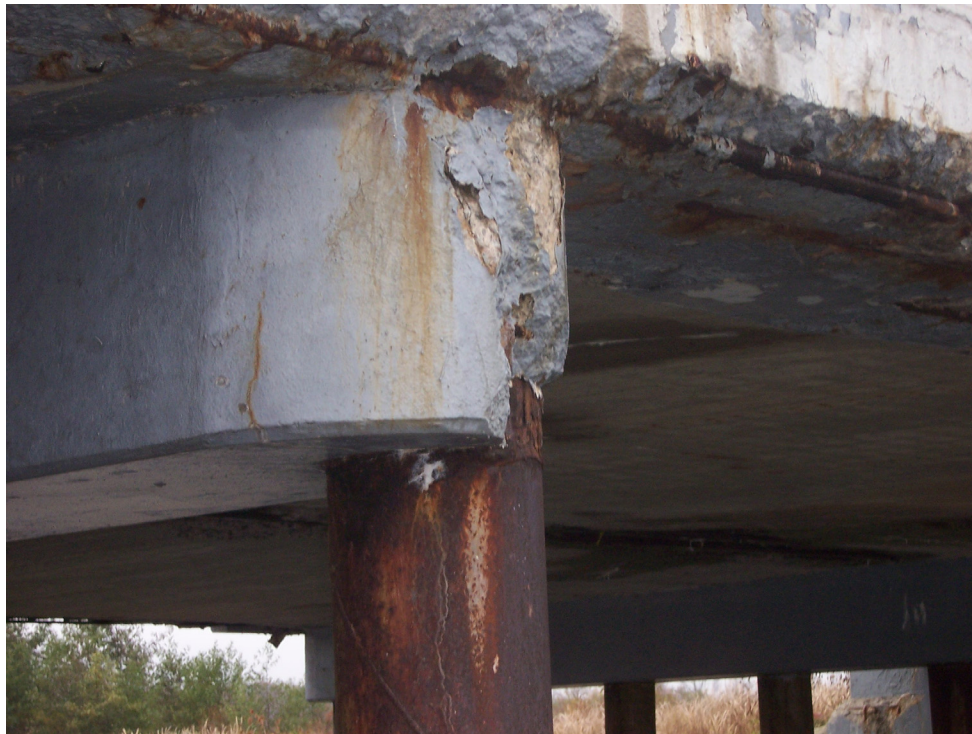
Photo by T. Clower, 10/28/09

Photo 8 – Facing Southeast. West end of Pier 2 (North Pier) pile cap with Corner Spall.
