BRIDGE INSPECTION REPORT

2800152
Structure File NumberBRIDGE NUMBER **GEA 00044 0135**YEAR BUILT **1960**DIST **12** Bridge Type **112** TYPE SERVICE **5 5** **LA DUE RES. 1.23 MIS 422**

GEA-44-0135
SFN 2800152

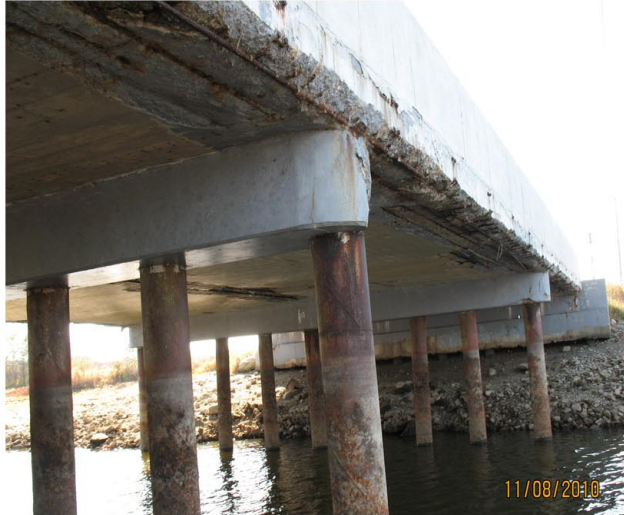
SLAB: BOTH DECK EDGES ARE COMPLETELY SPALLED WITH 360 DEGREE
REBAR EXPOSURE. SPALLED AND DELAM AREAS UNDER LANES ABOVE:
SPAN #1= 170 SF SPALLED. SPAN #2= 185 SF SPALLED.
SPAN #3= 155 SF SPALLED. ALL THREE SPANS HAVE LONG LENGTHS

P5: TYPICAL EDGE SPALLING.

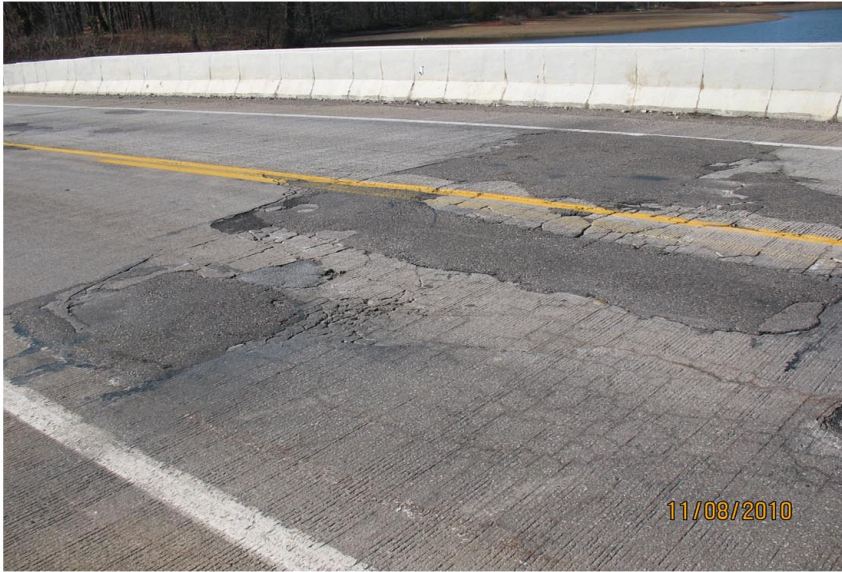
FL: SEE ITEM #10 (SLAB). FLOOR IS 25-30% DETERIORATED.
WS: CRACKS SOME AS WIDE AS 1/8". 250 SF OF ASPHALT PATCHES.
10% DELAMINATED. 30 SF BREAKING UP. 2 SF SPALLED. WS IS
15-20% DETERIORATED. SEE ATTACHED PHOTO 5 - 8 DATED
11/8/10.
RAILING: VERTICAL CRACKS.
EXJTS: ASPHALT PATCHES & BREAKING UP AT BOTH EXJTS; SEE
ATTACHED PHOTOS 6 & 7 DATED 11/8/10.

P5: LARGE ASPHALT PATCHES AND BREAKING UP AREAS OVER MID-SPAN.

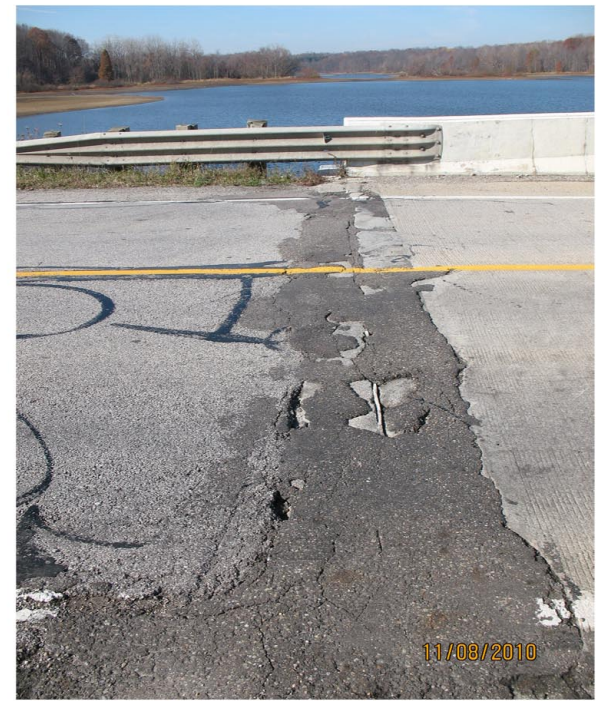
PAVEMENT: CRACKS. ASPHALT PATCHES ALONG TOPS OF BOTH
BACKWALLS WITH SOME BREAKING UP AREAS.
EMBANKMENT: EROSION AT ALL FOUR CORNERS. EROSION ALONG
NORTHWEST CAUSEWAY EMBANKMENT WITH SEVERAL WASHOUTS THAT
EXTEND TO GUARDRAIL POSTS.

P6: REAR APPROACH AND DECK.

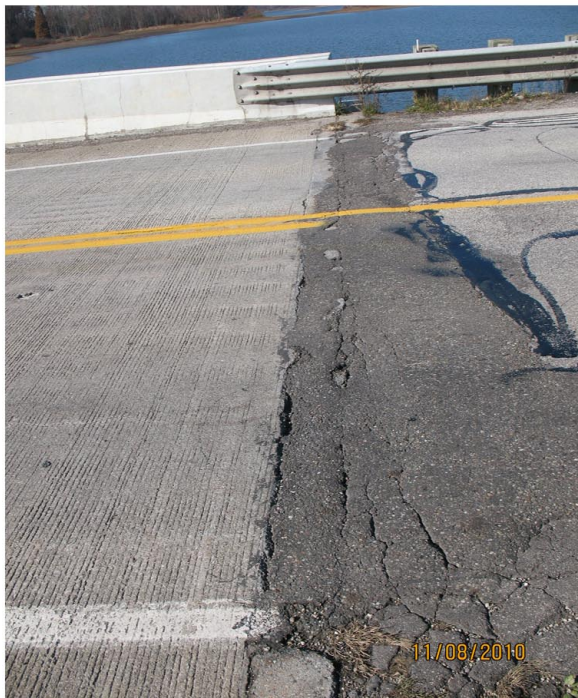
P7: FORWARD APPROACH AND DECK.

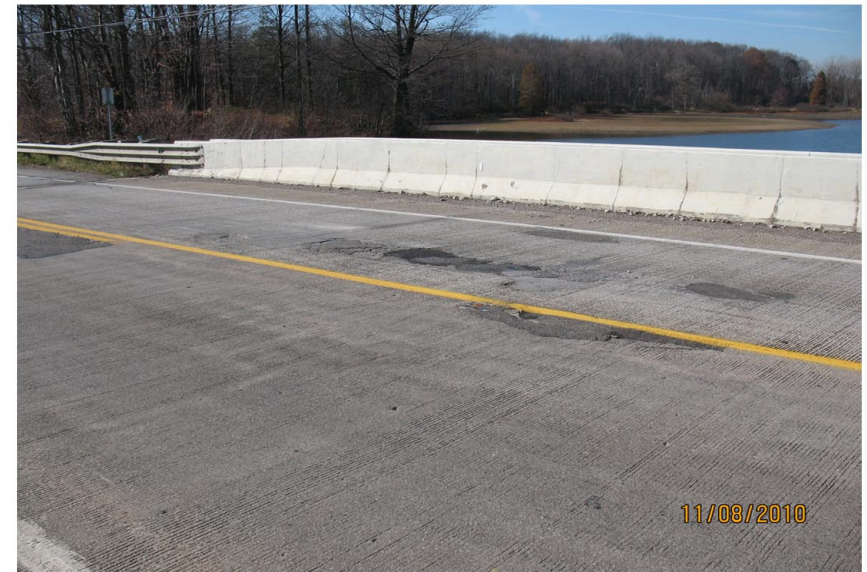
P8: ASPHALT PATCHES AND BREAKING UP AREAS OVER SPAN #1 AND PIER #1.

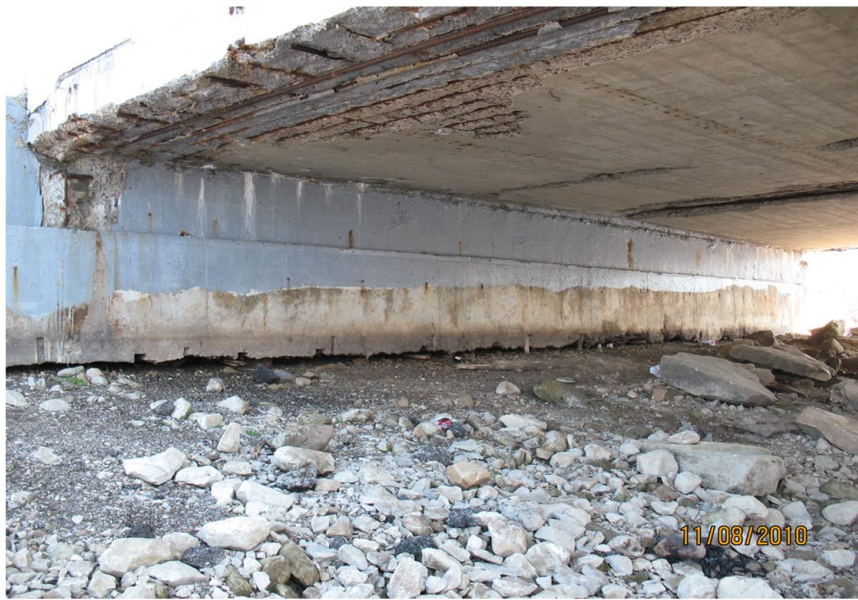
ATTACHED PHOTOS 10 & 11 DATED 11/8/10.
PIERS: MINOR DELAMINATIONS AND SPALLS OF CAPS. RUSTING
SECTION LOSS OF STEEL PIER COLUMNS NEAR WATERLINE.
SCOUR: SOME EROSION IS HAPPENING BEHIND REAR ABUTMENT NEAR
CENTERLINE OF BRIDGE.
BACKWALLS: SPALLS. SOME DETERIORATED AREAS.
WINGWALLS: CRACKS. SPALLS. DETERIORATING CONCRETE.
SLOPE PROTECT: UNDERMINING OF BOTH ABUTMENTS EXPOSE SOME
PILES AT FORWARD ABUT AND ALL PILES AT REAR ABUT TO AIR &
WATER WHEN LAKE IS HIGH; SEE ATTACHED PHOTOS 9 - 12 DATED
11/8/10.

PROTECTION: ALMOST ALL OF THE STONES HAVE WASHED AWAY FROM
BOTH ABUTMENTS.

P9: FORWARD ABUTMENT UNDERMINED.

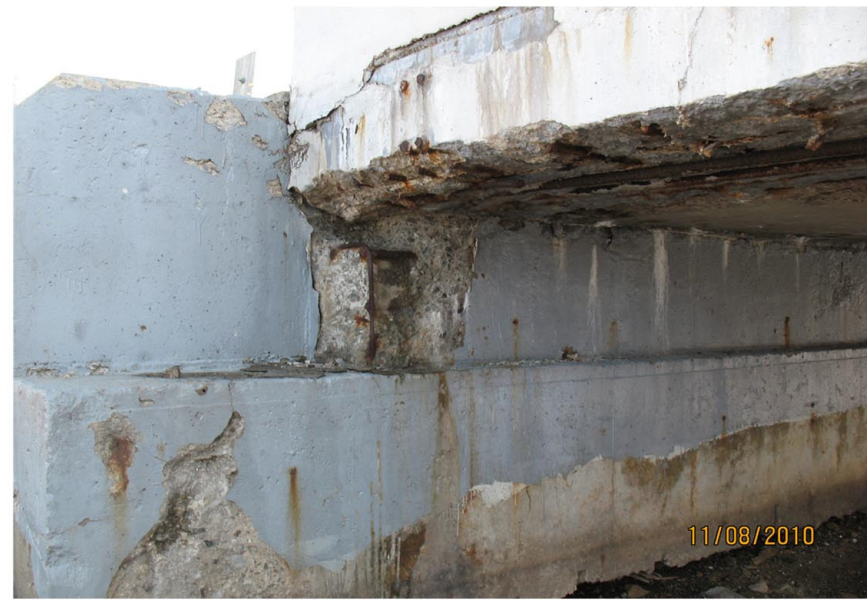
ABUTMENTS: SPALLS.
ABUTMENT SEATS: AREAS OF SEAT LOSS AT ENDS OF ABUTMENTS; SEE

P10: FORWARD ABUTMENT SEAT LOSS UNDER NORTHWEST CORNER OF THE DECK.

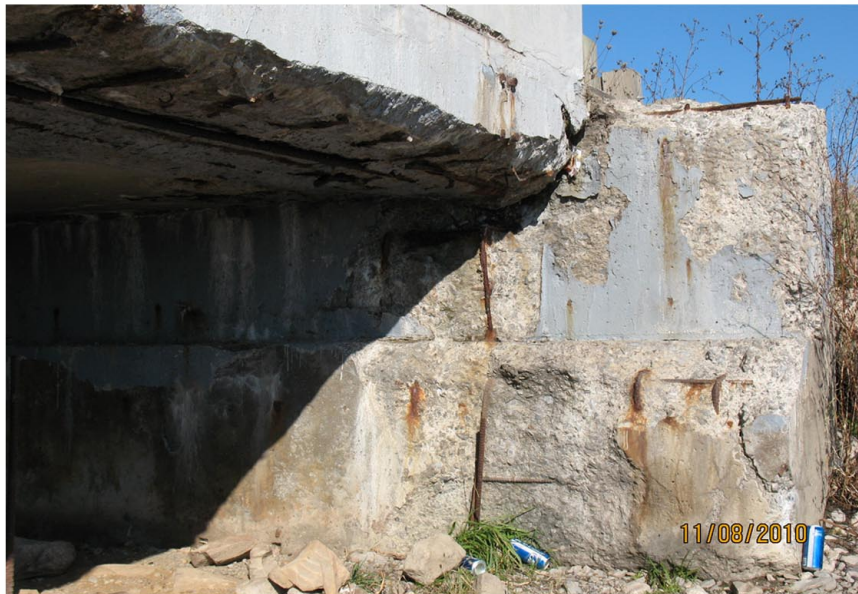
P11: FORWARD ABUTMENT SEAT LOSS UNDER NORTHEAST CORNER OF THE DECK.

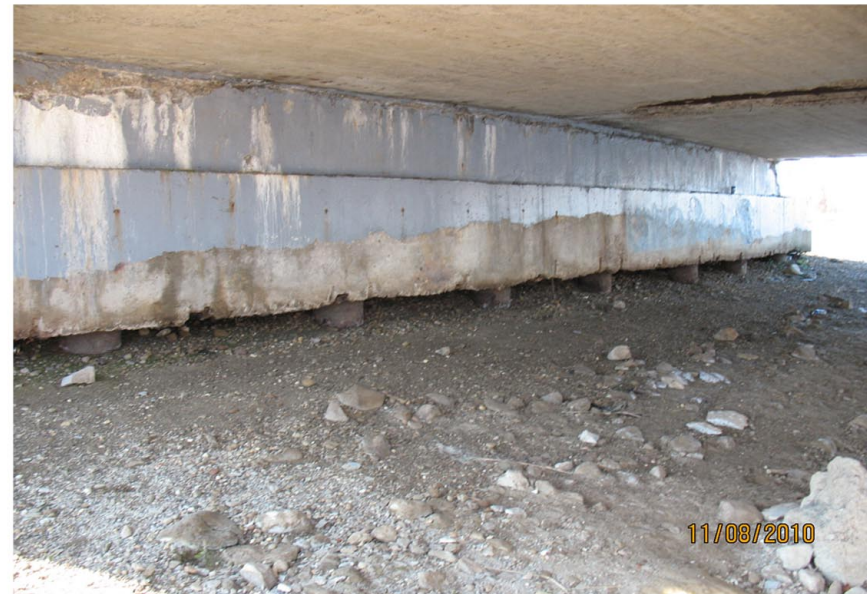
P12: REAR ABUTMENT UNDERMINED. A FEW AREAS OF THE UNDERMINING ARE STARTING TO GET BEHIND BACKWALL HERE.
