BRIDGE INSPECTION REPORT

2800152
Structure File NumberBRIDGE NUMBER **GEA 00044 0135**YEAR BUILT **1960**DIST **12** Bridge Type **112** TYPE SERVICE **5 5** **LA DUE RES. 1.23 MIS 422**

GEA-44-0135
SFN 2800152

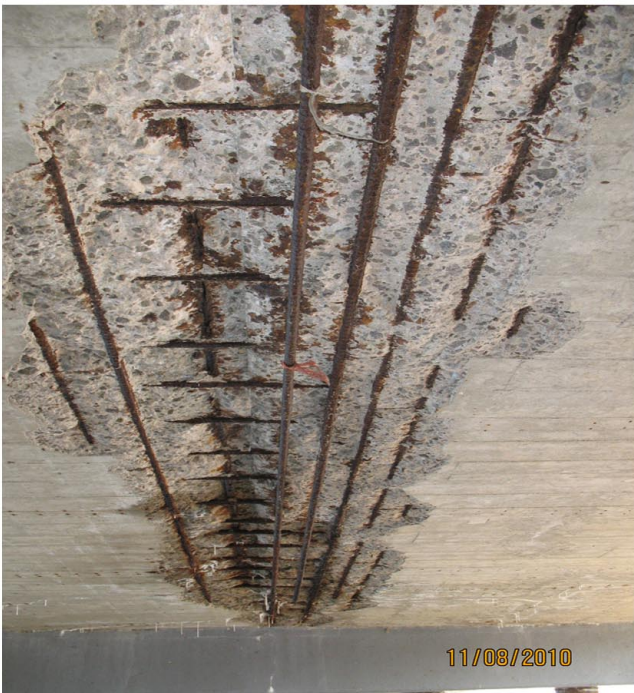
SLAB: BOTH DECK EDGES ARE COMPLETELY SPALLED WITH 360
DEGREE REBAR EXPOSURE. SPALLED AREAS UNDER TRAFFIC
AS FOLLOWS: SPAN #1= 200 SF SPALLED, SPAN #2= 225 SF
SPALLED AND SPAN #3= 185 SF SPALLED. ALL THREE SPANS
HAVE LONG LENGTHS OF 360 DEGREE REBAR EXPOSED UNDER
TRAFFIC. SEE ATTACHED PHOTOS P1 - P5 DATED 11/8/10.

P1: LOOKING NORTH IN SPAN #1 (SOUTH SPAN)

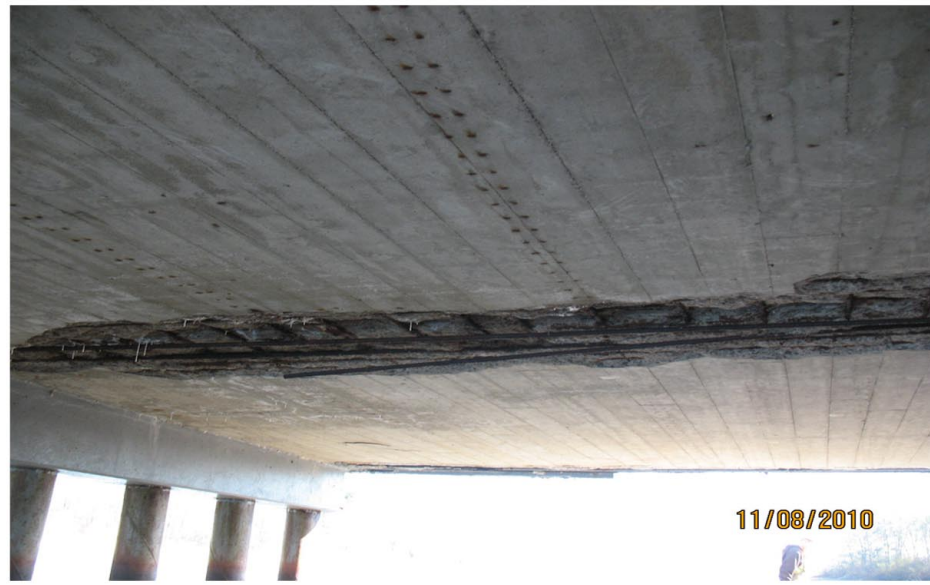
P2: LOOKING EAST IN SPAN #1. NOTE 360 DEGREE REBAR EXPOSURE

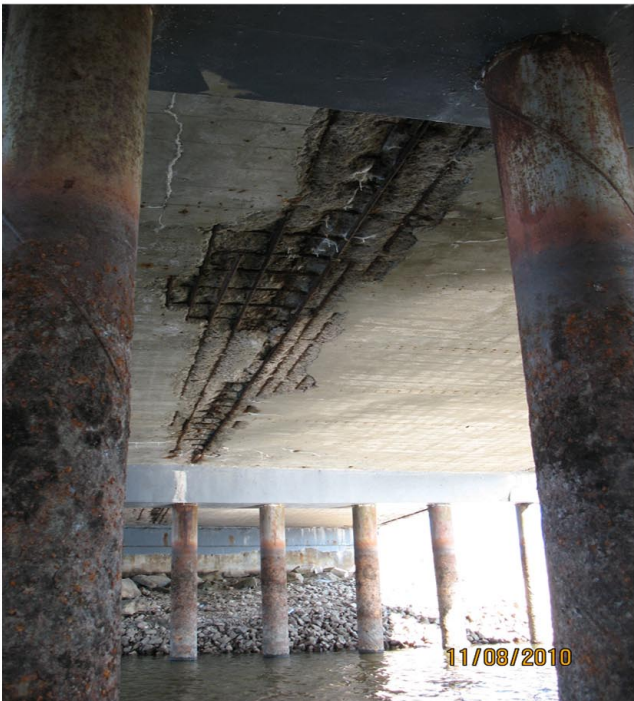
P3: LOOKING NORTH AT MID-SPAN.

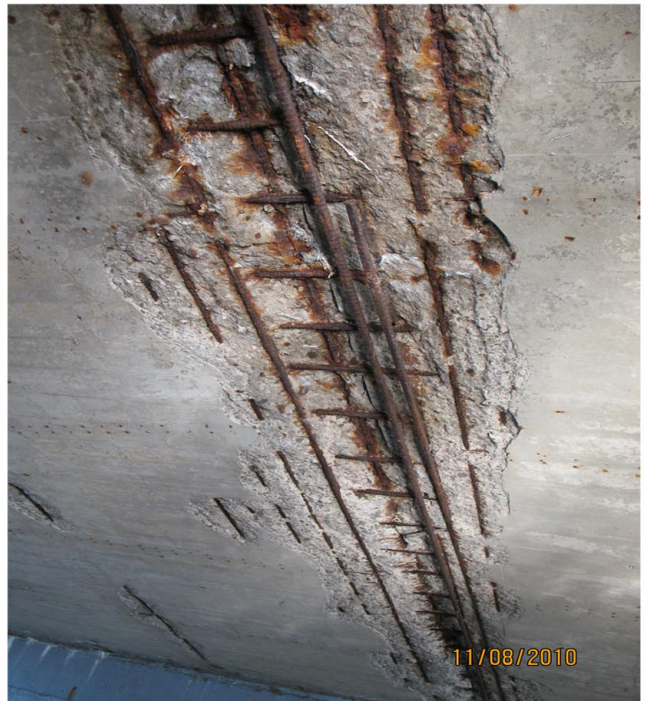
P4: LOOKING NORTH IN SPAN #3.

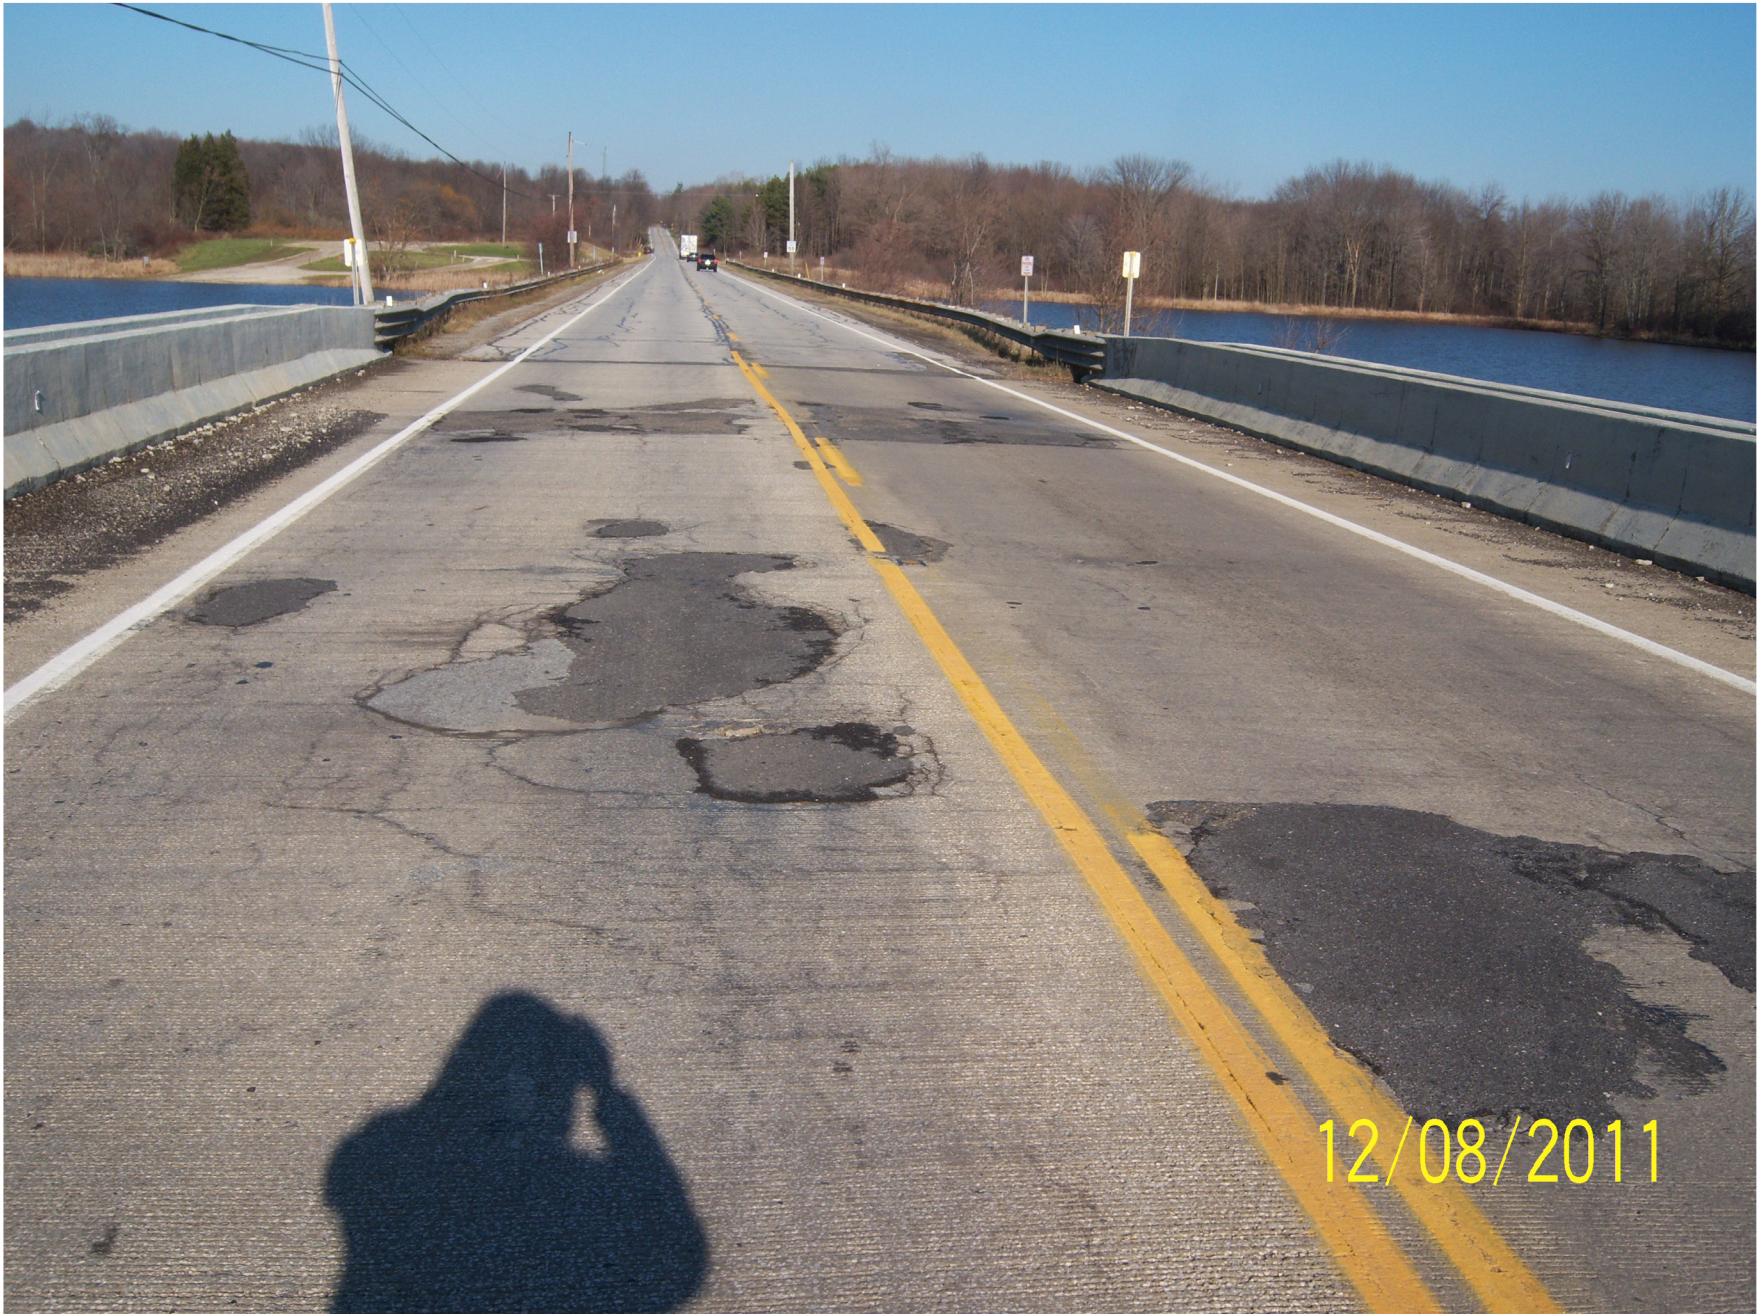
FLOOR: SEE ITEM #10 (SLAB). FLOOR IS 25-30% DETERIORATED.
WS: CRACKS SOME AS WIDE AS 1/8". 400 SF OF ASPHALT PATCHES.
15% DELAMINATED. 40 SF BREAKING UP. WS IS 25-30%
DETERIORATED. SEE ATTACHED PHOTO P6 DATED 12/08/11.
RAILING: VERTICAL CRACKS.
EXJTS: ASPHALT PATCHES, SOME BREAKING UP AT BOTH EXJTS.

P6: Wearing surface viewed facing north from south end of deck.

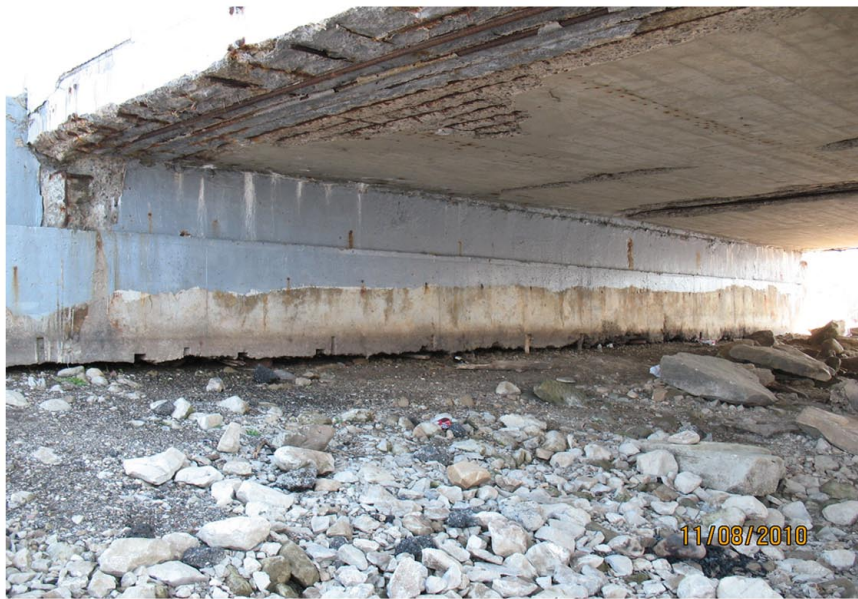
ABUTMENTS: SPALLS.
ABUTMENT SEATS: AREAS OF SEAT LOSS AT ENDS OF ABUTMENTS.
SEE ATTACHED PHOTOS P10 & P11 DATED 11/8/10.
PIERS: MINOR DELAMINATIONS AND SPALLS OF CAPS. RUSTING
SECTION LOSS OF STEEL PIER COLUMNS NEAR WATERLINE.
SCOUR: BOTTOM OF ENTIRE REAR (SOUTH) ABUTMENT FOOTING IS
EXPOSED WITH 1' OF PILES EXPOSED. SCOUR HAS PUNCHED
THRU UNDER REAR ABUTMENT TO APPROACH FILL.
BACKWALLS: SPALLS. SOME DETERIORATED AREAS.
WINGWALLS: CRACKS. SPALLS. DETERIORATING CONCRETE.
SLOPE PROTECT: UNDERMINING OF BOTH ABUTMENTS EXPOSE SOME
PILES AT FORWARD ABUT AND ALL PILES AT REAR ABUT TO AIR &
WATER WHEN LAKE IS HIGH; SEE ATTACHED PHOTOS P9 AND P12
DATED 11/8/10.

P9: FORWARD ABUTMENT UNDERMINED.

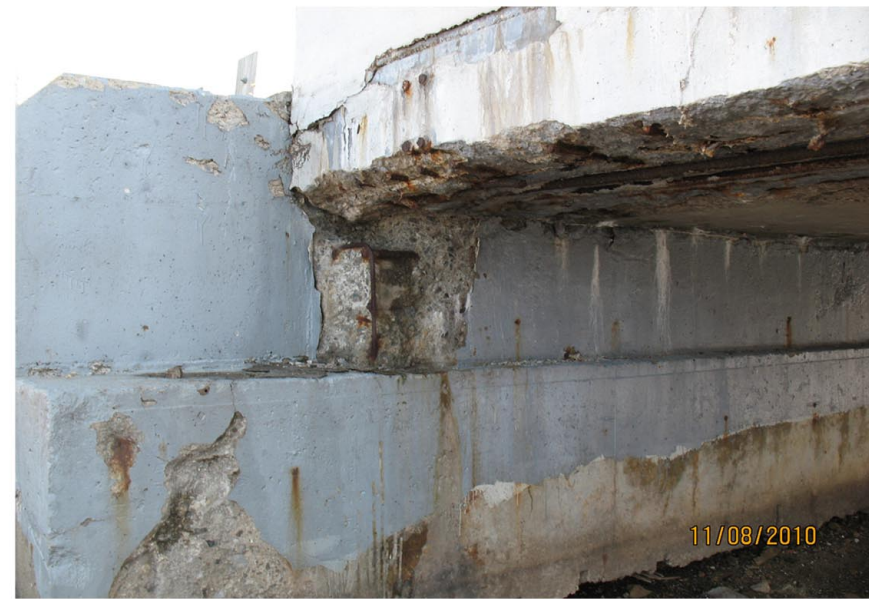
P10: FORWARD ABUTMENT SEAT LOSS UNDER NORTHWEST CORNER OF THE DECK.

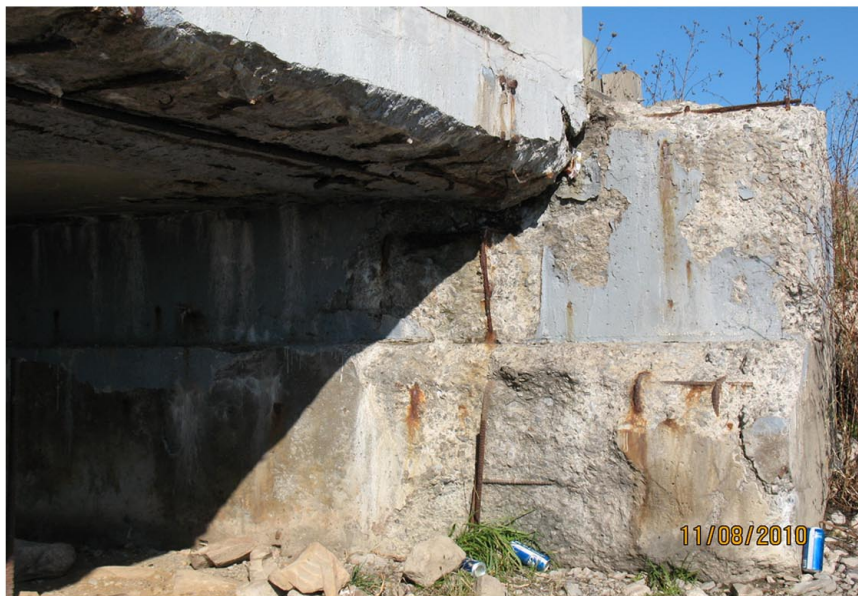
P11: FORWARD ABUTMENT SEAT LOSS UNDER NORTHEAST CORNER OF THE DECK.

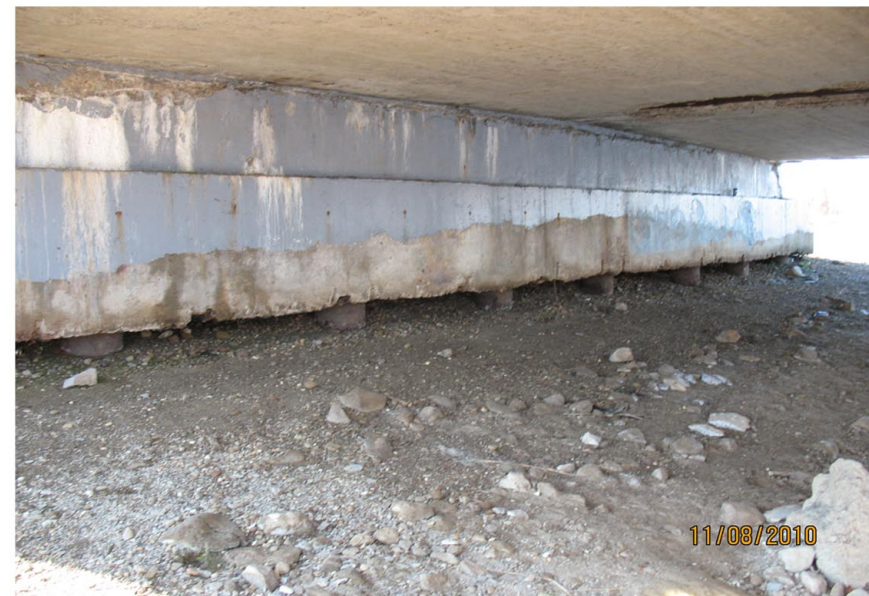
P12: REAR ABUTMENT UNDERMINED. A FEW AREAS OF THE UNDERMINING ARE STARTING TO GET BEHIND BACKWALL HERE.
