**Underwater Inspection of
SFN - 2800152
State Route 44 over the La Due Reservoir
(GEA-44-0135)
October 20, 2014
for
Ohio Department of Transportation
District-12**

By
GPI/Greenman-Pedersen, Inc.

Inspection Report

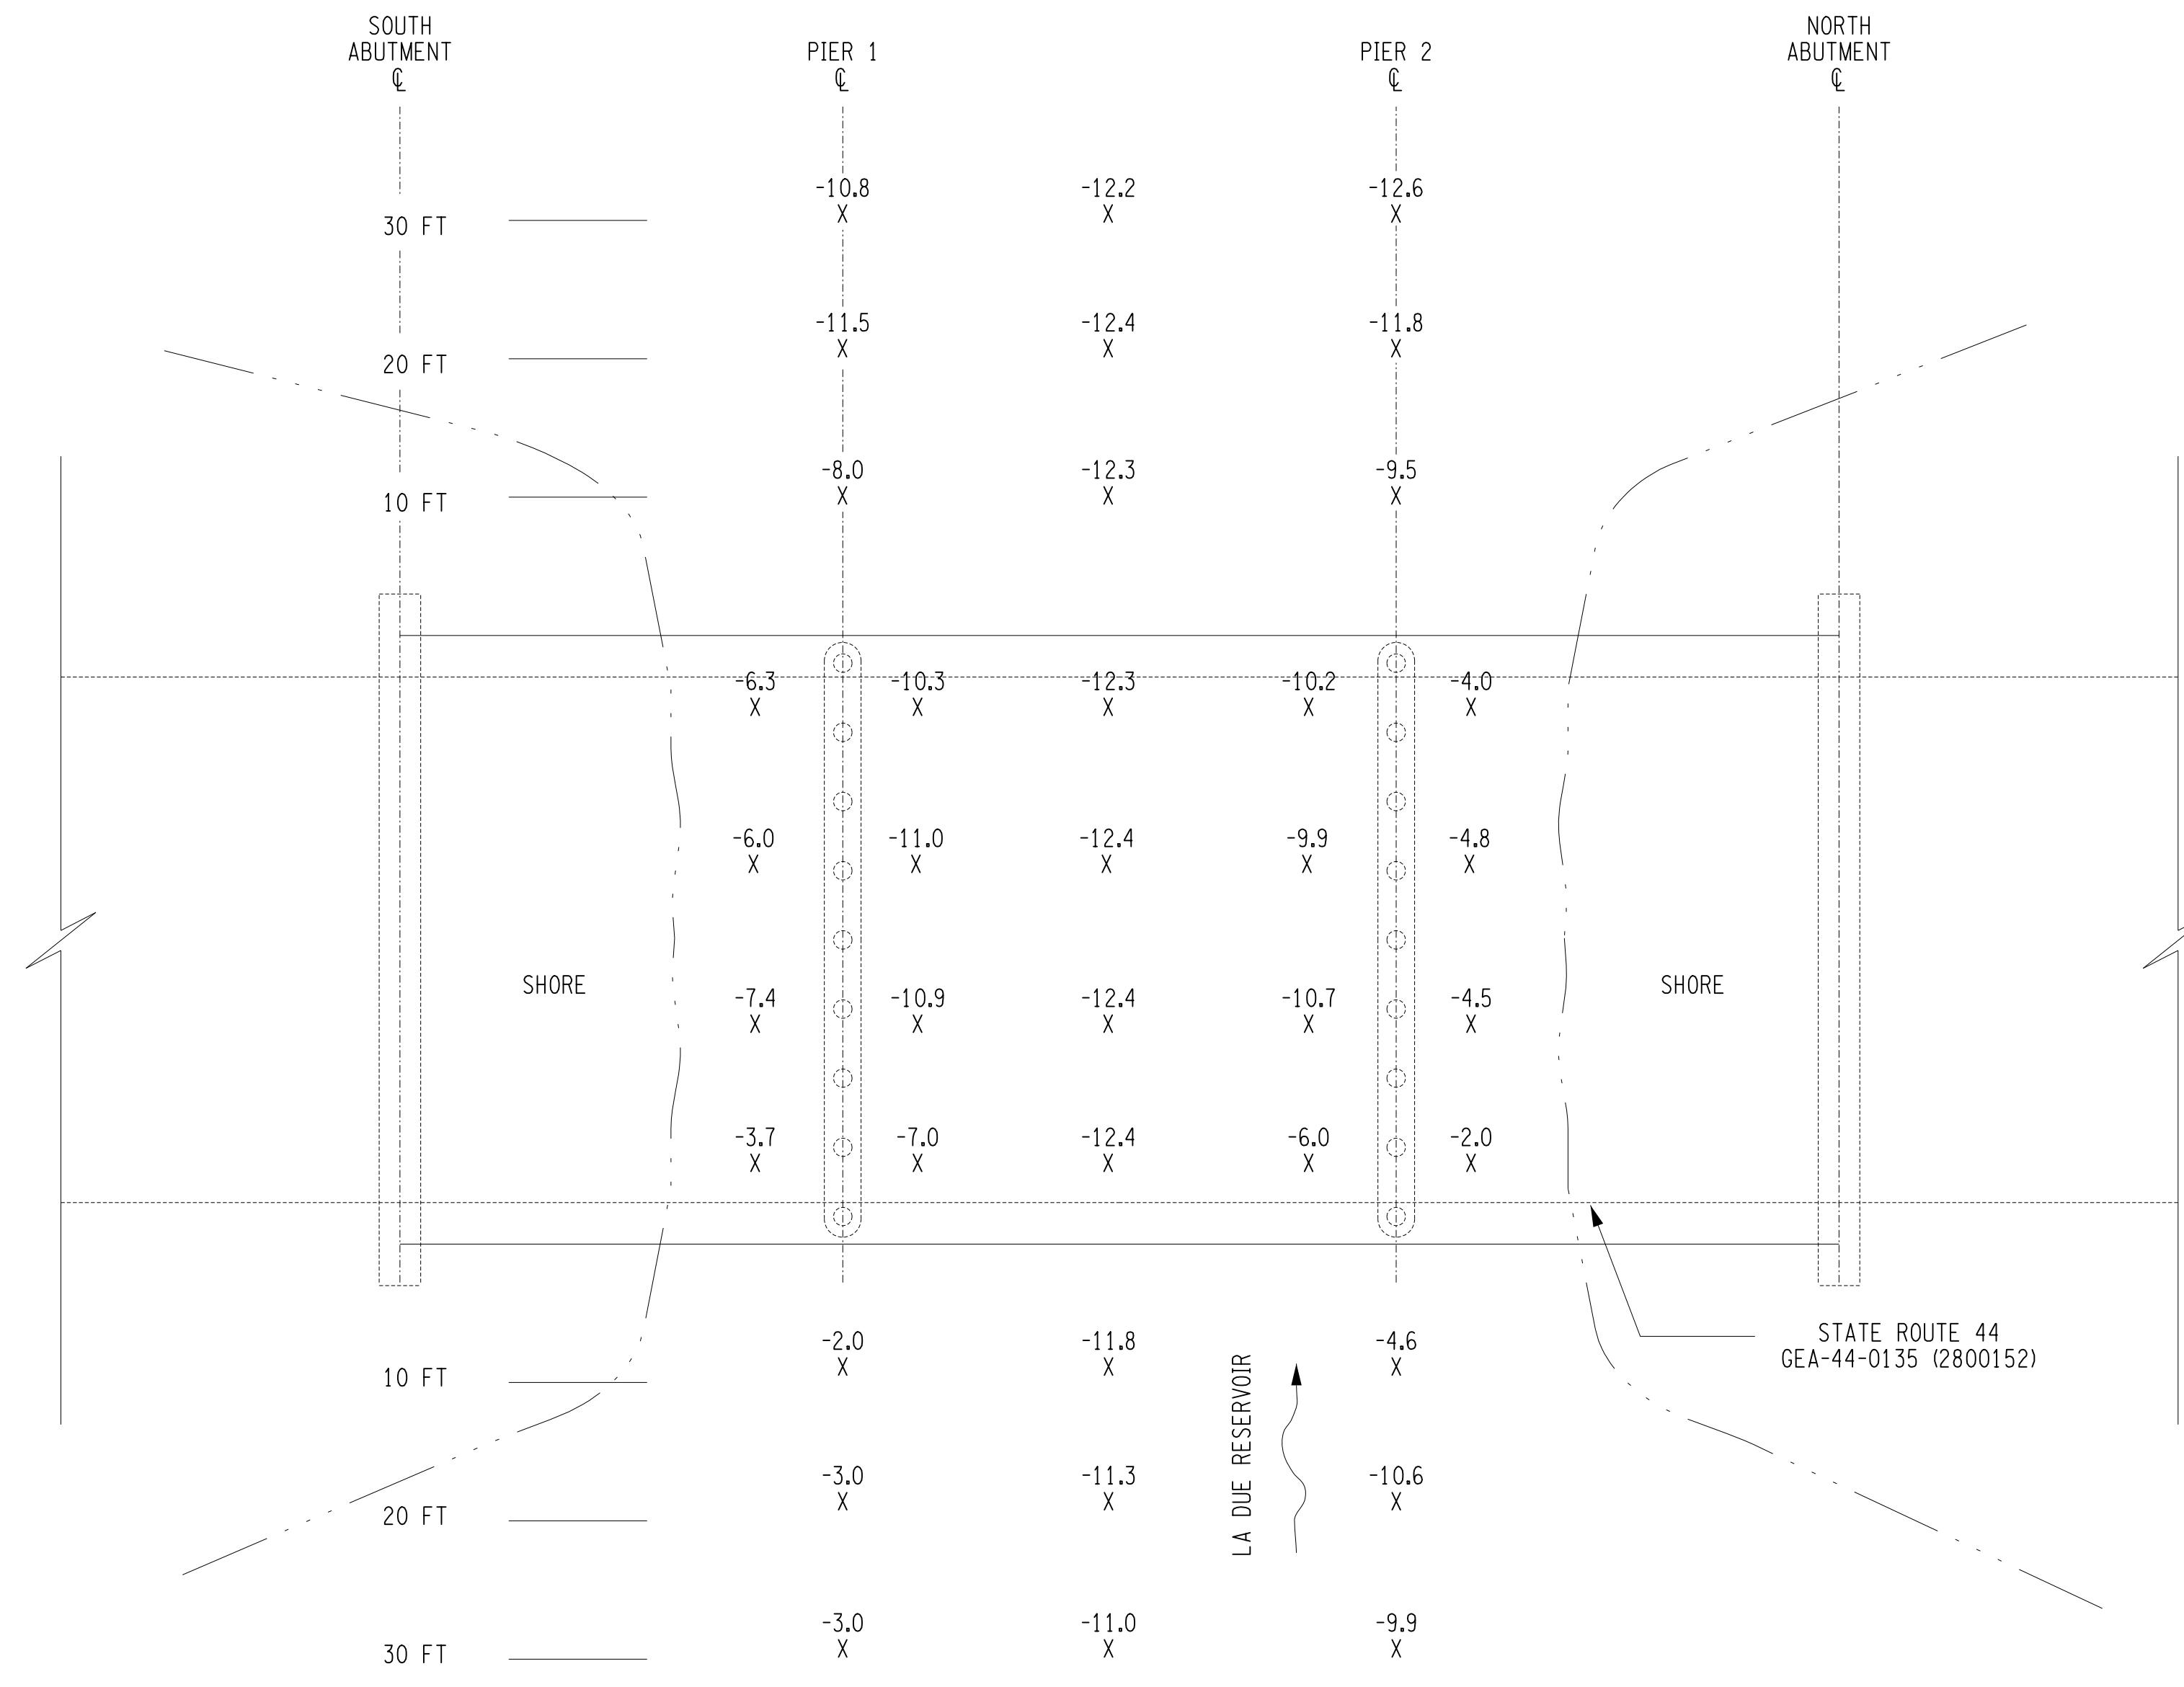
SOUNDING PLAN
NTS

- The channel alignment is satisfactory and appears to be unchanged from the 2009 report. The channel bed profile appears to be relatively unchanged from the prior inspection, with the exception of a localized area approximately 20 feet east of Pier 2 that appears to be approximately 8 feet deeper than the previous report.
- Penetrations taken during soundings were typically 1 to 3 inches within 10 feet of the upstream and downstream nose of Piers 1 and 2. The composition of the channel around the piles is 4-18 inch stone riprap. The stone riprap slope protection surrounds the piles extending and dropping in depth abruptly toward the center of the channel. The riprap is relatively loose and gives way under contact. The composition of the channel bottom at mid-span consists of gravel and soft silt –mud material.

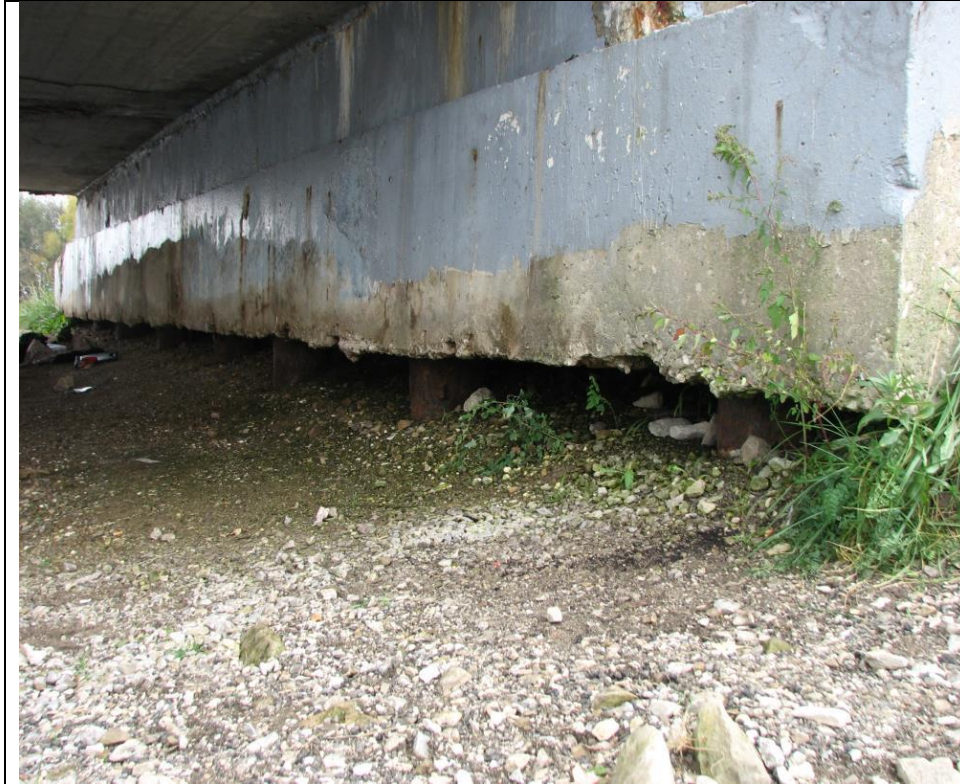
Photograph 5

- The abutment concrete has moderate spalling of up to 1/2-inch depth. The concrete is partially painted with a coating that stops at what appears to be the previous elevation of the slope protection.
- Both the East and West ends of the abutment exhibit corner spalling that has exposed the reinforcing steel (See photo 11). This spalling does not appear to have advanced in severity since the last inspection.
- The abutment has been undermined along its' entire width. The most severe undermining is located approximately ten feet from the West end and has dimensions of approximately 14 inches high by 44 inches deep (See photos 5 and 6). This undermining does not appear to have materially advanced in severity since the last inspection.

Undermining of
South Abutment

(looking East)

- Re-inspect the submerged substructure units at the normal maximum recommended interval of five (5) years and after a significant event such as flood, impact or other phenomenon that could affect the structural integrity of the bridge.
- Undermining of abutments may have compromised the backfill. Above water bridge inspectors should be cognizant of any potential settlement of the bridge approach.
- Slope protection should be placed at both abutments to prevent further undermining.
- Consideration should be given to performing ultrasonic thickness measurement of the pile jackets. If so desired this work can be performed by GPI dive personnel.

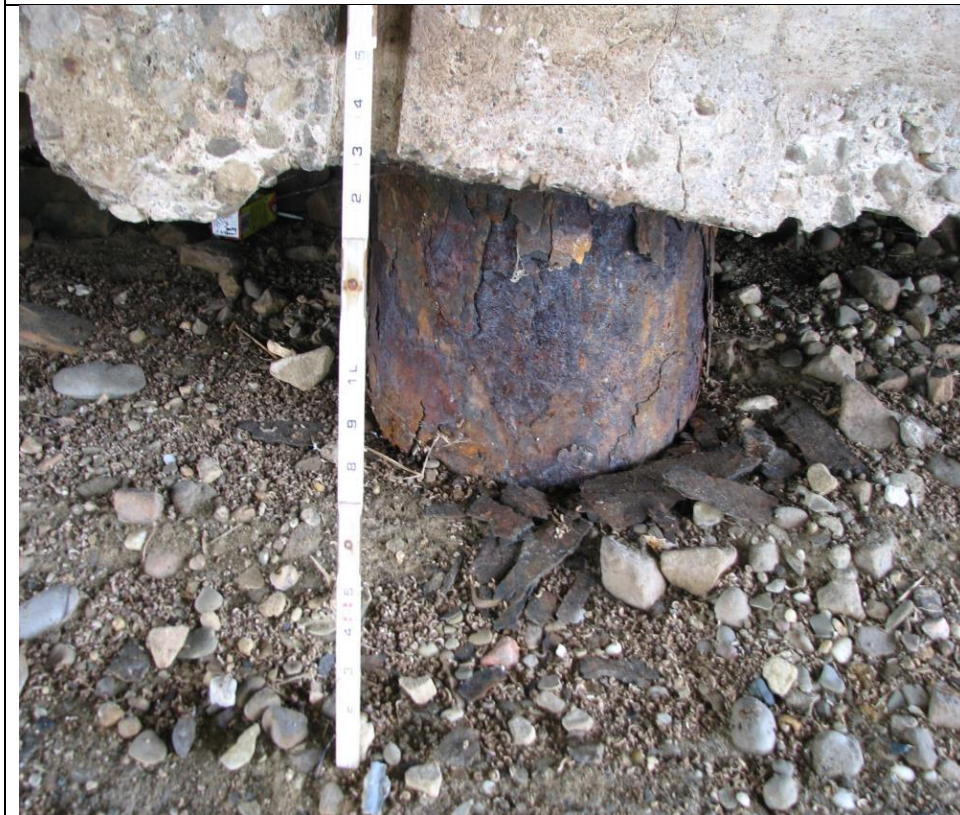
Photograph 6

Detail of South
Abutment
undermining.

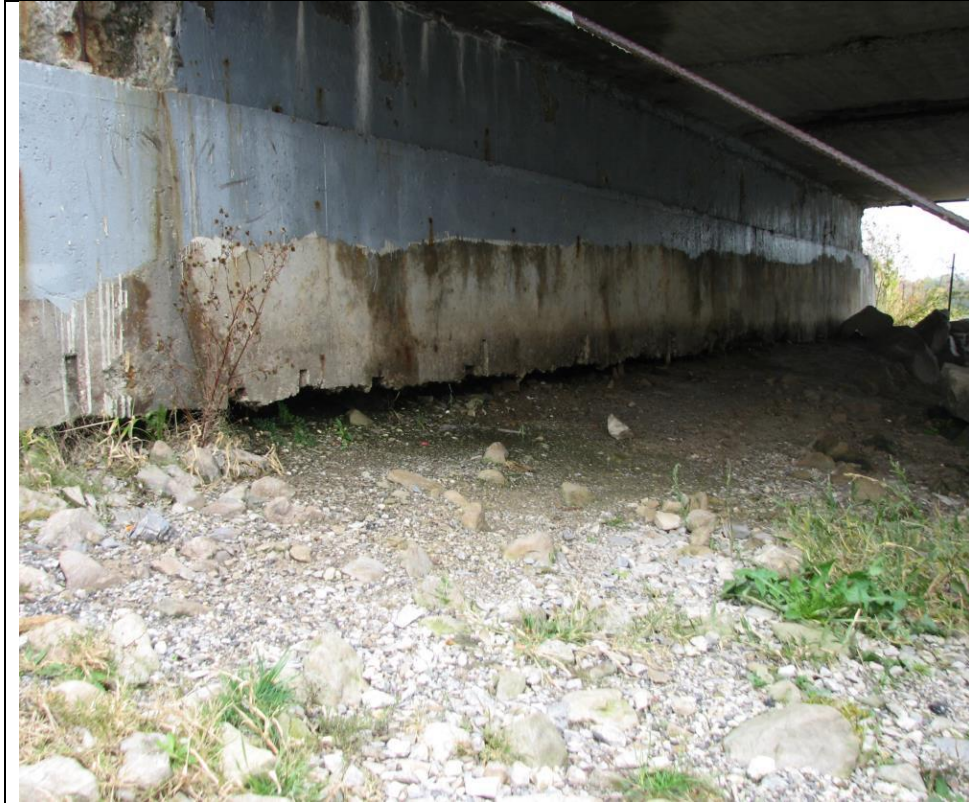
Photograph 7

- The abutment concrete has moderate spalling of up to 1/2-inch depth with some localized areas of up to 2-inch depth. The concrete is partially painted with a coating that stops at what appears to be the previous elevation of the slope protection.
- Both the East and West ends of the abutment exhibit corner spalling that has exposed the reinforcing steel (See photo 12). This spalling does not appear to have advanced in severity since the last inspection.
- The abutment has been undermined for a distance of approximately 38 feet from the West end of the abutment. The most severe undermining is located approximately ten feet from the West end and has dimensions of approximately 6 inches high by 36 inches deep (See photo 7). This undermining has advanced in severity since the last inspection. In 2009, the distance of undermining was approximately 22 feet from the West end.

Undermining of
North Abutment

(looking East)

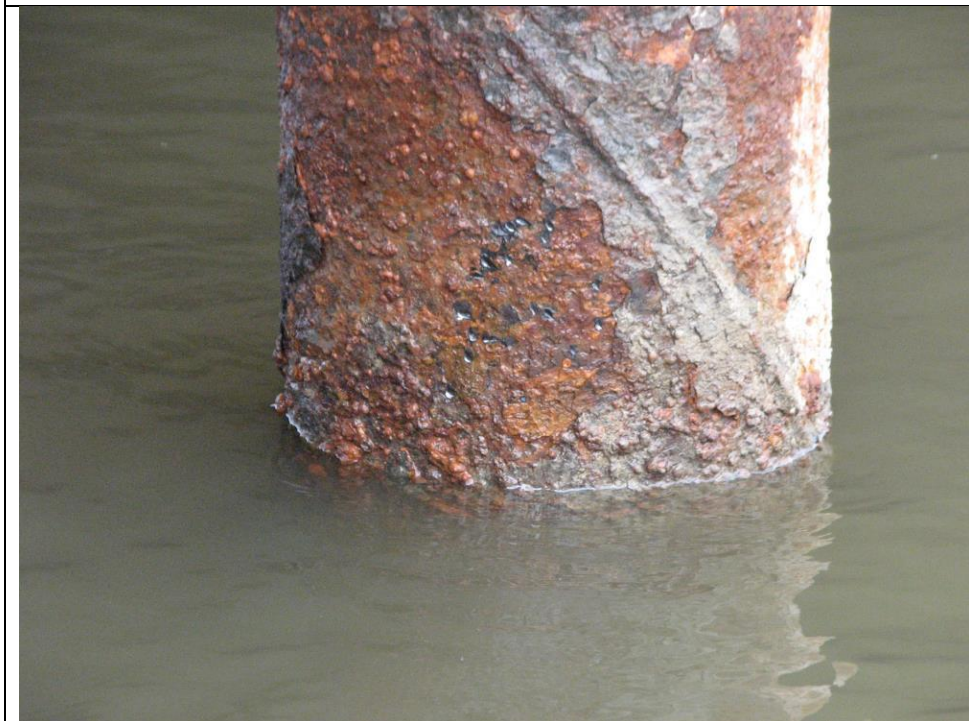
Photograph 8

- All pile casings have typical moderate corrosion with 1/4 to 3/8 inch layers of delaminating scale (See photo 8). This corrosion has appeared to have slightly advanced in severity since the last inspection. The corrosion occurring appears to be an anaerobic corrosion condition. This was detected when the layers of scale were removed at the presently exposed below waterline length of the piles. All piles were sounded with a hammer from the waterline to the rock line and were found to be sound, with no perforations.
- All of the piles are surrounded by 4 to 6 inch diameter rock with larger 12 to 18 inch diameter rock in some areas.
- As noted in the previous inspection report, the pier cap exhibits moderate spalling. This condition exists on both the East and West ends of the cap.

Pier 1, East pile.
Typical ¼-inch
thick corrosion.

(looking North)

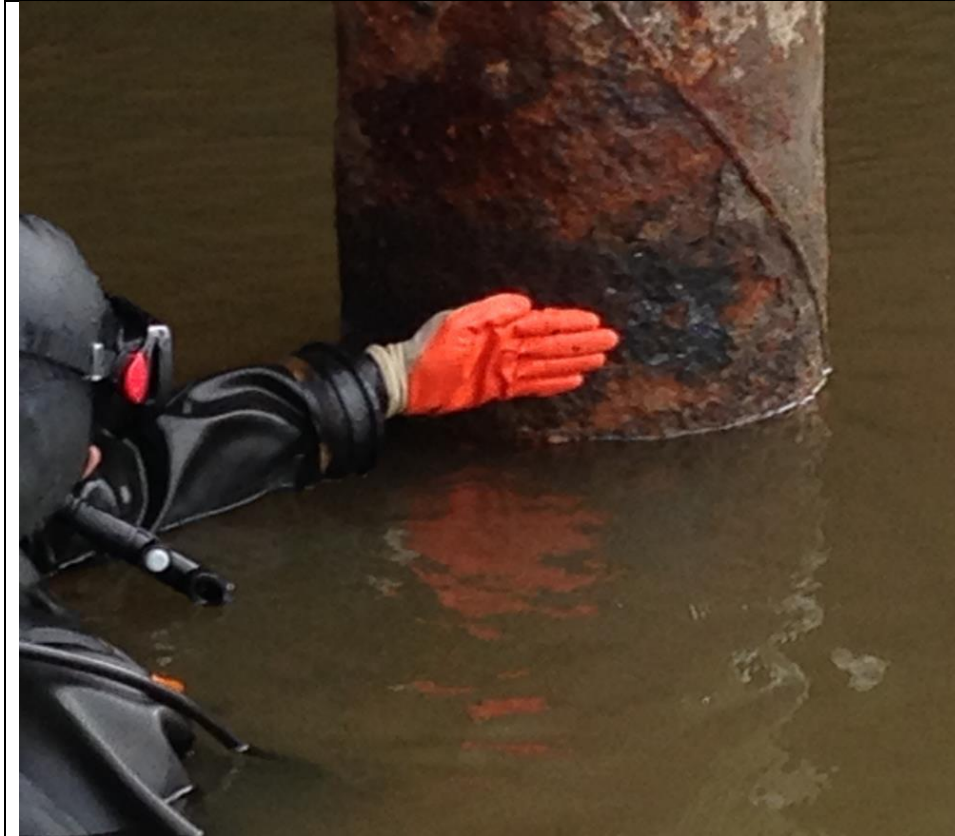
- All pile casings have typical moderate corrosion with 1/4 to 3/8 inch layers of delaminating scale (See photo 9). This corrosion has appeared to have slightly advanced in severity since the last inspection. The corrosion occurring appears to be an anaerobic corrosion condition. This was detected when the layers of scale were removed at the presently exposed below waterline length of the piles. All piles were sounded with a hammer from the waterline to the rock line and were found to be sound, with no perforations.

Photograph 9
View of Pier 2,
West pile.
Typical ¼-inch
thick corrosion.

(looking South)

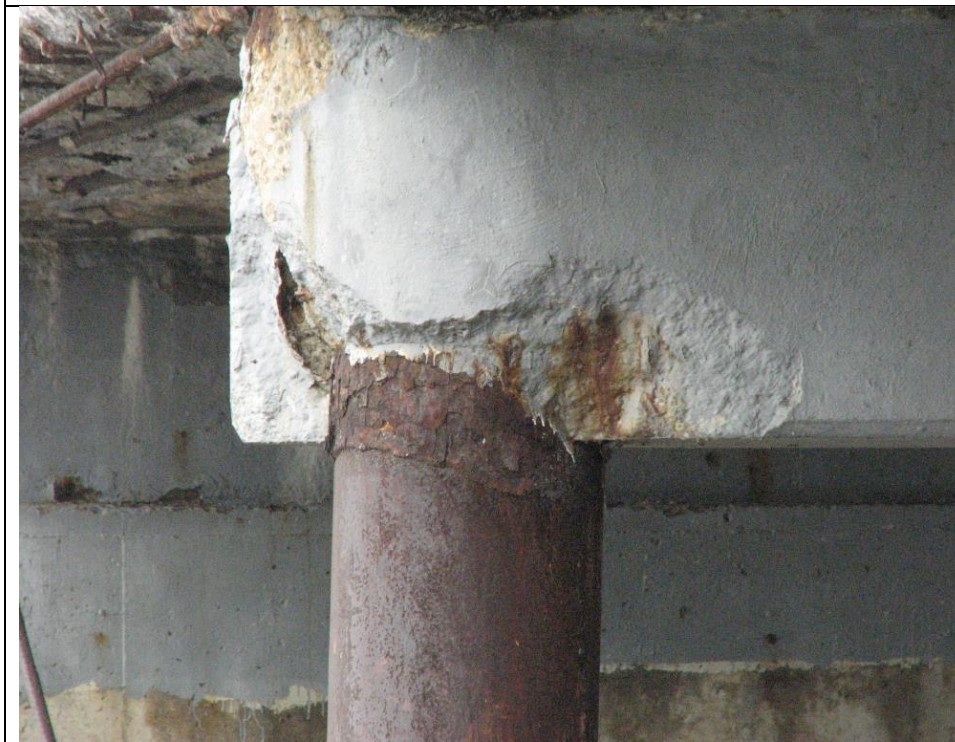
Photograph
10

- All of the piles are surrounded by 4 to 6 inch diameter rock with larger 12 to 18 inch diameter rock in some areas.
- As noted in the previous inspection report, the pier cap exhibits moderate spalling. This condition exists on both the East and West ends of the cap. (See photo 10).

View of Pier 2,
Pile cap South
Face. Concrete
spall

(looking North)

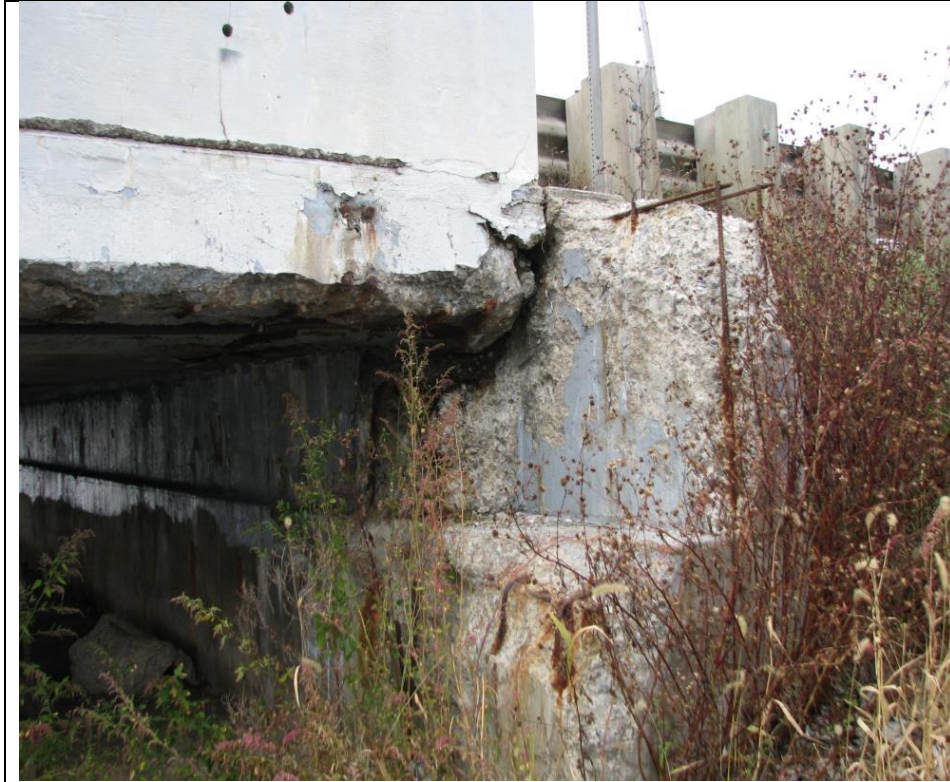
Photograph
11

View of South
abutment, West
end.

(looking South)

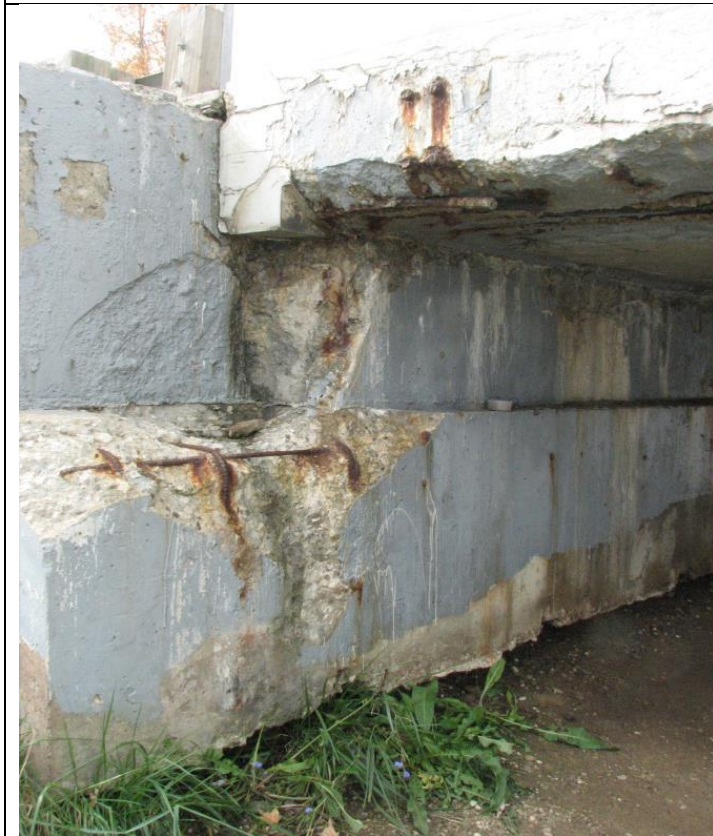
Photograph
12

View of North
abutment, West
end.

(looking North)
