BRIDGE INSPECTION REPORT

BRIDGE NUMBER **GEA 00322 0863**

Underwater Inspection Report for:

US 322 (Mayfield Road) over Beaver Creek
Geauga County, Ohio
(Three cell culvert)

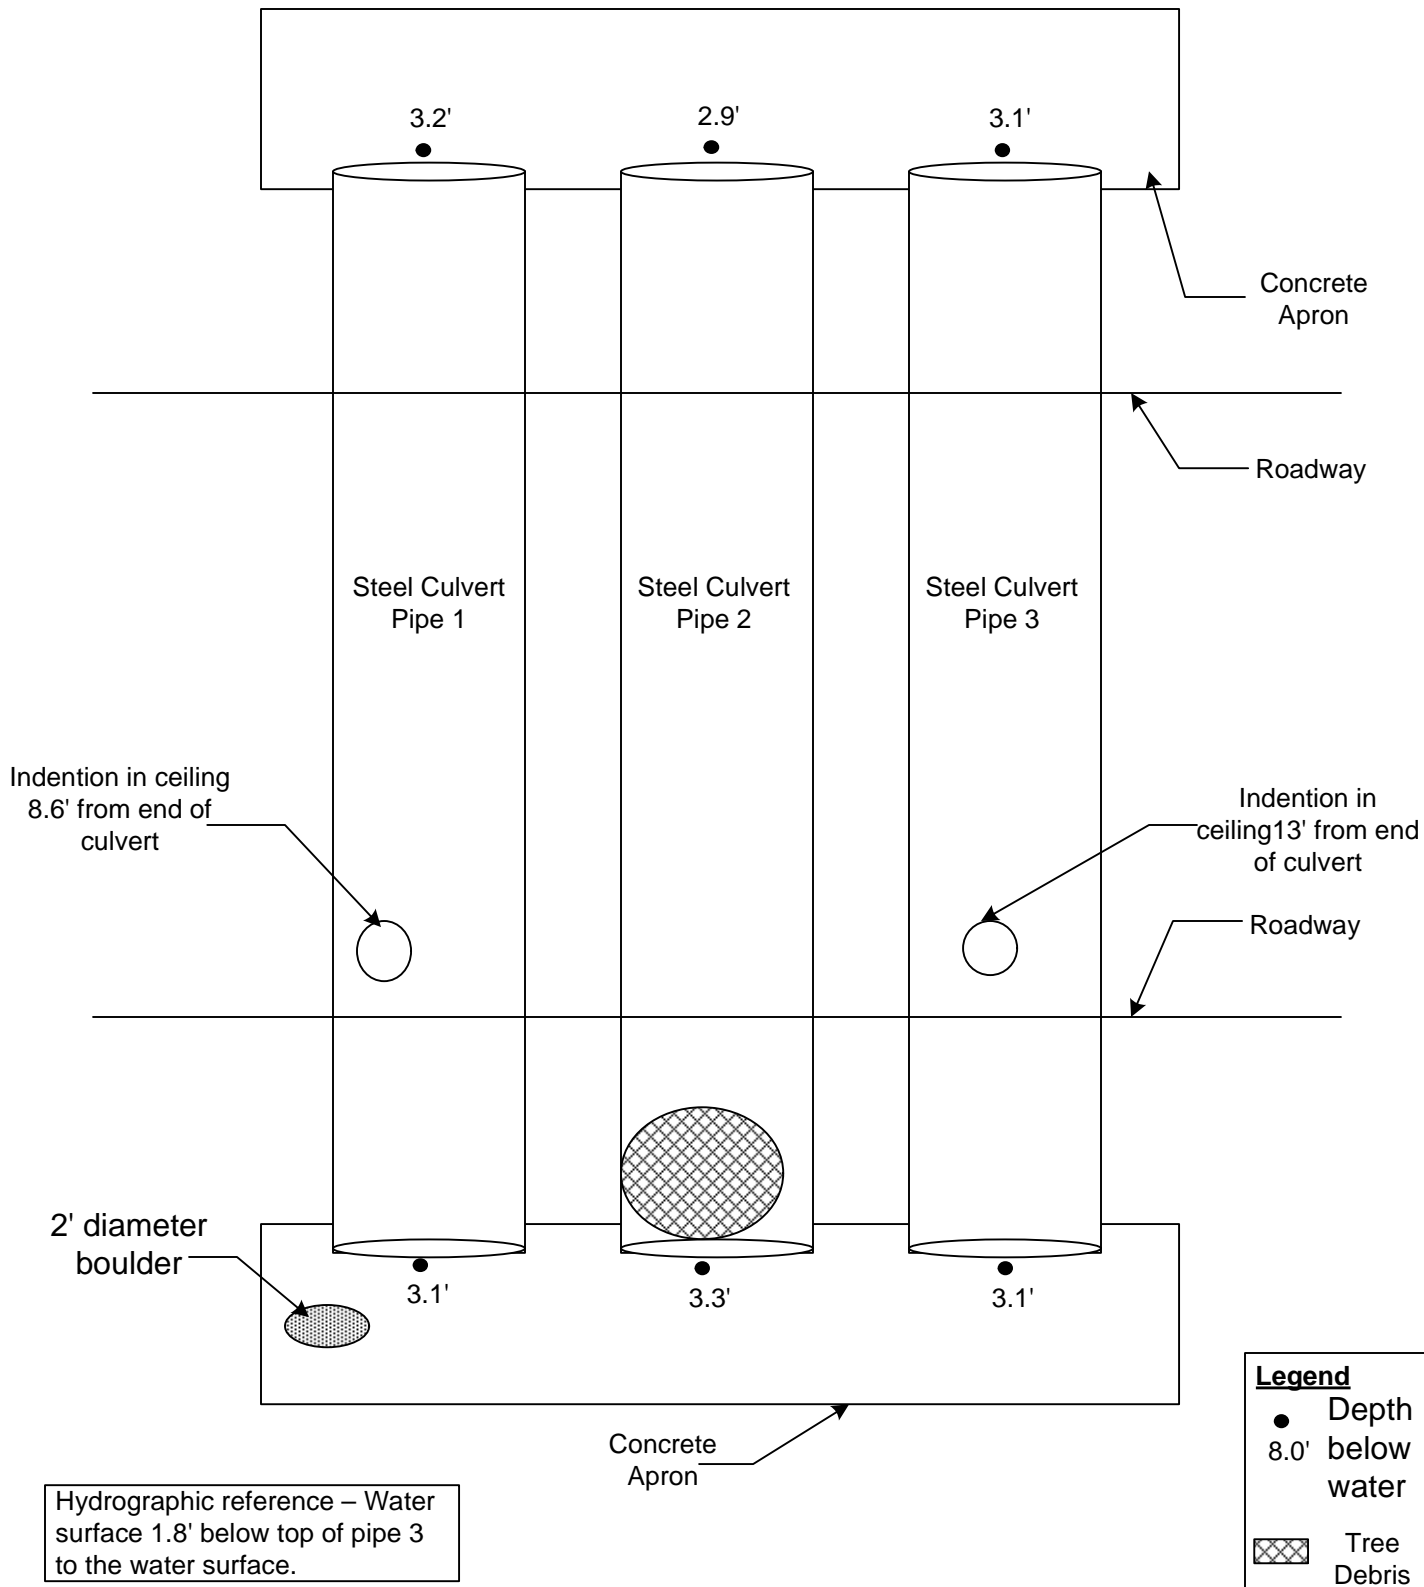
Substructure Plan View

- Depth 8.0' below water
- ▣ Tree Debris
