BRIDGE INSPECTION REPORT

BRIDGE NUMBER **GEA 00322 0863**

Underwater Inspection Report for:

US 322 (Mayfield Road) over Beaver Creek
Geauga County, Ohio
(Three cell culvert)

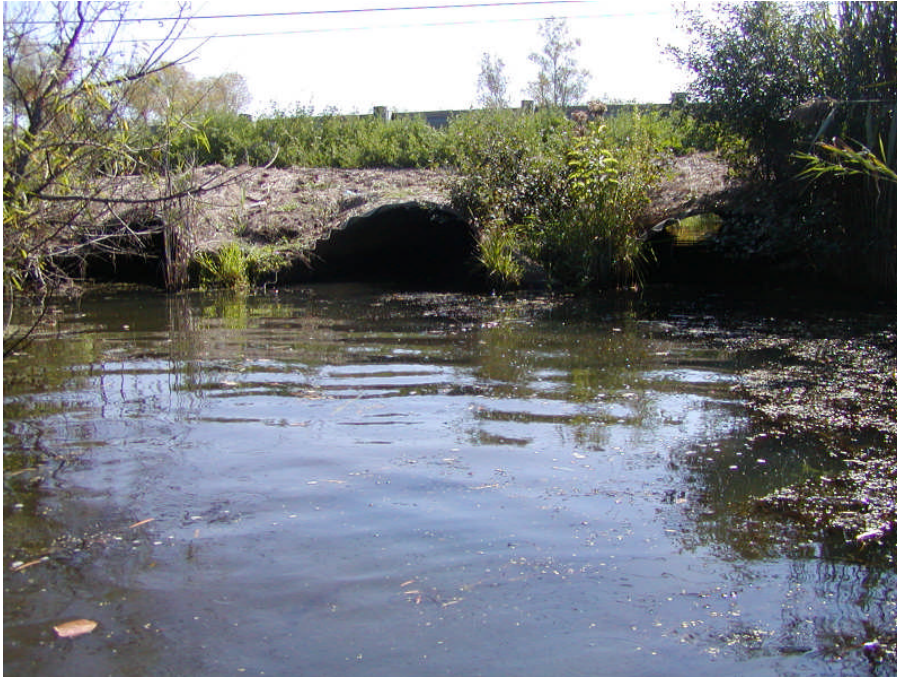
Photo 1. Elevation view looking North to South.

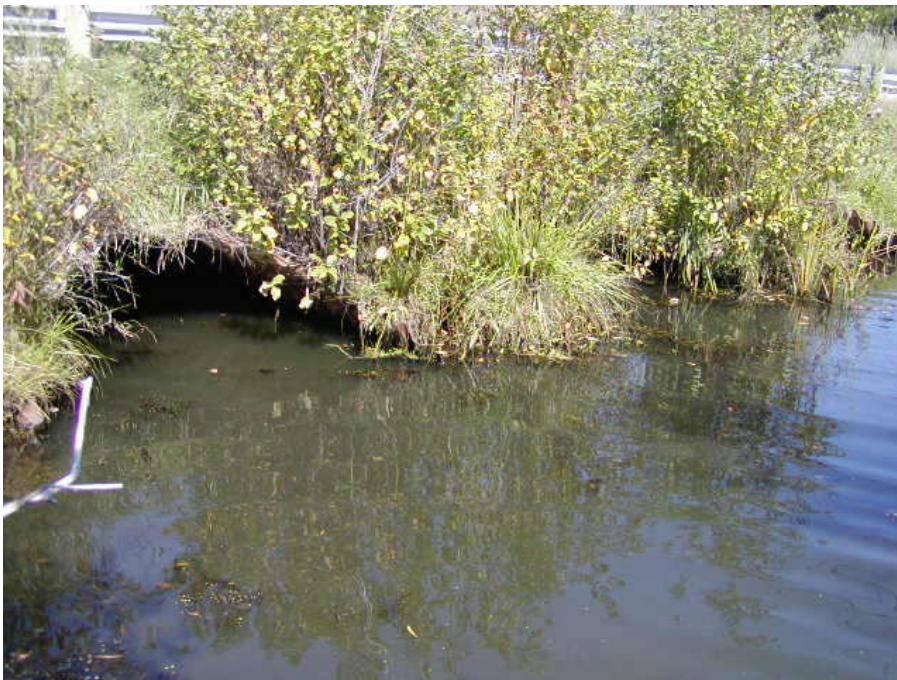
Photo 2. Elevation view looking South to North.
