BRIDGE INSPECTION REPORT

BRIDGE NUMBER **GEA 00322 0863**

Underwater Inspection Report for:

US 322 (Mayfield Road) over Beaver Creek
Geauga County, Ohio
(Three cell culvert)

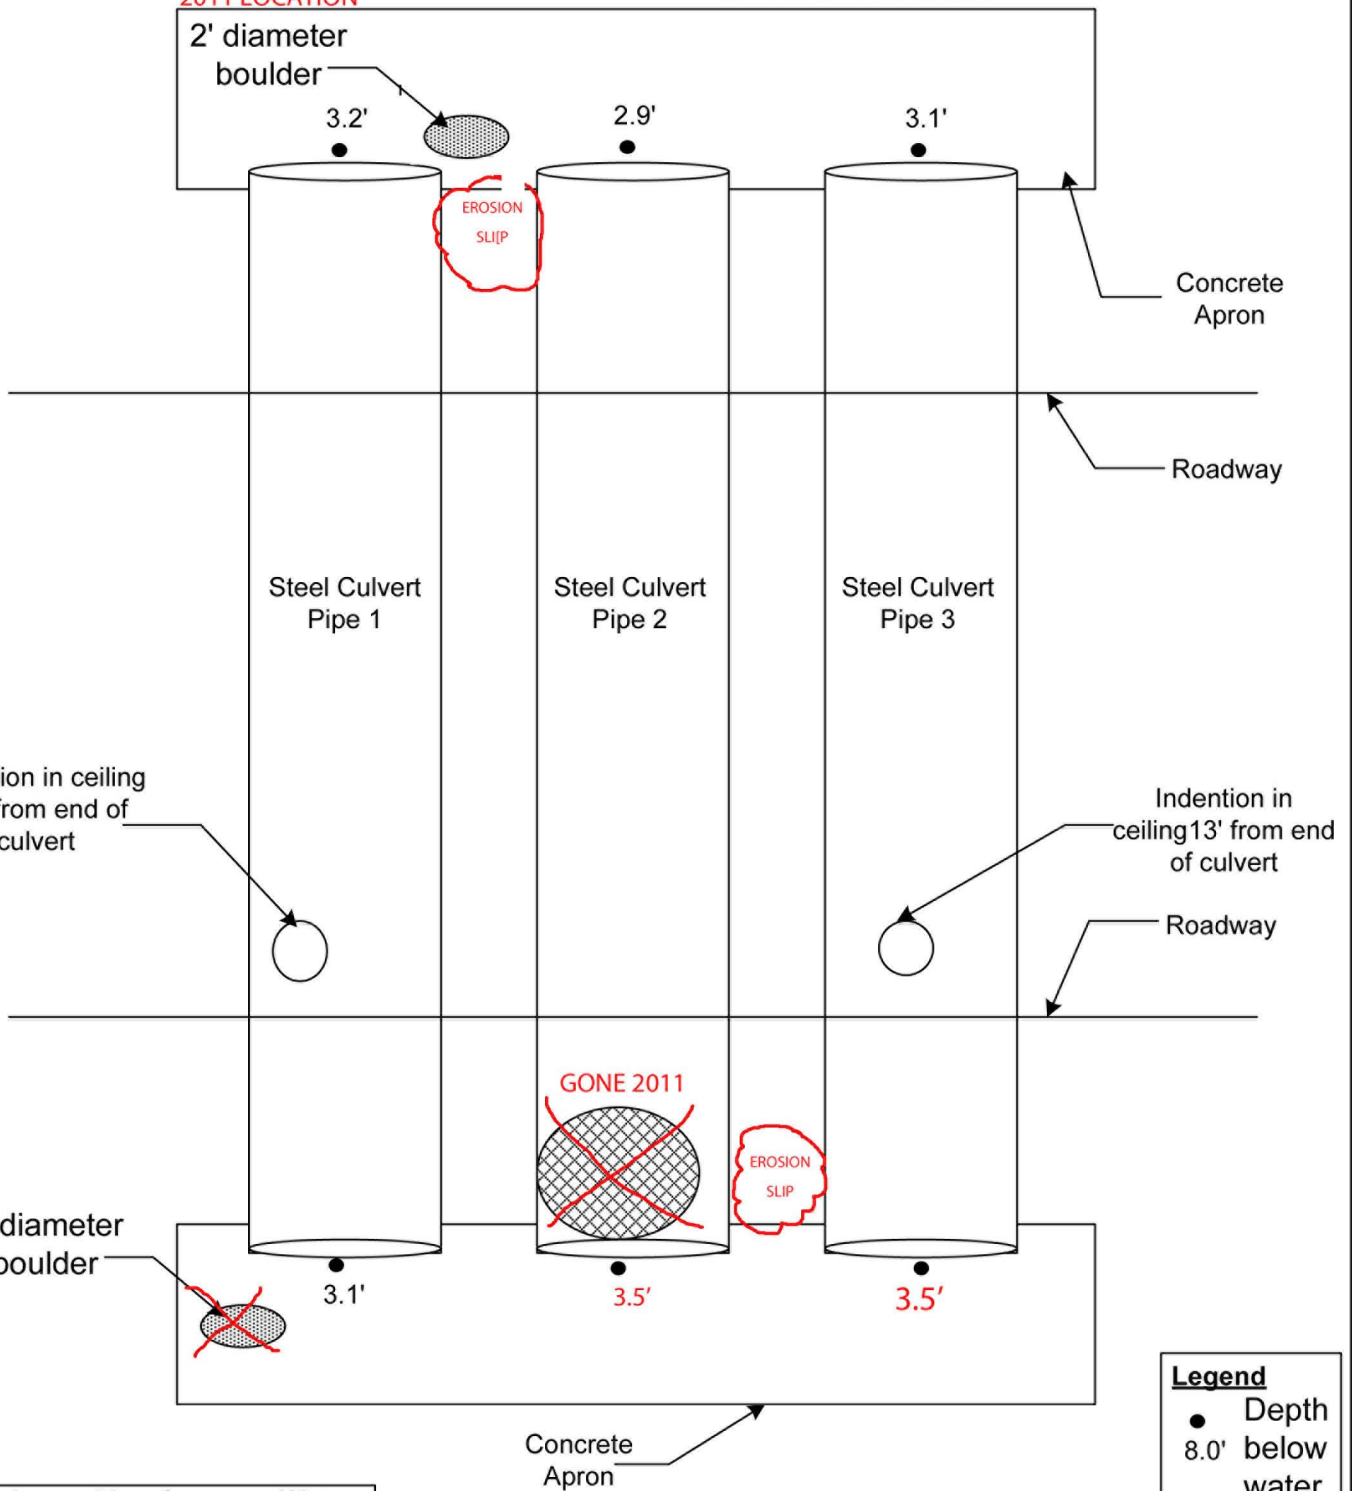
PROJECT: ODOT District 12 2007 Underwater Bridge Inspections	
SHEET: GEA-00322-0863 US 322 (Mayfield Rd) over Beaver Creek Geauga County	
Substructure Plan View	
PAGE NO.:	B-2
FIG. NO.:	2

Hydrographic reference – Water surface 1.8' below top of pipe 3 to the water surface.

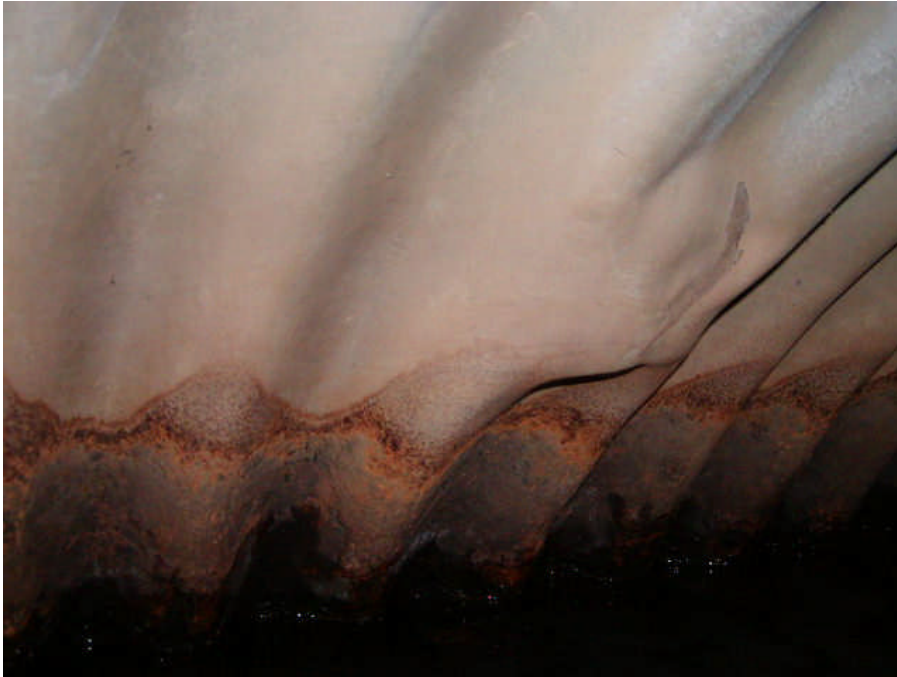
- There is light to moderate corrosion of the culvert pipes with no holes or section loss.
- The bottom material consists of the steel pipe with silt and light debris.
- There is an indentation in the top of barrel 1 measuring approximately 8 inches tall by 3 inches deep located 8.5 feet north of the south entrance of the barrel.
- There is an indentation in the top of barrel 3 measuring approximately 8 inches tall by 3 inches deep located 13.5 feet north of the south entrance of the barrel.
- There is light tree debris at the south entrance of barrel 2.
- There is a boulder measuring 2 feet in diameter located 2 feet south of the entrance to barrel 1.
- There is minor surface corrosion on the culvert joint bolt heads located throughout the three culvert pipes.

Photo 3. Indention in pipe number 1.

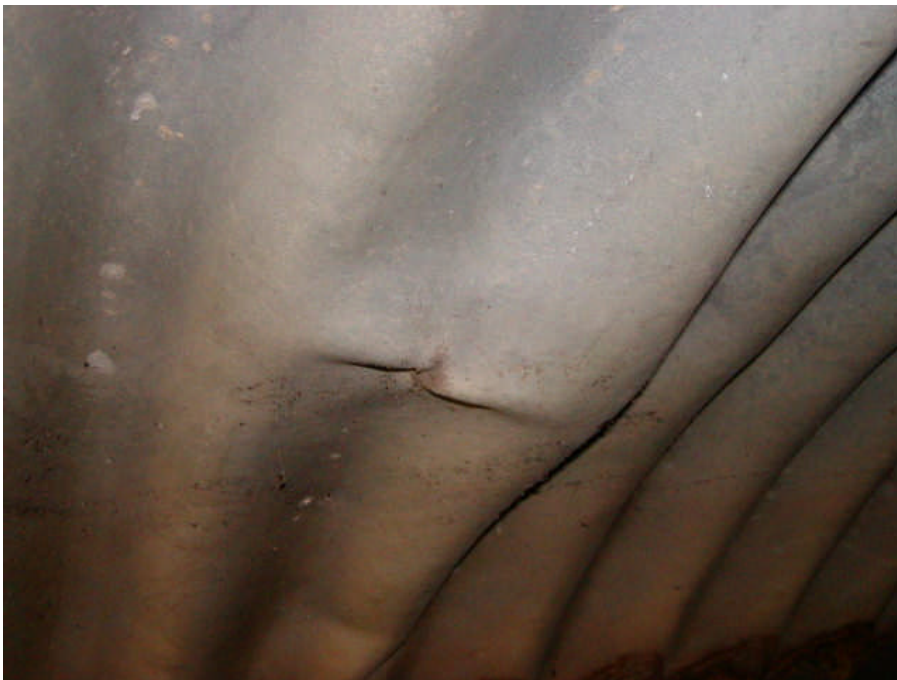
Photo 4. Indention in pipe number 3.

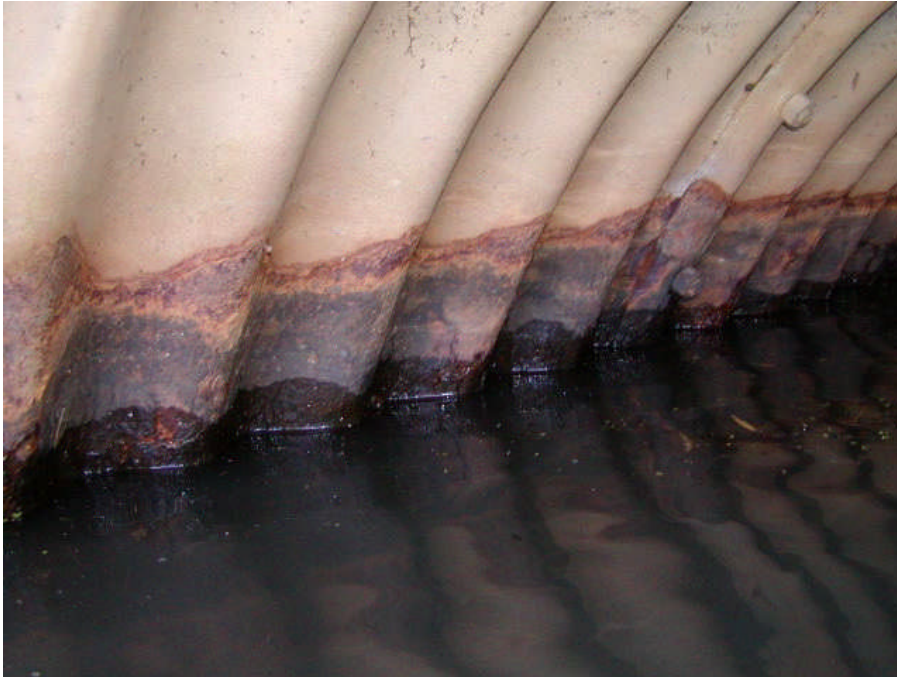
- There is an area of tree debris located on the northwest face of the pier.
- There is minor surface corrosion on the sides of the steel pipe from 1 foot below the surface to 1 foot above the water surface.
- There is minor surface corrosion of the steel culvert roof. There are isolated water seepage through the top of the culvert pipe.

Photo 5. Typical surface corrosion from water surface to 1 ft above.

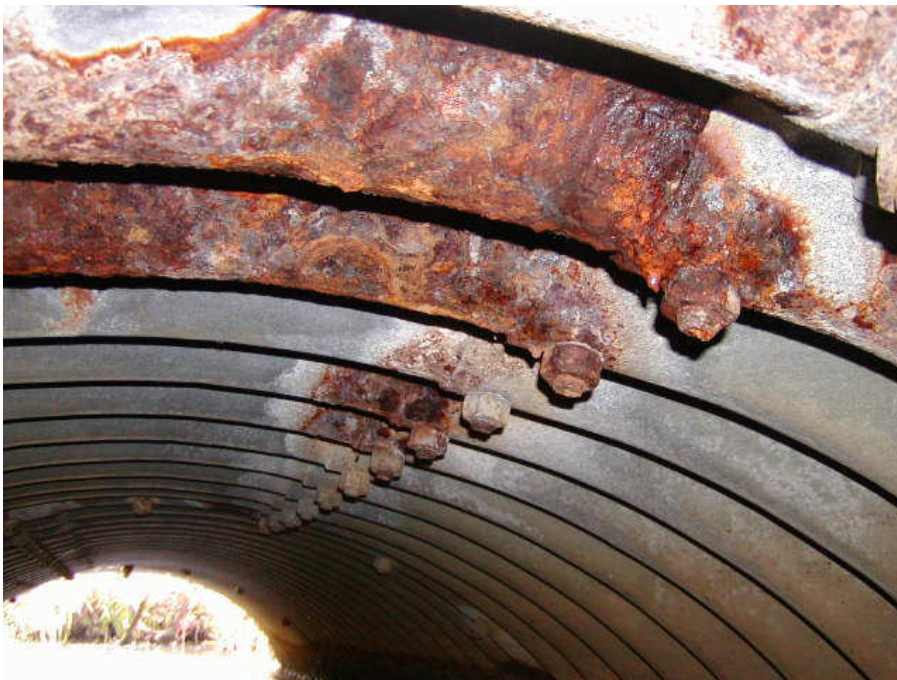
Photo 6. Typical surface corrosion on roof of culvert.
