**Underwater Inspection of  
SFN - 2801388  
US 322 (Mayfield Road) over the Beaver Creek  
(GEA-322-0863)  
July 23, 2014  
For  
Ohio Department of Transportation  
District-12**

Bridge GEA-322-0863 (2801388) carries the US 322 over Beaver Creek in Claridon Township, OH. The structure was built in 1961. The three Pipes and aprons of this structure were inspected during this underwater inspection. The numbering convention will follow that previously established by last underwater inspection report with the west pipe as Pipe 1.

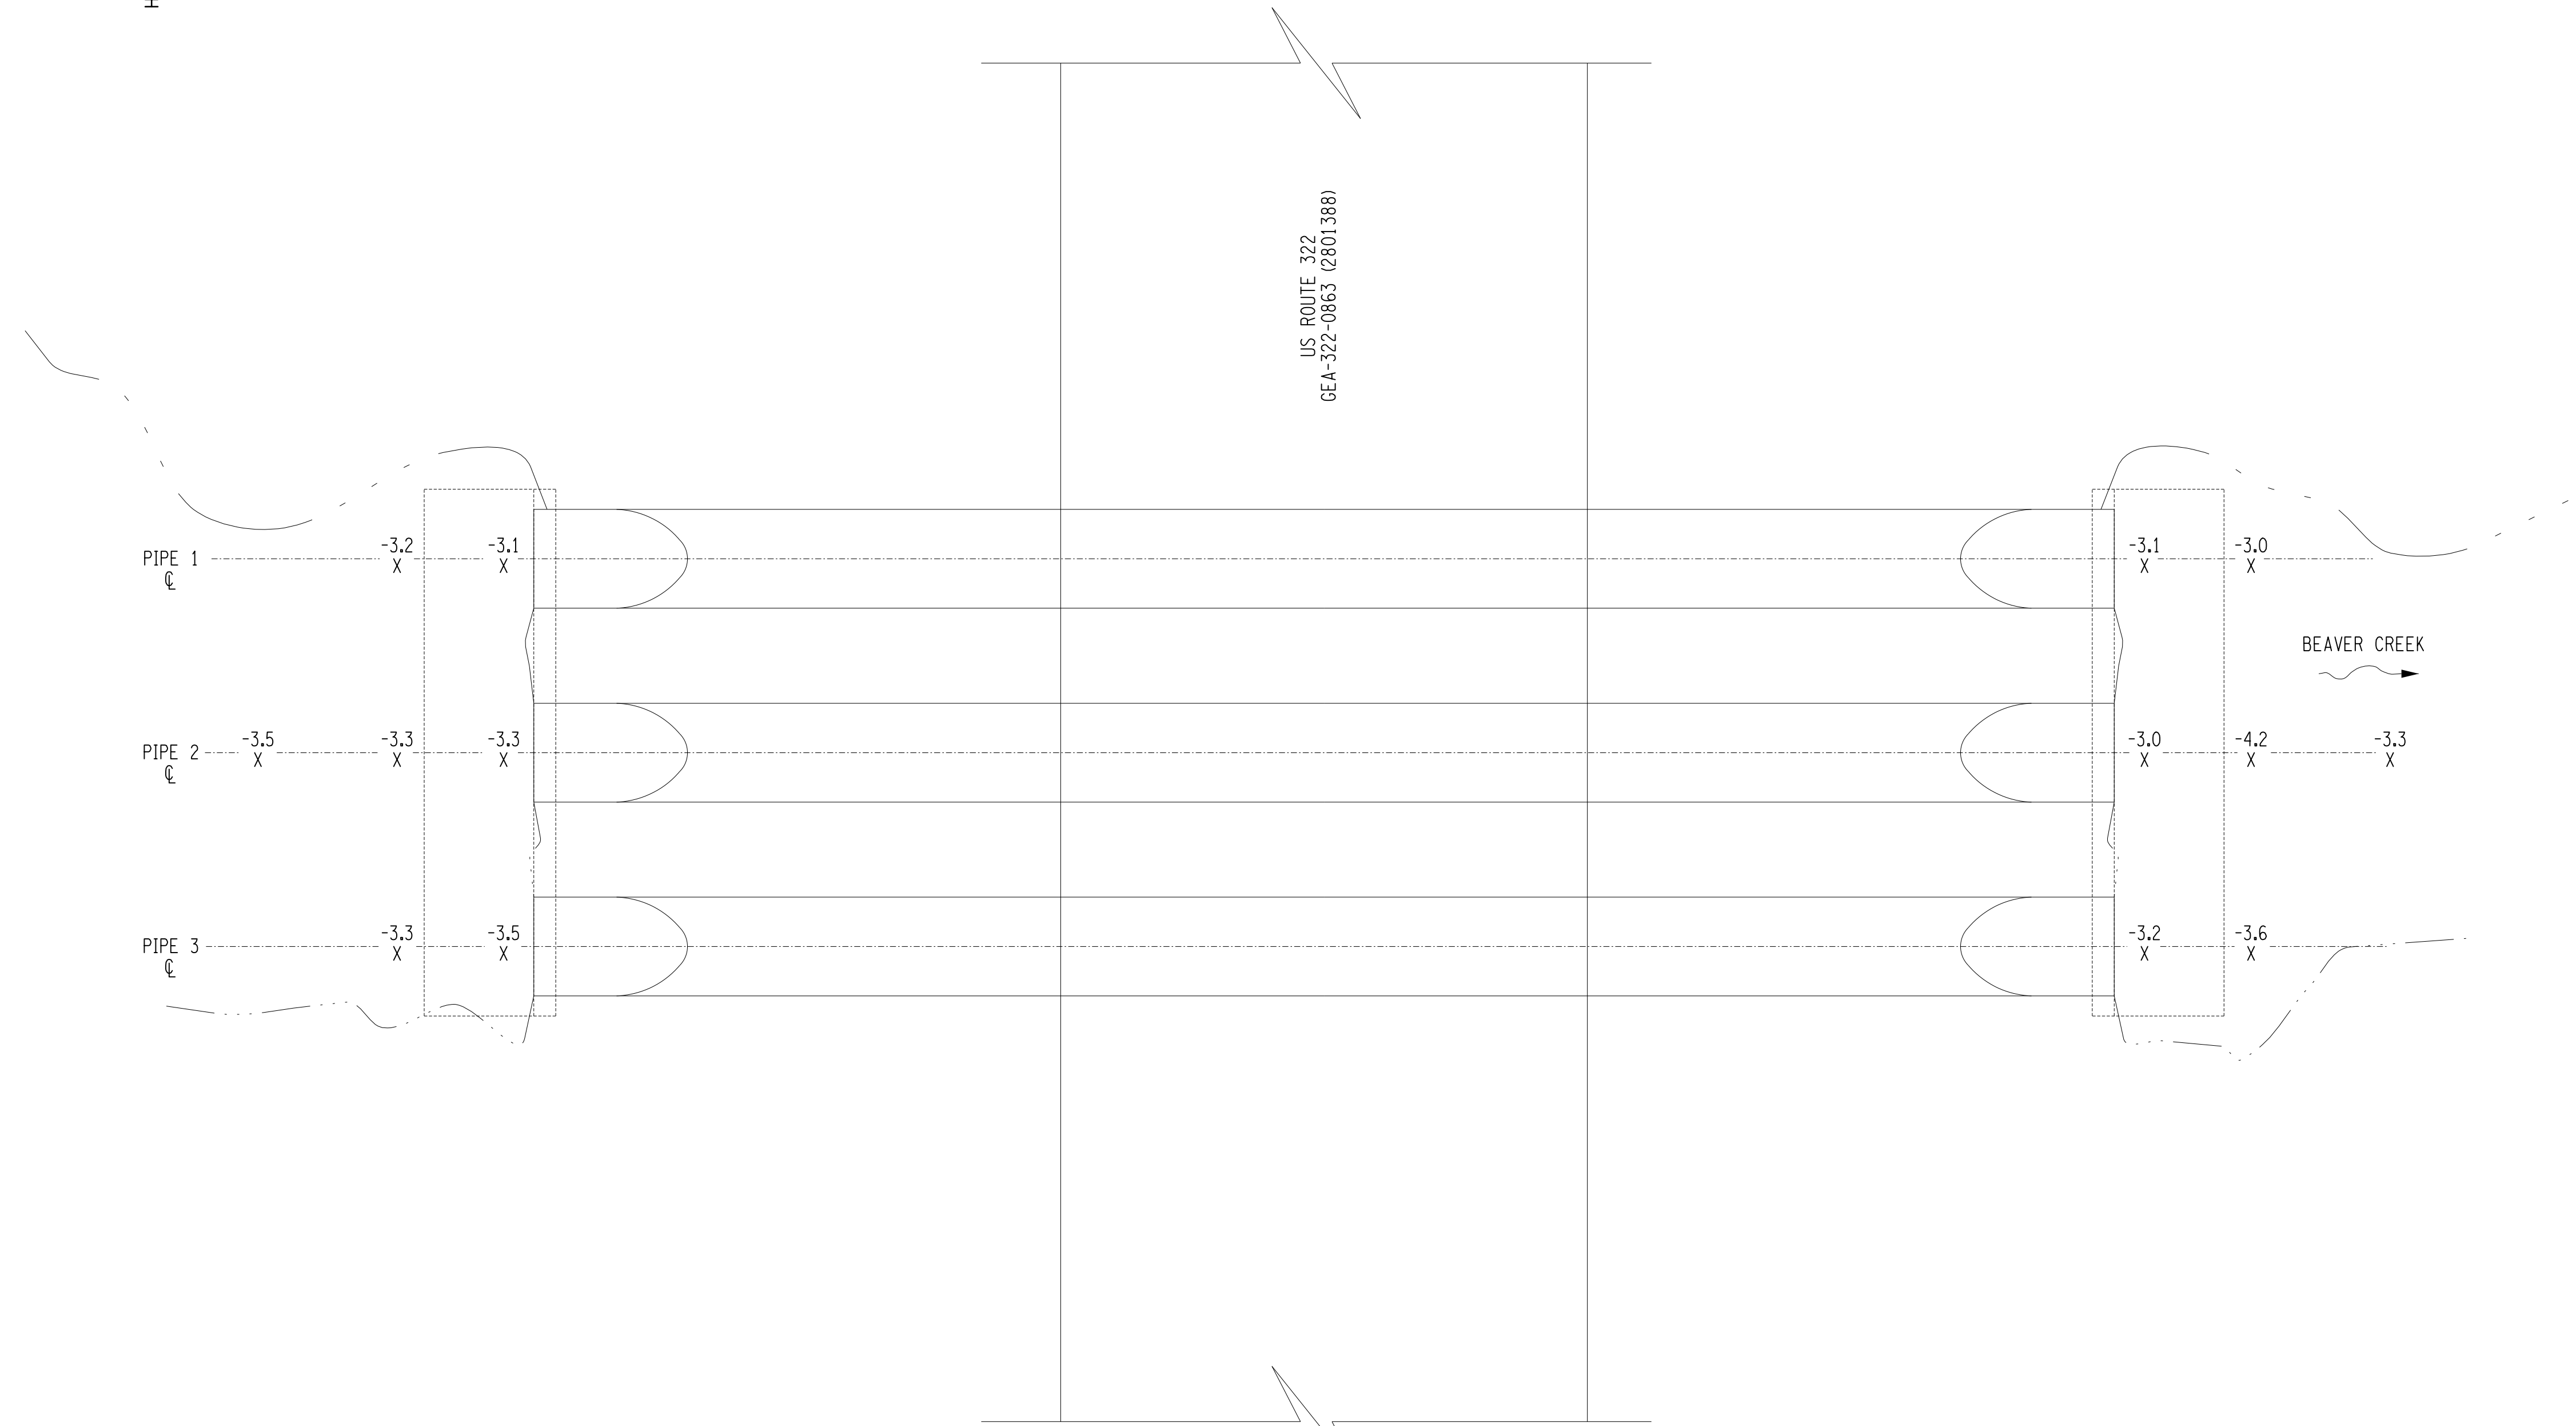
SOUNDING PLAN  
NTS

1. WATER LINE REFERENCE ELEVATION WAS TAKEN FROM TOP OF PIPE 2 AT THE NORTH ENTRANCE. ON JULY 23, 2014 THIS DISTANCE WAS 18 INCHES.
2. THREE SOUNDINGS TAKEN AT ENTRANCES OF PIPES, 1 FOOT OFF APRONS AND ONE SOUNDING TAKEN AT 10 FEET OFF APRON CENTER CHANNEL.

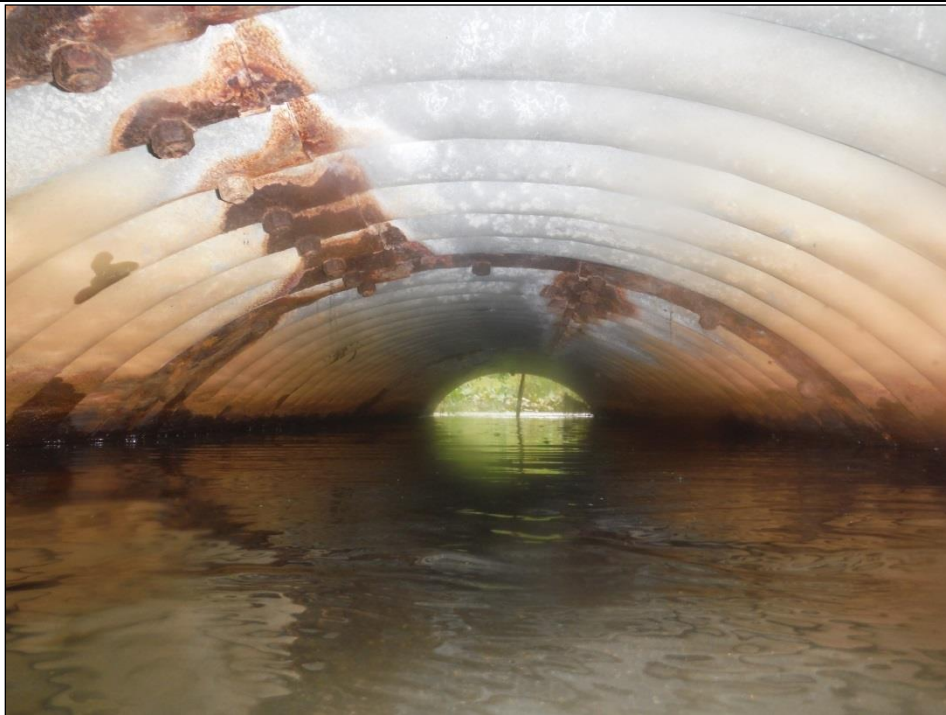
Photograph 6  
View of Pipe 1,  
Typical  
corrosion.  
Looking South.

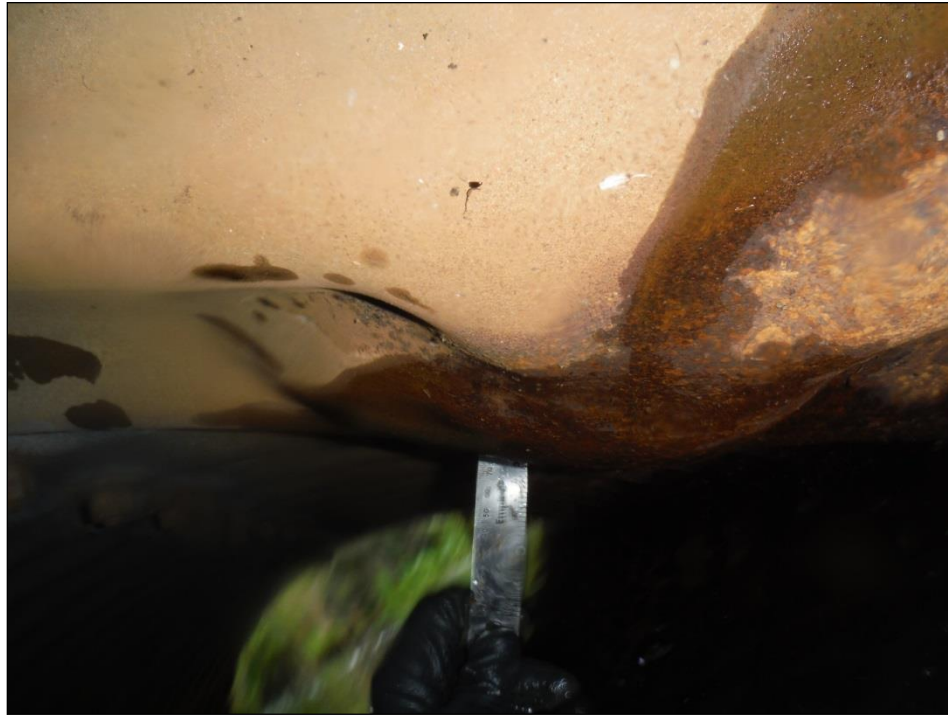
- Moderate to heavy corrosion was observed throughout Pipe 1 at waterline and bolted connections. Corrosion was documented in underwater inspection performed in 2007 and has advanced in severity. (See photo 8)
- Light surface corrosion on bolted connections was confirmed throughout Pipe 1 as documented in underwater inspection performed in 2007 and has not advanced in severity. All connections are secure and intact.
- Indention at 2 o'clock position looking north to south in Pipe 1 63 feet from north entrance measuring 8 inches tall 3 inches deep 6 inches wide was confirmed from underwater inspection performed in 2007 and has not advanced in severity. (See photo 7)

Photograph 7  
View of  
indentation Pipe  
1, Looking South.

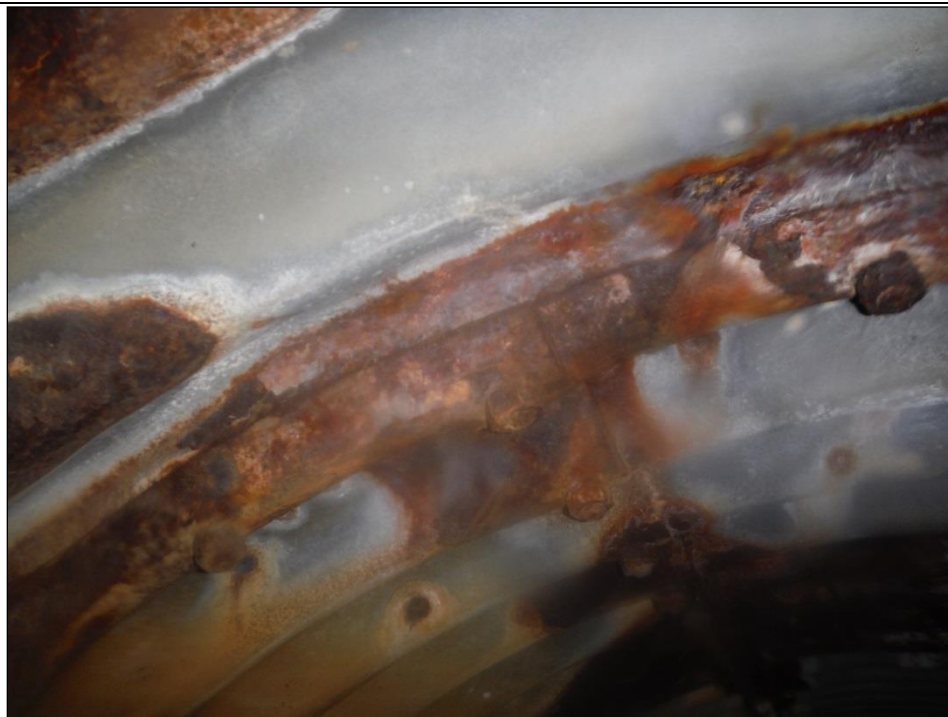
Photograph 8  
View of Pipe 1,  
Typical heavy  
corrosion on  
bolted  
connections.  
Looking south.

With heavy corrosion on bolt heads and seams of connections and other deficiencies noted we would recommend this structure for future replacement. This structure is at or near end of the anticipated service life.

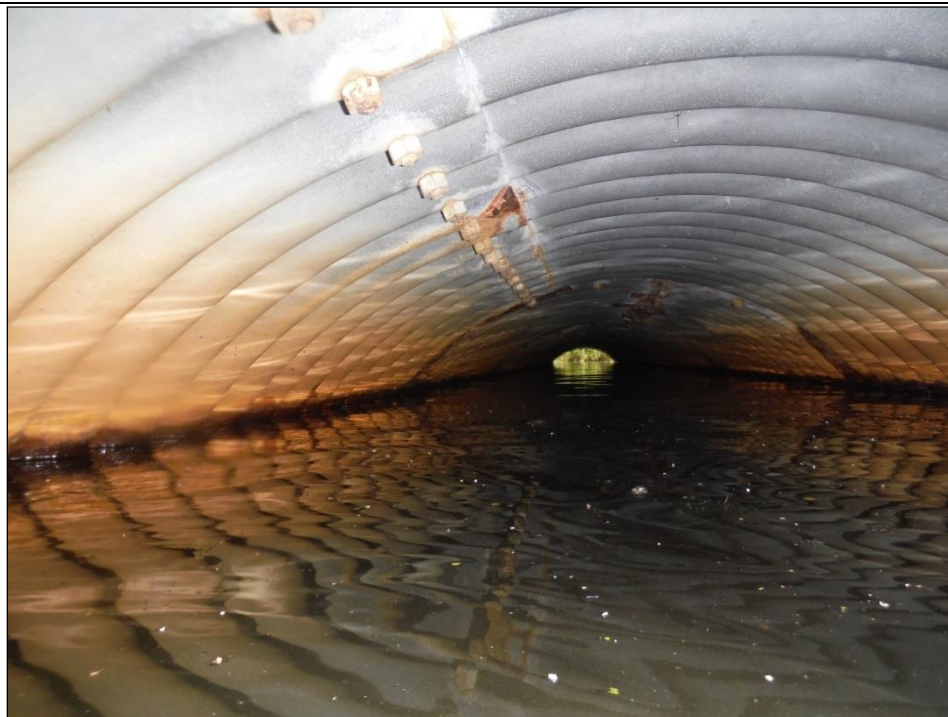
- Light to heavy corrosion was observed throughout Pipe 2 at waterline and bolted connections. Corrosion was documented in underwater inspection performed in 2007 and has advanced in severity. (See photo 10)
- Light to heavy surface corrosion on bolted connections was confirmed throughout Pipe 2 as documented in underwater inspection performed in 2007 and has advanced in severity. Most connections are secure and intact with isolated backed out bolts observed. (See photos 11 and 12)
- Deflection at 1 o'clock position looking north to south in Pipe 2 starts 8 feet 6 inches from north entrance and continues approximately 8 feet north to south at bolted connection measuring 3 inches tall.

Photograph  
10  
View of Pipe 2,  
Typical  
corrosion.  
Looking South.

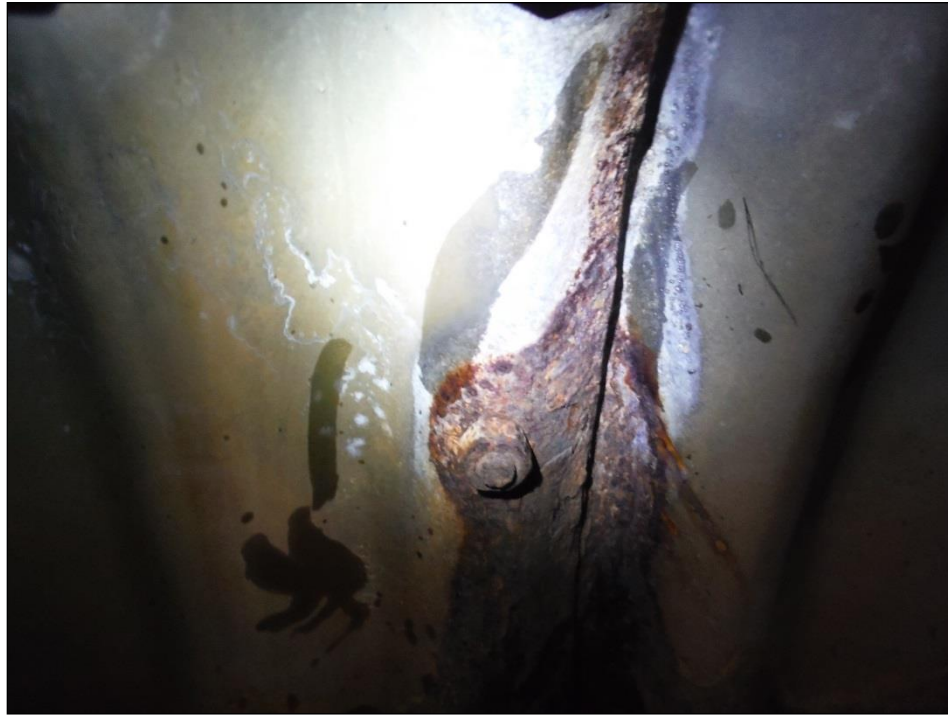
Photograph  
11  
View of Pipe 2,  
Typical heavy  
corrosion on  
bolted  
connections.  
Looking south.

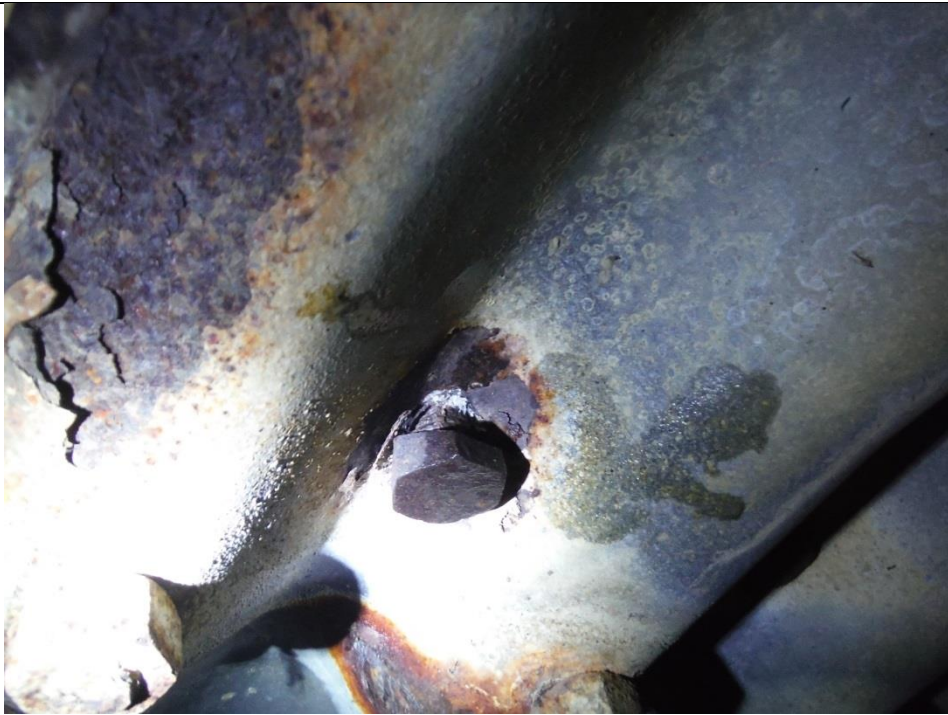
Photograph  
12  
View of Pipe 2.  
Typical Backed  
out bolt.

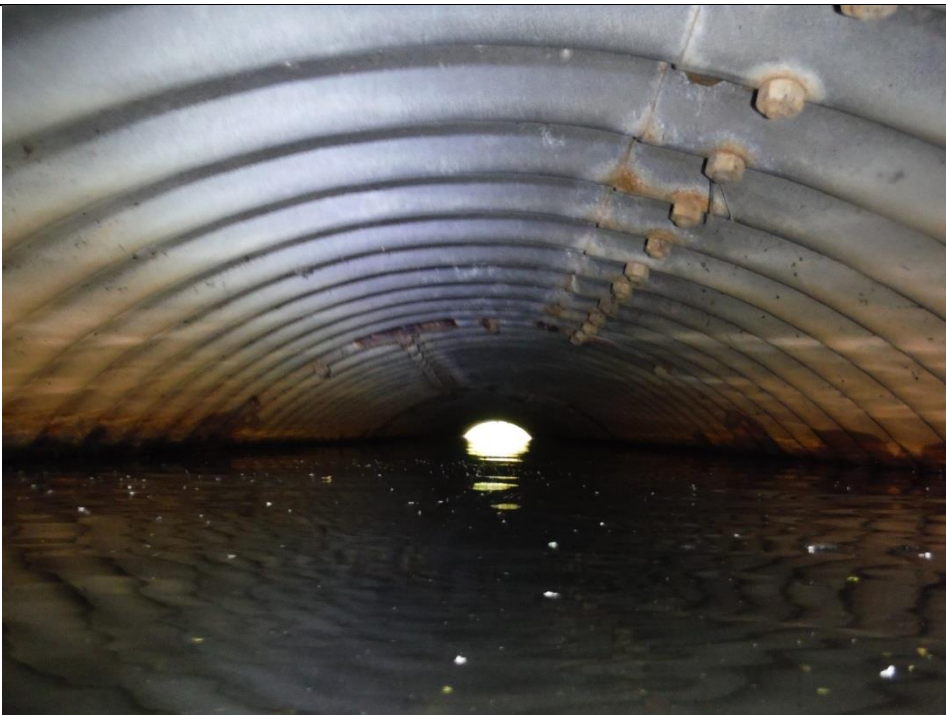
Photograph  
14  
View of Pipe 3,  
Typical  
corrosion.  
Looking South.

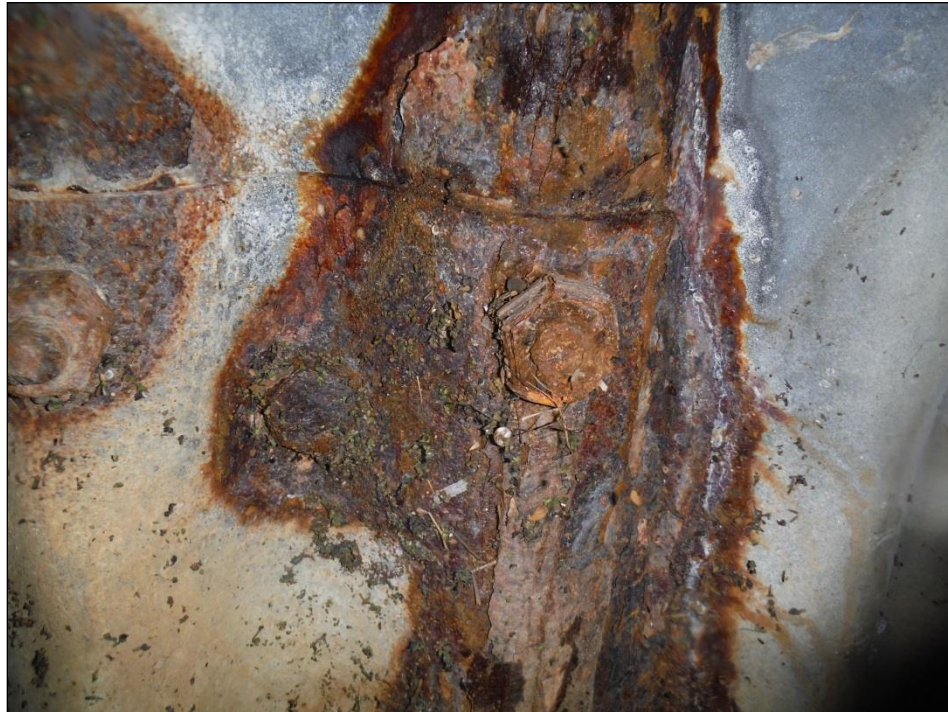
- Light to heavy corrosion was observed throughout Pipe 3 at waterline and bolted connections. Corrosion was documented in underwater inspection performed in 2007 and has advanced in severity. (See photos 15)
- Light to heavy surface corrosion on bolted connection was confirmed throughout Pipe 3 as documented in underwater inspection performed in 2007 and has advanced in severity. One bolt missing at 11 o'clock position looking north to south in Pipe 3 approximately 45 feet from north entrance. (See photo 16)

Photograph  
15  
View of Pipe 3,  
Typical heavy  
corrosion on  
bolted  
connections.  
Looking south.

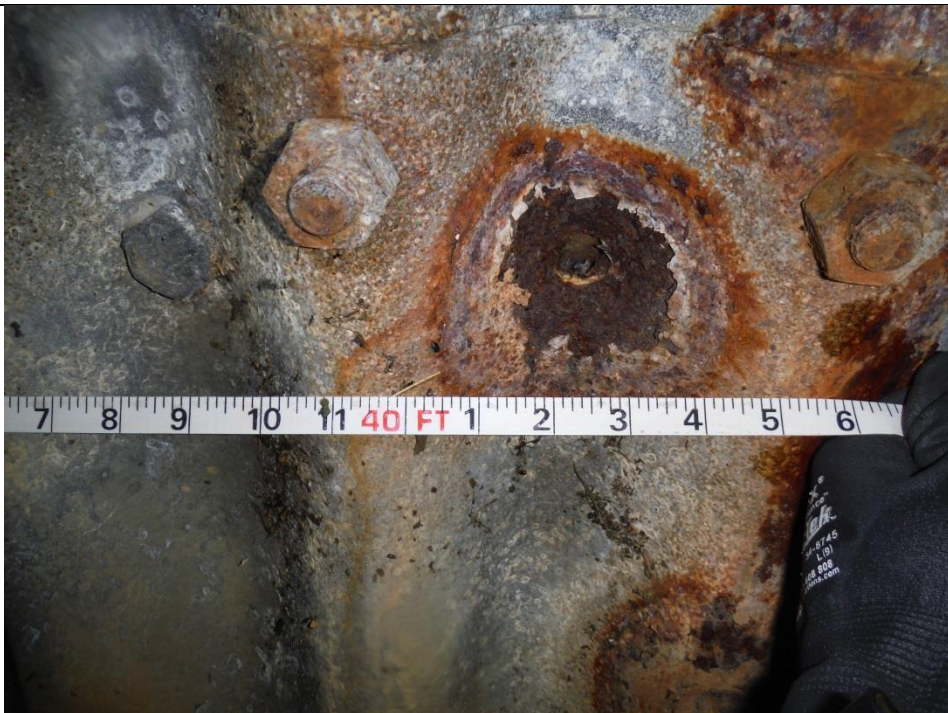
Photograph  
16  
View of Pipe 3,  
Missing bolt.

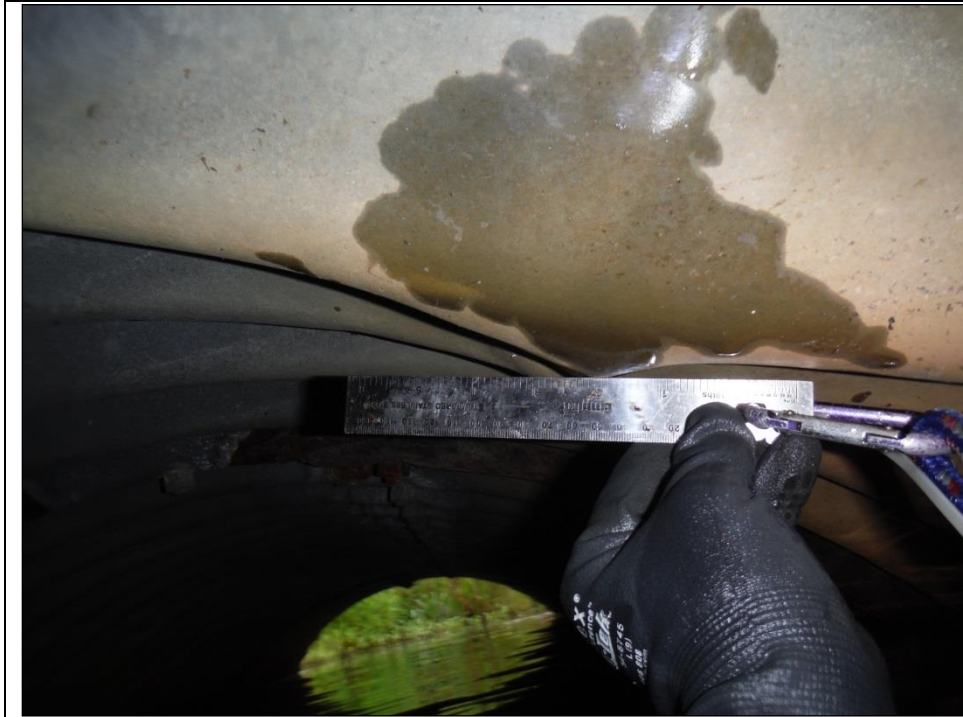
- Indention at 12 o'clock position looking north to south in Pipe 3 58 feet from north entrance measuring 8 inches tall 7 inches deep 12 inches wide was confirmed from underwater inspection performed in 2007 and has advanced in severity from 3 inches in depth to 7 inches in depth. (See photo 17)

Photograph  
17  
View of  
indentation Pipe  
3, Looking South.
