BRIDGE INSPECTION REPORT

2801655
Structure File NumberBRIDGE NUMBER **GEA 00422 0986 L**YEAR BUILT **1960**DIST **12** Bridge Type **322** TYPE SERVICE **1 5** **LA DUE RES. 0.71 MI E 44**

SFN 2801655 Bridge GEA-422-0986 L

USR 422 WB over the La Due Reservoir

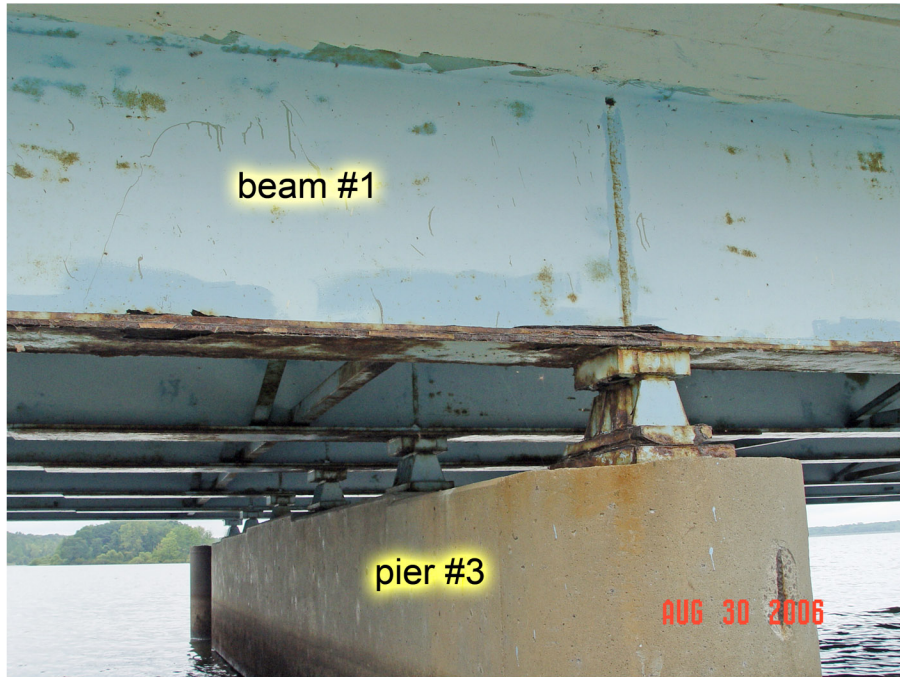
BEAMS: RUSTED SECTION LOSS AT BOTH ABUTMENTS. RUSTING
SECTION LOSS OF LOWER FLANGE OF BEAM #1 AT PIER #3;
SEE ATTACHED PHOTOS #1 THRU #4 DATED 8/30/06.

P1 rusting section loss of beam #1 at pier #3.psd

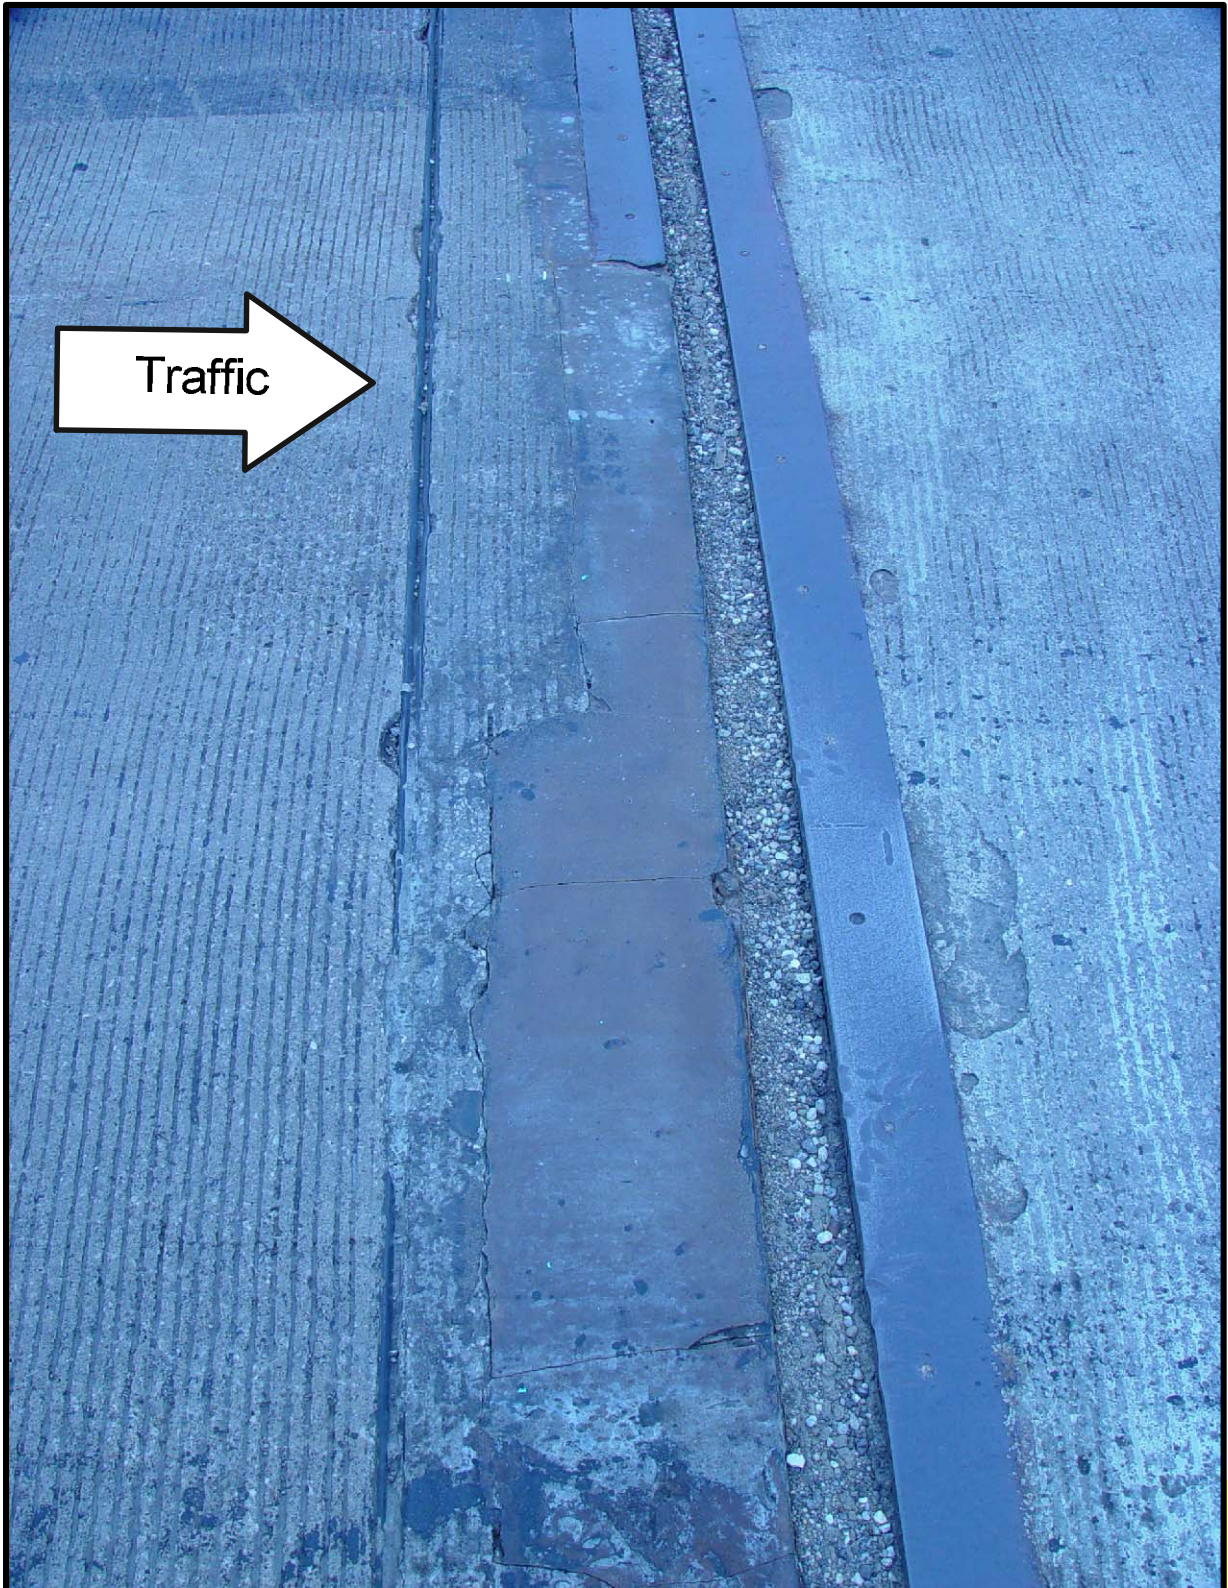
▲ Photo #2. Facing south at the start (east) expansion joint.
Close-up of cracks in epoxy resin shown in photo #1.

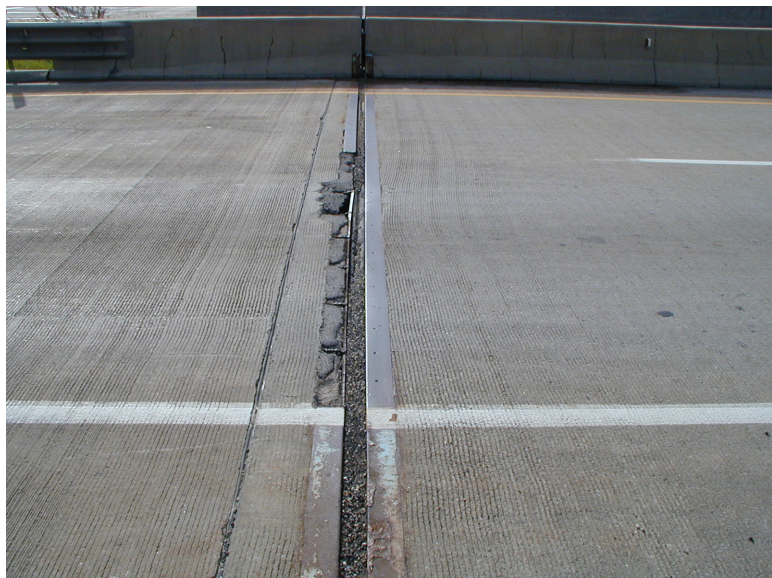
PHOTO #1
12 FOOT OF THE APPROACH SLAB SIDE OF THE DECK ARMOR, WAS CUT OUT IN LANE #2.

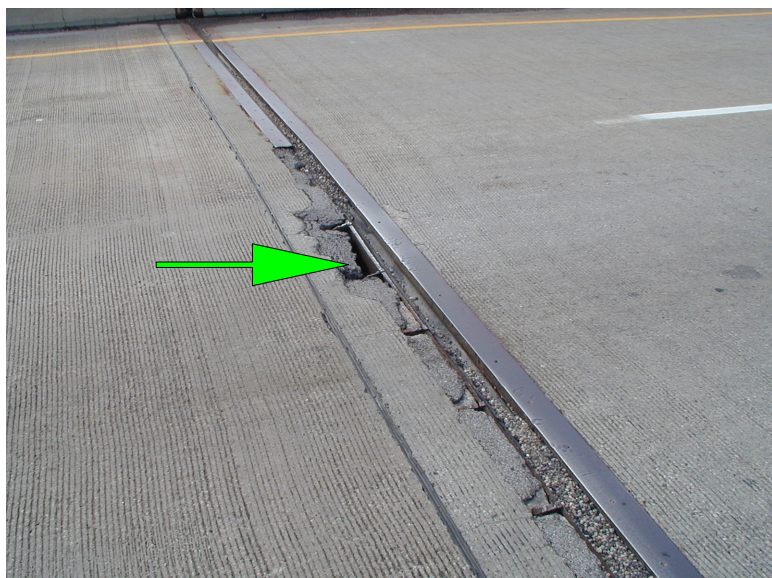
PHOTO #2
ARROW SHOWS A THROUGH HOLE TO THE BACKWALL BELOW WEARING SURFACE. THIS HOLE IS IN LINE WITH WHEEL OF ON COMING TRAFFIC.

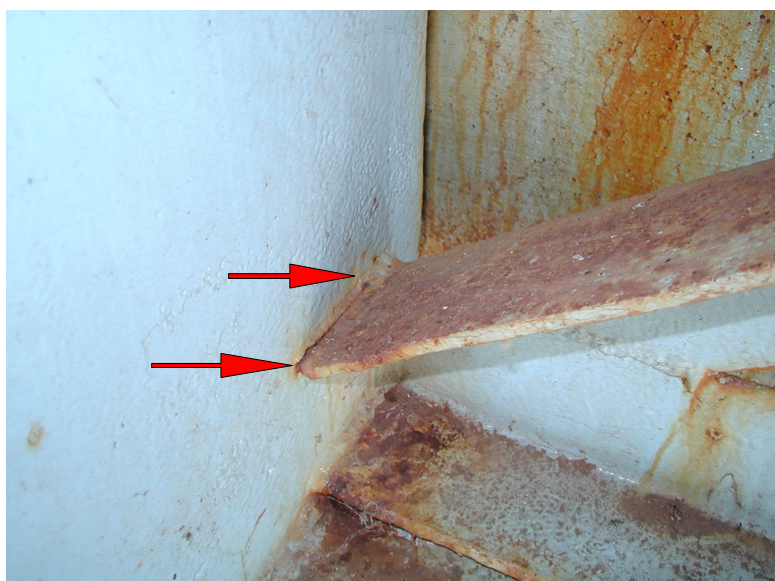
CROSSFRAMES: ENDFRAME RUSTED SECTION LOSS. 1.5 INCH LONG
CRACK IN WELD THAT JOINS START ABUTMENT
ENDFRAME ANGLE TO LEFT BEAM IN BAY #1; SEE
ATTACHED PHOTO #4 DATED 10/29/01. 3 INCH LONG
CRACK IN WELD THAT JOINS START ABUTMENT
ENDFRAME ANGLE TO BEAM #2 IN BAY #1; SEE
ATTACHED PHOTO #3 DATED 10/29/01.

PHOTO #3
BOTH CRACK PICTURES ARE IN THE SAME BAY. ARROWS SHOW A 3" CRACK OF THE EAST ABUTMENT END FRAME ANGLE WELD TO THE 2ND BEAM WEB, IN FROM THE SOUTH.

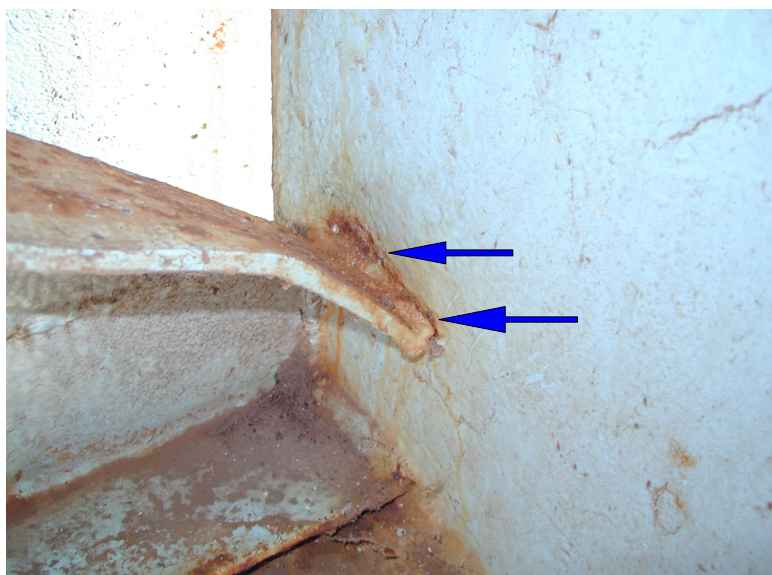
PHOTO #4
ARROWS SHOW A 1-1/2" CRACK OF THE EAST ABUTMENT END FRAME ANGLE WELD TO THE INSIDE BEAM WEB OF THE SOUTH FASCIA.
