BRIDGE INSPECTION REPORT

2801655
Structure File NumberBRIDGE NUMBER **GEA 00422 0986 L**YEAR BUILT **1960**DIST **12** Bridge Type **322** TYPE SERVICE **1 5** **LA DUE RES. 0.71 MI E 44**

USR 422 WB over the La Due Reservoir

UNDERWATER INSPECTION REPORT
on CONCRETE COLUMN PIERS

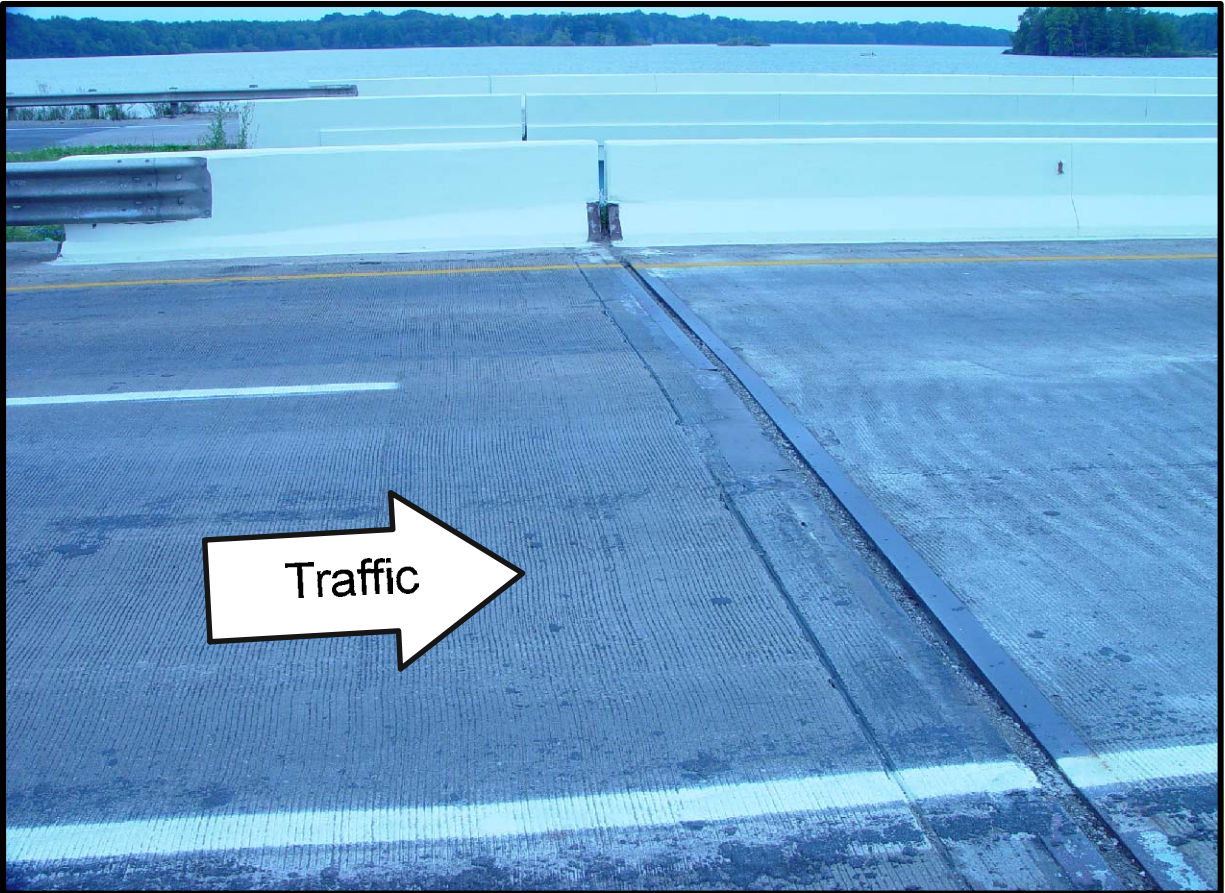
EMBEDDED WOOD 2 BY 4 IN SPAN #2.
EXJTS: WATER LEAKING DOWN START BACKWALL IN BAY #3.
THE EPOXY RESIN USED TO FILL THE VOID LEFT BY THE
REMOVAL OF PART OF THE START BACKWALL EXJT ARMOR HAS
CRACKED; SEE ATTACHED PHOTOS #1 AND #2 DATED 9/18/03.
40 SQUARE INCHES OF THIS RESIN HAS POPPED OUT OF THE
LEFT WHEEL TRACK OF LANE #2.
GOUGES IN FINISH EXJT BACKWALL ARMOR.

▲ Photo #1. Facing south at the start (east) expansion joint. Note the longitudinal cracks in the epoxy resin used to fill the void left by the removal of part of the backwall joint armor.

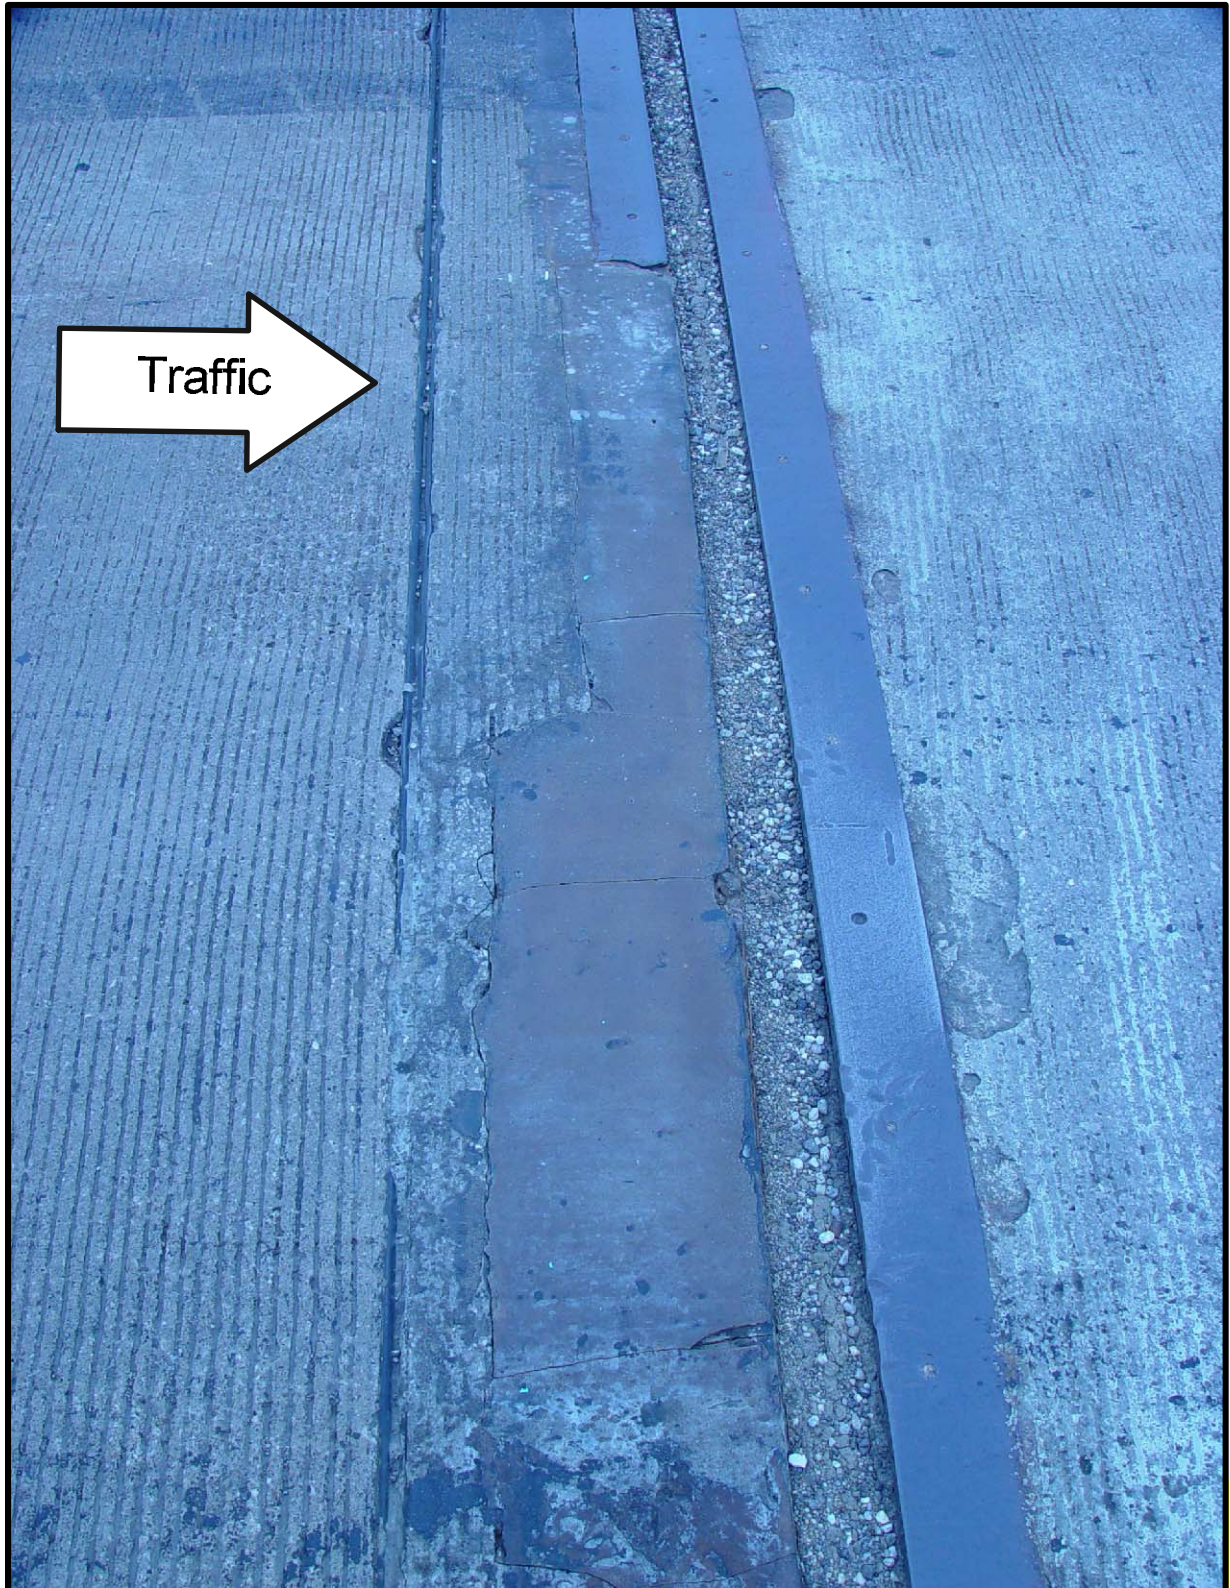
▲ Photo #2. Facing south at the start (east) expansion joint.
Close-up of cracks in epoxy resin shown in photo #1.

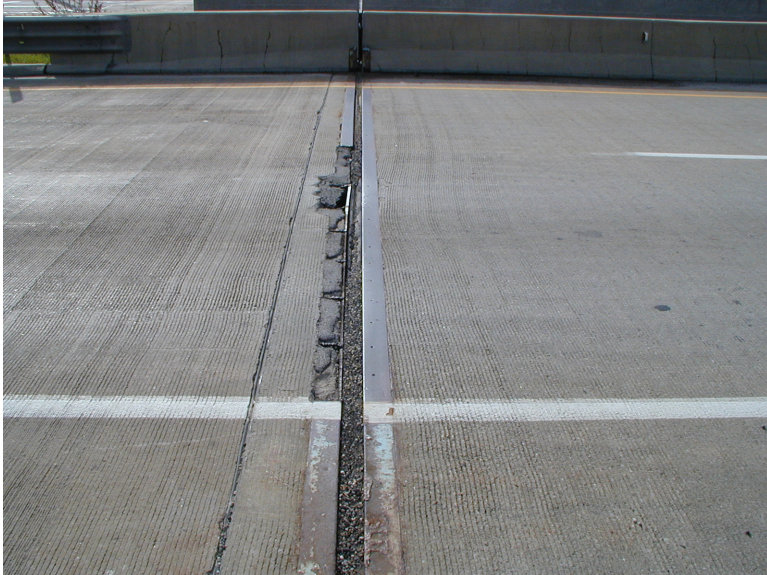
PHOTO #1
12 FOOT OF THE APPROACH SLAB SIDE OF THE DECK ARMOR, WAS CUT OUT IN LANE #2.

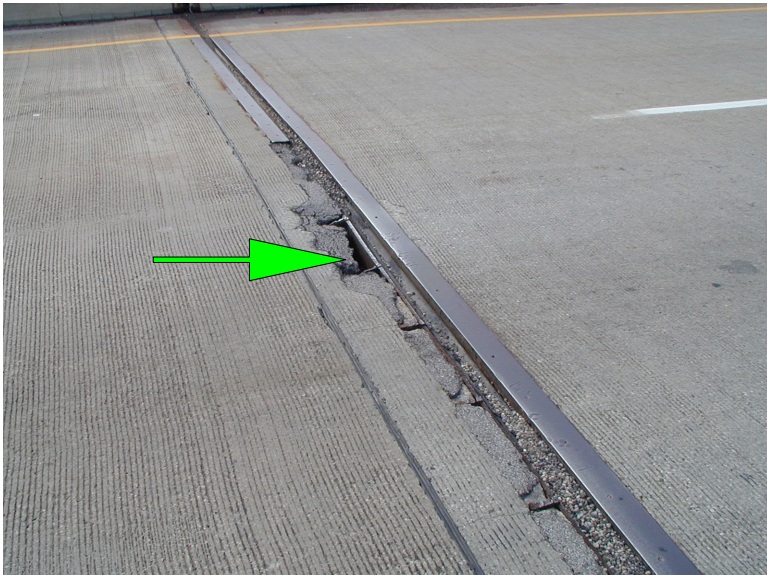
PHOTO #2
ARROW SHOWS A THROUGH HOLE TO THE BACKWALL BELOW WEARING SURFACE. THIS HOLE IS IN LINE WITH WHEEL OF ON COMING TRAFFIC.

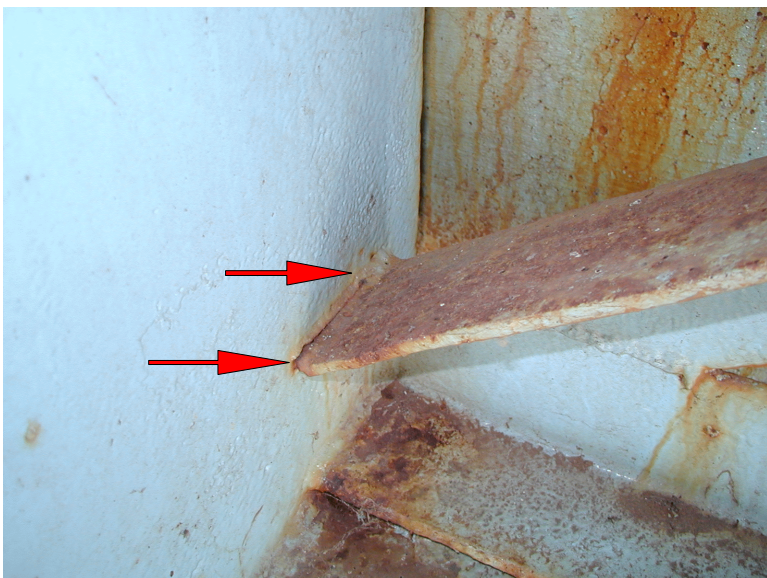
PHOTO #3
BOTH CRACK PICTURES ARE IN THE SAME BAY. ARROWS SHOW A 3" CRACK OF THE EAST ABUTMENT END FRAME ANGLE WELD TO THE 2ND BEAM WEB, IN FROM THE SOUTH.

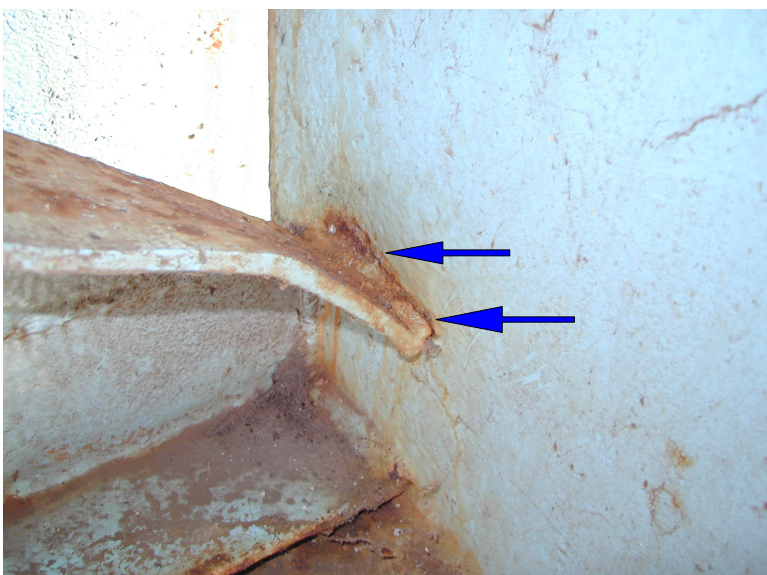
PHOTO #4
ARROWS SHOW A 1-1/2" CRACK OF THE EAST ABUTMENT END FRAME ANGLE WELD TO THE INSIDE BEAM WEB OF THE SOUTH FASCIA.

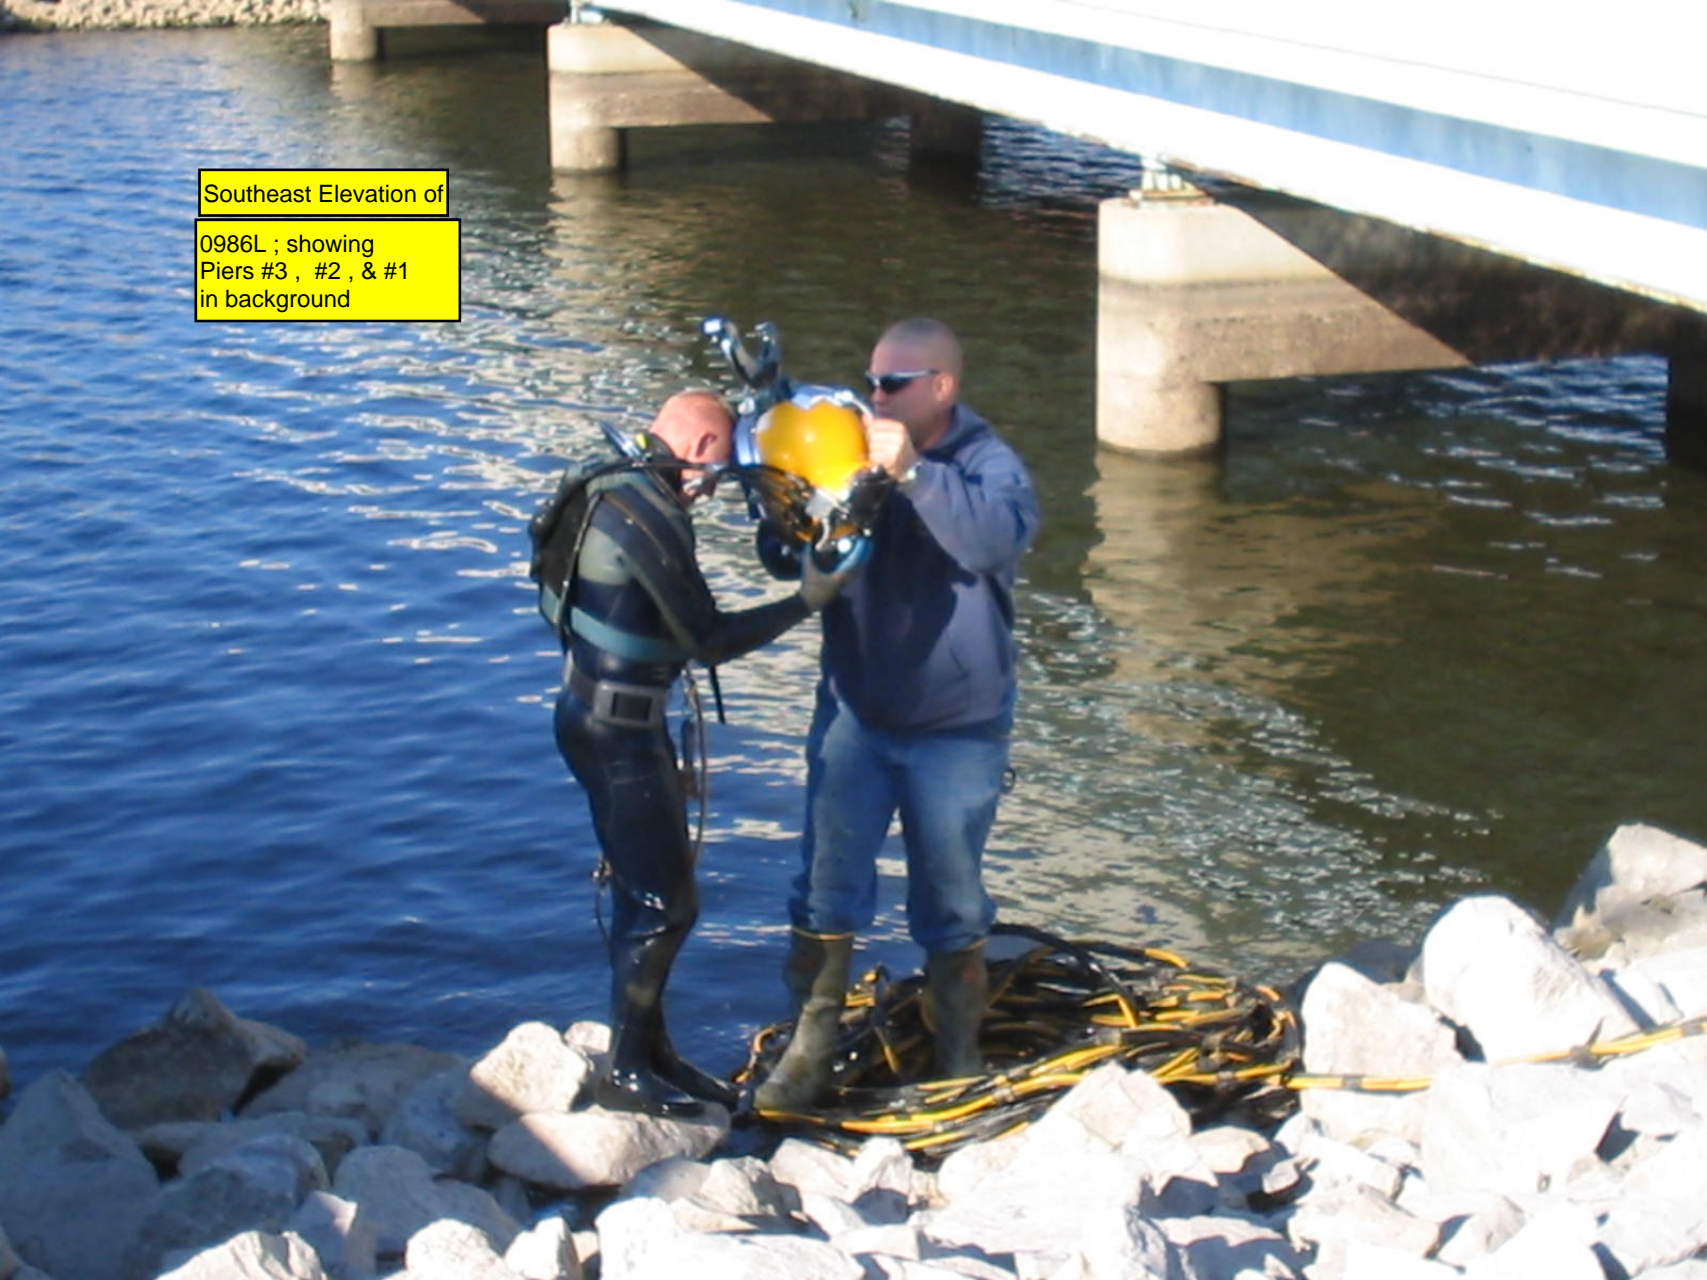
Southeast elevation of
PIER # 3 , Column #3.

Rip-Rap embankment
protection in foreground
