## BRIDGE INSPECTION REPORT

2801655  
Structure File NumberBRIDGE NUMBER **GEA 00422 0986 L**YEAR BUILT **1960**DIST **12** Bridge Type **322** TYPE SERVICE **1 5** **LA DUE RES. 0.71 MI E 44**

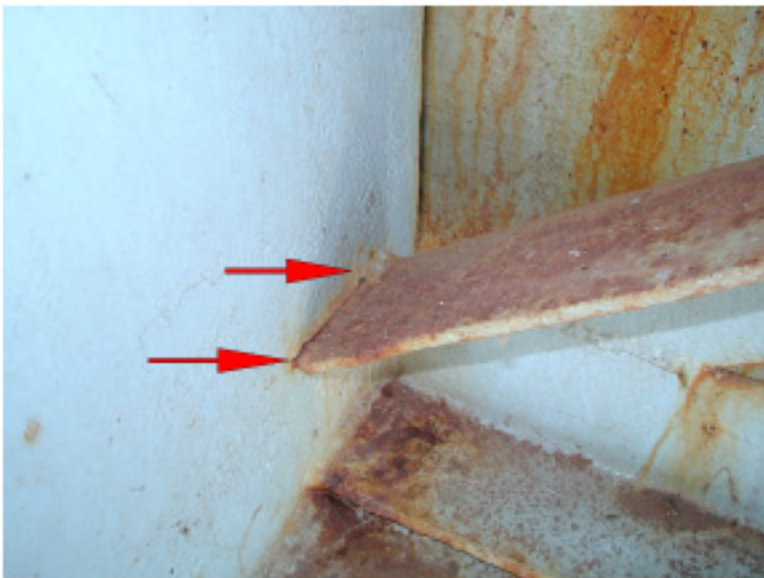
**PHOTO #3**  
**BOTH CRACK PICTURES ARE IN THE SAME BAY.**  
**ARROWS SHOW A 3" CRACK OF THE EAST**  
**ABUTMENT END FRAME ANGLE WELD TO THE**  
**2<sup>ND</sup> BEAM WEB, IN FROM THE SOUTH.**

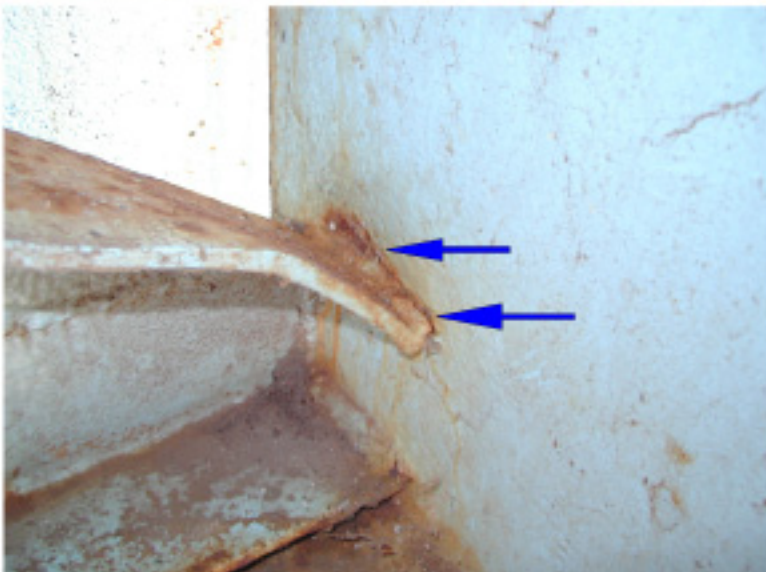
**PHOTO #4**  
**ARROWS SHOW A 1-1/2" CRACK OF THE EAST**  
**ABUTMENT END FRAME ANGLE WELD TO THE**  
**INSIDE BEAM WEB OF THE SOUTH FASCIA.**
