BRIDGE INSPECTION REPORT

2801655
Structure File NumberBRIDGE NUMBER **GEA 00422 0986 L**YEAR BUILT **1960**DIST **12** Bridge Type **322** TYPE SERVICE **1 5** **LA DUE RES. 0.71 MI E 44**

Underwater Inspection Report for:
State Route 422 (Westbound) over La Due Reservoir Geauga County, Ohio
(Four Span, Steel Beam Bridge)

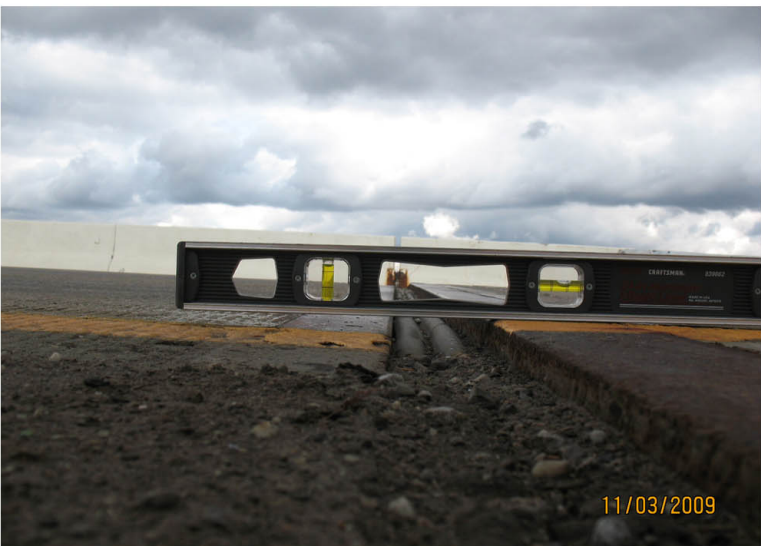
APPROACH SLABS: START SLAB IS 1/2" HIGHER THAN DECK AND
FINISH IS <1/4" AT EXJTS. FULL WIDTH CRACK IN FINISH SLAB.

P6: BRIDGE DECK IS A 1/2" LOWER THEN APPROACH SLAB. MEASUREMENT IS TAKEN BY ARROW IN P1 ABOVE.

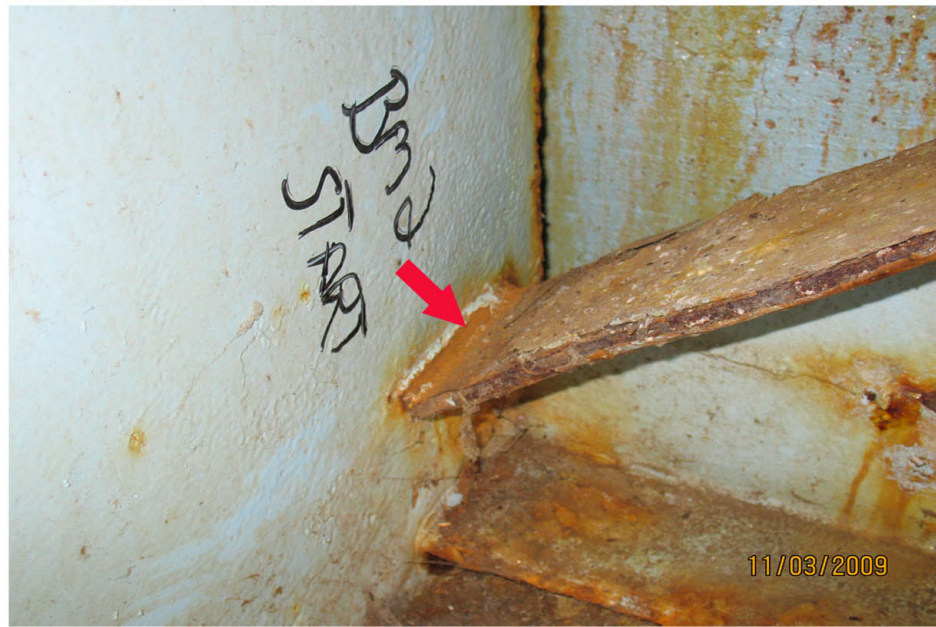
SOUTH FASCIA; SEE ATTACHED PHOTO 8 DATED 11/3/09.
XFRAMES: ENDFRAME RUSTING SECTION LOSS. TWO CRACKED ENDFRAME
WELD AT START ABUT, ONE AT BEAM #2 AND ONE AT SOUTH
FASCIA; SEE ATTACHED PHOTOS 7 & 8 DATED 11/3/09.
BEARINGS: RUSTED SECTION LOSS. START ABUTMENT ROCKERS #2,
#3, & #4 ARE LOOSE.
PCS: PEELING PAINT, 5% RUST, PCS IS 5-10% DETERIORATED.
LLR: BEAMS #2, #3, AND #4 MOVE UP & DOWN UNDER HEAVY LOADING

P7: ARROW SHOWS CRAKED ENDFRAME WELD TO BEAM #2 AT START (E) ABUTMENT.

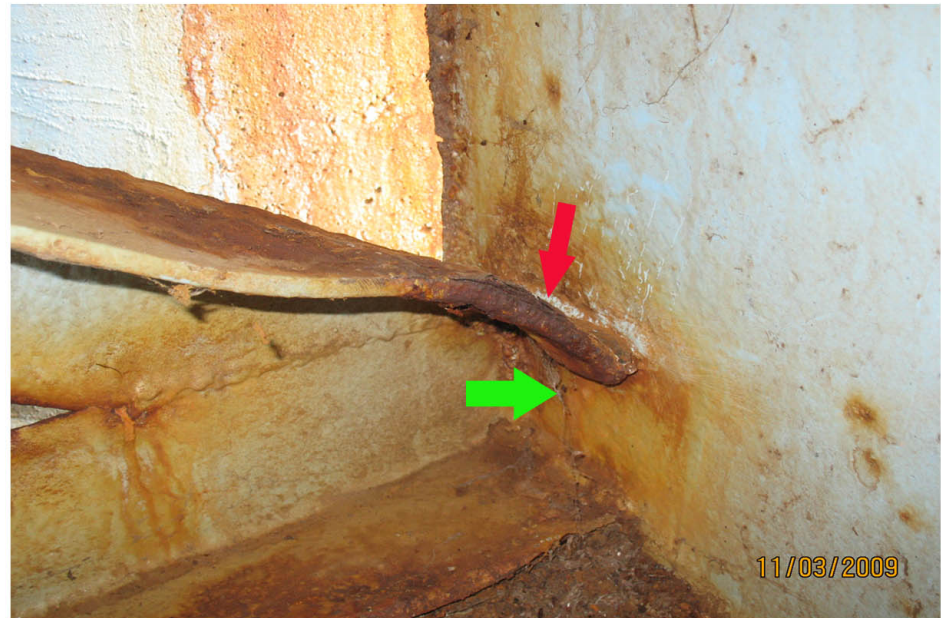
AT THE START ABUTMENT. ALSO SOUTH FASCIA AT ENDFRAME
FLEX'S WITH HEAVY LOAD.

P8: RED ARROW SHOWS CRAKED ENDFRAME WELD TO BEAM OF SOUTH FASCIA BEAM AT START (E) ABUTMENT. GREEN ARROW SHOWS POSSIBLE CRACK IN WEB OF BEAM. NOTE BOW IN DIAGONAL ANGLE THIS WHOLE AREA FLEX'S WITH LIVE LOAD.

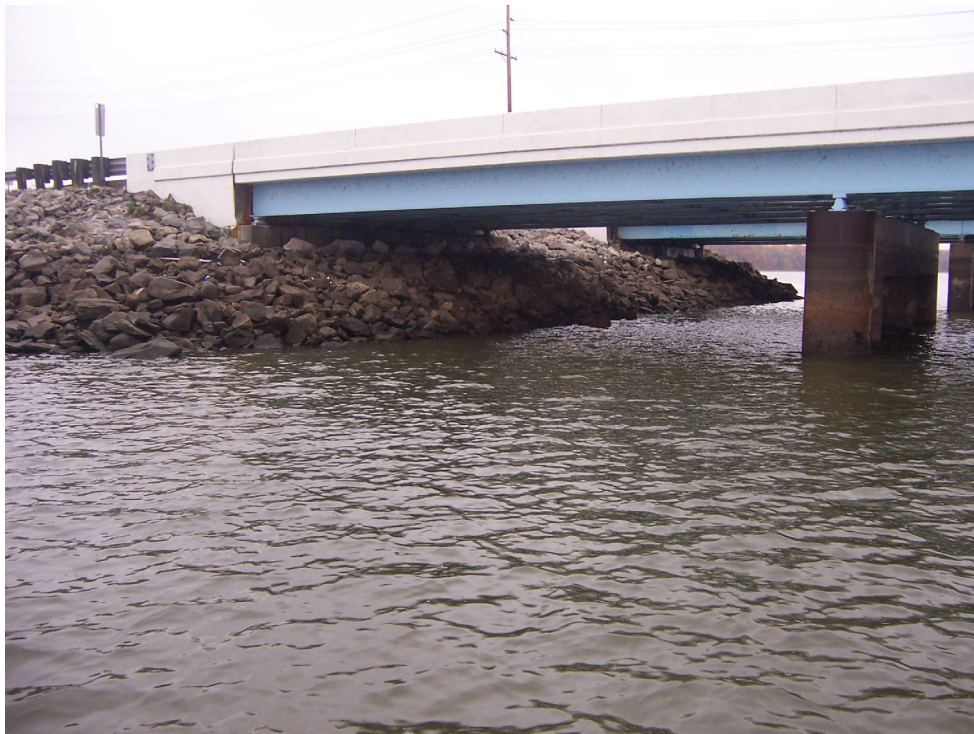
- The bottom composition is flat mud and small stone.
- Each abutment is surrounded with large diameter riprap stone (shown in Photos 5 and 6). This stone slopes downward toward the piers.

Photo 6 – Facing Southeast. East Abutment with large Riprap Stone Shore Protection.

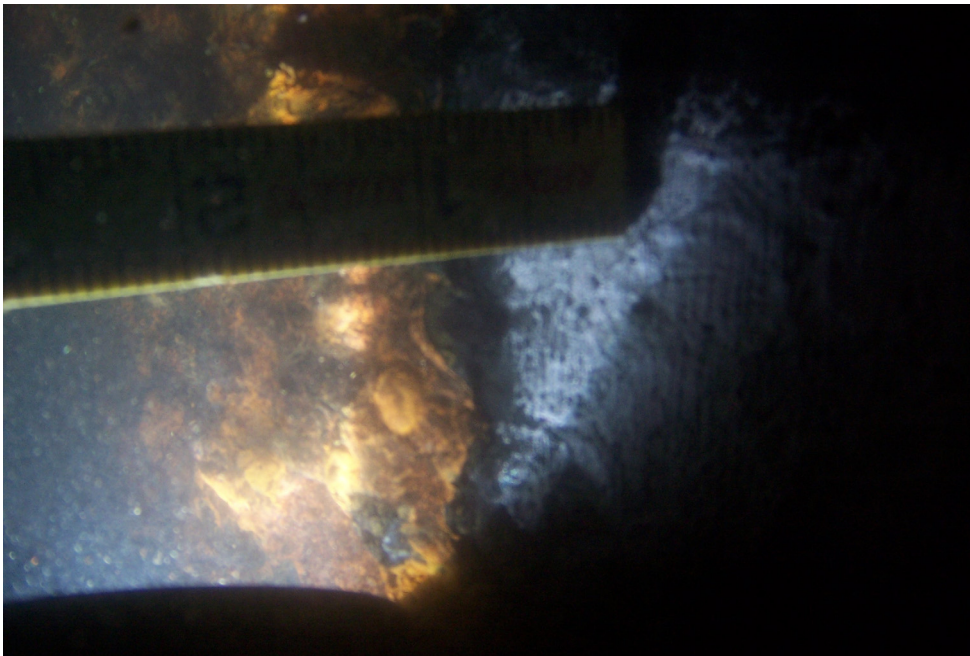
- The concrete surfaces had up to ¼-inch scaling. The concrete was sounded in numerous locations and found to be hard with no signs of delamination.
- The steel jacketed concrete drilled shafts had a 1/8-inch layer of surface corrosion (see Photo 8).
- Underwater visibility was less than 2 feet with no current.

- The concrete surfaces had up to ¼-inch scaling.
- The steel jacketed concrete drilled shaft has a 1/8-inch layer of surface corrosion. Photo 8 is an underwater picture of this corrosion on Pier 1.

Photo 8 – Facing North. South side of Pier 1 steel jacket on the drilled shaft at the mudline. Typical 1/8-inch thick corrosion of the steel.
