BRIDGE INSPECTION REPORT

2801655
Structure File NumberBRIDGE NUMBER **GEA 00422 0986 L**YEAR BUILT **1960**DIST **12** Bridge Type **322** TYPE SERVICE **1 5** **LA DUE RES. 0.71 MI E 44**

GEA-422-0986L
SFN 2801655

Underwater Inspection Report for:
State Route 422 (Westbound) over La Due Reservoir Geauga County, Ohio
(Four Span, Steel Beam Bridge)

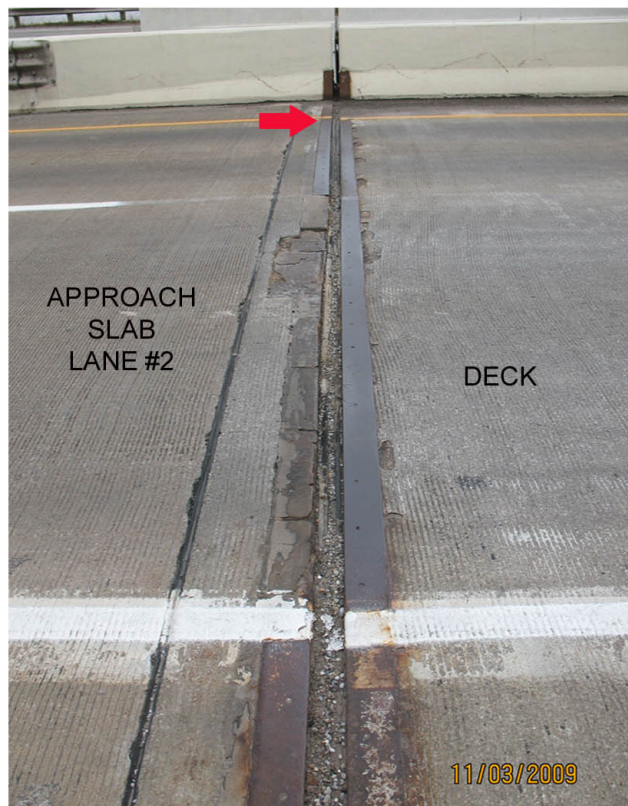
P5: EPOXY REPAIR TO START (E) EXJT IS CRACKED AND BREAKING UP.

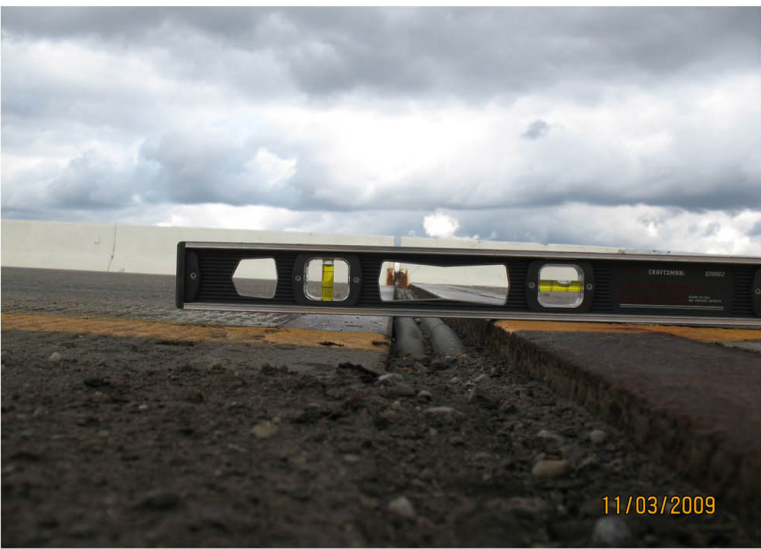
APPROACH SLABS: FORWARD SLAB IS 1/2" HIGHER THAN DECK AND
REAR SLAB IS 1/8" HIGHER AT EXJTS. FULL
WIDTH CRACK IN REAR SLAB.

P6: BRIDGE DECK IS A 1/2" LOWER THEN APPROACH SLAB. MEASUREMENT IS TAKEN BY ARROW IN P1 ABOVE.

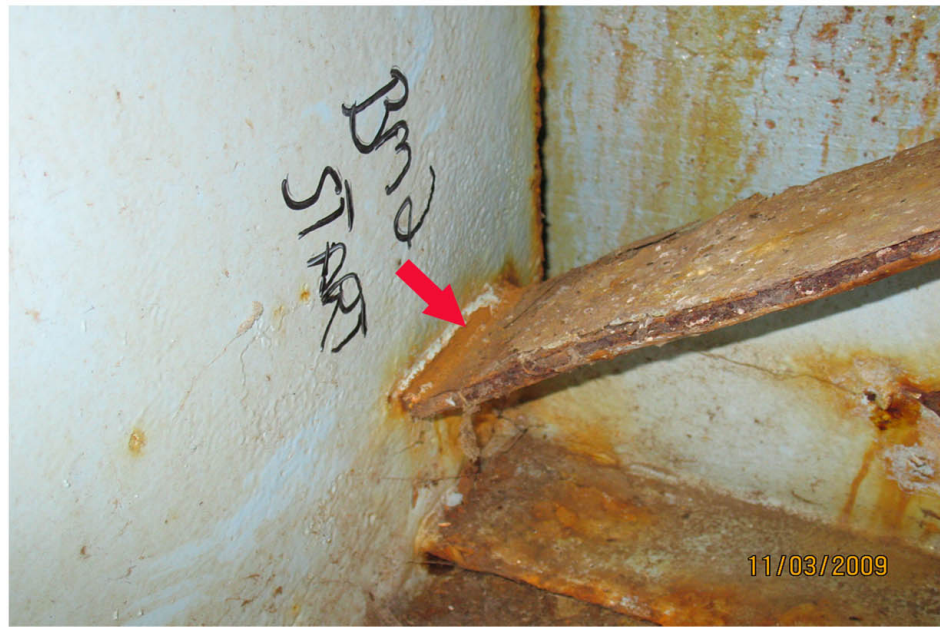
P7: ARROW SHOWS CRAKED ENDFRAME WELD TO BEAM #2 AT START (E) ABUTMENT.

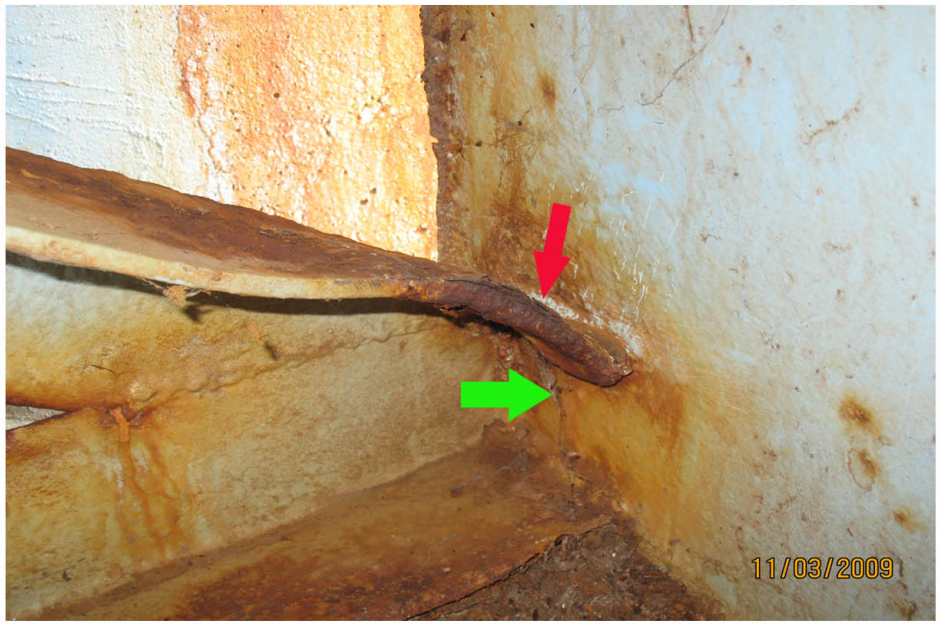
P8: RED ARROW SHOWS CRAKED ENDFRAME WELD TO BEAM OF SOUTH FASCIA BEAM AT START (E) ABUTMENT. GREEN ARROW SHOWS POSSIBLE CRACK IN WEB OF BEAM. NOTE BOW IN DIAGONAL ANGLE THIS WHOLE AREA FLEX'S WITH LIVE LOAD.

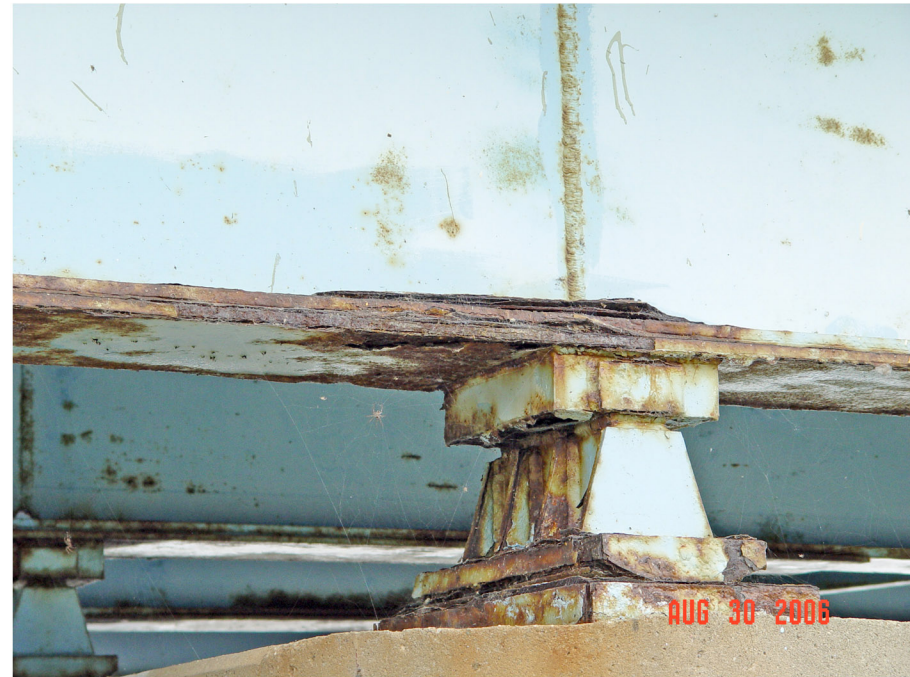
P2 close-up of P1.jpg

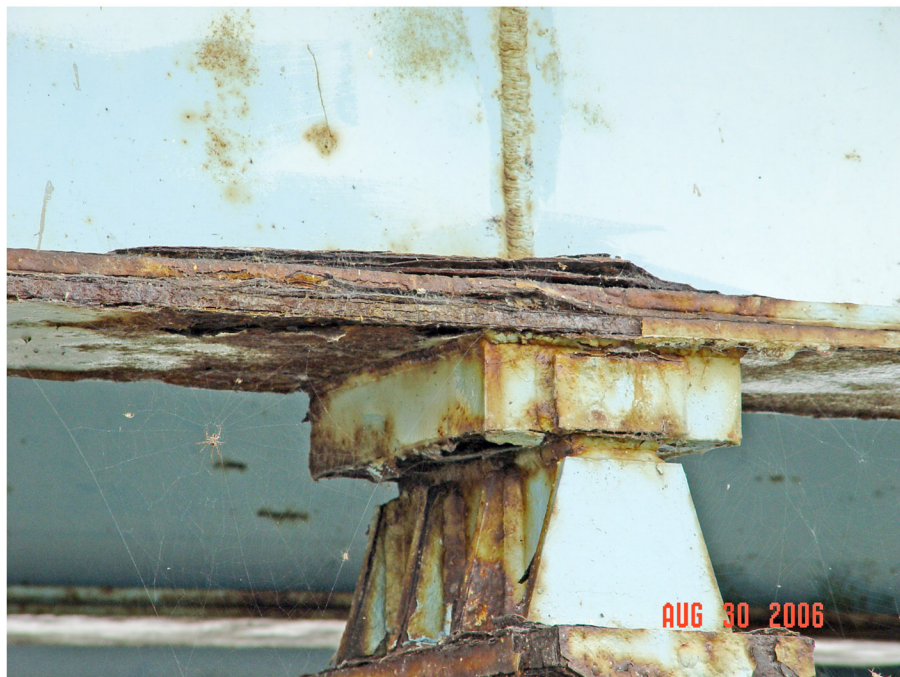
P3 close-up of P2.jpg

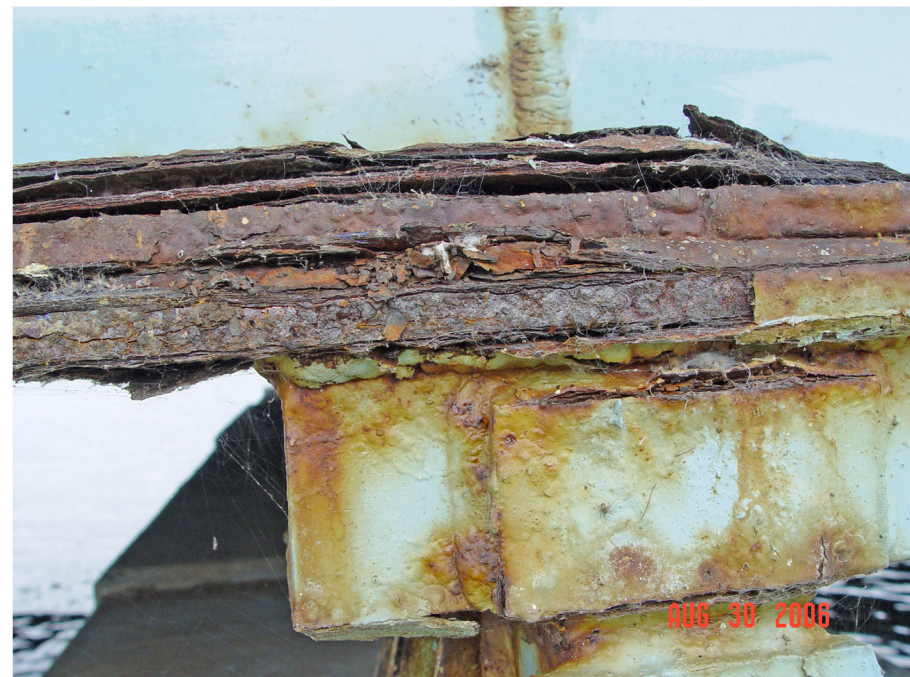
P4 close-up of P3.jpg

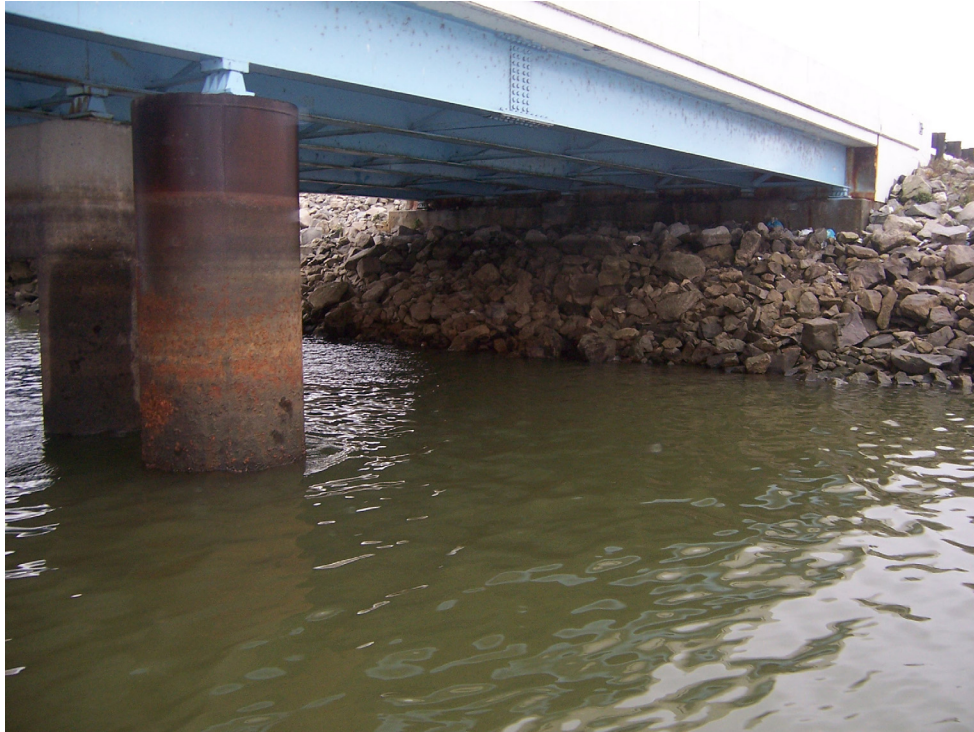
- The bottom composition is flat mud and small stone.
- Each abutment is surrounded with large diameter riprap stone (shown in Photos 5 and 6). This stone slopes downward toward the piers.

Photo 5 – Facing West. West Abutment with large Riprap Stone Shore Protection.

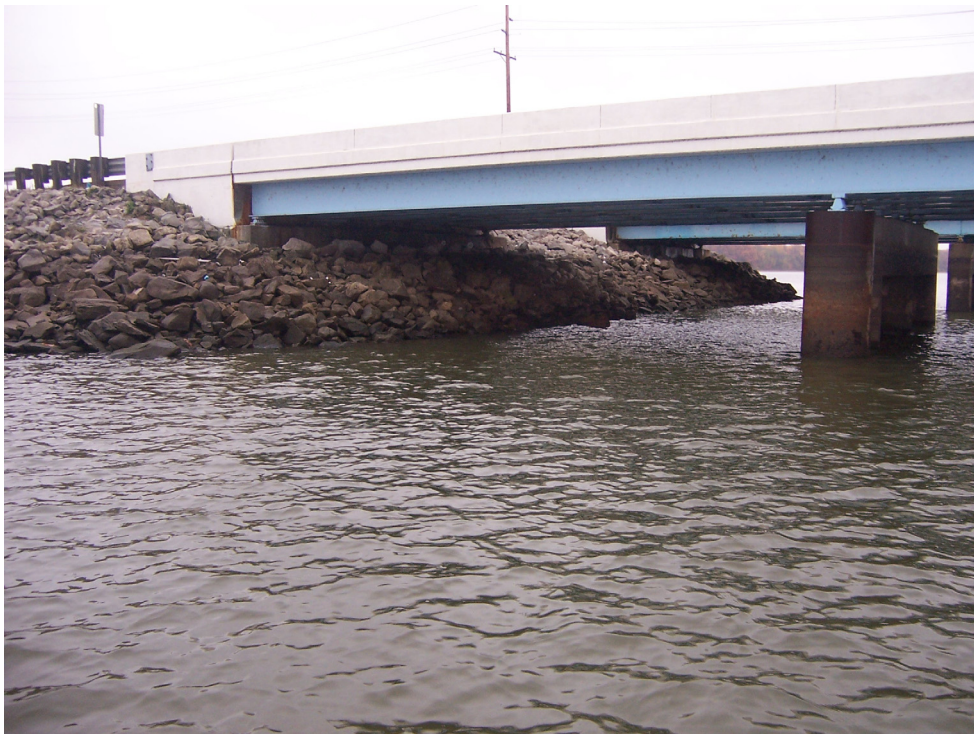
Photo 6 – Facing Southeast. East Abutment with large Riprap Stone Shore Protection.

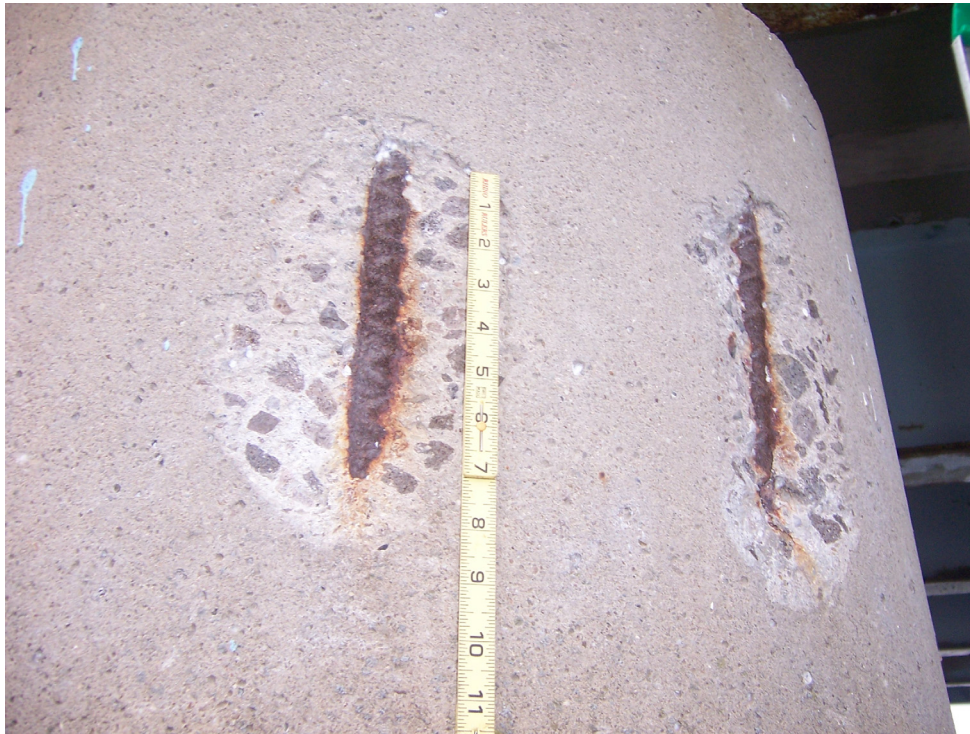
Photo 7 – Facing North. South end of Pier 3 Cap with Spalls and exposed Rebar.
(9-inch high x 6-inch wide x 1-inch deep)

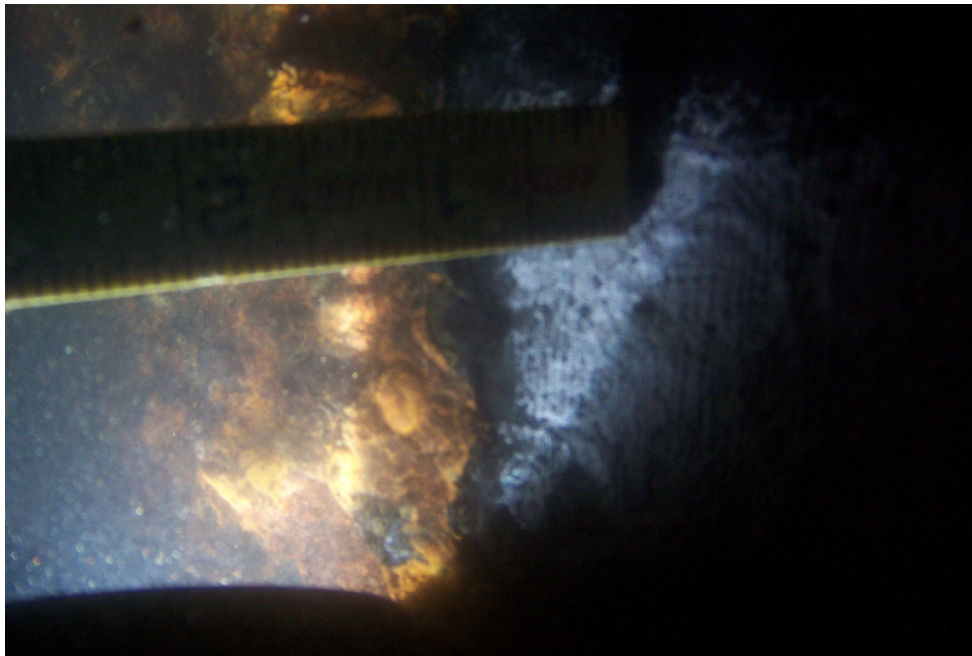
- The concrete surfaces had up to ¼-inch scaling. The concrete was sounded in numerous locations and found to be hard with no signs of delamination.
- The steel jacketed concrete drilled shafts had a 1/8-inch layer of surface corrosion (see Photo 8).
- Underwater visibility was less than 2 feet with no current.

- The concrete surfaces had up to ¼-inch scaling.
- The steel jacketed concrete drilled shaft has a 1/8-inch layer of surface corrosion. Photo 8 is an underwater picture of this corrosion on Pier 1.

Photo 8 – Facing North. South side of Pier 1 steel jacket on the drilled shaft at the mudline. Typical 1/8-inch thick corrosion of the steel.
