Underwater Inspection Report for:
State Route 422 (Westbound) over La Due Reservoir Geauga County, Ohio
(Four Span, Steel Beam Bridge)

DESCRIPTION

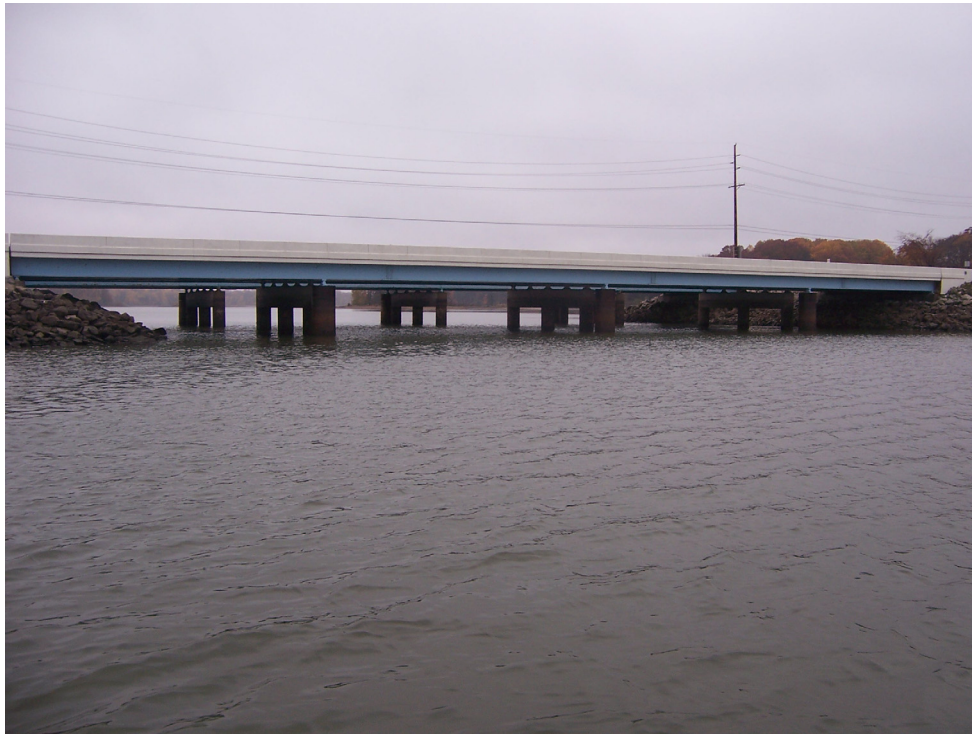
Photo 1 – Facing South. North Elevation of the Bridge.

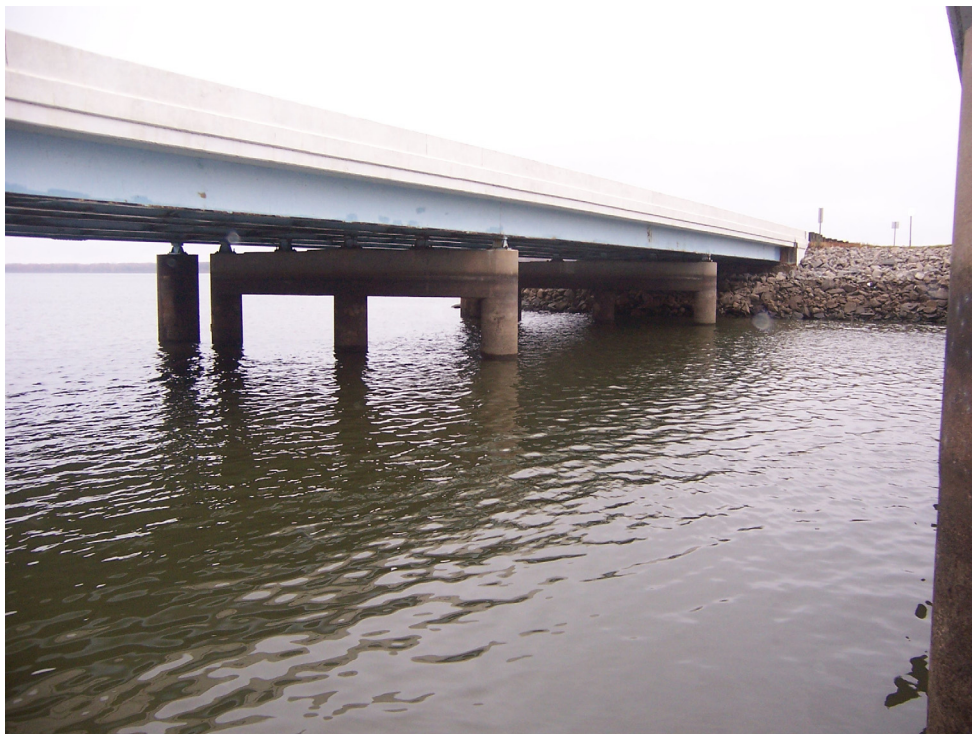
Photo 2 – Facing Northeast. South Elevation of the Bridge.

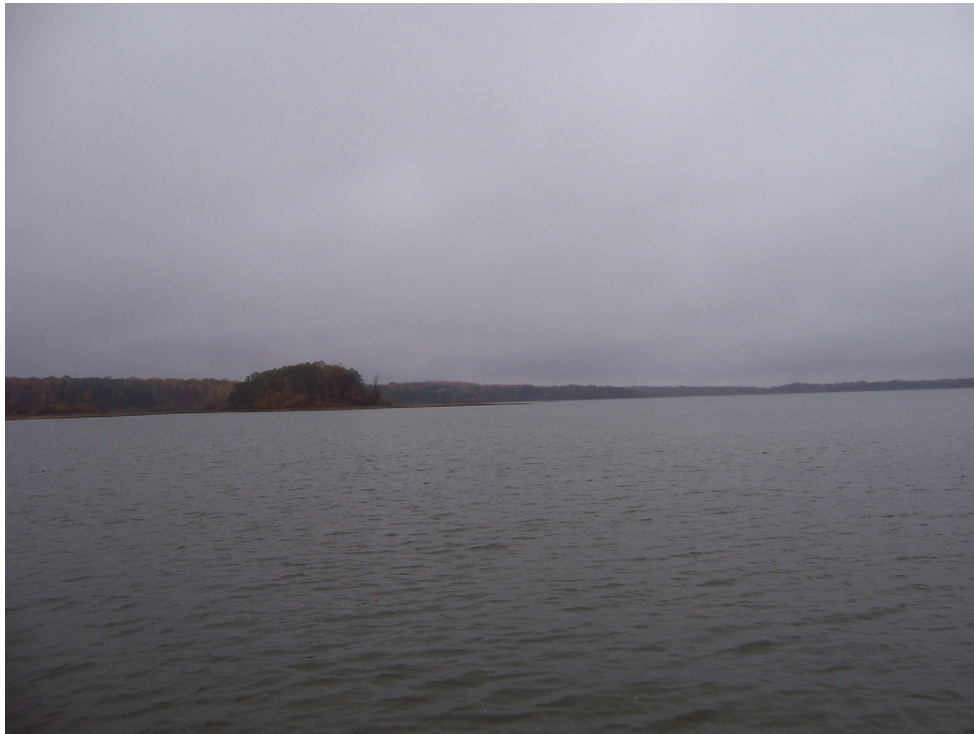
Photo 3 – Facing North. View of La Due Reservoir from the Bridge.

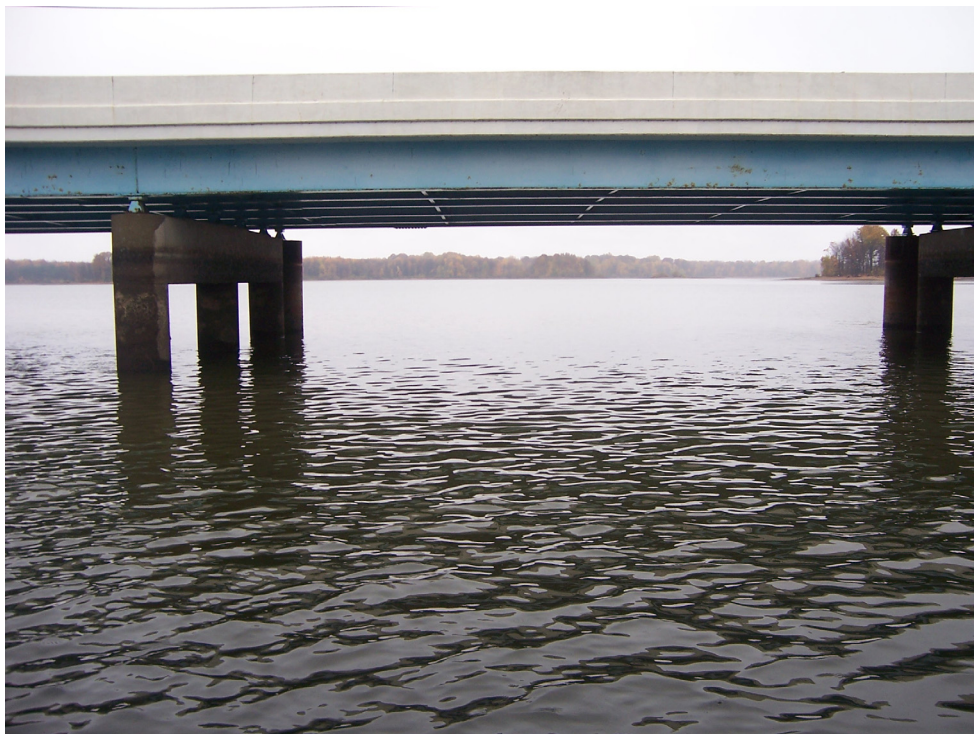
Photo 4 – Facing South. View of La Due Reservoir and Bridge GEA-422-0986 R.

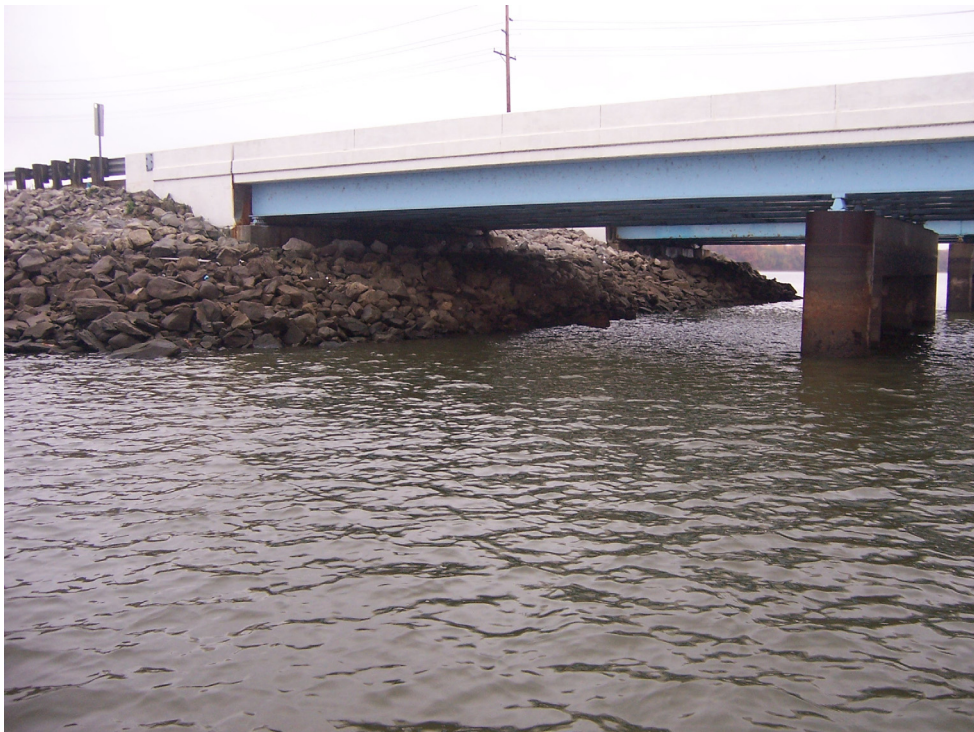
- The bottom composition is flat mud and small stone.
- Each abutment is surrounded with large diameter riprap stone (shown in Photos 5 and 6). This stone slopes downward toward the piers.

Photo 6 – Facing Southeast. East Abutment with large Riprap Stone Shore Protection.
