**Underwater Inspection of
SFN - 2801655
State Route 422 over the La Due Reservoir
(GEA-422-0986 L)
July 25, 2014
For
Ohio Department of Transportation
District-12**

By
GPI/Greenman-Pedersen, Inc.

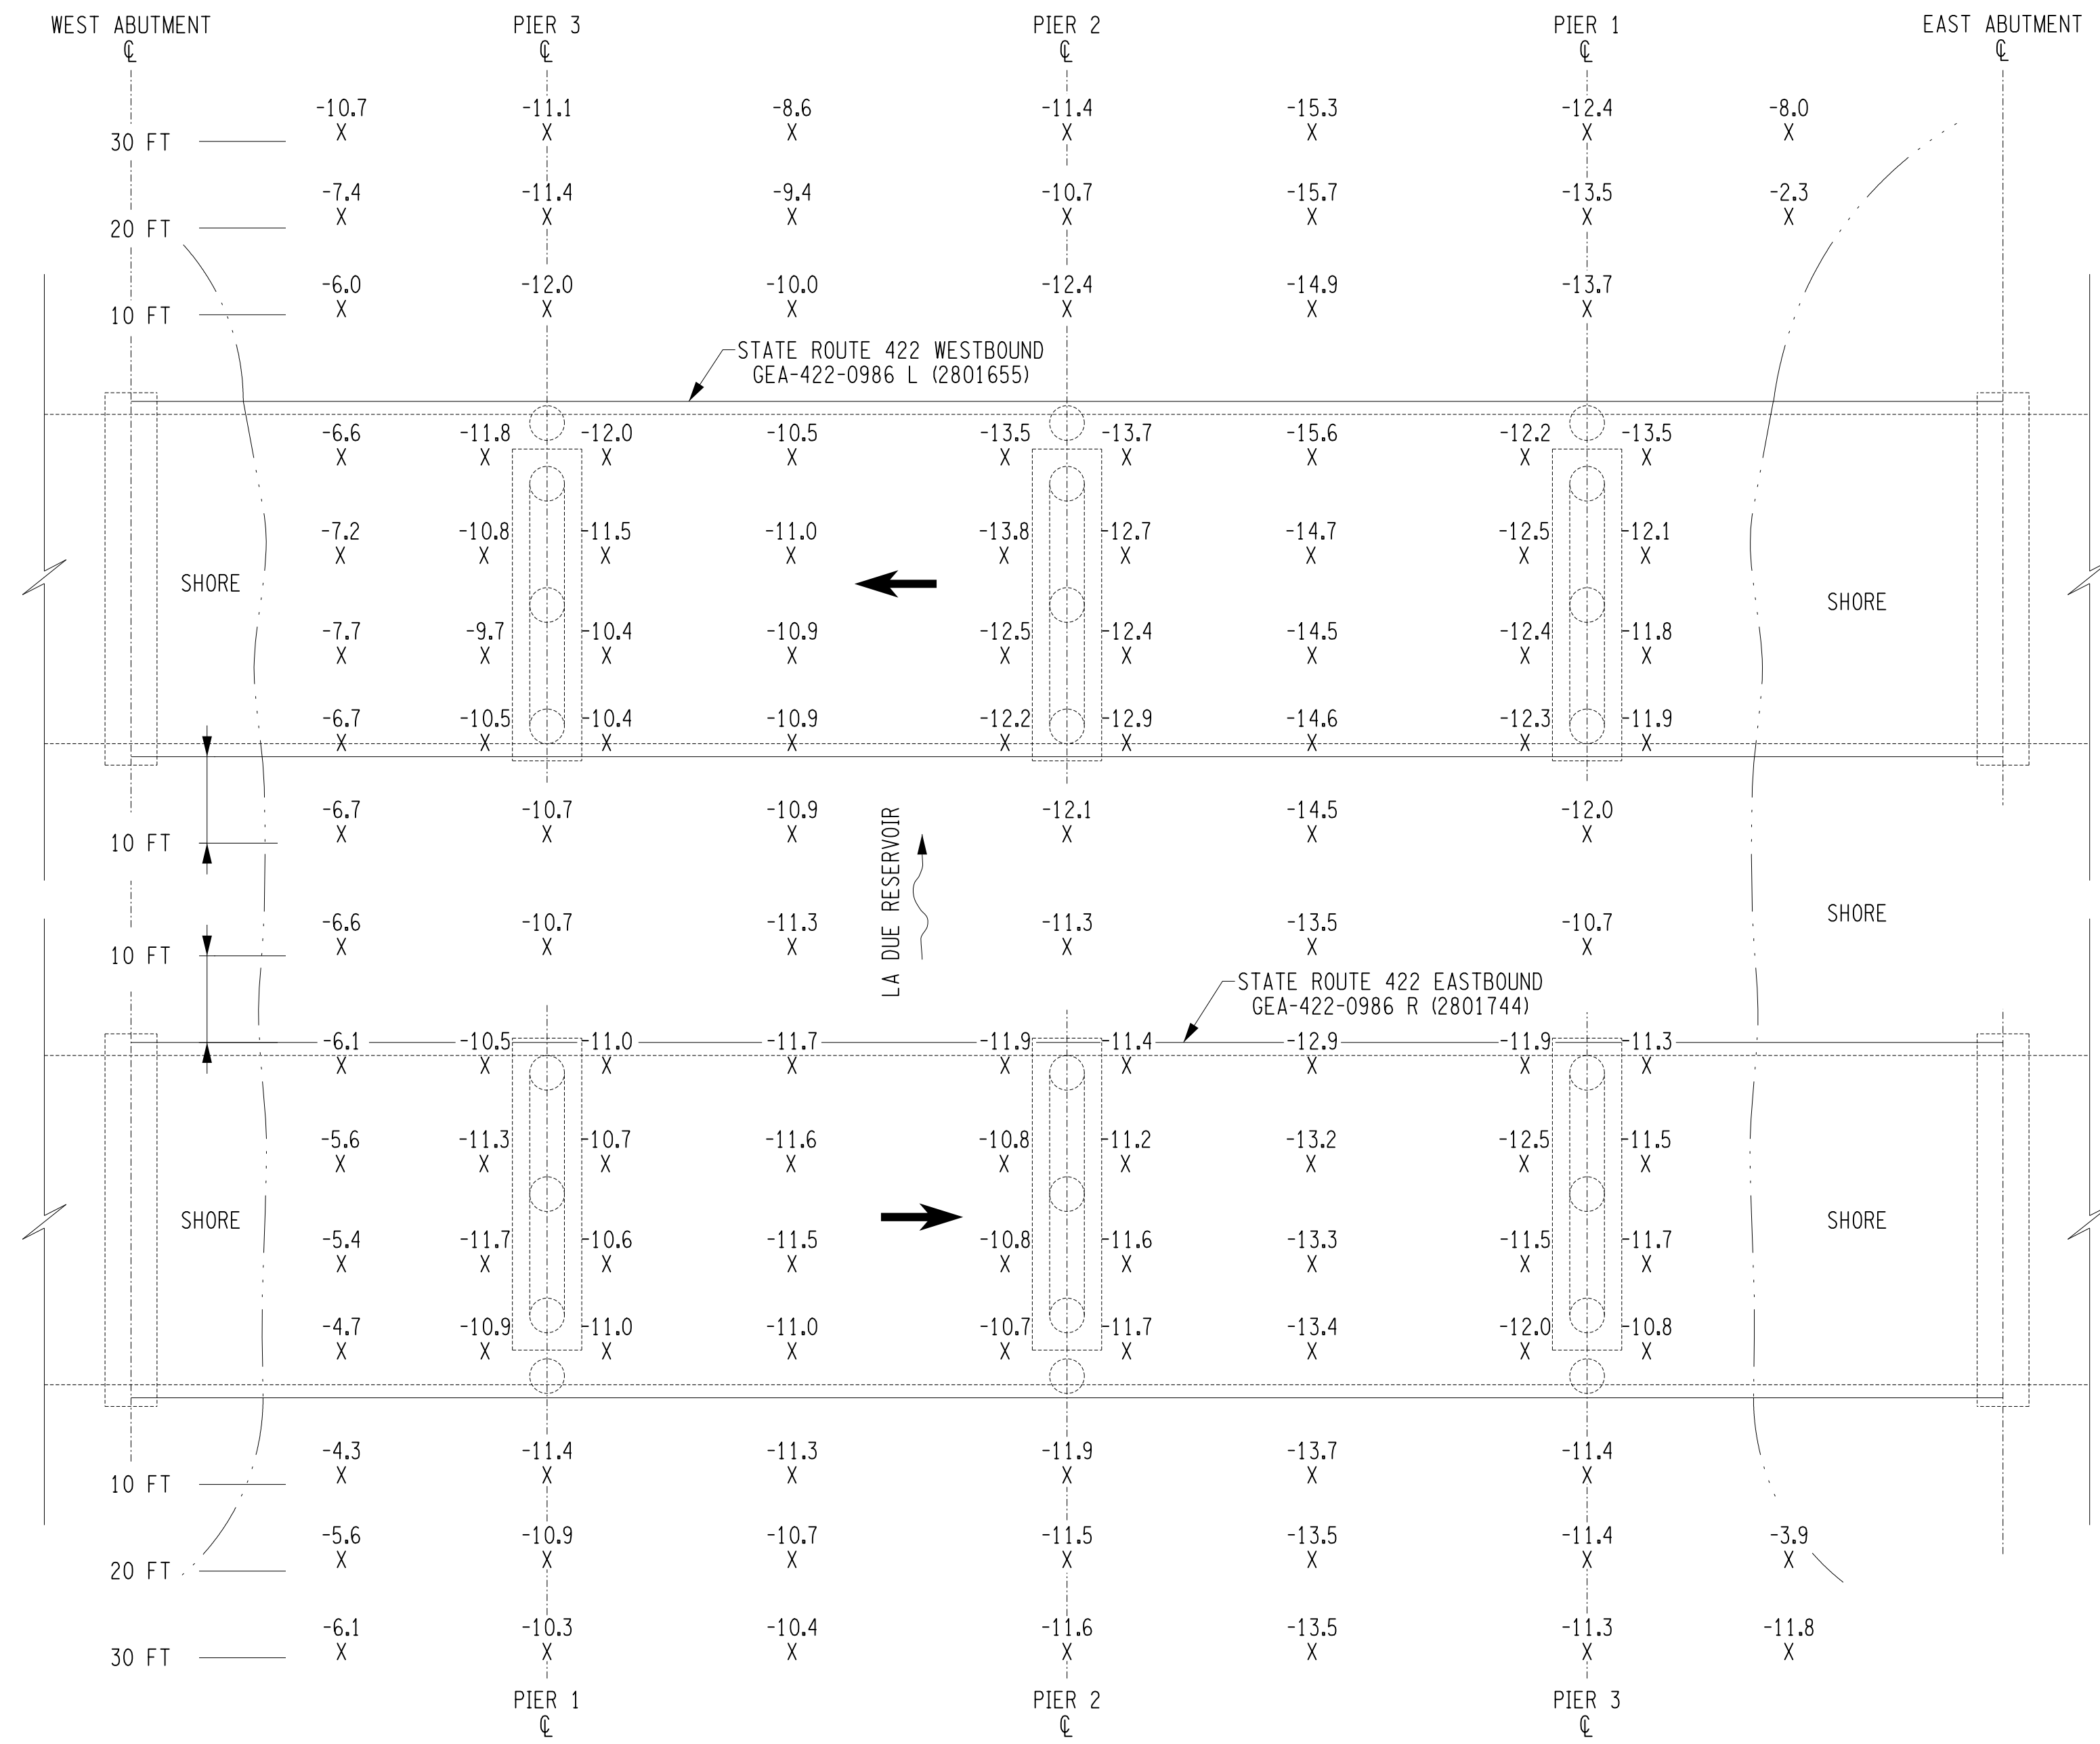
SOUNDING PLAN
NTS

The La Due Reservoir flows south to North under this structure. The thalweg of this river runs between Pier 1 and Pier 2 midspan. A maximum depth of 15.6 feet was found under the structure in the thalweg. Flow at this bridge was less than 1 foot per second.

- The Channel has stayed relatively the same since the last inspection with some minor changes in streambed elevation.
- Penetrations taken during soundings were typically 1 to 5 feet.

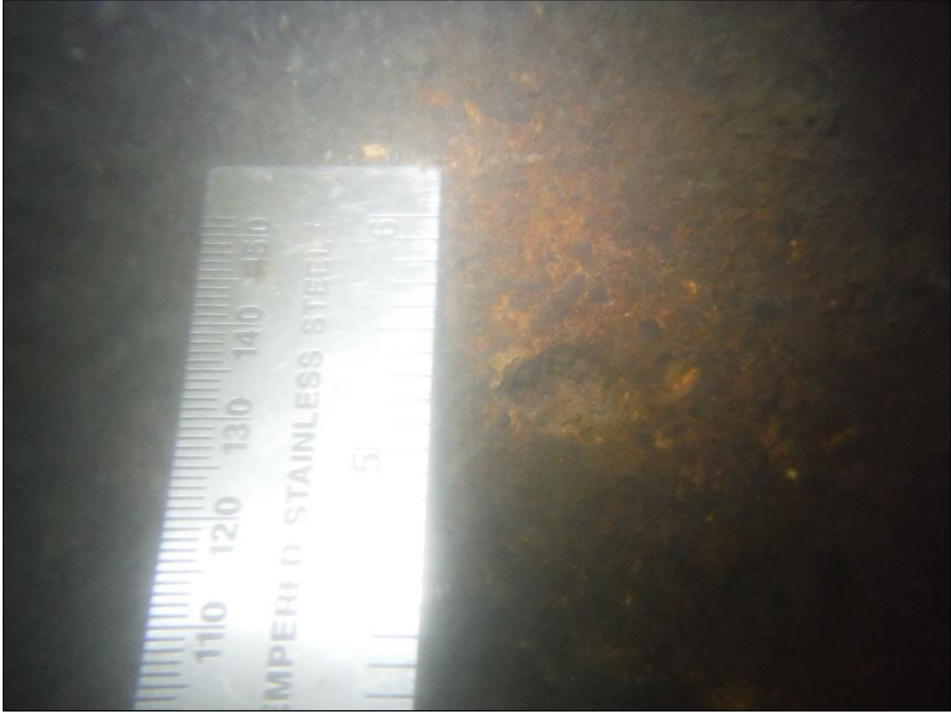
- Steel jacketed concrete drilled shaft has moderate corrosion and rust nodules 1/4 inch in diameter cover 25% of shaft from mudline to 10 feet above mudline on entire circumference of shaft. On south face of shaft 3 feet down from waterline rust nodules 1 ½ to 8 inches in diameter where observed. The rest of shaft has light to moderate corrosion present with no rust nodules observed.
- Light to moderate scaling at columns 1, 2 and 3 of Pier 2 where confirmed as documented in underwater inspection done in 2009 and has not advanced in severity.
- Minor construction debris observed at mudline near column 3.

A close-up photograph showing a dark, textured surface with a prominent, irregular rust nodule. The nodule is a mix of brown and orange colors. To the left of the nodule is a stainless steel ruler with markings in millimeters and centimeters. The ruler is labeled "IMPERIAL STAINLESS STEEL" and has numbers 110, 120, 130, 140, and 150 visible. The background is dark and out of focus.	<p>Photograph 11 Typical rust nodule on Steel Jacketed Shafts.</p>

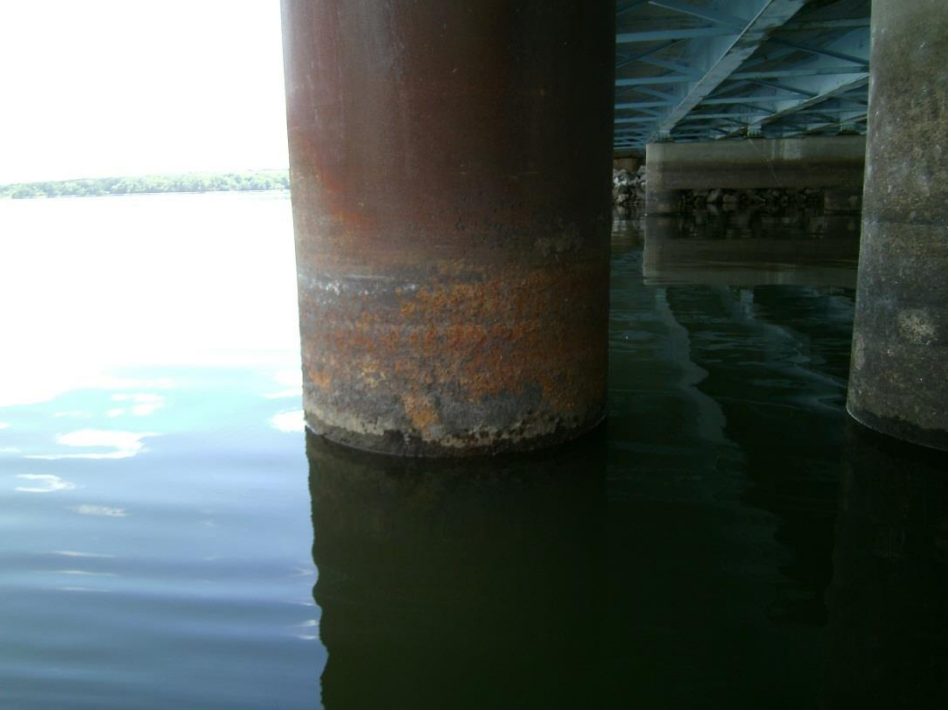
- Steel jacketed concrete drilled shaft has moderate corrosion and rust nodules 1/8 inch in diameter cover 25% of shaft from mudline to 8 feet above mudline on entire circumference of shaft .The rest of shaft has light to moderate corrosion present with no rust nodules observed.
- Light to moderate scaling at columns 1, 2 and 3 of Pier 1 where confirmed as documented in underwater inspection done in 2009 and has not advanced in severity (See photo 13).
- Minor construction debris observed at mudline near column 1.

A photograph of a large, cylindrical steel jacketed shaft in a body of water. The shaft is heavily corroded, with a thick layer of orange-brown rust covering most of its surface. The water is dark blue and reflects the shaft. In the background, there are other similar shafts and a concrete structure, possibly a bridge pier, under a clear sky.	<p>Photograph 12 Typical moderate corrosion. Representative of corrosion underwater on Steel Jacketed Shafts.</p>

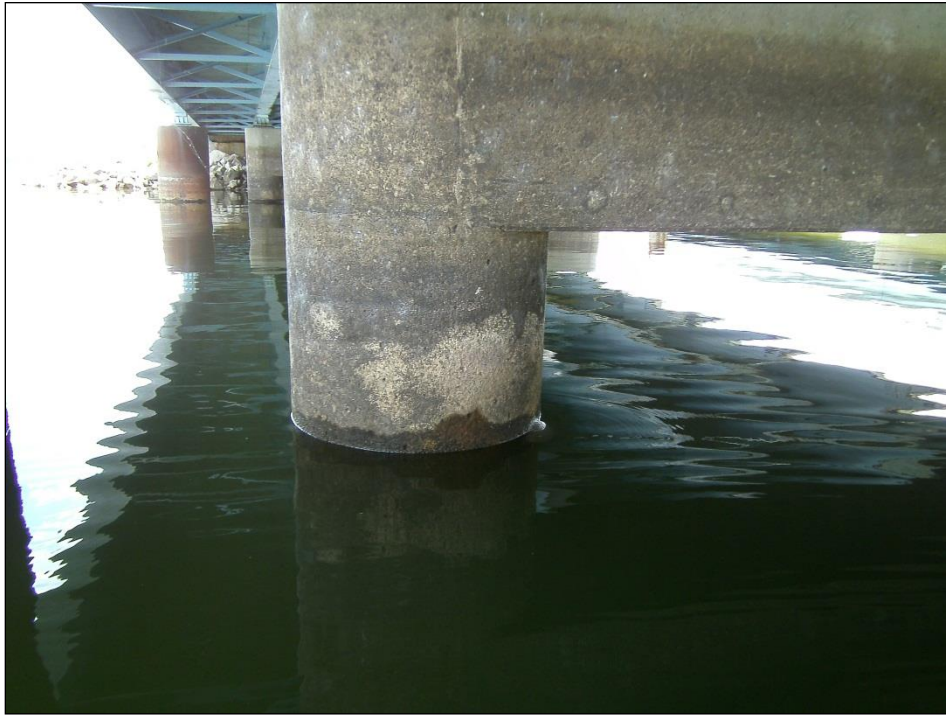
Photograph
13
Typical scaling
on columns.

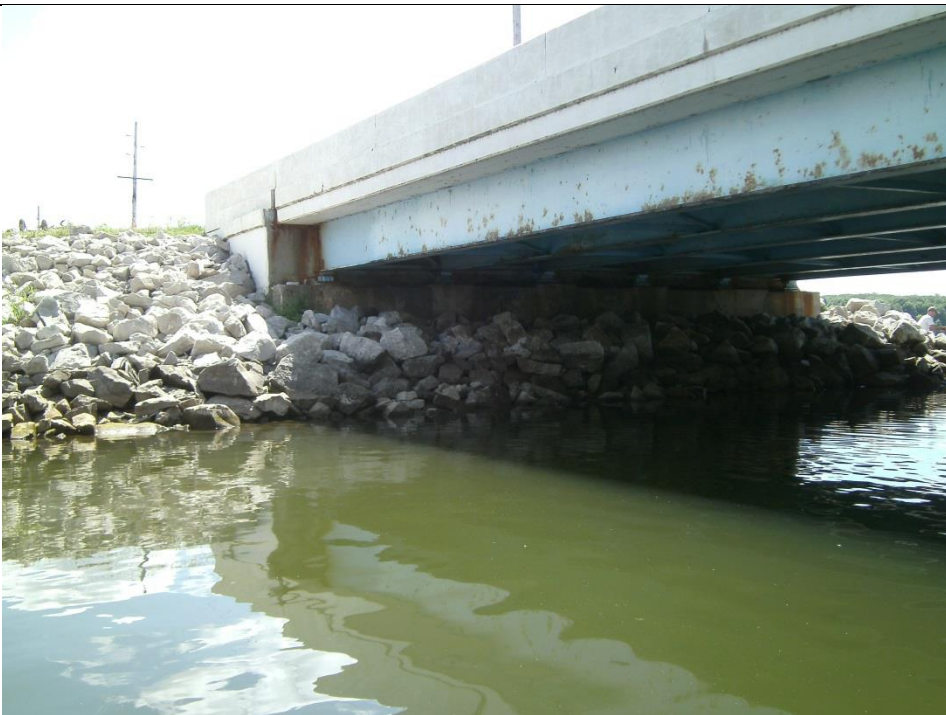
Photograph
14
Typical
embankment
protection.
