## BRIDGE INSPECTION REPORT

2801744  
Structure File NumberBRIDGE NUMBER **GEA 00422 0986 R**YEAR BUILT **1960**DIST **12** Bridge Type **322** TYPE SERVICE **1 5** **LA DUE RES. 0.71 MI E 44**

BRIDGE No. GEA-422-0986R

UNDERWATER INSPECTION REPORT  
on CONCRETE COLUMN PIERS

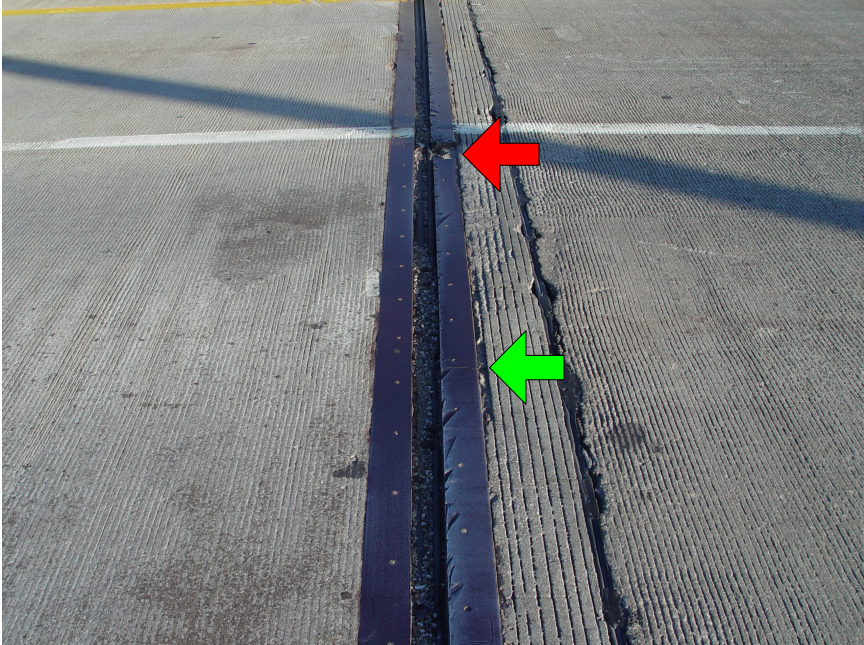
FLOOR: A FEW TRANSVERSE CRACKS. FLOOR < 1% DET.  
WS: CRACKS. WS < 1% DET.  
EXJTS: FINISH BACKWALL ARMOR IS GOUGED AND CRACKED.  
A 6 INCH LONG PIECE OF THIS ARMOR IS MISSING.  
SEE WORK ORDERS 620 2007\*5 AND 620 2007G 17.  
SEE ATTACHED PHOTOS #1 THRU #3 DATED 10/28/04.  
RAILING: MINOR SPALL AND DELAMINATIONS ON LEFT RAIL.

PHOTO #1  
FINISH JOINT APPROACH SLAB DECK  
ARMOR IS BROKEN AT RED ARROW, AND  
CRACKED AT THE GREEN ARROW. THIS IS  
IN THE #2 LANE. NOTE SEVERAL GOUGES  
TO APPROACH SLAB SIDE OF DECK  
ARMOR. DECK SIDE ARMOR IS 3/8" LOWER  
THAN SLAB SIDE IN PLACES.

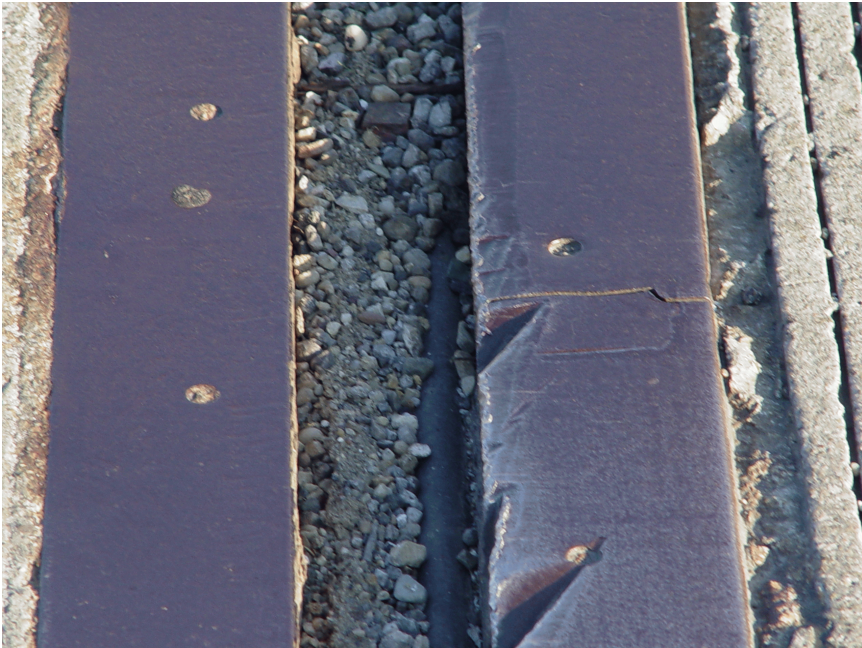
PHOTO #2  
CLOSE UP OF GREEN ARROW ABOVE.

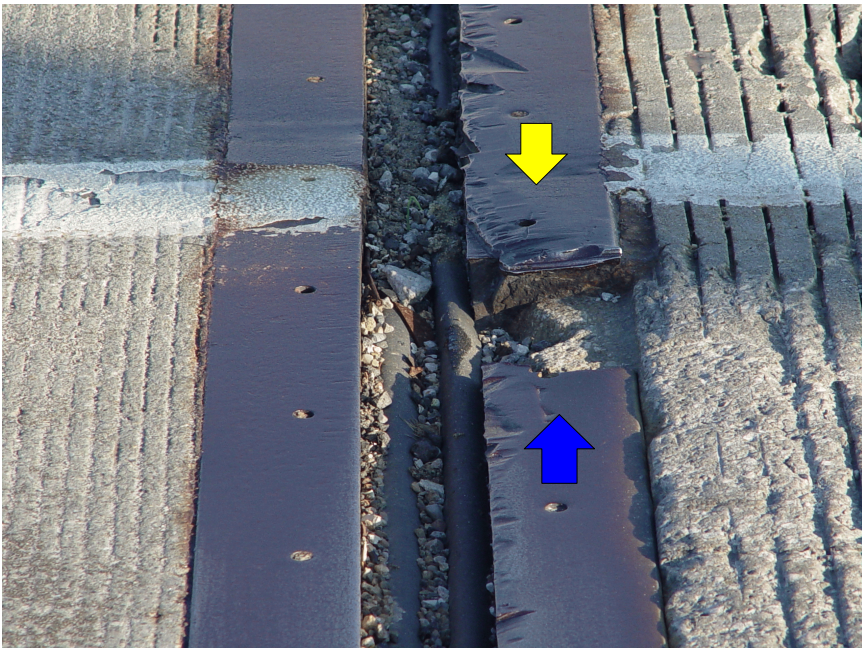
PHOTO #3  
CLOSE UP OF RED ARROW ABOVE. BLUE  
ARROW SHOW THAT THIS SIDE OF  
ARMOR IS A 1/2" LOWER THEN YELLOW  
SIDE OF ARMOR.

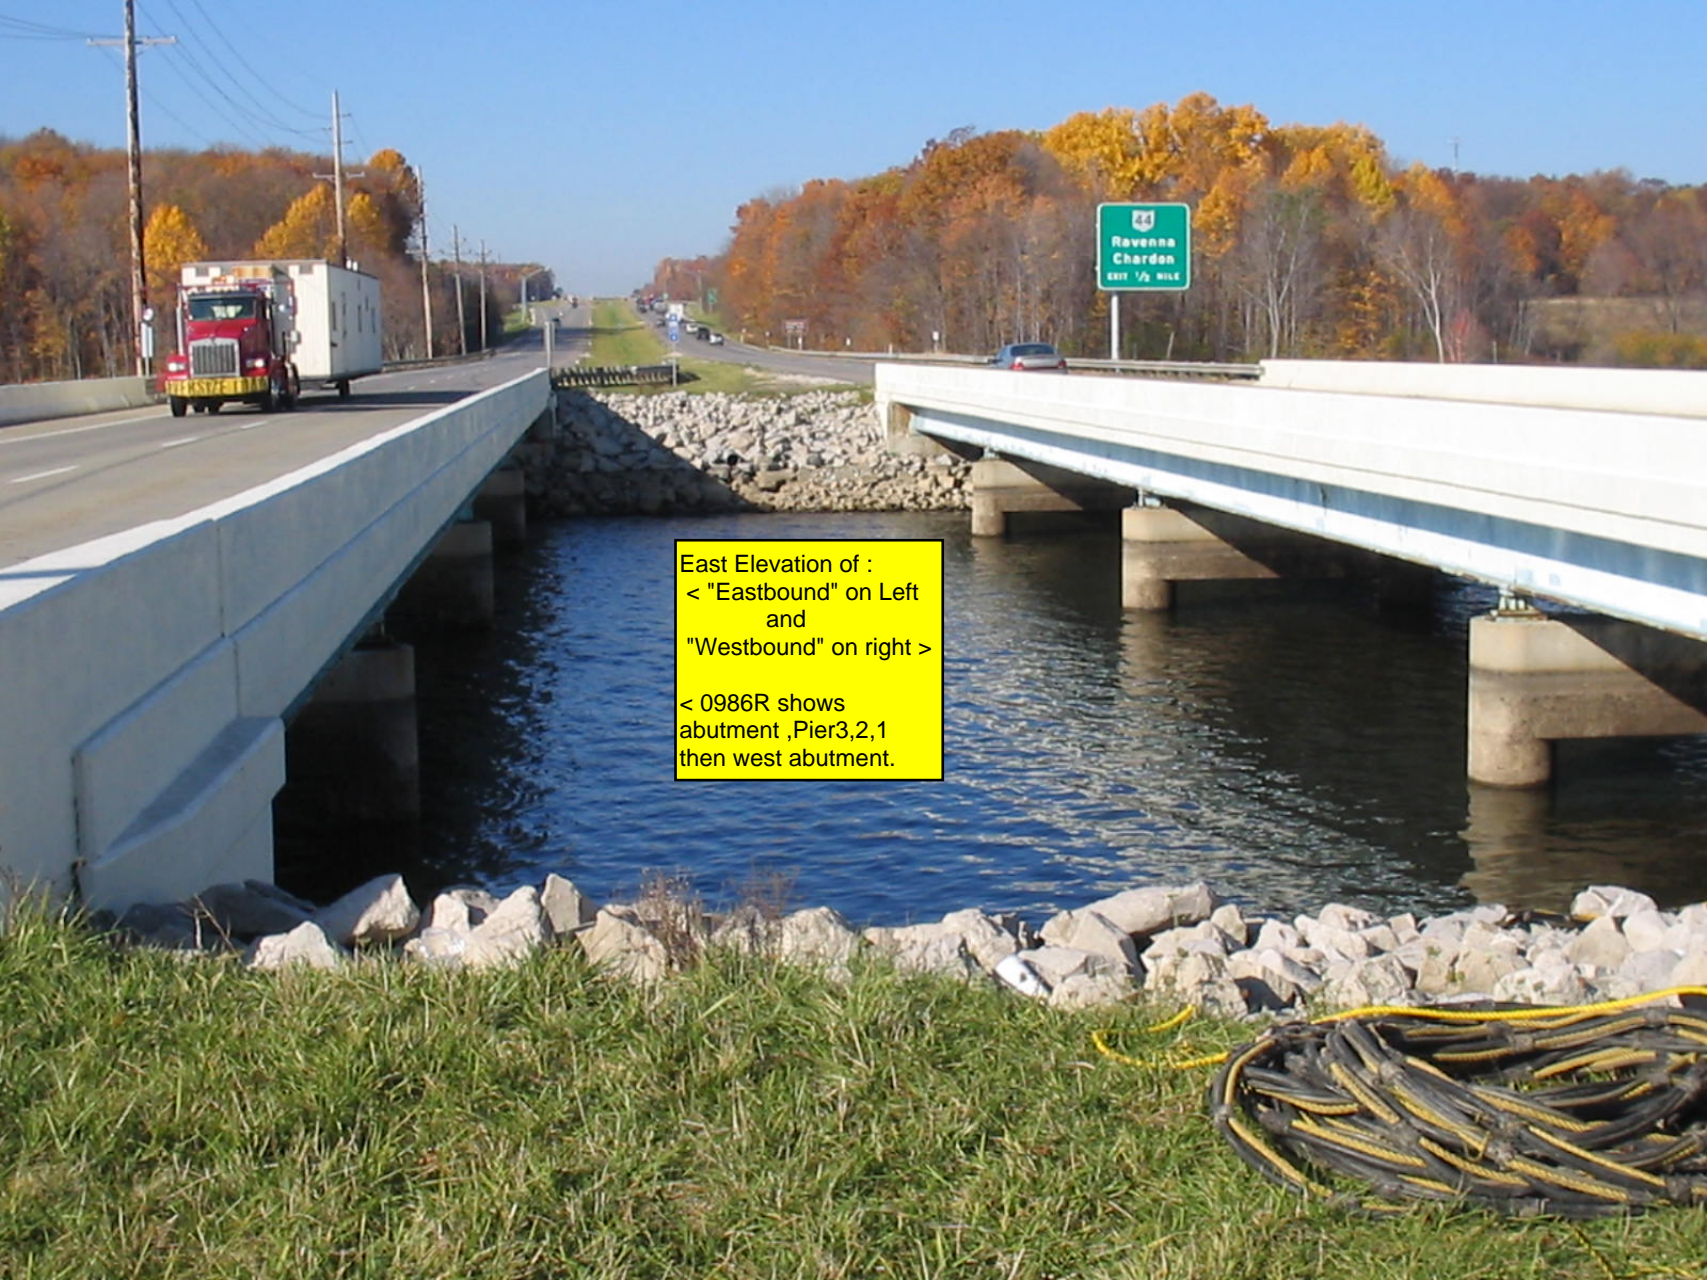
East Elevation of :  
< "Eastbound" on Left  
and  
"Westbound" on right >

< 0986R shows  
abutment ,Pier3,2,1  
then west abutment.

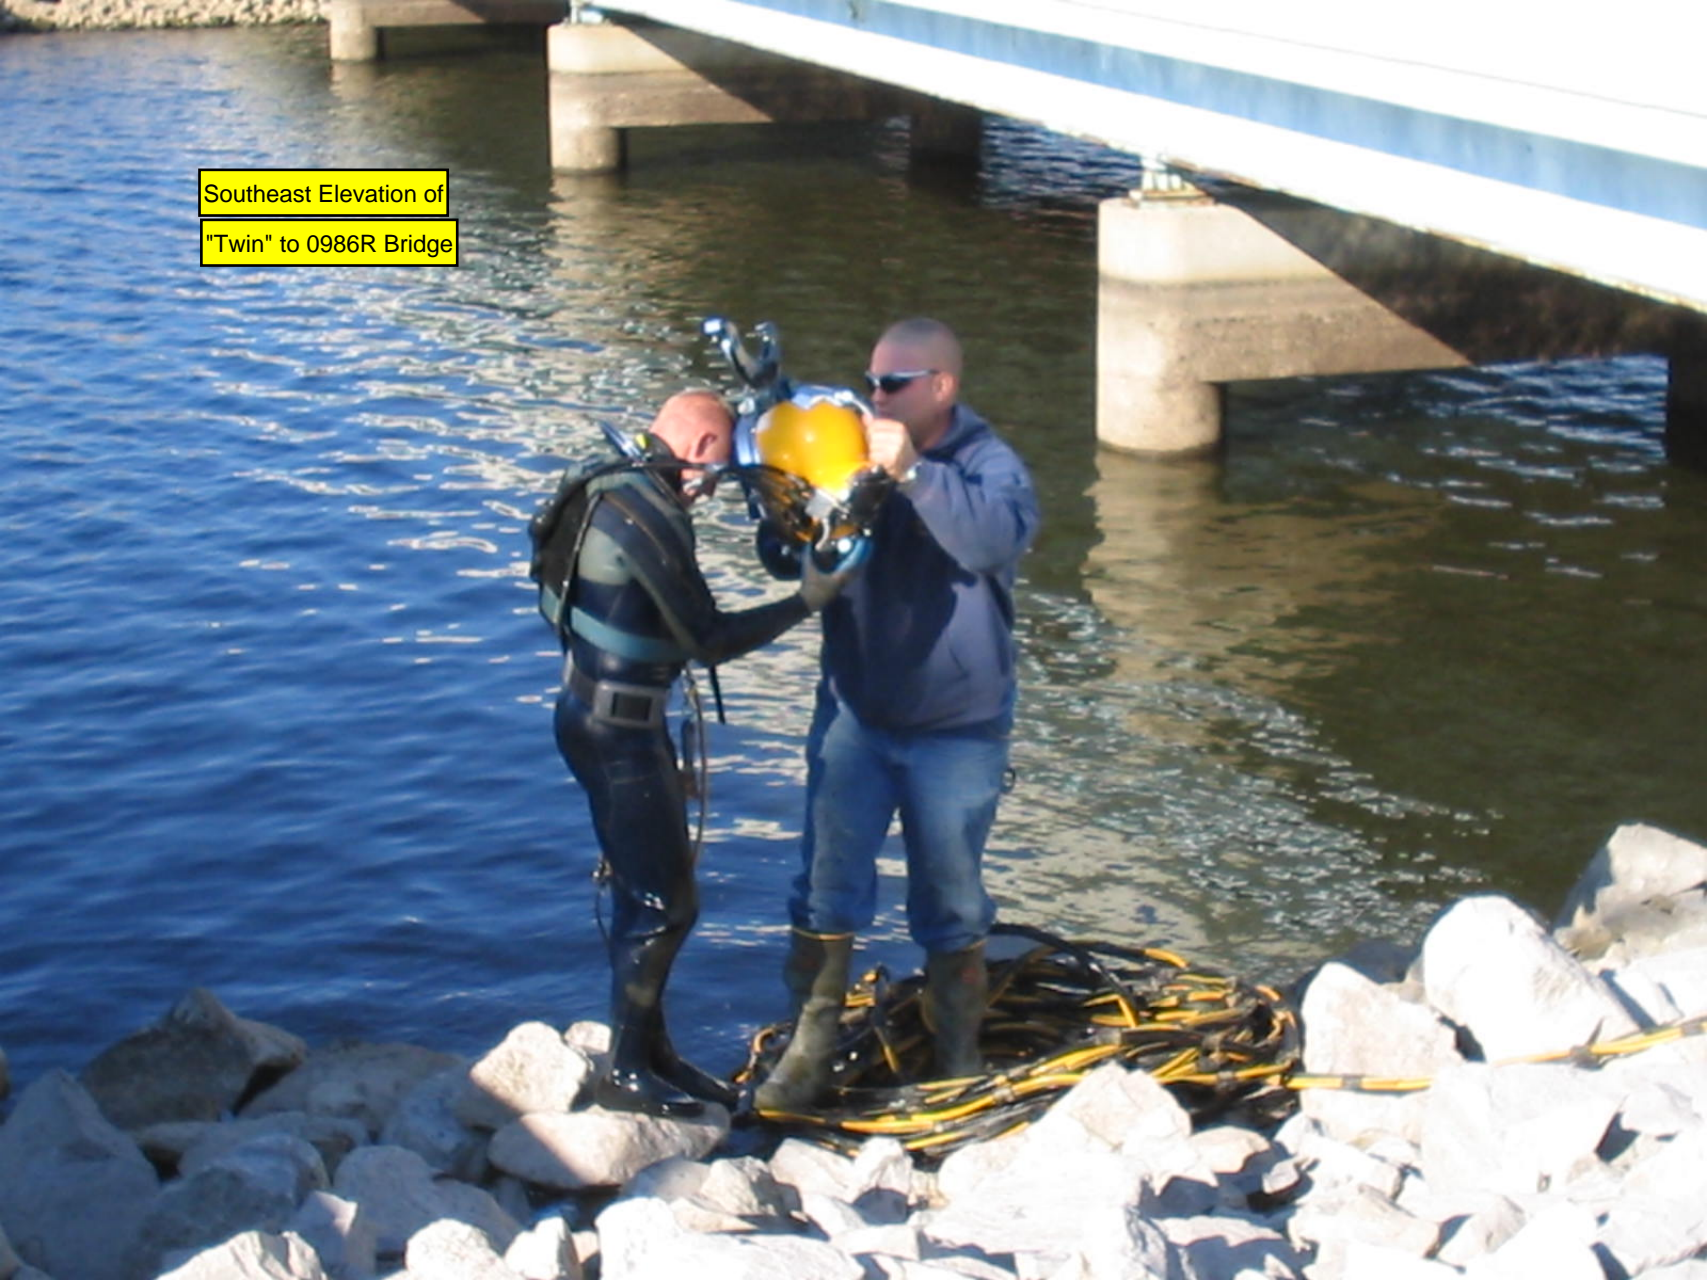
Southeast Elevation of

"Twin" to 0986R Bridge
